SUMMARY REPORT
GROUND PROJECT SURVEYS
FOR THE QUARTER ENDED
MARCH 31, 2006

SIGIR PA-06-052
JULY 31, 2006

Summary Report of Ground Project Surveys for the Quarter Ending March 31, 2006

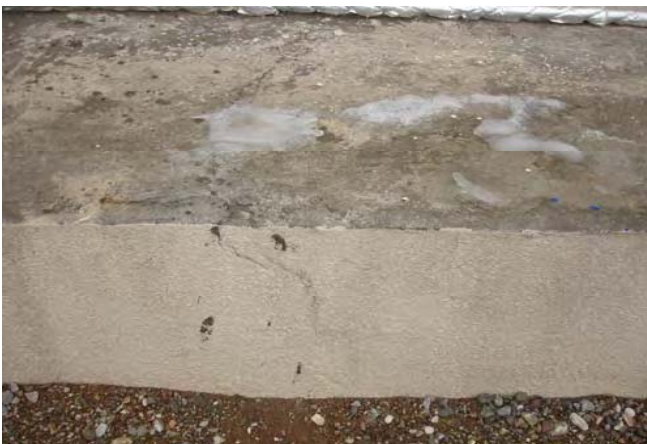
- Numerous cracks in the sidewalks and 45-degree cracks in the border post interior and exterior walls were observed “almost everywhere”. The 45-degree cracks could be shear cracks caused by differential settling. Site Photos 7 and 8 show examples of cracks in the sidewalks and walls.

Site Photo 7: Cracks in sidewalk (Project 12807)

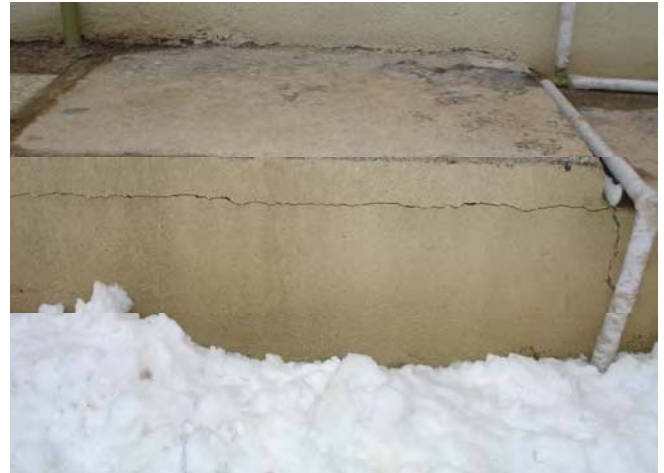
- Numerous cracks in the sidewalks and interior walls were observed. Site Photo 10 shows cracks in the sidewalks.
- Cracks could be due to poor quality workmanship or differential settling. Base plates for generators and fuel tanks were not properly secured.

Site Photo 10: Cracks in sidewalks (Project 12809)

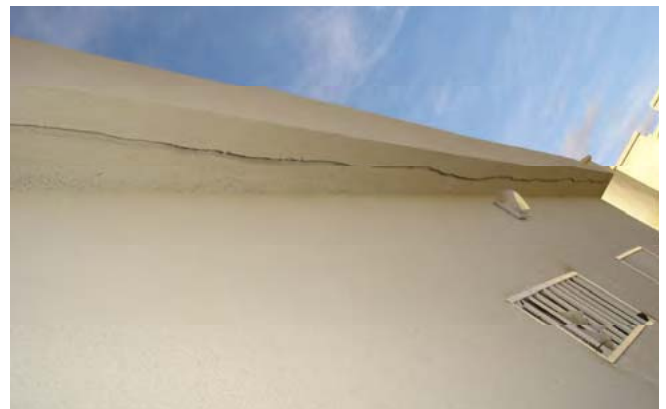
Site Photo 18: Cracks on exterior wall (Project 12835)

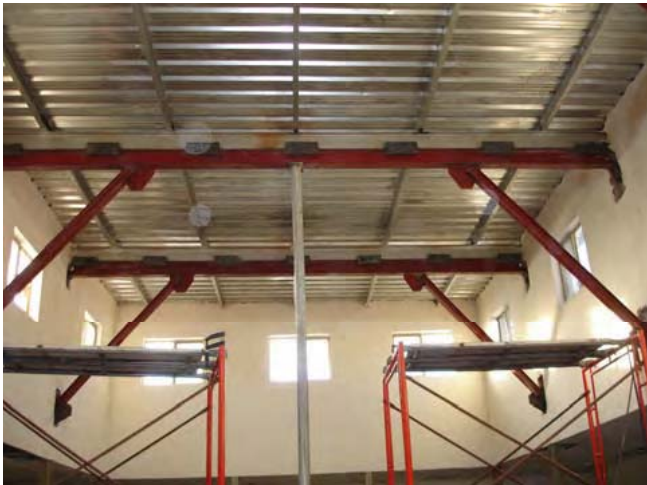
- No perimeter security fences or gates were present.
- The road to the border post was reported as difficult to access during the rainy or snowy seasons.
- The structural steel retrofit required due to the deflection of I-beams was in-progress. Steel angle supports mounted to block walls were observed to be of poor construction. Site Photo 20 shows the structural steel retrofit in progress.
- No filtration or sterilization (except boiling) of the water was available.
- Spot welds on the generator roofing appeared to be poor quality.
- The generator was not anchored to the concrete base. Site Photo 21 shows the generator and concrete base.
- Surface of exterior walls was not straight (inward curvature) and poor finishing was observed.

Site Photo 20: Steel retrofit in progress (Project 12850)

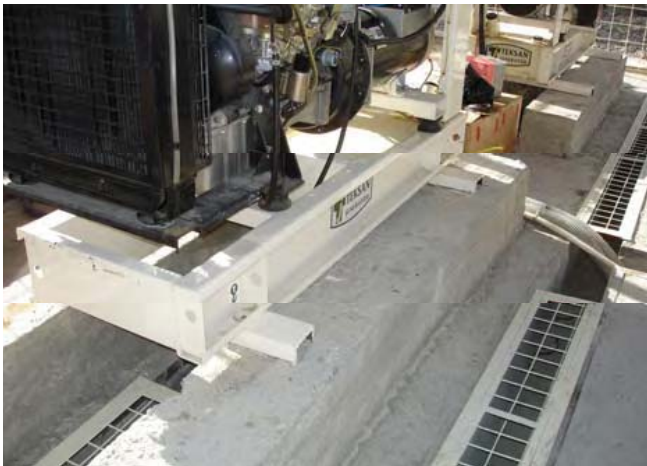
- No perimeter security fences or gates were present.
- The generator was not anchored to the concrete base. Site Photo 22 shows the generator and concrete base.
- Spot welds on the generator roofing appeared to be of poor quality.
- Poor finishing and broken concrete was observed at the septic tank cover.
- Roof water tanks base girders were not fastened to the concrete foundation. Site Photo 23 shows the water tank base.

Site Photo 22: Generator mounted on concrete base (Project 12855)

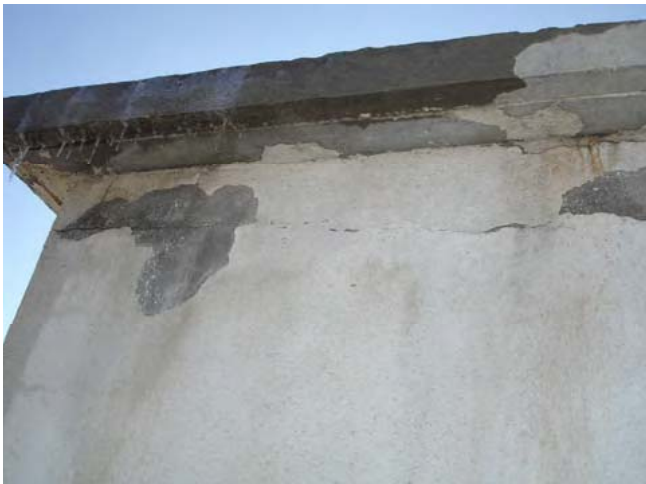
- Cracks in the concrete were observed extensively throughout the exterior of the three buildings, possibly due to differential settling of the foundation and/or poor construction. Site Photo 26 shows exterior wall cracks.

Site Photo 26: Cracks in exterior walls (Project 20558)

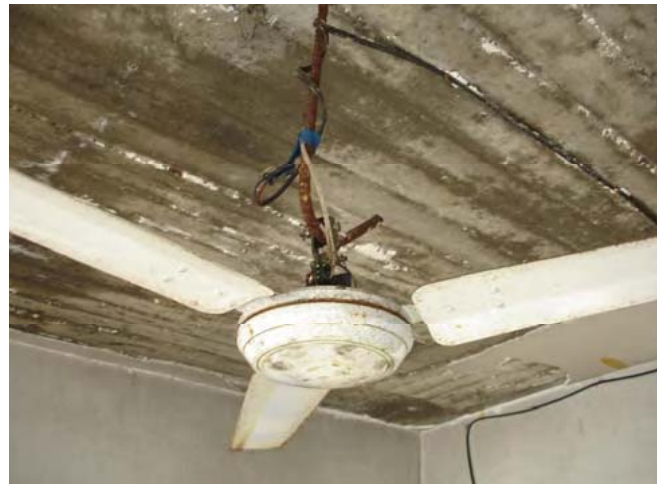
- Finishing of interior walls was extremely poor, showing cracks, staining, and peeling of plaster.
- Electrical installation was extremely poor with numerous areas of exposed wiring. Site Photo 27 shows exposed electrical wiring for ceiling fan.

Site Photo 27: Ceiling fan with exposed wiring (20558)

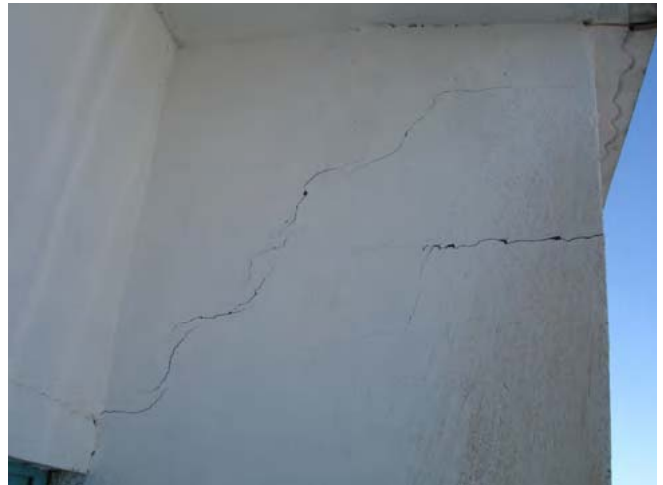
Site Photo 35: Cracks in exterior wall (Project 20573)

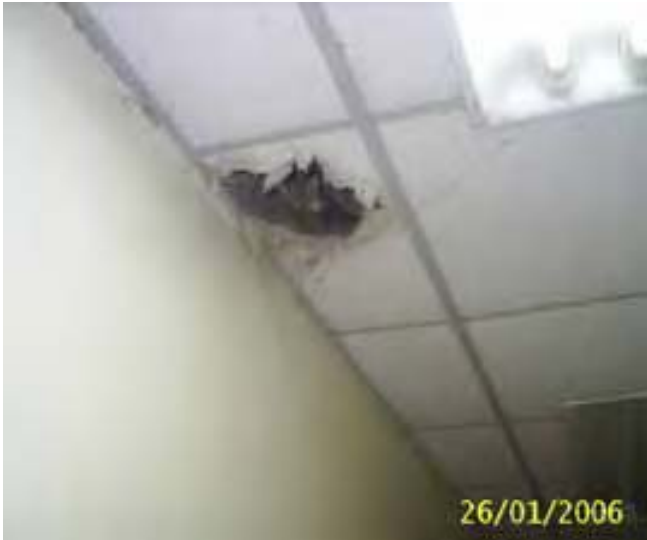
- Suspended ceiling showed signs of water damage, reportedly from leaking pipes. Site Photo 51 shows an example of a water damaged suspended ceiling tile.
- Standing water was observed adjacent to the exterior of the building from water pipe leaks.
- Painted walls were blistering, possibly due to improper preparation and/or low quality paint.
- The bathrooms showed signs of water leakage and tile damage. Site Photo 52 shows a bathroom with water leaks and tile damage.
- Water pipes in the basement were leaking, causing water to accumulate on the concrete floor. Site Photo 53 shows water accumulated in the hospital basement.
- Doors and locks were reported to be of low quality.

Site Photo 51: Water damaged suspended ceiling (Project 16124)

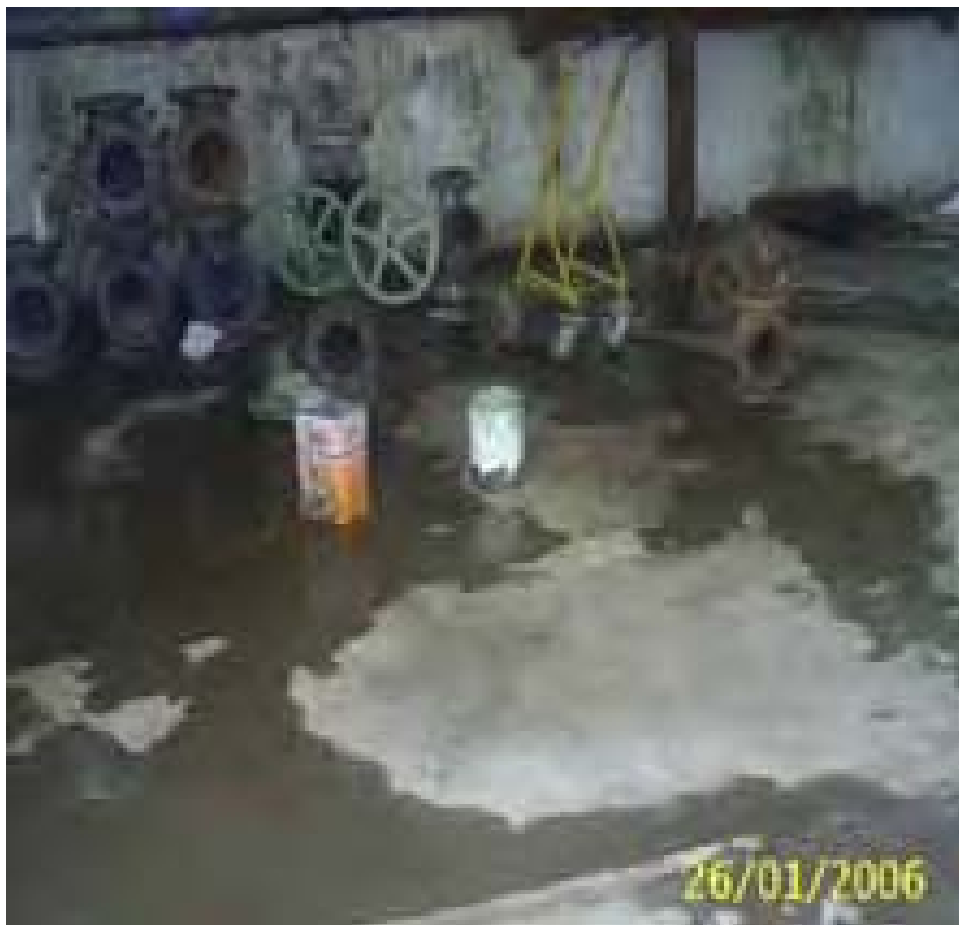
Site Photo 53: Water leaking in hospital basement (Project 16124)

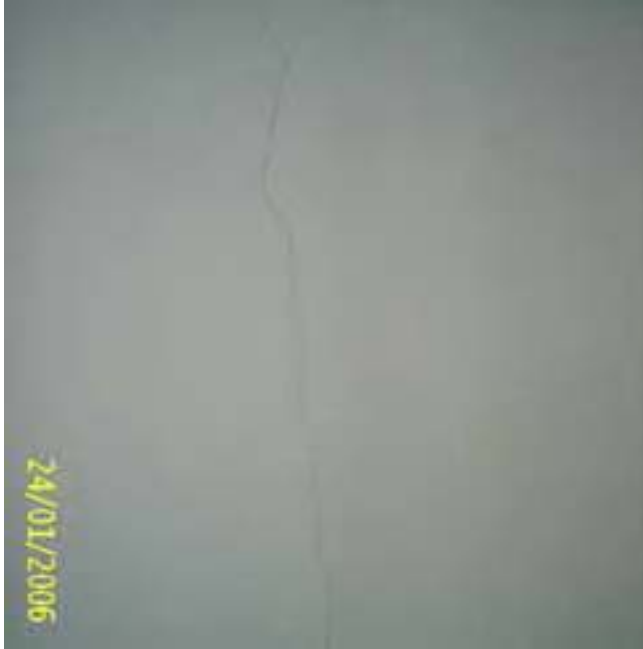
The IRMS database listed the project as 100 percent complete on 16 May 2005. The project consisted of the renovation of existing structures and new construction. Perimeter security walls topped with concertina wire, entrance gates, and corner guard posts were complete at the time of the visit. Contract line item 10 (d) included \$12,000 for a generator. It was reported the contractor did not supply new generators because the Police Headquarters supplied the facility with generators. Discrepancies noted during the visit included numerous cracks in interior walls. Site Photo 64 and 65 show examples of cracks in the walls.

Site Photo 64: Cracks in interior wall (Project 19117)

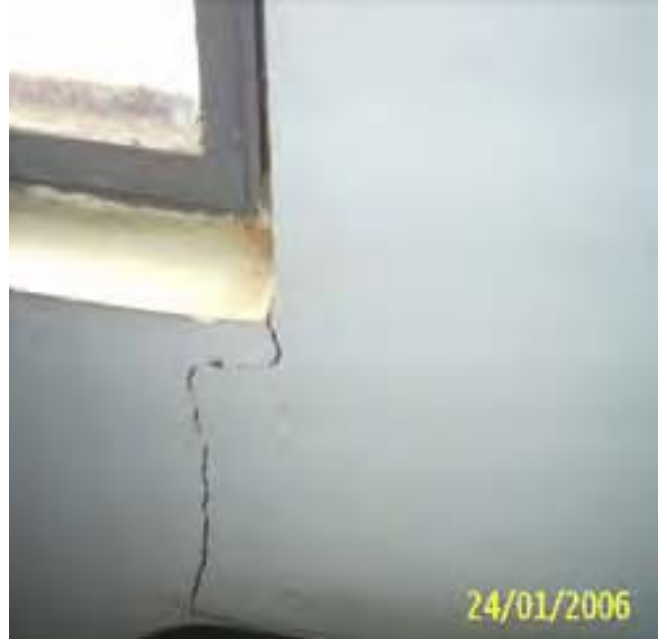
Site Photo 65: Wall cracks below window (Project 19117)

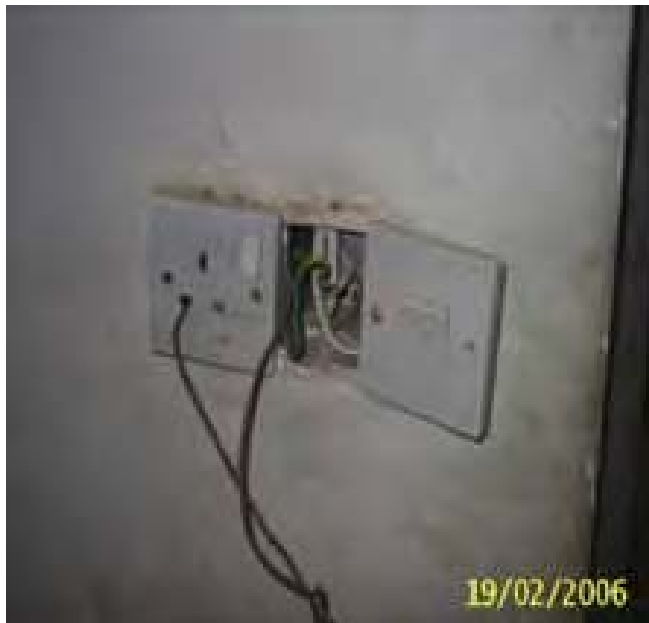
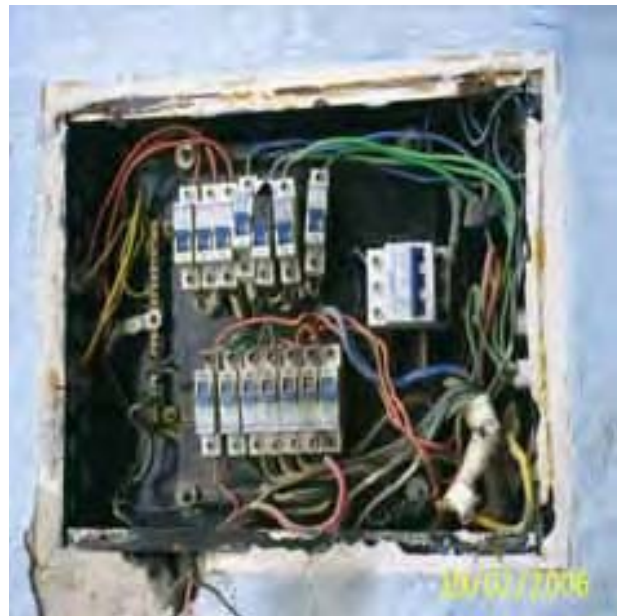
- Electrical systems had exposed wiring, broken fixtures, improper connections, and missing electrical covers throughout the entire police station. Site Photo 66 and 67 show examples of the electrical systems
- Interior and exterior paint was peeling due probably to low quality paint and/or improper preparation of the walls before painting. Site Photo 68 shows an interior wall with peeling paint.
- Numerous cracks were visible in the interior walls.
- Exterior walls were not completely finished, with exposed concrete block present.
- Roof tiles were not properly repaired and installed. Site Photo 69 shows an example of the damaged roof tiles.

Site Photo 66: Electrical wall switches (Project 19175)

Site Photo 67: Electrical circuit breaker panel (Project 19175)

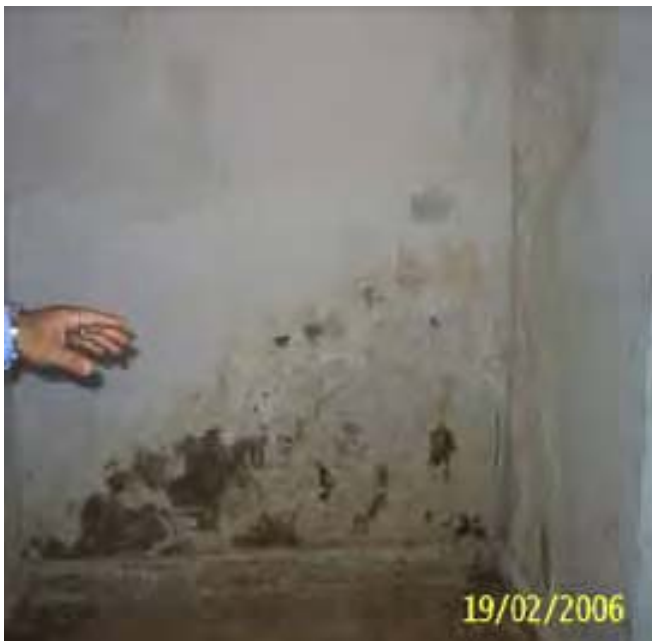
Site Photo 68: Interior wall with peeling paint (Project 19175)

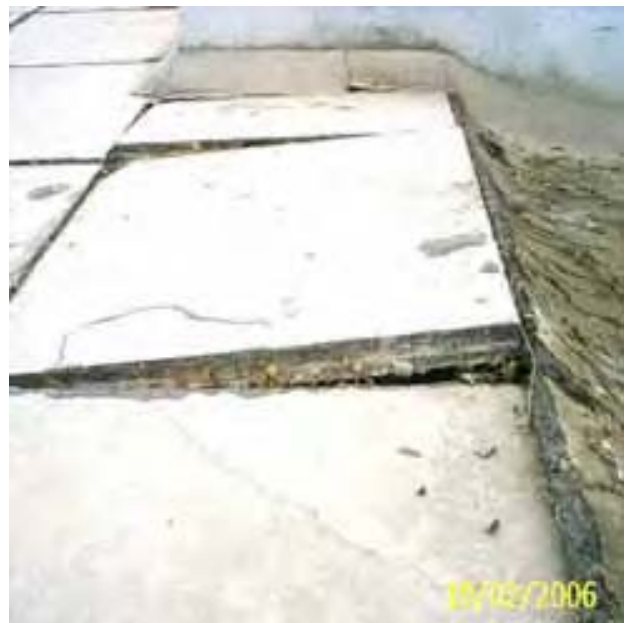
Site Photo 69: Damaged roof tiles (Project 19175)

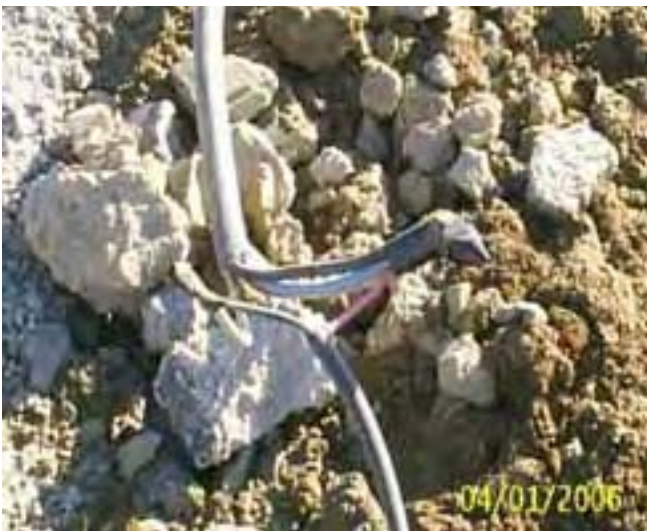
improper electrical connections. Site Photo 72 shows exterior electrical wiring located on the ground surface and Site Photo 73 shows interior lights with possible fire damage.

Site Photo 72: Exposed electrical wirings (Project 19179)

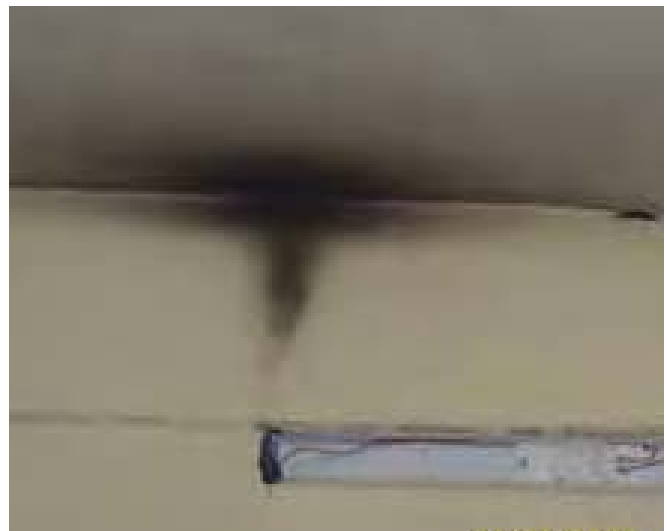
Site Photo 73: Interior electrical light with smoke damage (Project 19179)

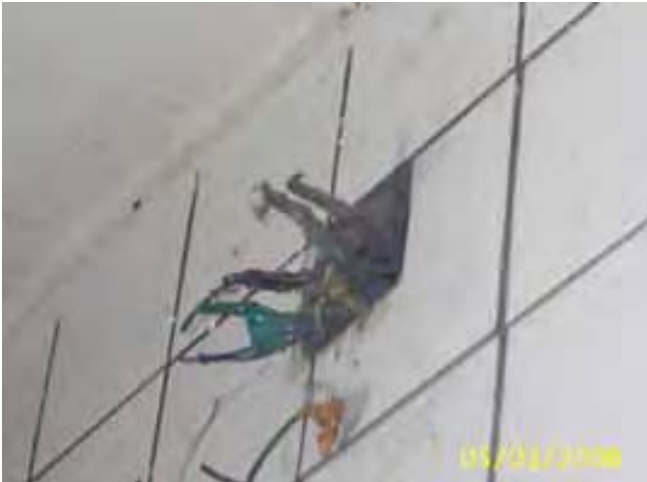
Site Photo 74: Exposed electrical wirings (Project 19181)

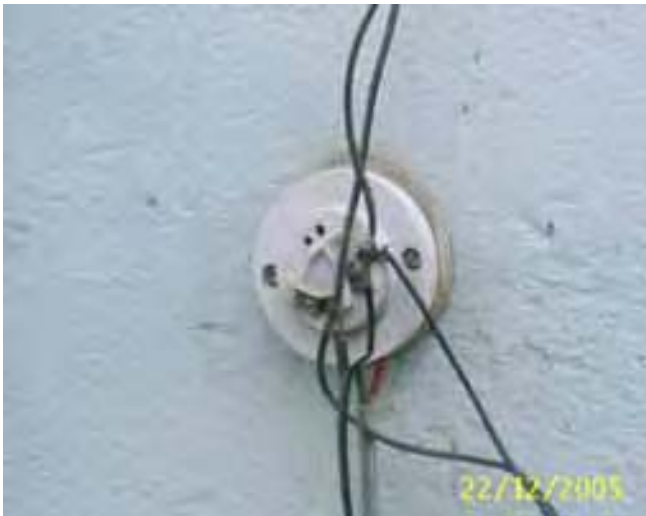
Site Photo 76: Exposed electrical wirings (Project 19189)

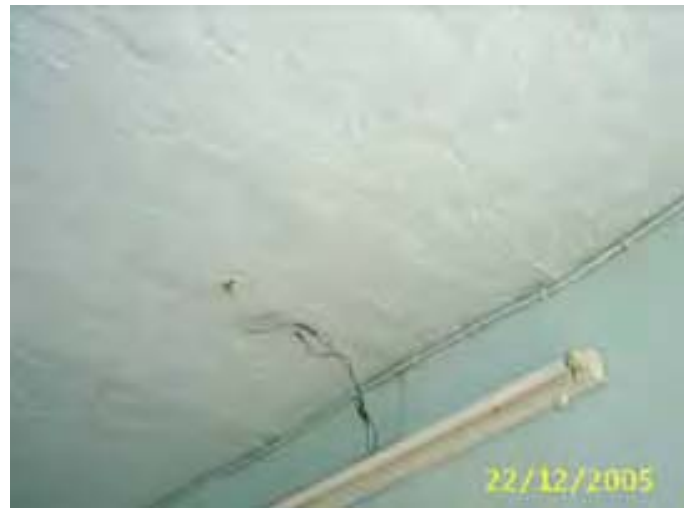
Site Photo 77: Roof and inconsistent ceiling texture (Project 19189)

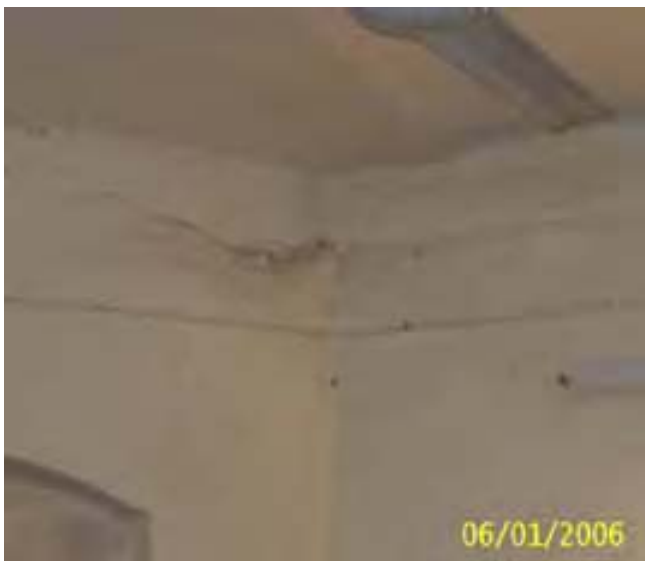
Site Photo 78: Cracks and peeling paint in walls and ceiling (Project 19227)

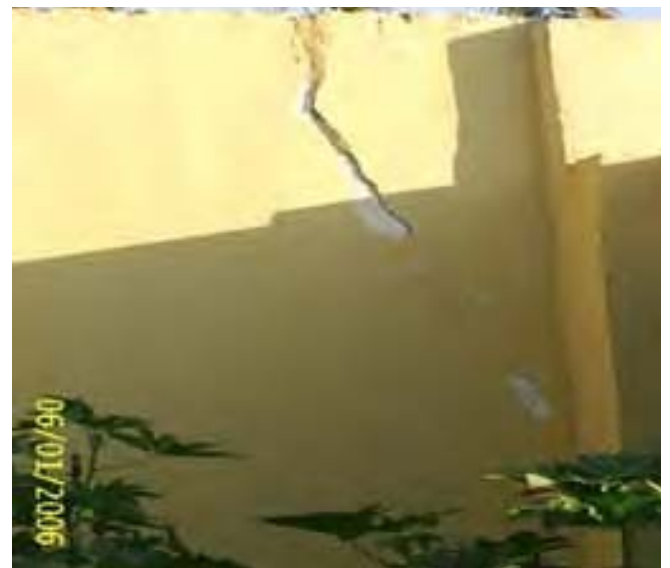
Site Photo 79: Crack in perimeter wall (Project 19227)

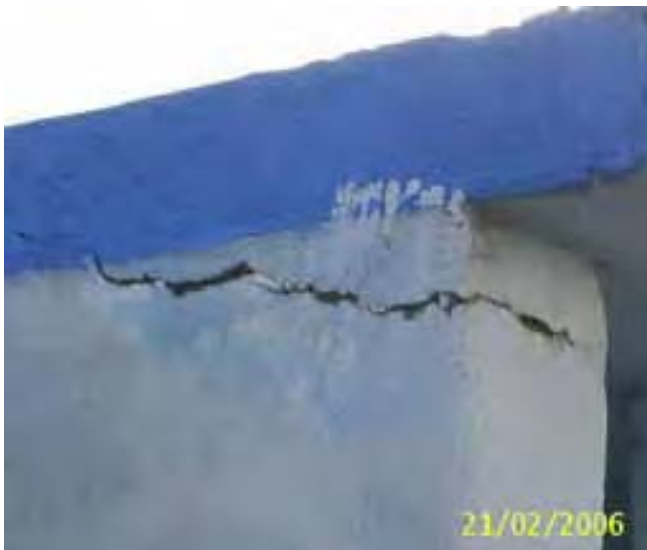
Site Photo 80: Cracks in exterior walls (Project 19230)

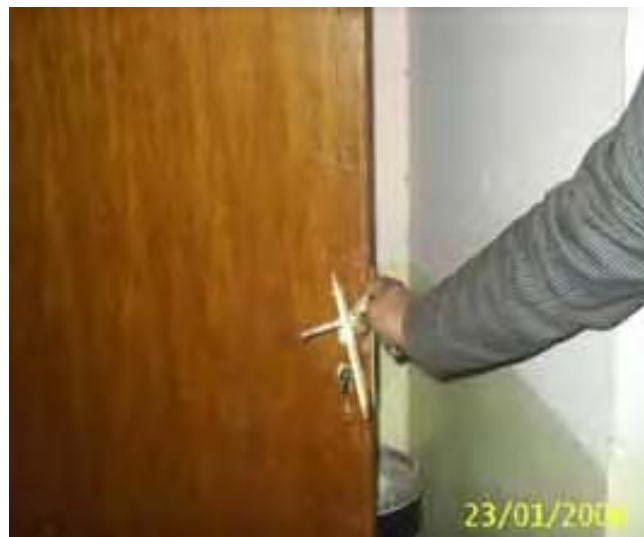
Site Photo 83: Broken door handle (Project 20324)
