BAGHDAD AL KARKH
COURTHOUSE
BAGHDAD, IRAQ

SIGIR-PA-06-058
OCTOBER 10, 2006

SUBJECT: Report on Project Assessment of the New Al Karkh Courthouse,
Baghdad, Iraq (Report Number SIGIR-PA-06-058)

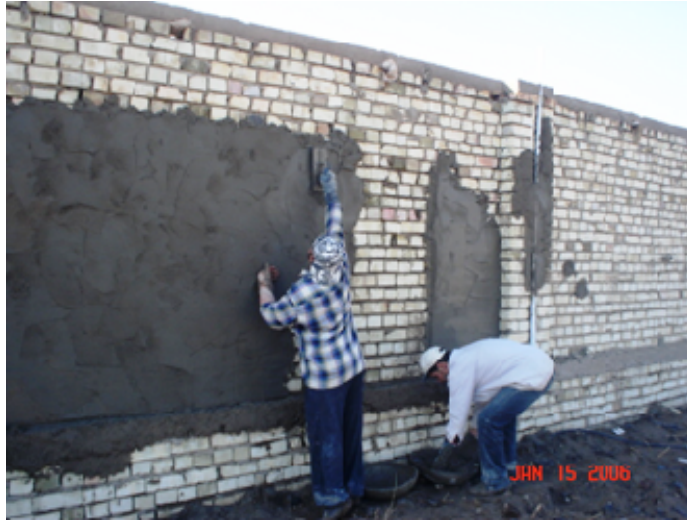
Based on our review of the QA reports and progress photos, there were no issues with the quality of the workmanship on the brick perimeter wall. Site Photo 1 shows the contractor's workers rendering the brick wall using a cement plaster.

**Site Photo 1. Rendering the Brick Perimeter Wall with a Cement Plaster
(Photo provided by USACE)**

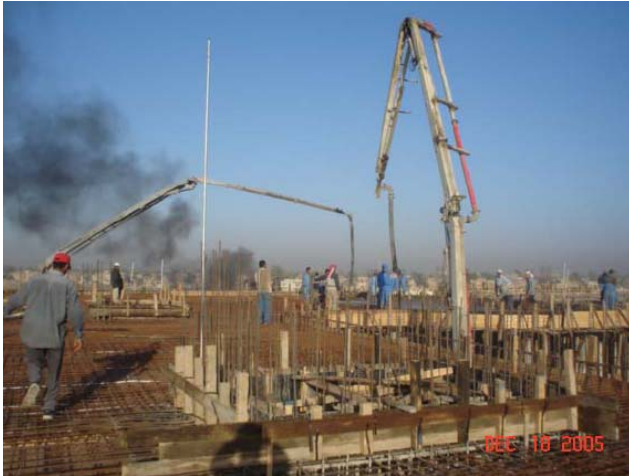
Overall, based on our review of the QA reports and the progress photos, the structural contract work appeared to meet the requirements of the SOW and the design. One of the contributing factors was the contractor’s concrete operations. The contractor set up a batch plant on site because of the significant concrete requirements. In addition, for large floor and roof slab concrete pours, the contractor utilized multiple pump trucks to place the concrete. As an example, Site Photos 2 and 3 show the booms from the contractor’s pump trucks delivering concrete for the roof slab placement.

Site Photo 2. Pump truck booms delivering concrete for roof slab pour (Photo provided by USACE)

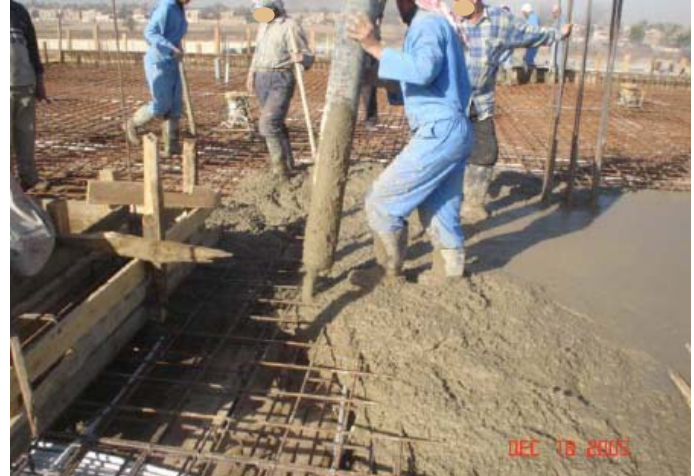
Site Photo 3. Concrete placement for roof slab pour (Photo provided by USACE)

In our review of the progress photos and QA reports we did not find any evidence of problems with the quality of the concrete, such as honeycombing, segregation, or exposed reinforcing steel. Additionally, our review of the QAR reports did not indicate any problems with the concrete achieving required compressive strengths.

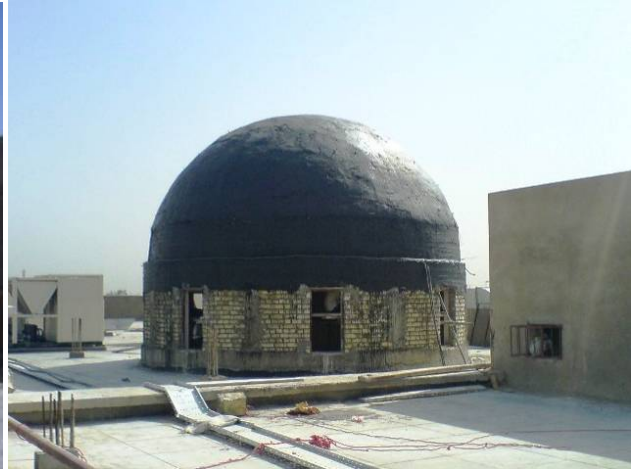
The roof dome over the building's atrium was a unique architectural feature of the building. The design required a reinforced concrete dome structure, clad with an exterior finish of stone panels. To build the dome, the contractor constructed a reinforced concrete base and a middle section with brick. The dome's middle section was anchored to the existing concrete base using structural steel H-columns as shown in Site Photo 9. Site Photo 10 shows the steel reinforcement in place in the dome prior to concrete placement and Site Photo 11 shows the dome after concrete placement and sealing with a bituminous waterproofing coat. The QA reports did not indicate any problems with the workmanship or document any deficiencies associated with the dome construction.

Site Photo 11. Dome after concrete placement and waterproofing (Photo provided by USACE)

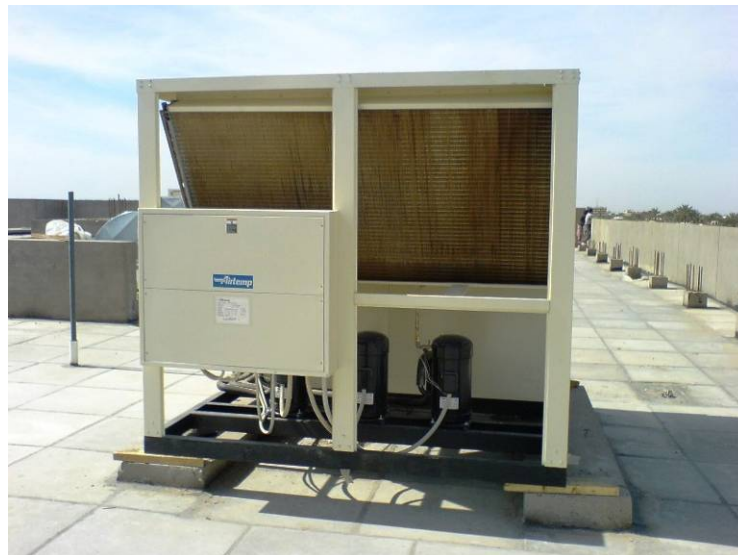
The design required 15 roof top HVAC units with a total cooling capacity of 795,000 BTU/hour or 66.25 tons. Site Photo 12 shows one of the roof top units. The progress photos indicate two types of HVAC units were installed, an Airtemp Model 530 and an Airtemp Model 415. We were not provided with the manufacturer's catalog information showing the cooling specifications of each type of unit installed; therefore, we could not verify if the units met the requirements of the design.

Site Photo 12. Roof top HVAC unit (Photo provided by USACE)

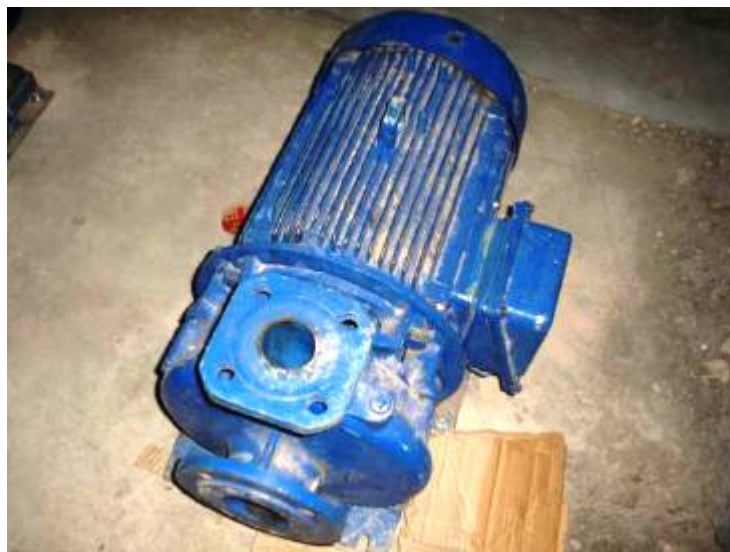
The design required four water circulation pumps, three for domestic water and one for the fire hydrant system. The capacity of the pumps according to the design was 18 m³/hour (hr) at 25 m head for the domestic water pumps and 18 m³/hr at 25 m head for the fire hydrant system pump. The contractor supplied and installed four circulation pumps. The pumps, based on our review of the QA report photos, do not appear new. We observed photos showing rust and dirt on the pump and motor housings. Site Photo 15 shows the condition of one of the pumps. In addition, the face plate on the fire hydrant pump system appears to have been altered because there are scratches in the entries for flow capacity.

Site Photo 15. Domestic water circulation pump (Photo provided by USACE)

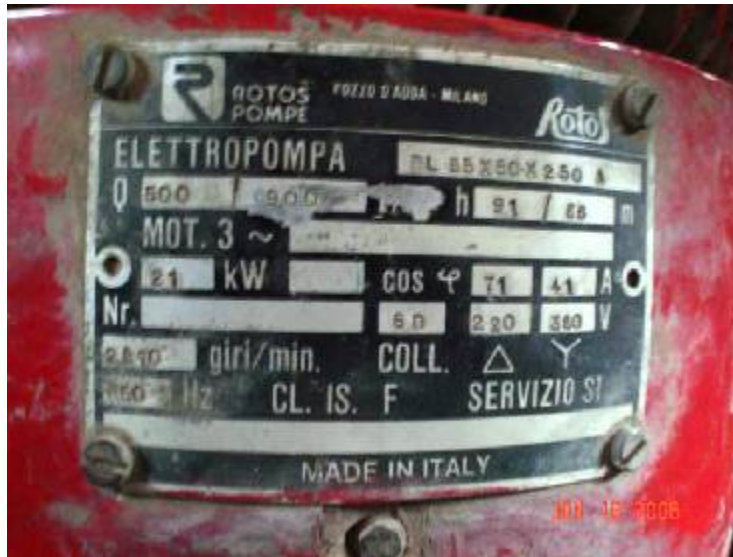
Site Photo 16. Factory plate for fire hydrant system pump (Photo provided by USACE)

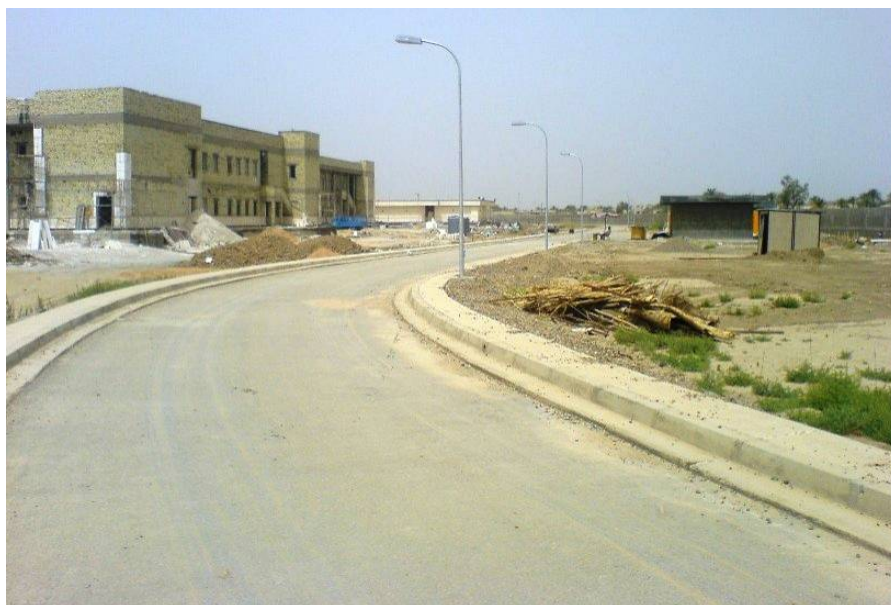
construction traffic. We found no reported deficiencies regarding the road and parking lot construction in our review of the QA reports and progress photos.

**Site Photo 19. Asphalt concrete base course with concrete curb and gutter
(Photo provided by USACE).**
