# BAGHDAD MUNICIPAL SOLID WASTE LANDFILL

SIGIR PA-06-067 OCTOBER 19, 2006

SUBJECT: Report on Project Assessment of the Baghdad Municipal Solid Waste Landfill, Baghdad, Iraq (Report Number SIGIR-PA-06-067)

# Baghdad Municipal Solid Waste Landfill Synopsis

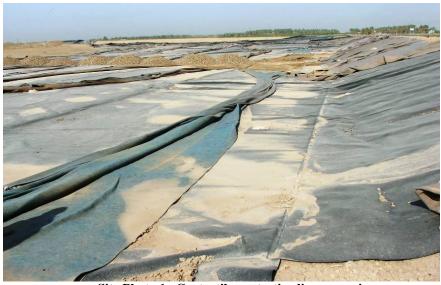
Site Photo 1. Geotextile protective liner covering

There was also wind blown sand covering parts of the geomembrane liner and geotextile covering as seen in Site Photos 1 and 2. If the landfill is commissioned into service, the geomembrane liner and geotextile cover will require remedial work to bring their condition up to standards. The contractor's geotextile cover specification states:

The specification also required seaming of the geotextile sections, either by sewing or thermally bonding the seams together. Based on our observations, many sections of the geotextile fabric in the uncovered part of the MSW landfill needed to be seamed. This seaming process should take place after the underlying geomembrane is cleaned, followed by the cleaning and placement of the geotextile fabric over the geomembrane.

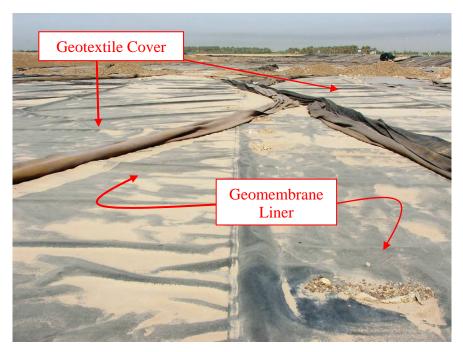
Site Photo 2. Exposed geomembrane liner

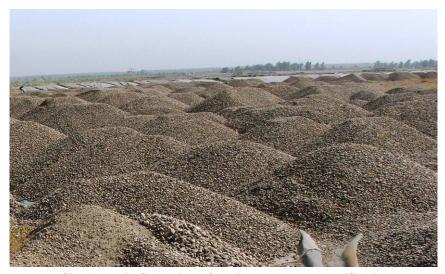
In areas around the unfinished portion of the MSW landfill, we observed stockpiles of gravel that can be spread over the liner and geotextile cover. Site Photo 3 shows some of the gravel piles that could be used for constructing the gravel drainage layer over the liner system. Also, to ensure there is an adequate supply of gravel, an estimate of the amount required to finish the drainage layer is needed. We did not see any sand stockpiles, so sand would also need to be delivered to the site to complete the drainage layer.

Site Photo 3. Stockpiles of available gravel at landfill site

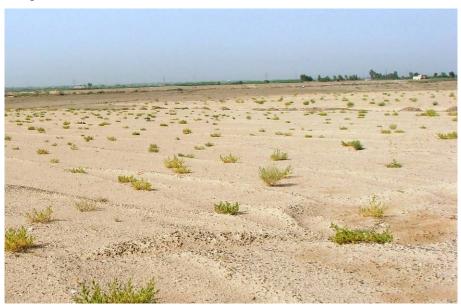
The drainage layer as shown in Figure 2 consists of 0.2 m of sand over 0.3 m of gravel that is supported by a compacted 0.3 m cohesive soil subgrade. The geomembrane liner and the geotextile cover lie between the subgrade layer and the gravel. The drainage layer was in place on the majority (approximately 75%) of the 9.7 hectare MSW landfill cell. We could not verify thicknesses of the sand layer and gravel layer, but the surface of the sand layer appeared to be graded and finished in accordance with the design. Site Photo 4 provides an example of an area where the drainage layer in the landfill is complete. The foliage in the picture occurred in the preceding seven months after construction ended in November 2005.

Site Photo 4. Surface of the drainage layer

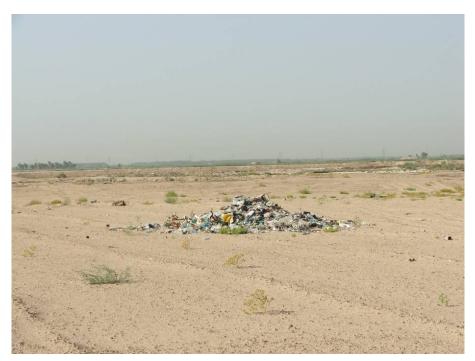
The finished portions of the landfill are ready to receive municipal solid waste, and in one small area, we observed a truck load of trash had actually been dumped (Site Photo 5).

Site Photo 5. Trash located in one section of the landfill.

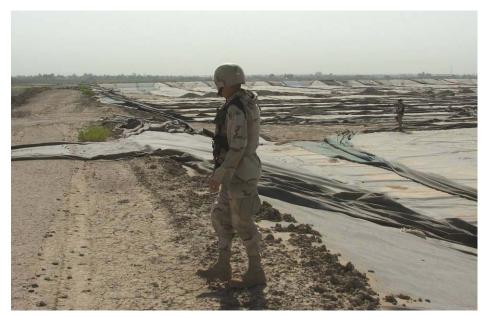
We observed the berm in place along the perimeter of the MSW landfill. The design required the liner system to extend up the 3 horizontal to 1 vertical side slope of the berm and terminate in an anchor trench along the top of the perimeter berm. In the unfinished areas of the landfill, the liner along the inside of the berm, as shown in Site Photo 6, will require remedial work to ensure it is placed and anchored properly.

Site Photo 6. Section of the perimeter berm requiring remedial work to anchor the liner

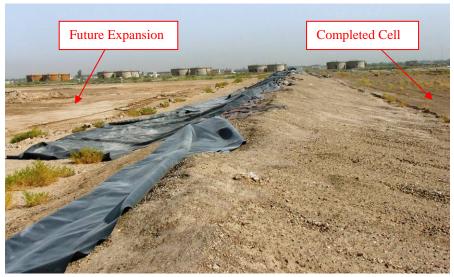
The portion of the berm adjacent to the future expansion area of the MSW landfill cell, along the west side, was designed as an *interphase berm*, which would be integrated into the next landfill phase if the MSW landfill is expanded to the west. We found the interphase berm in place. However, along most of the length of this berm, we saw geomembrane liner material loosely lying on top of the berm, as seen in Site Photo 7. It appeared this geomembrane material was excess.

Site Photo 7. Interphase berm bordering future expansion area

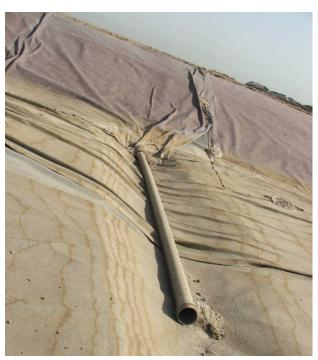
In the unfinished portion of the landfill, two of the collection pipes were exposed because the drainage layer had not been applied. The design required a 150 mm diameter, HDPE, perforated pipe. We measured the pipe and verified a 150 mm diameter, HDPE perforated pipe in place at the correct locations within the landfill. Site Photo 8 shows one of the pipes in the unfinished portion of the landfill.

Site Photo 8. HDPE Leachate Collection Pipe

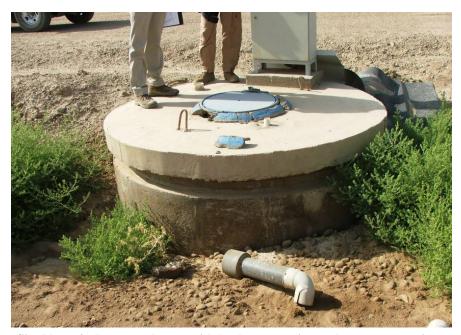
We also inspected the four leachate collection pump stations. The design called for submersible pumps inside a concrete enclosure. The access cover was locked on each station, so we did not inspect or verify the presence and the condition of the pumps. The exposed features of the pump stations (concrete housing, access cover, ventilation pipe, etc.) appeared to be constructed as designed. We did notice on two of the stations, the ventilation pipes were dislodged and no longer attached to the concrete cover of the pump housing. Also on one of the stations, the concrete ring supporting the access cover was crumbling (Site Photo 9). Additionally, on each of the pump stations, the electrical cable to and from the motor starter cabinet to the pump was exposed and not enclosed in conduit, as depicted in the design.

The design shows each pump station, connected to a HDPE solid wall force main, buried beneath the ground surface. The design shows the force main running parallel to the perimeter road around the MSW landfill. The original plan showed the force main transporting leachate to the Al Kerkh WWTP, located adjacent to the landfill site. However, the manager of the Al Kerkh WWTP refused to grant permission to connect the leachate collection system force main to the treatment plant because of concern regarding the effect of the leachate on the plant biological processes used to treat sewage. As a result, JCC-I/A directed the contractor to cap the force main at the property line.

Site Photo 9. Pump enclosure with broken vent pipe and access cover ring

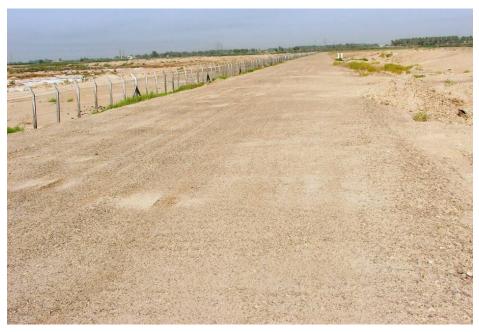
The design required a crushed gravel perimeter road, 9 m in width, with V-shaped drainage ditches along both sides of the roadway with a cross section consisting of a base (surface) course of crushed stone (0.3 m thick), supported by a 0.3 m sub-base of well graded fill material. We drove on approximately 75% of the entire perimeter road and inspected the road at two locations. We did not observe any noticeable surface defects, such as wash boarding or eroded areas. The road appeared adequately constructed to support trash hauling trucks. Site Photo 10 shows one section of the crushed gravel road along the landfill perimeter.

Site Photo 10. Perimeter road along the MSW landfill cell

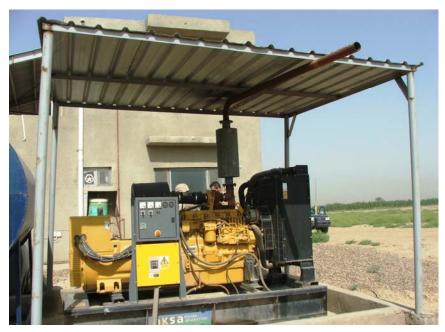
- The exhaust stack, shown in Site Photo 11, was not properly supported. Also, it appears vibration of the generator could damage the roof and/or generator because the stack location being so close to the metal frame and the roof skin.
- The feeder cable shown in Site Photo 13 was not properly installed in conduit. The connection to the generator control panel was made with exposed wire, not enclosed in conduit. Further, part of the feeder cable was lying exposed on the ground surface. The cable was not in conduit as required by the design nor buried to a proper depth.
- The generator skid was not anchored to the concrete pad.

Site Photo 11. Landfill site electrical generator

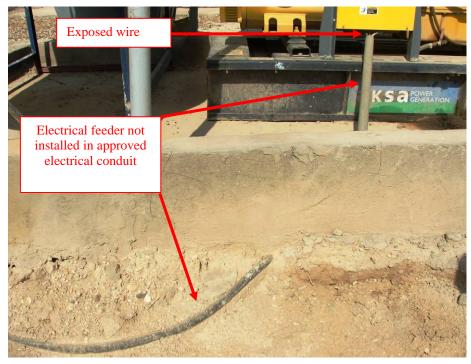
Site Photo 13. Exposed cable and wire

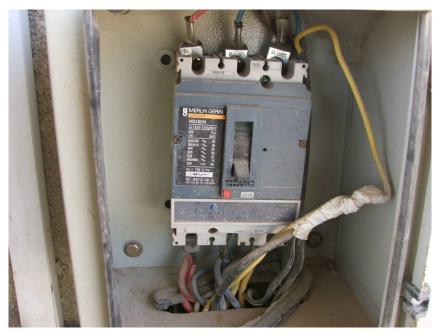
We also observed poor wiring installation on one of the dedicated electrical circuits in the maintenance bays (Site Photo 14). It appears there is a non-acceptable splice on the line side of the circuit breaker, as evidenced with the taped wiring. We also observed exposed wiring at other locations around the exterior of the building. In addition, the circuit breaker shown below should be in an enclosed circuit breaker panel.

Site Photo 14: Wiring to one of the dedicated circuits

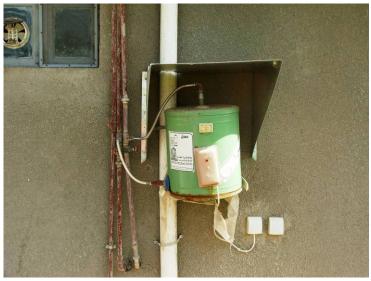
Although partially covered with a sheet metal sun shade, the water heater for the building was located outside and exposed to the elements. We also observed some cracking in the concrete perimeter sidewalk around the building. In addition, there was a need for touch up painting, particularly in areas where rust had started such as window frames, lighting brackets for exterior fixtures, and even structural steel components.

Site Photo 15. Water heater outside administration building
