WASTE WATER TREATMENT PLANT  
AL KASIK MILITARY TRAINING BASE  
AL KASIK, IRAQ

**SIGIR PA-06-074**  
**JANUARY 29, 2007**

SUBJECT: Report on Waste Water Treatment Plant, Al Kasik Military Training Base, Al Kasik, Iraq (Report Number SIGIR PA-06-074)

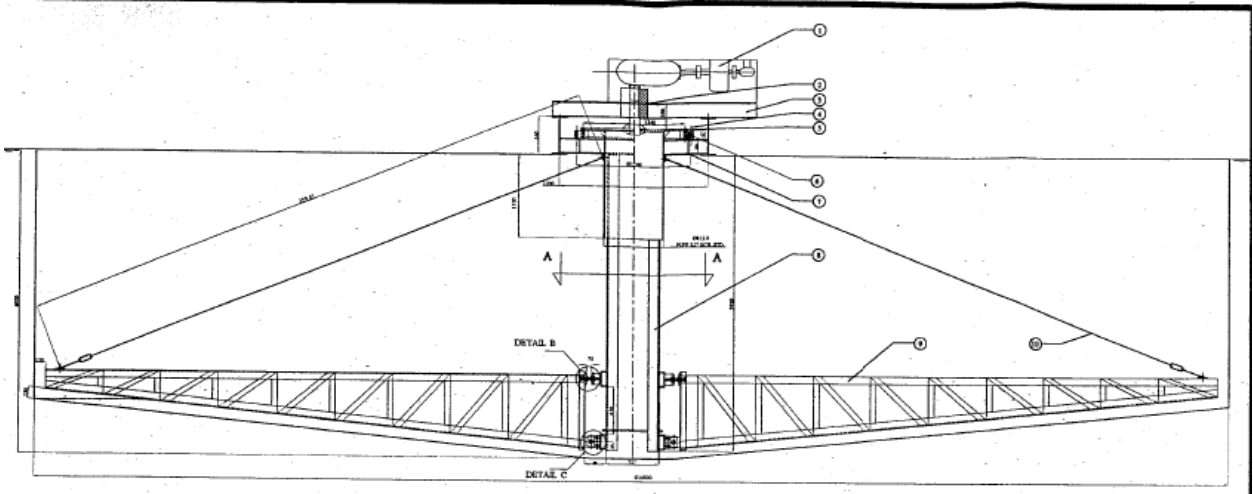
Sweeping occurs when the sweep arm assembly rotates around the bottom of the tank. The diagram below (Diagram 1) shows the approved design for the sweep arm assembly. The sweep arm assembly consists of two horizontal metal sweep arms that are supported by a rotating central shaft. Cables attached to the center shaft support the outer ends of the arms. Sweeping takes place by rubber flaps or scrapers attached to the bottom of each arm. The rubber scrapers are positioned to move the solids on the tank floor as the assembly rotates around the tank.

**Diagram 1. Diagram from contractor's submittal A-106 for clarifier torque calculations. The diagram does not show a vertical skimmer arm attached to the sweep arm.**

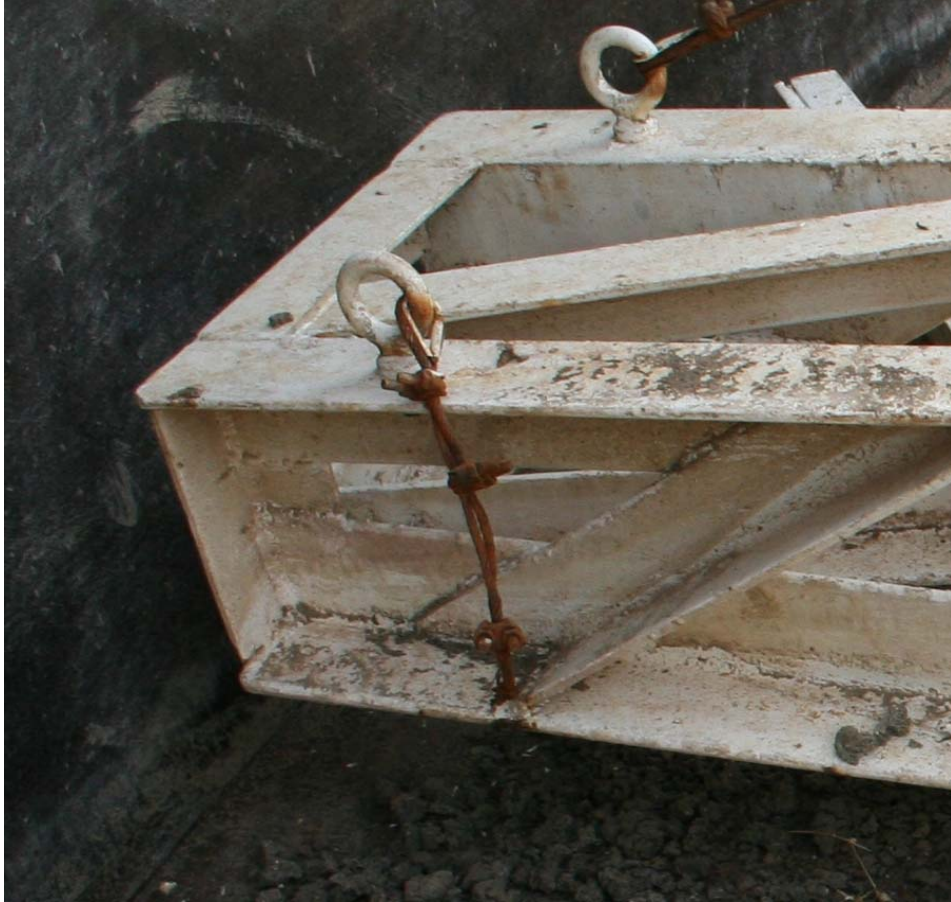
The complete failure of the clarifier tank likely occurred after a rapid series of negative events. Site Photo 1 shows the frayed segment of scraper arm support cable attached to the left front eyebolt of the arm. This suggested that the support cable attached to the front of the scraper arm broke, which caused the horizontal sweep arm assembly to drop and make contact with the floor. Site Photo 2 shows the presence of heavy surface and internal corrosion on the U-bolt assembly and the cable. The cable had a heavy degree of both surface and subsurface corrosion. Corrosion indicated that the cable material may not have been suitable for the application environment. Besides corrosion, overloading most likely contributed to cable failure. Specifically, the cable used may not have been strong enough for the load conditions encountered. The assessment team observed that the horizontal sweep arm assembly was built with a vertical skimmer structure. However, Diagram 1 does not show such an apparatus as part of the original design of the sweep arm assembly. In response to the assessment team's inquiry, the Contracting Officer Representative (COR) of the Air Force Center for Engineering Excellence (AFCEE) contacted the contractor. In an e-mail message dated 28 September 2006 sent to the AFCEE/COR, the contractor's program manager wrote:

**Site Photo 1. Cable failure caused the clarifier arm assembly to drop to the bottom of the tank.**

Based on the assessment team's observation, a review of relevant documentation, and discussions conducted with WWTP operators and the AFCEE/COR, the assessment team concluded that the likely root cause of the break down of the clarifier tank was the addition of the vertical skimmer structure during construction without proper redesign to compensate for the added load placed on the supporting cable. After the cable broke, the sweep arm assembly dropped and made contact with the floor and wall. At that point in time, stresses quickly escalated and the gear box failed because a fail-safe system (shear key) was not included in the design and the installed magnetic contactor overload relay did not function properly and shut down the motor.

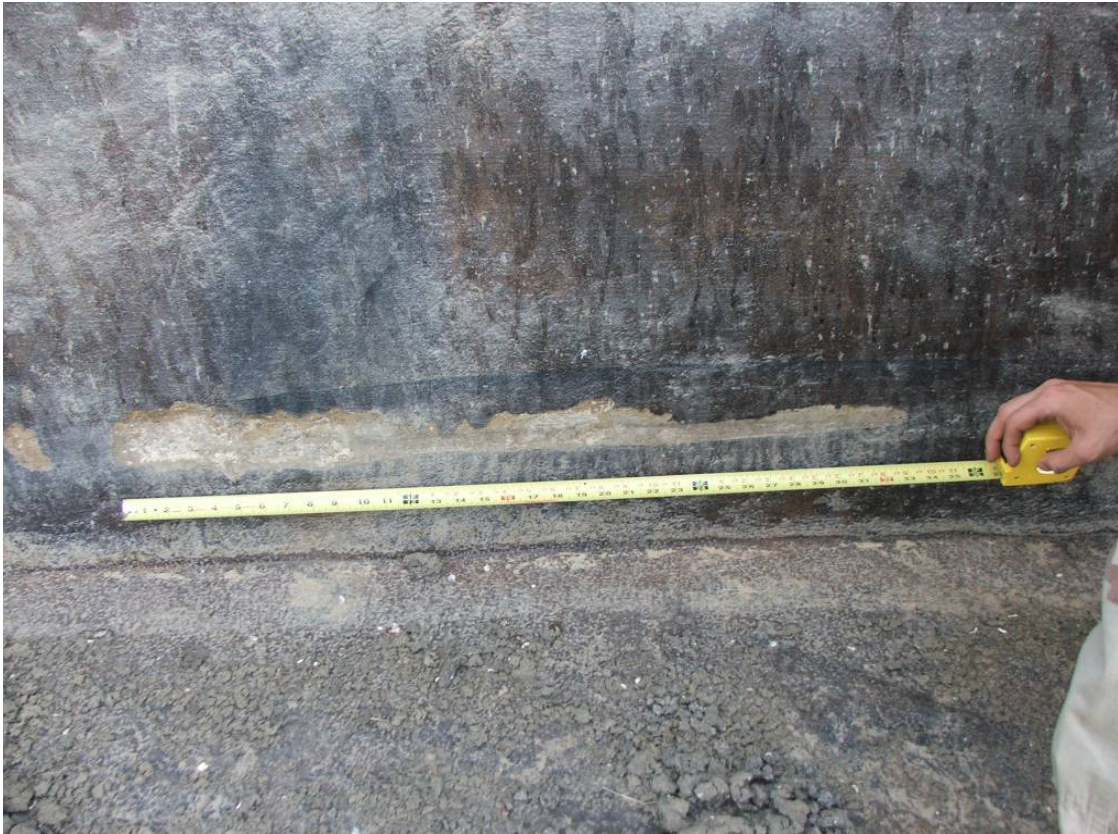
The assessment team observed a scrape or gouge approximately 33 inches long in the wall of the clarifier tank (Site Photo 3) while a thin buildup of wall material remained on the leading edge of the scraper arm (Site Photo 4). No other similar scrapes were observed elsewhere in the clarifier tank. It would be reasonable to conclude that the supporting cable failure caused the scraper arm to fall and position the scraper arm against the tank wall while the arm was in motion and in contact with the floor. Accordingly, it is likely that subsequent gear box failure occurred quickly while the arm was in contact with the tank wall.

**Site Photo 3. Gouge mark approximately 33 inches long.**

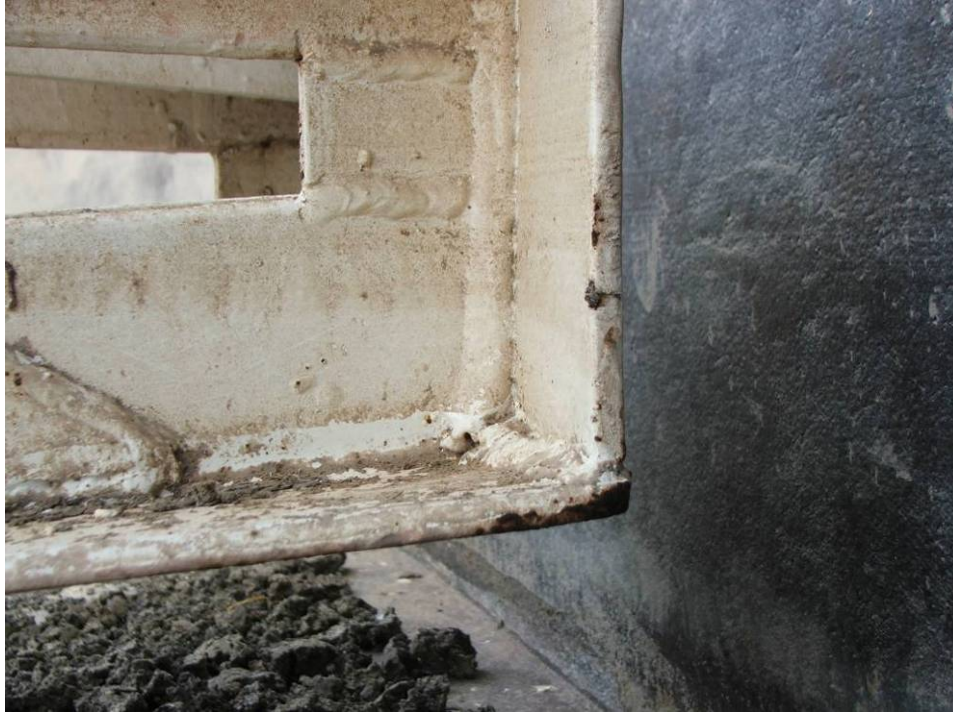
**Site Photo 4. Sweep arm contact point.**

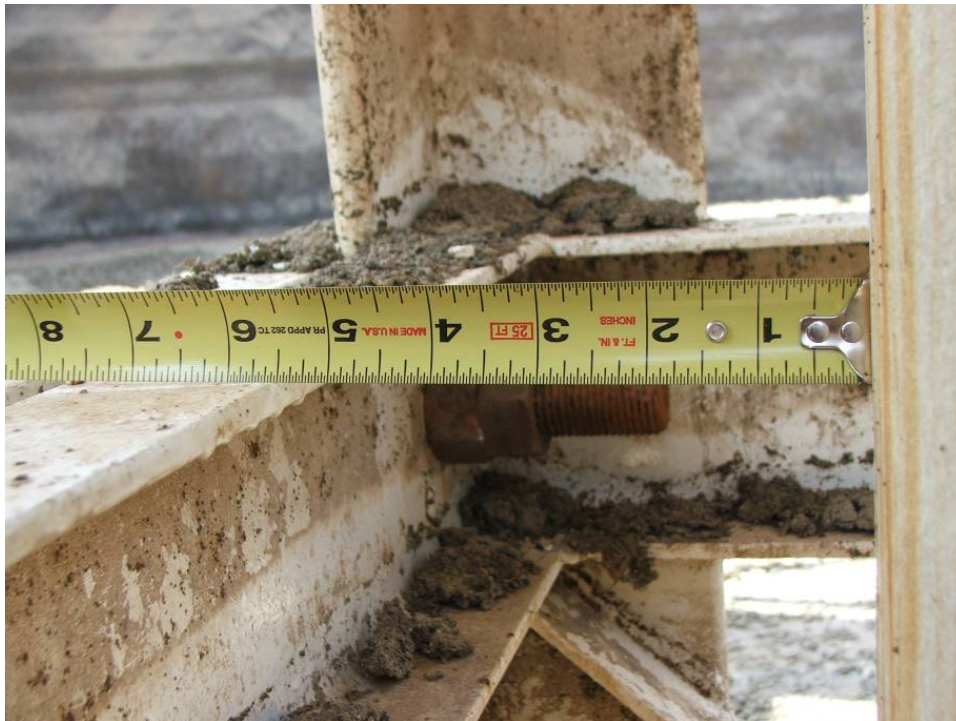
The main vertical supporting shaft of the rotating scraper arms was observed to be off center by over 2 1/8 inches. Site Photos 5 and 6, show the off center position of the main vertical shaft following the break down of the scraper arm assembly.

**Site Photo 5. Main shaft was positioned approximately 5 5/8 inches from the static frame.**

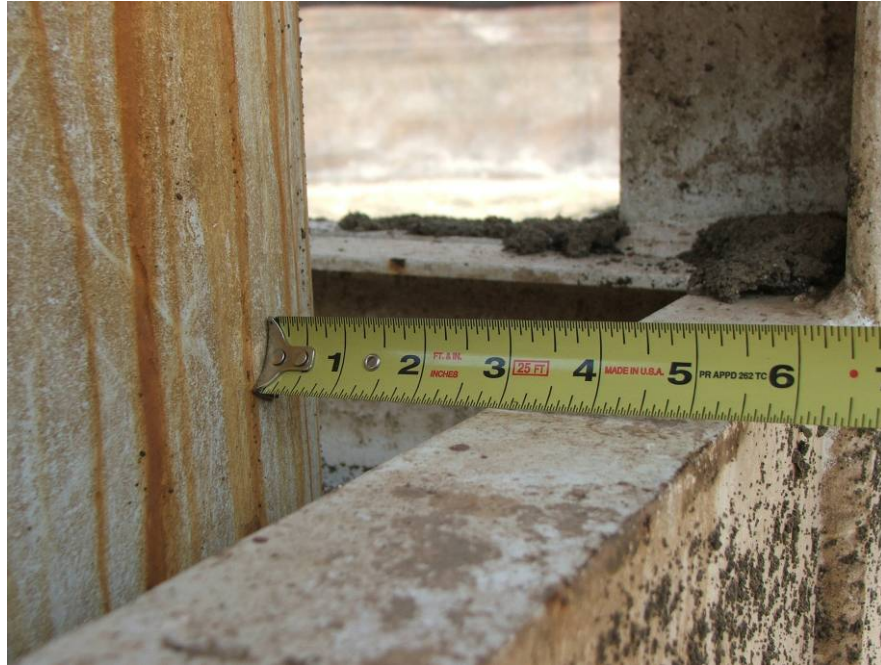
**Site Photo 6. Main shaft was positioned approximately 2 7/8 inches from the static frame.**

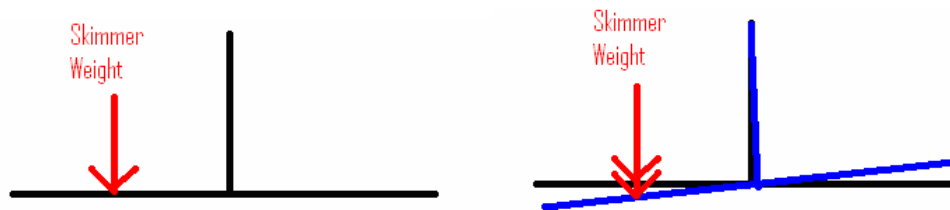
The off center vertical shaft was an indicator of an asymmetrical shaft load. The main shaft moved from center because of an unbalanced load caused by the added weight of the vertical skimmer structure attached during construction to one side of the horizontal scraper arm assembly. Conversely, the opposite side of the horizontal scraper arm assembly did not include a counterweight to offset the weight of the skimmer structure and unbalanced state of the horizontal sweep arm. In addition, an undetermined amount of additional drag force was created as the skimmer structure moved through the tank's liquid while the horizontal sweep arm assembly rotated. Accordingly, the overall load placed on the horizontal sweep arm assembly and drive gearbox likely increased substantially by the addition of the vertical skimmer structure. Simply put, the vertical skimmer structure attached during construction was big and heavy and caused the structure to be unbalanced. Diagram 2 illustrates the movement of the vertical shaft because of the unbalanced load on the horizontal sweep arm assembly. QA Photo 10 presented later in this report shows the skimmer assembly from the top while Site Photo 7 shows the skimmer from inside the tank.

**Diagram 2. An unbalanced load on the horizontal arm assembly caused stress on the vertical shaft which forced the shaft to an off center position.**

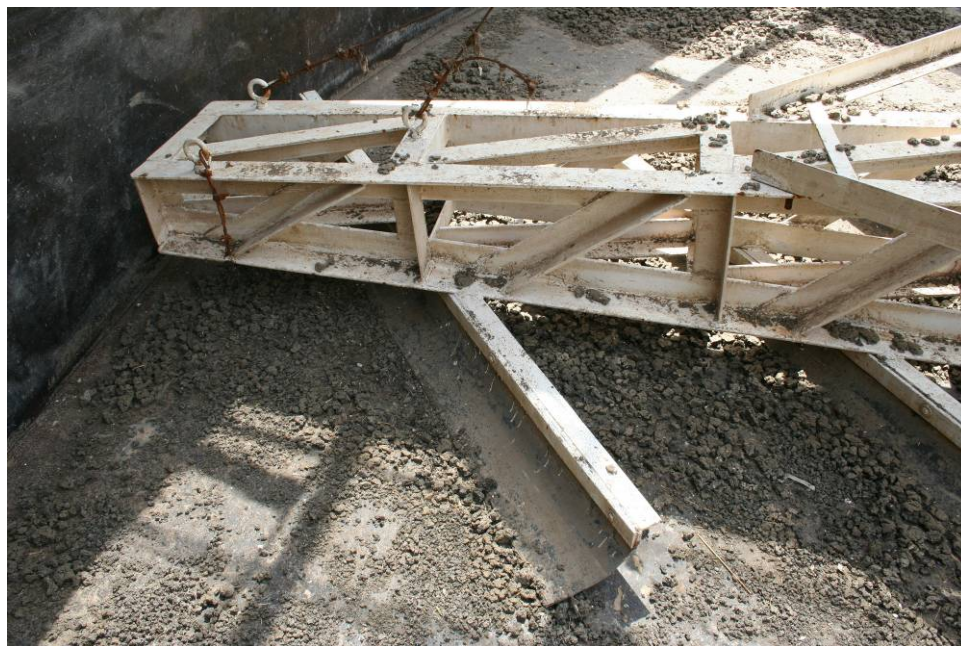
Site Photos 8 and 9 show the difference in clearance distance between the floor and each side of the horizontal sweep arm assembly. Site Photo 8 shows the side that dropped when the cable failed. In Site Photo 8, the rubber scrapers were bent and in full contact with the floor. Conversely, Site Photo 9 shows the opposite side that did not experience cable failure. As such, the rubber scrapers shown in Site Photo 9 are not bent and hang freely above the floor by approximately 2 to 3 inches. If properly balanced, such rubber scrapers should gently touch the floor in order to sweep the floor during rotation of the horizontal sweep arm assembly.

**Site Photos 8. Rubber scrapers contact the floor on side that experienced cable failure.**

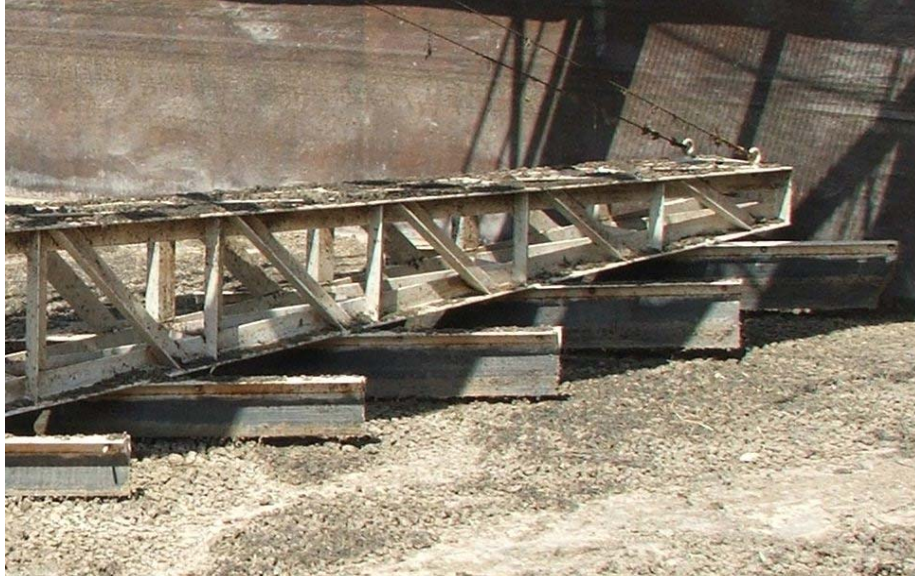
**Site Photo 9. The rubber scrapers hang freely on the side that did not experience cable failure.**

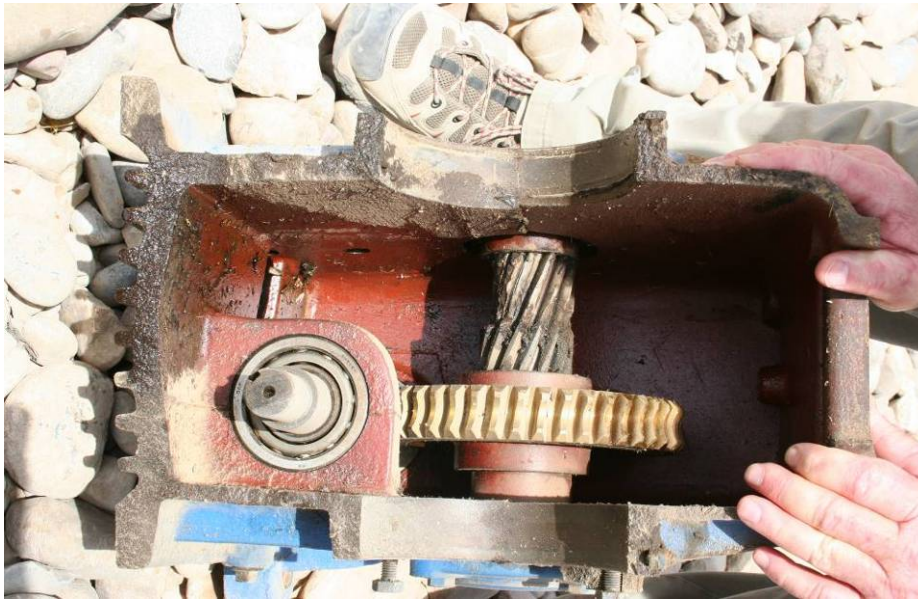
Immediately following the cable failure and subsequent contact between the dropped side of the horizontal sweep arm assembly and tank wall and floor, the clarifier gearbox, for all practical purposes, completely failed. The gearbox was lying in two pieces at the base of the clarifier tank. A fracture that bisected the gearbox housing ran the length of the cast metal casing. The oily coating and a distinct oil line observed indicated that the gearbox was operated with adequate lubrication before failure. Site Photo 10 shows the broken gear and fractured gearbox case. Based on the assessment team's observations of the failed cable, the off balanced horizontal sweep arm assembly, the off center vertical main shaft, the broken condition of the gearbox, discussions conducted with plant operators and Coalition Military Assistance Training Team/Regional Support Unit (CMATT/RSU) personnel, and a review of maintenance documentation (modest as it was), it is very unlikely that the gearbox failure was due to inadequate lubrication.

**Site Photo 10. "Chewed/sheared" gear teeth and a fractured gearbox case illustrate that abnormal force broke the gear box.**

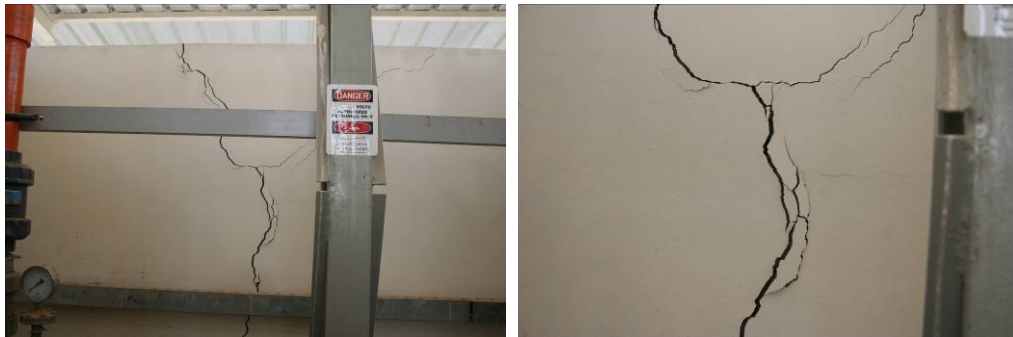
Site Photos 11 and 12 show that sizeable vertical cracks crept up the rear wall of the pump station.

**Site Photos 11 and 12. Vertical cracks were present in the inner rear wall of the pump station.**

During fieldwork discussions, the AFCEE/COR agreed that the pump station should be reconstructed to prevent continued degradation of the pump station and as a hedge against future failure in the G-03 pump station.

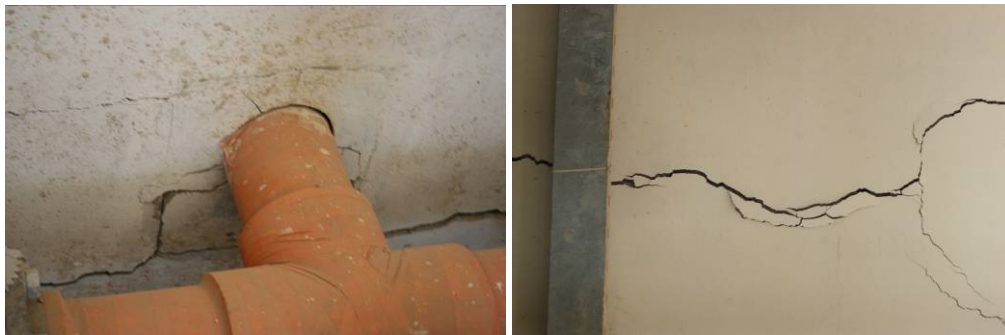
Site Photos 13 and 14 show the horizontal fracturing that occurred near the base of the structure and at a point approximately half way up the wall. The horizontal cracks were generally parallel to each other. Site Photos 15 and 16 show very similar horizontal cracks that wrapped around the opposite corners in the rear wall of the pump station.

**Site Photos 13 and 14. Horizontal wall cracks along floor and middle of the wall.**

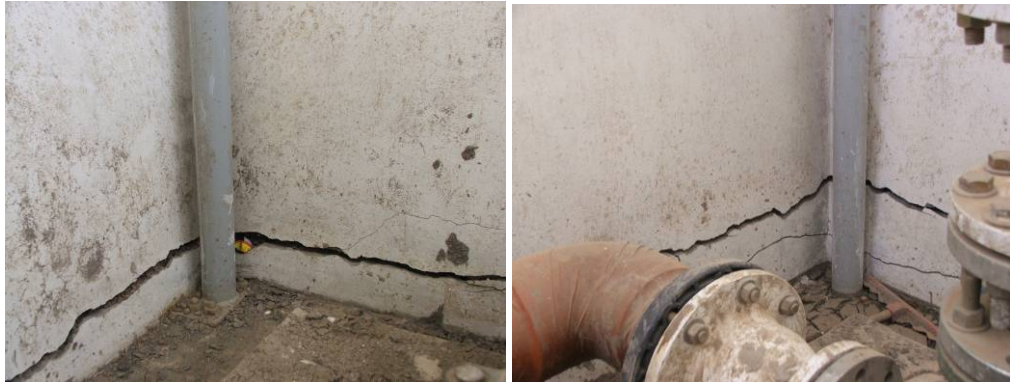
**Site Photos 15 and 16. Horizontal cracks near the floor at opposite corners of the G-03 building.**

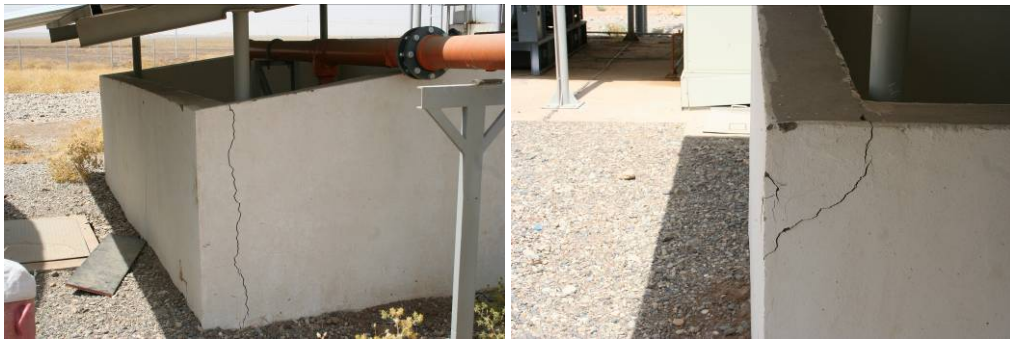
Site Photos 17 and 18 illustrate that the cracking extended all the way from the bottom to the top and from the inside to the outside of the structure's rear wall.

**Site Photos 17 and 18. Vertical cracks wound their way to the outer corners of the rear wall.**

Based on the assessment team's observations, a review of design and QC documentation, and discussions conducted with the CMATT/RSU Engineer and the AFCEE/COR, the number of cracks of such magnitude indicated that abnormal stress was distributed across the rear concrete wall of the structure. In addition, such cracks were likely caused by, either/or a combination of, insufficient steel reinforcement of the concrete or inadequate soil compaction. The horizontal cracks that ran from corner to corner of the rear wall indicated that settling of the base slab was very likely. Inadequate soil compaction could cause such settling. Even if properly reinforced, much less if not sufficiently reinforced, the concrete wall would have been prone to cracking if constructed on soil that was not sufficiently compacted.

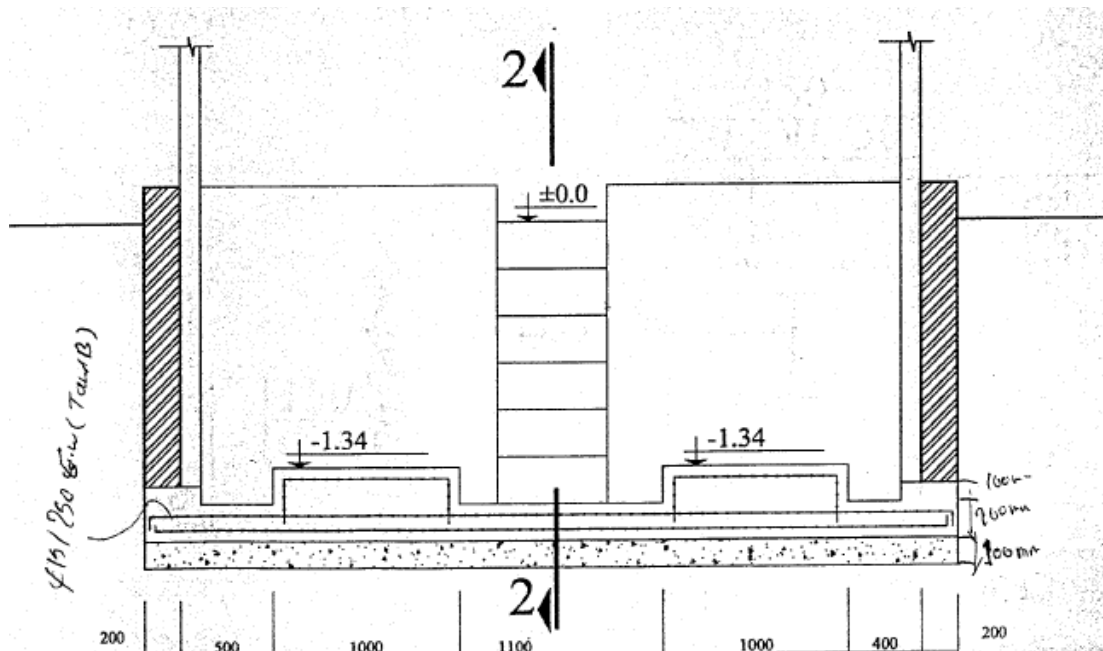
During a review of design and Quality Control documentation, the assessment team found contractor's submittal A-41, G-03 pump pad details, (Diagram 4) with comments that specified the BRC #63 should be replaced with steel bar reinforcement.

Diagram 4. Cross section of G-03 building from the contractor's A-41 submittal.

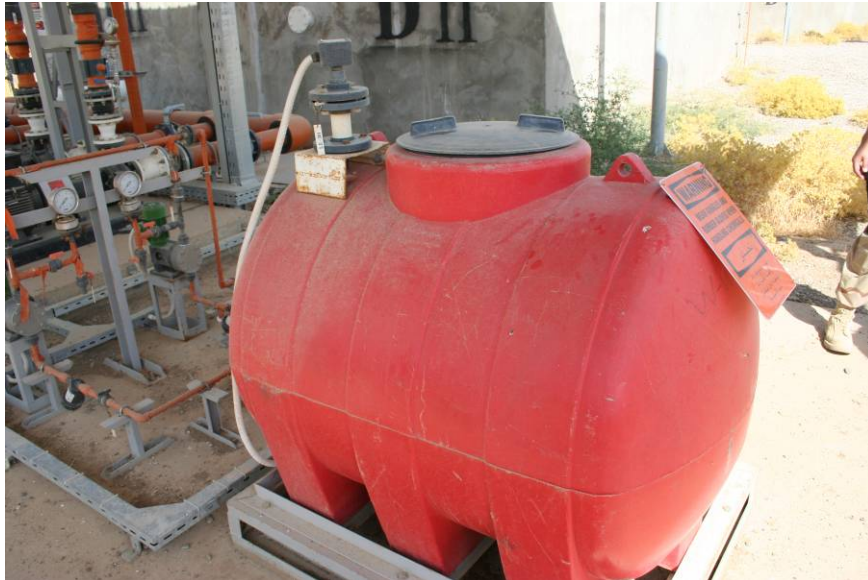
**Site Photos 19. Chlorination system included a holding tank for Sodium Hypochlorite (NaOCL).**

According to the EPA Chlorine Disinfection fact sheet, 85 degrees Fahrenheit is the maximum (not to exceed) temperature in which liquid NaOCL should be stored. At the time of the assessment team's visit, temperatures were well above 100 degrees Fahrenheit. Obviously, the temperatures routinely experienced in Iraq during the hot season exceed the EPA 85 degree Fahrenheit threshold.

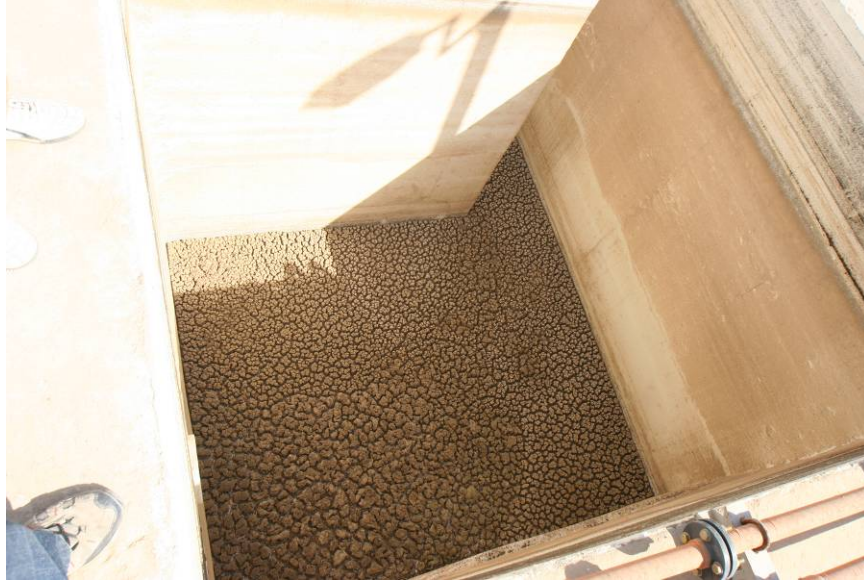
During the assessment team's visit, it was noted that the contact tank contained dried, suspended solids that were visible on the floor of the tank. Site Photo 20 shows the solids observed. While suspended solids are a normal part of unfiltered effluent processed in any waste water treatment plant, the unfiltered solution is normally not chlorinated because suspended solids interfere with the efficiency of a chlorination process. In the case at hand, chlorine was added before the effluent had effectively passed through the pressure filters, which would have removed suspended solids. The design, as built, exposed the suspended solids to chlorine in the contact tank.

Based on information from the EPA Chlorine Disinfection fact sheet, high levels of suspended solids entrap residual bacteria and interfere with the efficiency of waster water disinfection. In addition, the Standard Handbook for Civil Engineers cites that "The last step in secondary treatment of wastewater is disinfection of the effluent to kill pathogenic (disease-causing) bacteria and viruses." In contrast to the pre-filter system built at the Al Kasik WWTP, a post-filter contact tank system might have been a more efficient system to use.

**Site Photos 20. Prefilter chlorination tank floor was covered with solids.**

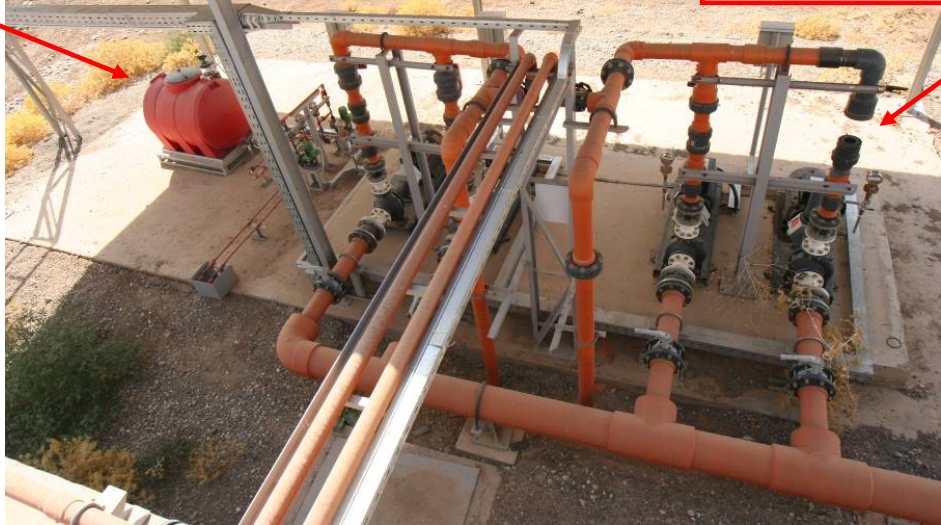
Back Flush Side Showing Missing Nipple.

**Site Photo 21. Effluent supply and back flush inlet piping systems.**

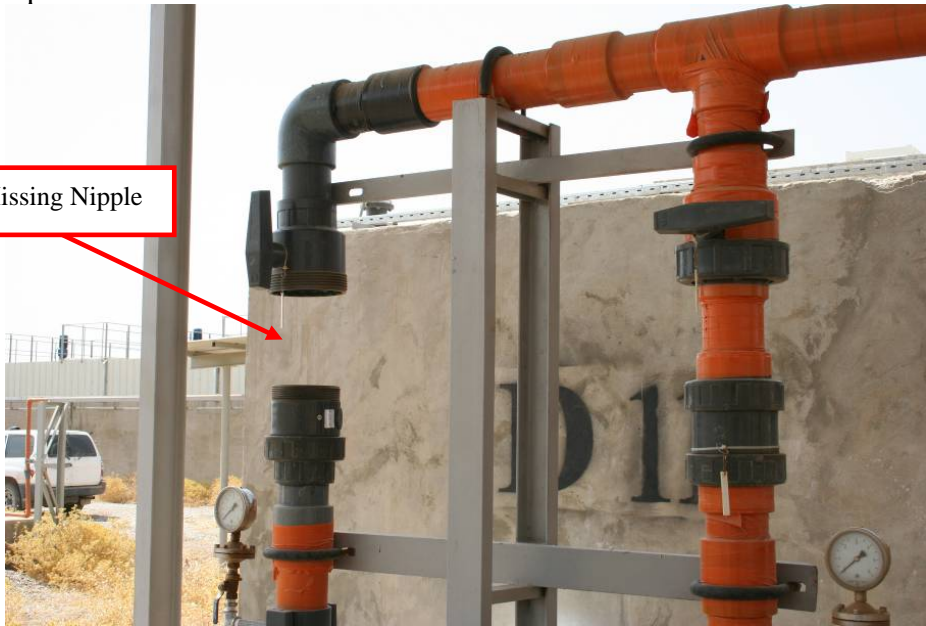
Missing Nipple

The assessment team observed that a pipe nipple on the back flush side of the inlet system was missing. A backup or spare nipple was not a required element of the Task Order and the WWTP operators claimed that the non-standard sized nipple could not be purchased locally. As a result, back flush operations could not be performed. Site Photo 22 shows the back flush inlet line was missing the relatively minor piece.

**Site Photo 22. Missing nipple meant that back flushing could not be performed.**

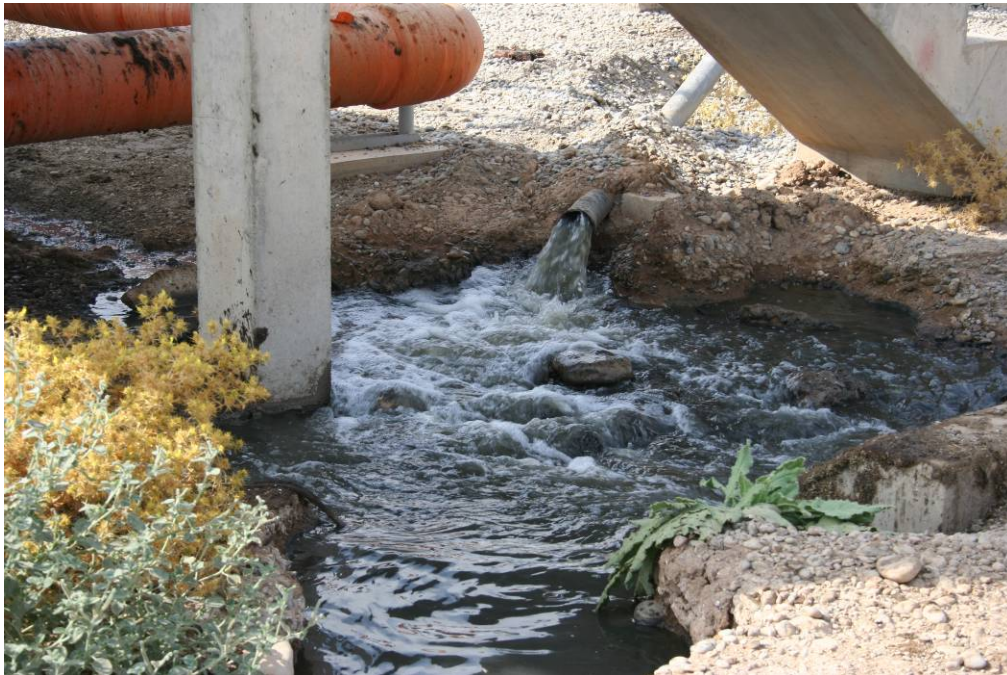
As a result of the failure of the clarifier, the WWTP was rendered inoperable and all waste water input was pumped directly off the site. Site Photo 23 shows raw sewage being pumped off the site.

Site Photo 23. Raw sewage pumped off site via surface ditch.
