51<sup>ST</sup> BRIGADE IRAQI ARMY BARRACKS  
AL HILLAH, IRAQ

**SIGIR PA-06-075**  
**JANUARY 29, 2007**

SUBJECT: Report on 51st Brigade Iraqi Army Barracks, Al Hillah, Iraq  
(Report Number SIGIR PA-06-075)

## 51st Brigade Iraqi Army Barracks, Al Hillah, Iraq

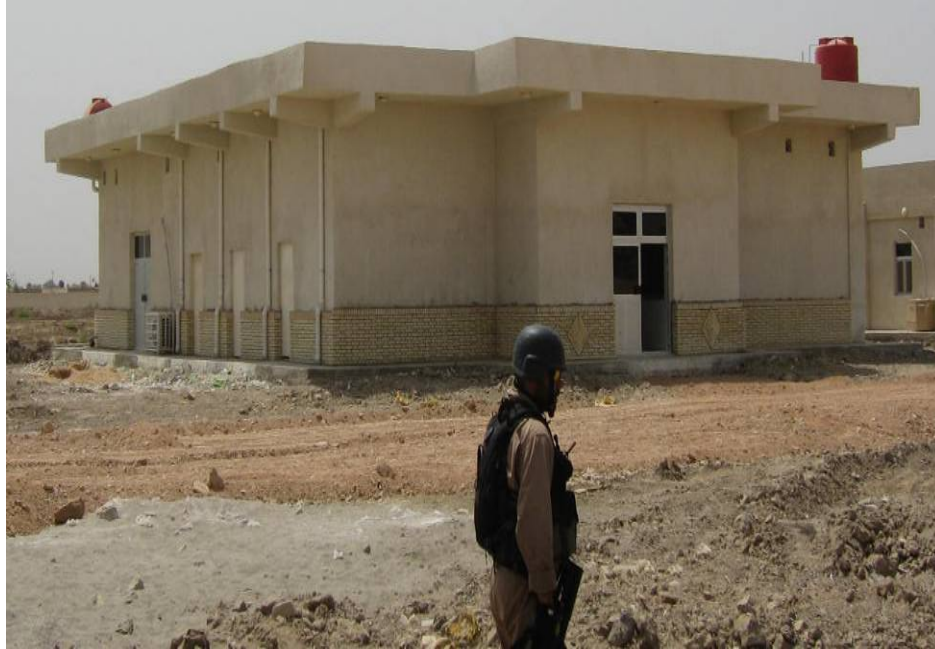
The dining facility floor plan included a 100-person dining room, a kitchen, a hand wash room, and three separate food storage rooms (dry storage, a chill box, and a frozen box). The design called for the base of the exterior walls to be covered with brick to a height of about 1 meter (m), and the upper portion of the walls covered with a ceramic type tile matt. Site Photo 1 shows the exterior of the dining facility. The contractor had constructed the brick facing along the bottom 1 m of the exterior; the upper portion of the walls were plastered, textured, and painted. We did not find any significant deficiencies with the exterior construction, except the top of the 1 m brick face on one side of the building. The contractor, on three sides of the building, had placed a ceramic tile cover over the top course of the brick face. However, on the front side of the building, the contractor had only placed a sand-cement topping, as shown in Site Photo 2. The USACE GRS Babil Resident Office PE informed us the contractor would make the necessary corrections.

**Site Photo 1. Dining facility exterior**

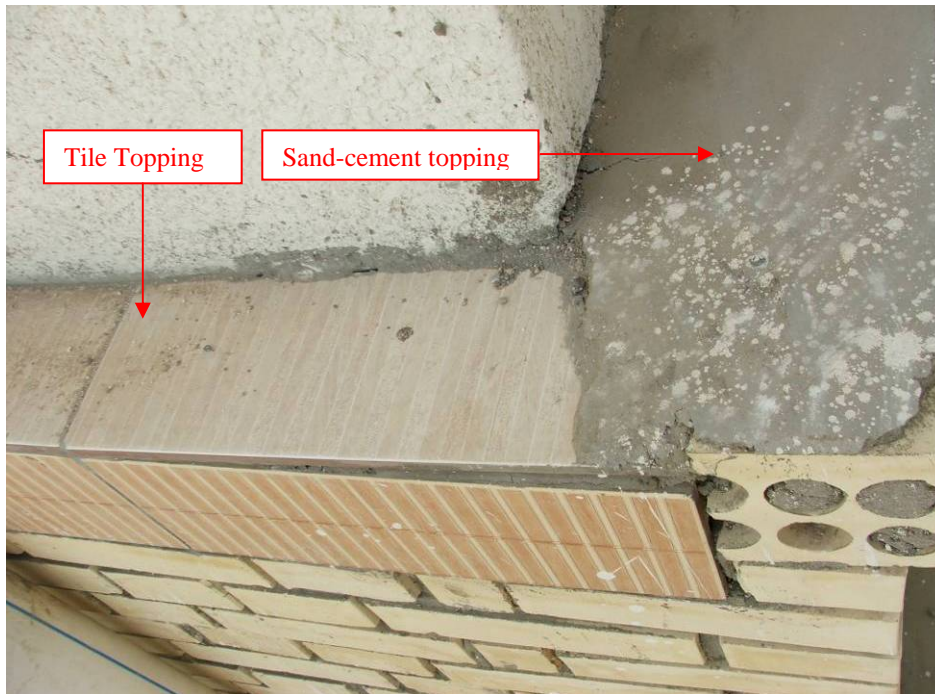
**Site Photo 2. Brick face finish**

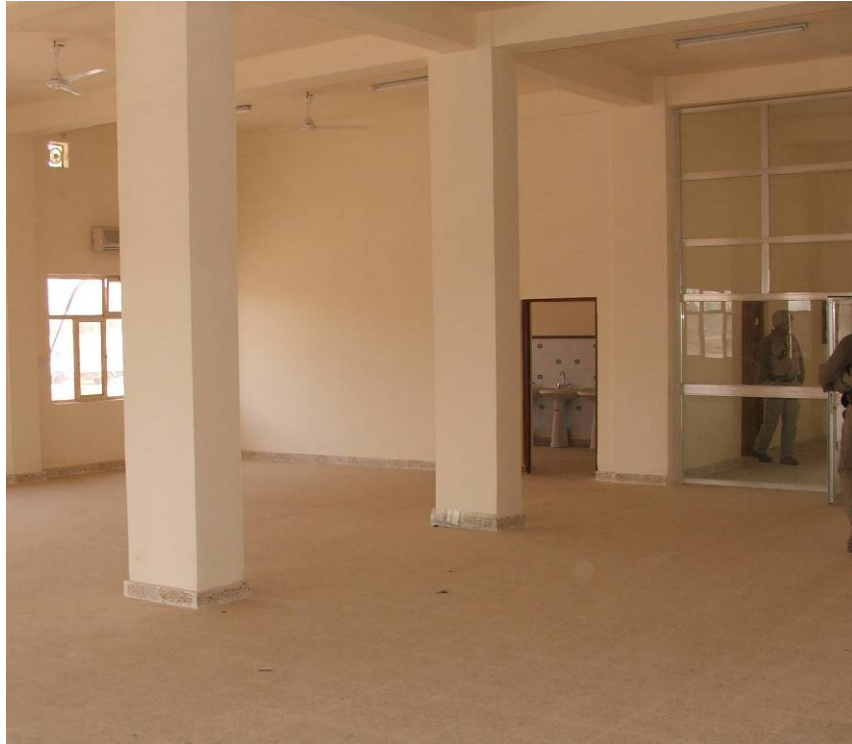
The interior walls of the dining facility were plastered and painted and the flooring included mosaic tiles. Site Photo 3 shows part of the interior finishes in the dining room.

**Site Photo 3. Dining room interior**

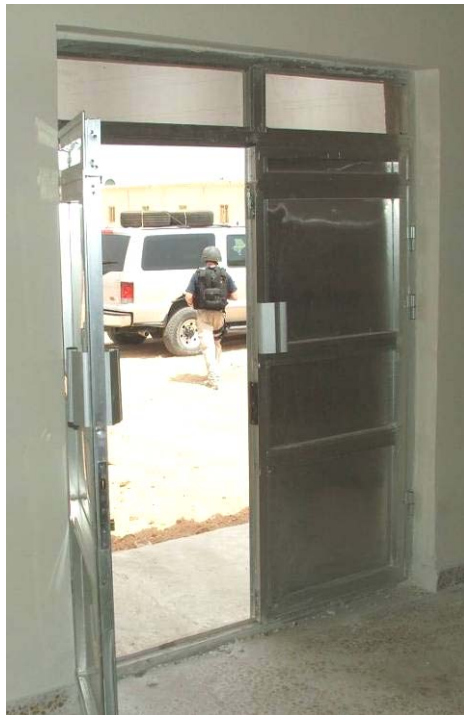
The SOW also required “good quality” aluminum windows and aluminum doors in the barracks sleeping quarters. In our inspection, we observed two sets of aluminum entry/exit doors in the sleeping quarters, one set of double doors serving as the front entrance, and a single door in the rear of the building. These doors did not appear to be “good quality,” especially considering the high traffic that a 75-man barracks will receive. Site Photo 5 shows the aluminum doors used for the entrance to the barracks sleeping quarters, and Site Photo 6 shows the rear entrance/exit door in one of the two barracks.

**Site Photo 5. Aluminum doors at front entrance to the barracks sleeping quarters**

In addition, we also identified the poor quality aluminum doors in the barracks sleeping quarters. As with the ablution buildings, considering the heavy traffic expected with a 75-man barracks, a higher quality type door was needed. Another concern is that during a strong windstorm, the aluminum doors may fly off.

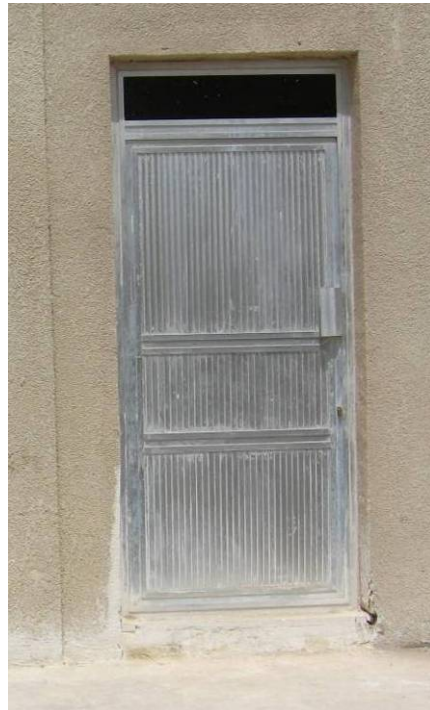
**Site Photo 6. Aluminum door at rear entrance to the barracks sleeping quarters**

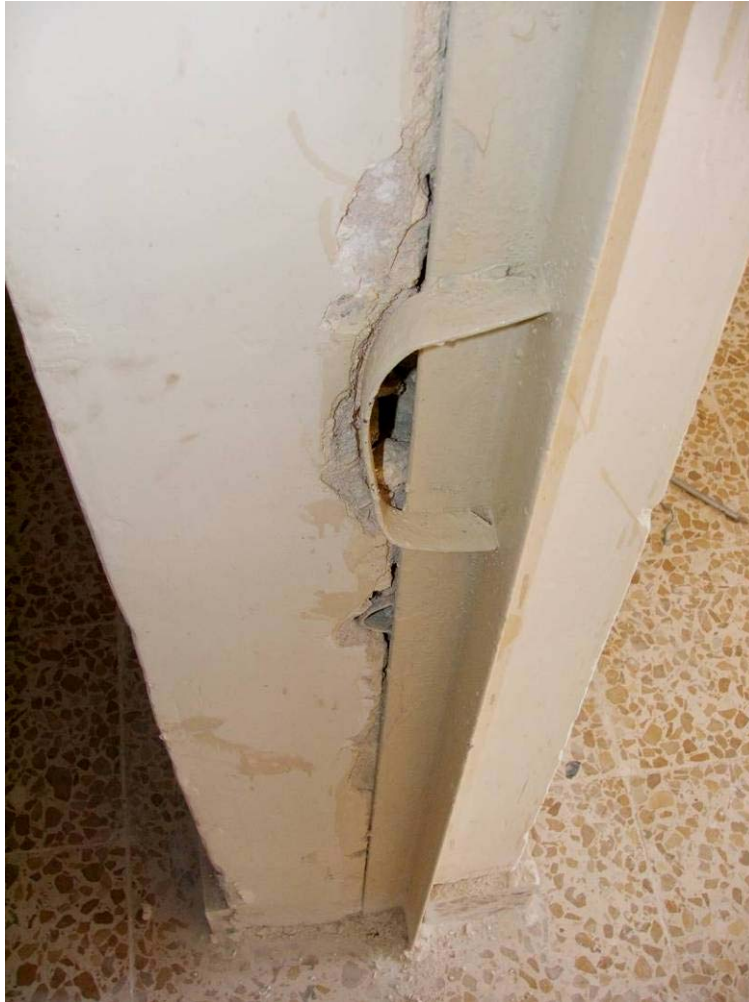
In the barracks' issue room and arms room, the design required metal doors. These doors appeared to be satisfactory in quality and adequately installed. We did notice on one of the door frames (Site Photo 7), the wall around the frame needed patching and painting.

**Site Photo 7. Arms room wall requiring patching in door frame**

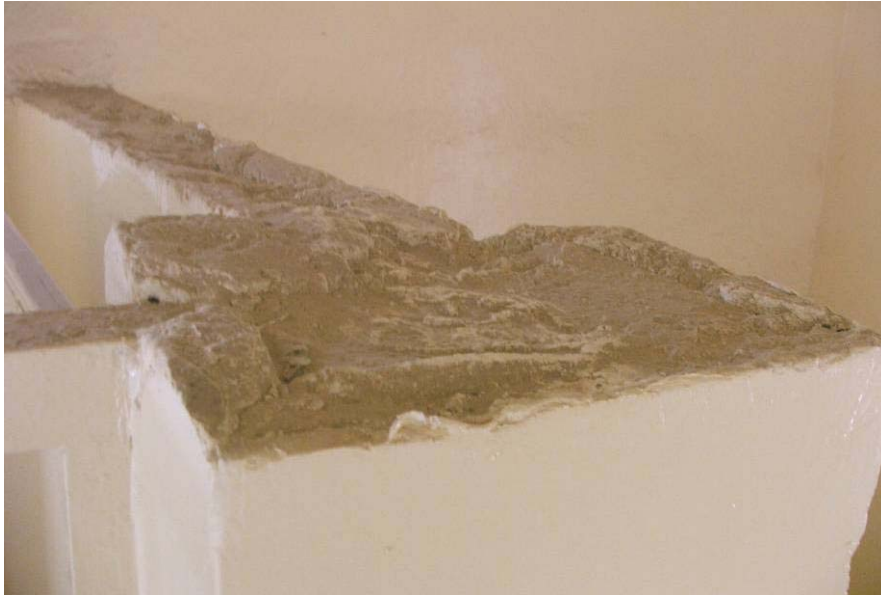
Although the walls and ceiling appeared to be finished properly, we did observe the top of the privacy walls constructed between showers and water closets were not finished in

the same manner as the walls and ceiling. The design contained no information regarding the finish requirements for the top of these walls. Site Photo 8 shows an example of the unfinished portion of the privacy walls. Aside from the ascetics, the rough surface will pose a problem for cleaning, and will trap moisture and dirt.

**Site Photo 8. Top of privacy walls constructed in ablution buildings**

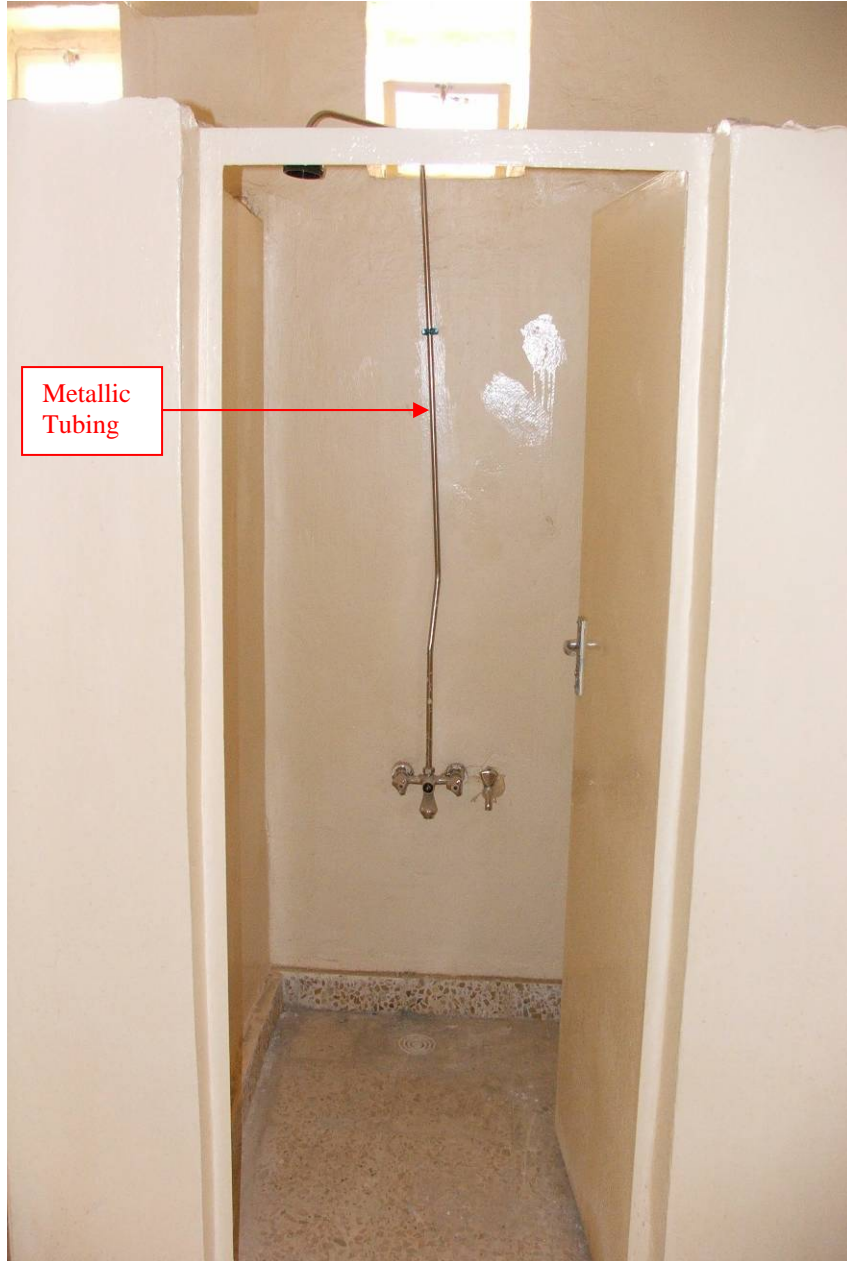
Regarding the plumbing fixtures used in the ablution buildings, we did observe what appeared to be low quality fixtures (shower heads, water supply lines, faucets, drain covers, etc.) installed in the showers, wash stations, and water closets. Site Photos 9 and 10 show the shower fixtures, including the shower head and the thin metallic tubing used to supply water to the shower head. Site Photos 11 and 12 show the type of plumbing materials used in the water closets, which includes flexible water hoses, plastic supply tanks, and thin wall plastic tubing supplying water from the tank to the toilet. Considering the ablution buildings will receive heavy usage, we believe the low quality plumbing fixtures will pose continual maintenance problems for the Iraqi Army.

**Site Photo 9. Shower in ablution buildings**

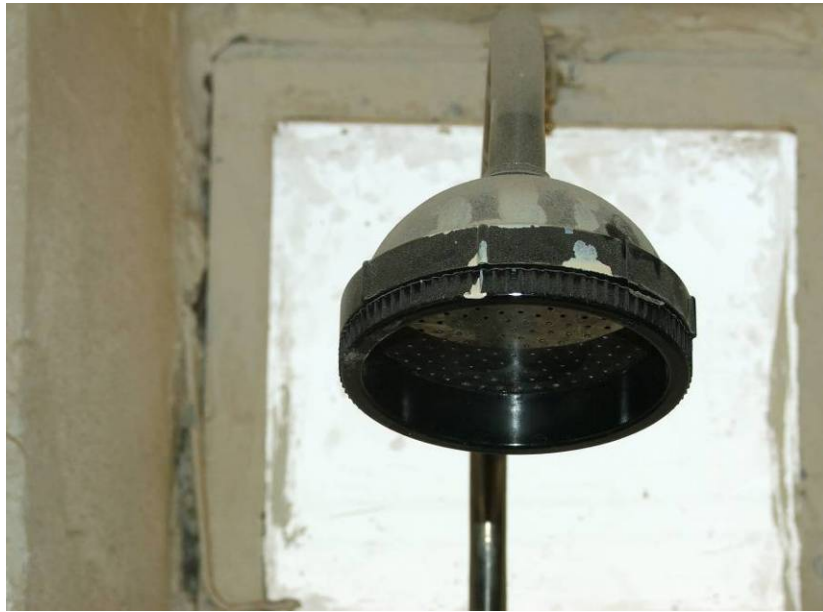
**Site Photo 10. Shower head in ablution building**

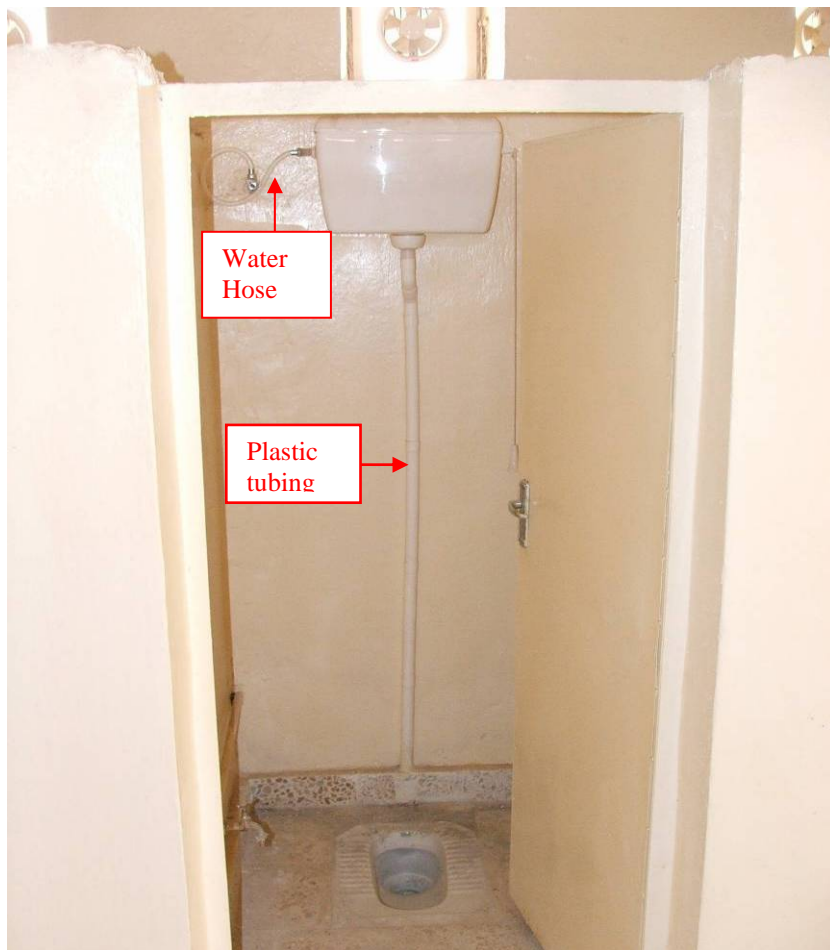
**Site Photo 11. Water closet in ablution building**

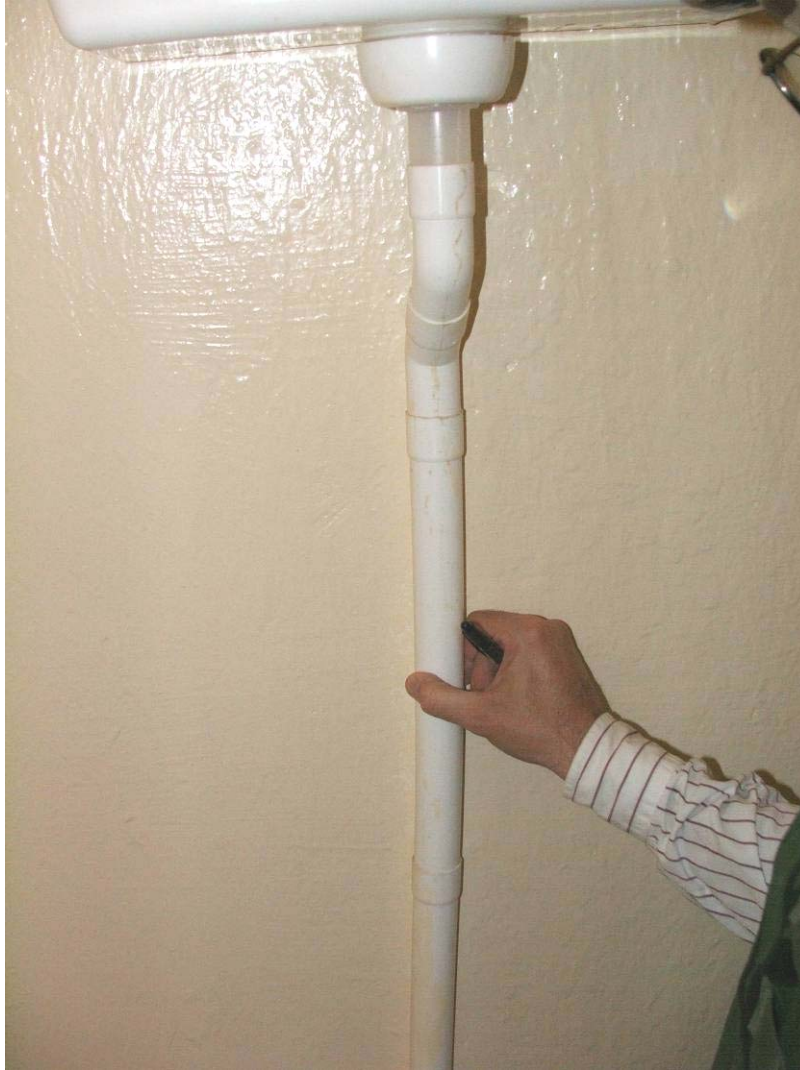
**Site Photo 12. Close-up of plastic tubing used in ablution building water closets**

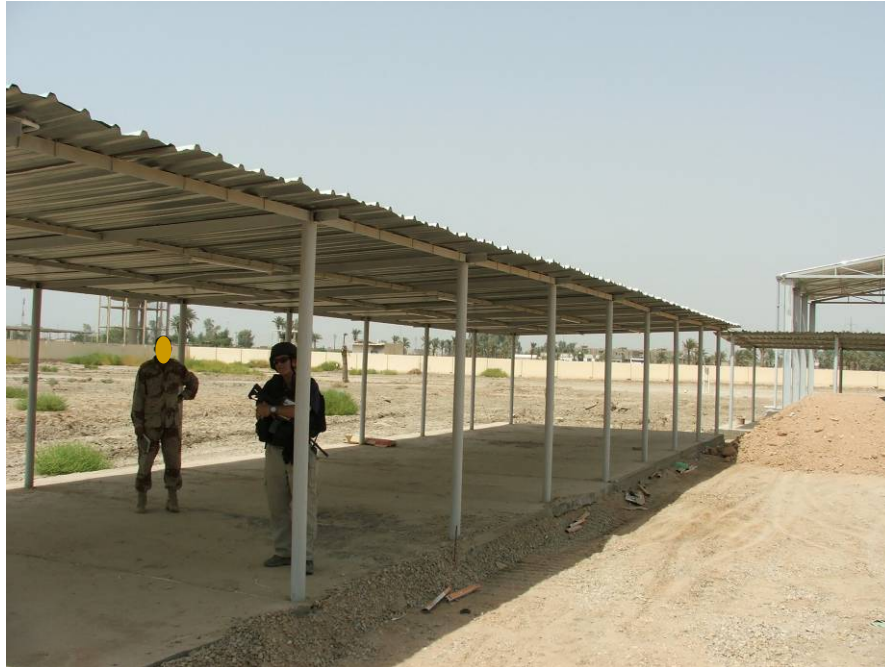
Site Photo 13 shows one section of the 40 vehicle sunshade. We did note that many of the four inch tubular columns consisted of spliced sections of pipe welded together to form one tubular column. The design did not provide any details as to whether or not welded pipe columns were allowed.

**Site Photo 13. 40- vehicle parking sunshade**

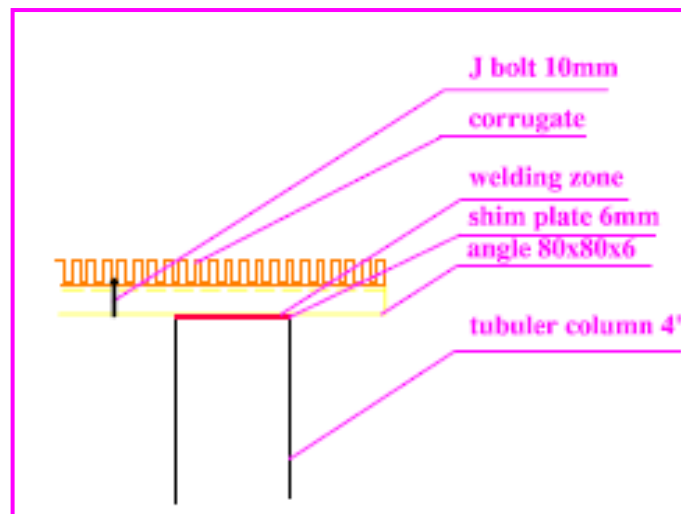
The design detail for the structural frame supporting the corrugated roof sheeting (Figure 1) showed an 80 x 80 x 6 angle supporting the roof sheeting. No units were provided for the angle, although it is assumed the dimensions are in millimeters. Figure 1 also shows the angle welded to a shim plate at the top of the column. There were no details provided on the type or size of weld or the type and thickness of the corrugated roof sheeting. The design also did not show any lateral cross bracing perpendicular to the angle support shown in Figure 1.

**Figure 1. Design detail for covered parking (sunshade)**

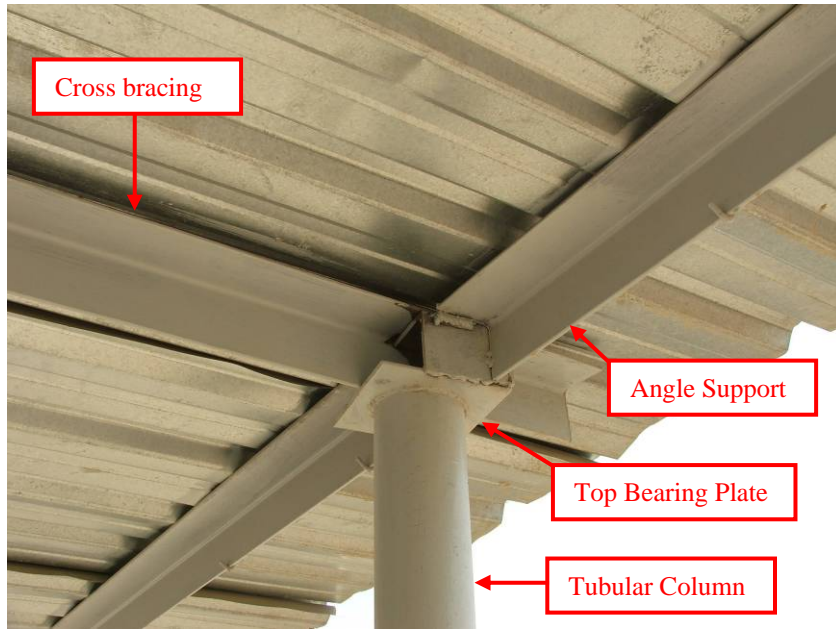
Site Photo 14 shows the actual welded angle connections at the bearing plate (i.e., shim plate) at the top of each tubular column, as well as, the lateral cross bracing. The roof sheeting material appeared to be a thin gage sheet metal, connected to the frame with J-bolts, as depicted in Figure 1.

**Site Photo 14. Typical column support for covered parking (sunshade)**

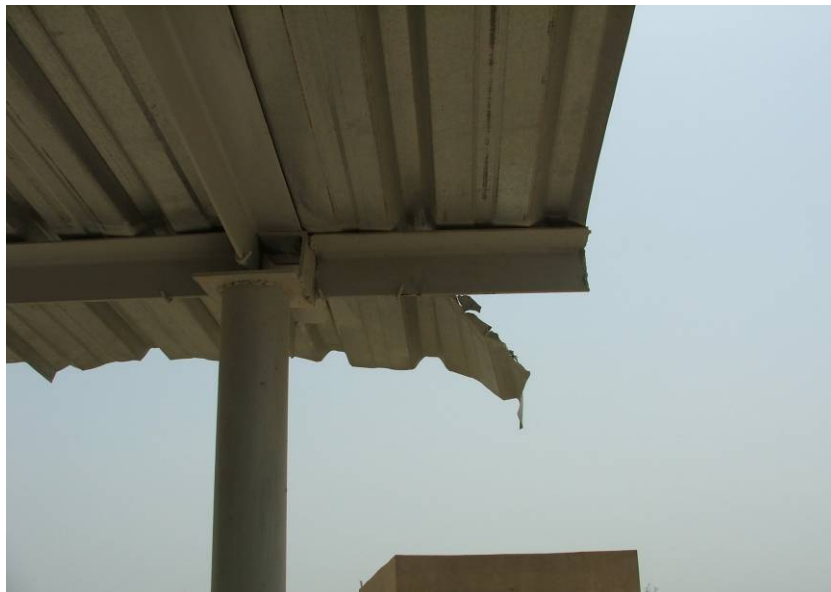
At one end of the sunshades, a portion of the metal sheeting was torn away at the corner (Site Photo 15). We also observed broken concrete at the base of one of the four inch tubular columns (Site Photo 16). Both of these items should be included in the punch list generated at final inspection.

**Site Photo 15. Torn sheeting at one end of the parking sunshade**

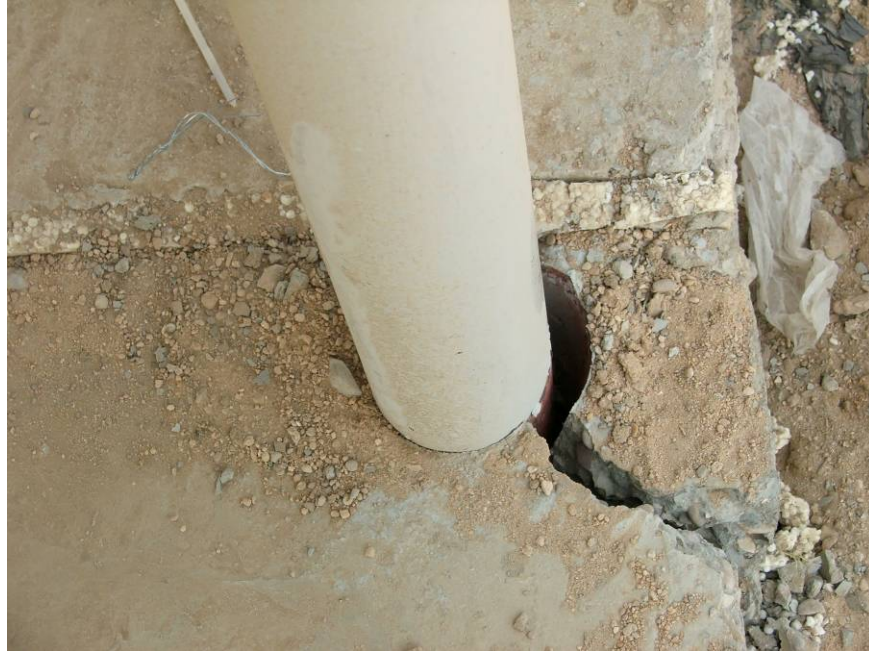
**Site Photo 16. Broken concrete at column base in the parking sunshade**

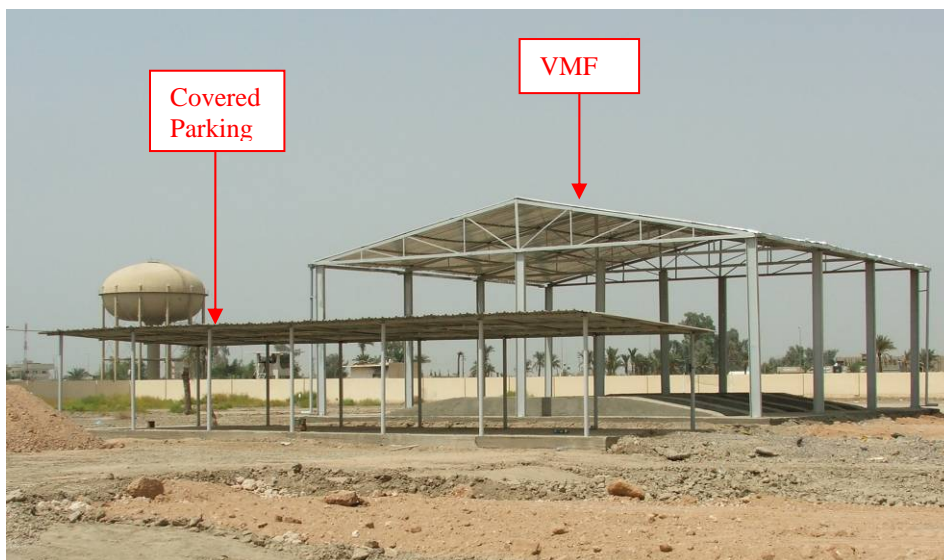
The SOW (page 5) required the contractor to construct a “Motor Pool with 3 vehicle ramps and sunshade” in accordance with the drawings. The motor pool will serve as a vehicle maintenance facility. Except for a power and lighting plan, there were no drawings in the design package pertaining to the motor pool. The motor pool we inspected, located adjacent to one section of the covered vehicle parking areas, was constructed as an open air facility with concrete ramps for three vehicles (Site Photo 17). Each vehicle ramp included a sunken pit in the center to facilitate maintenance of the vehicle from underneath when the vehicle was parked. Site Photo 18 shows one of the three ramps constructed for vehicle maintenance.

**Site Photo 17. Vehicle maintenance facility (VMF) next to a covered parking sunshade**

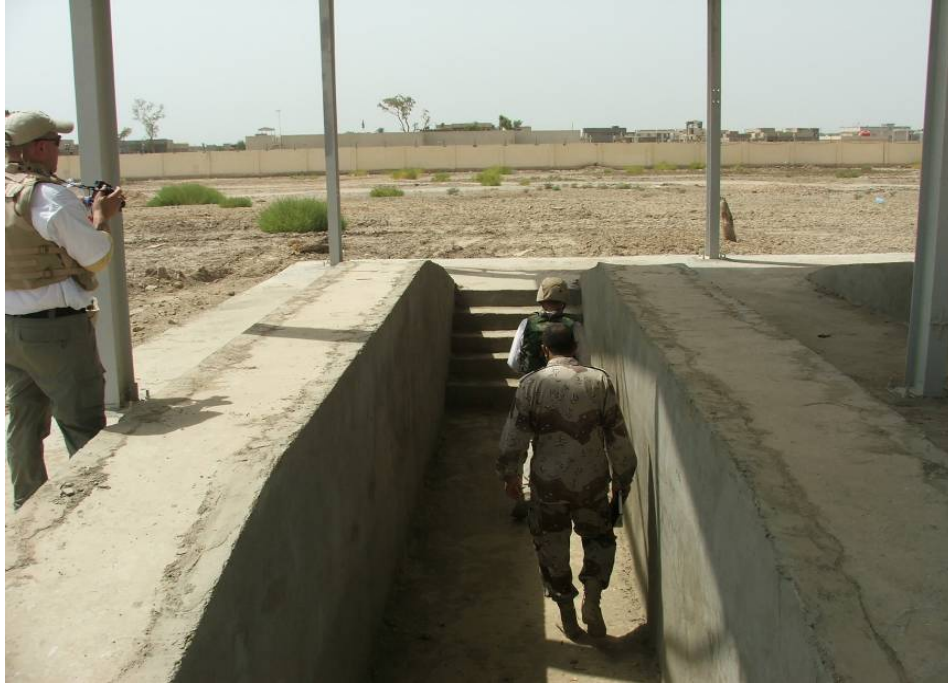
**Site Photo 18. One of the three vehicle ramps and maintenance pits at the VMF**

We recommend the Commanding General, Gulf Region Division, U.S. Army Corps of Engineers should assess the adequacy of the motor pool facility's concrete vehicle ramps and the structural steel frame supporting the roof.

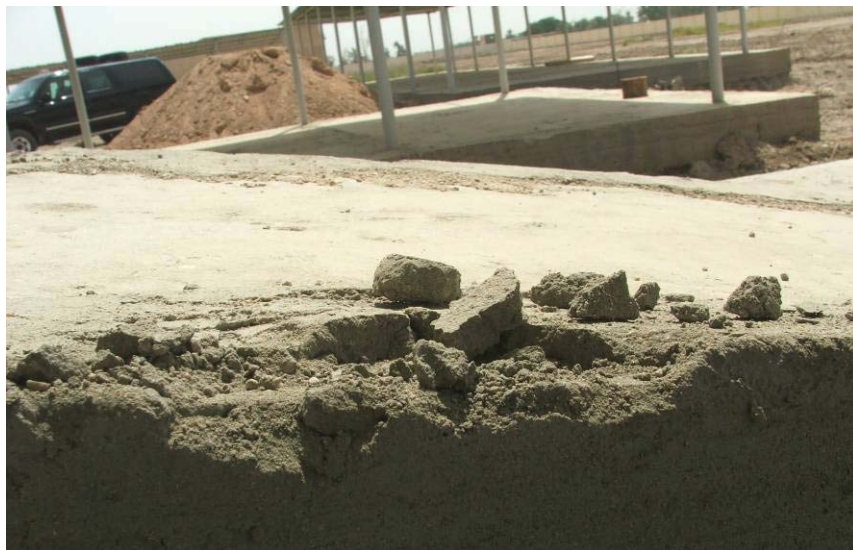
We also found the contractor had patched the ramp surface with a sand-cement mortar. There was no explanation for the need for patching; however, in several areas, the patch was crumbling. Site Photo 20 shows the crumbling material along the top of the ramp.

**Site Photo 20. Crumbling mortar at the surface of the vehicle ramp**

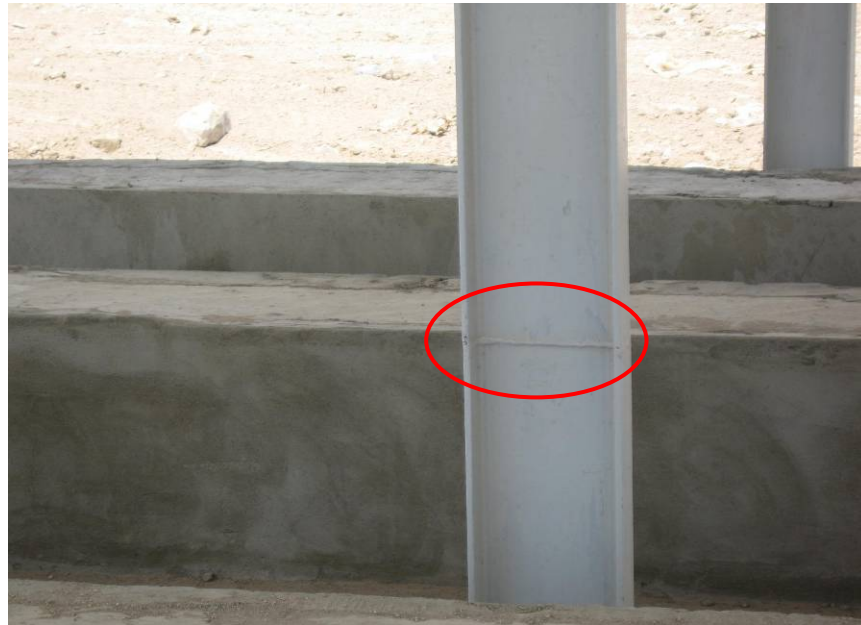
We also observed one of the H-columns consisted of two sections, butt welded together to form the column (Site Photo 21). In addition, in two of the 12 columns, we observed four bolt holes in the flange section of the column (Site Photo 22).

**Site Photo 21. Spliced steel H-column at the motor pool**

Our concerns about the motor pool noted above should be reviewed by a USACE GRS structural engineer, particularly since there were no structural design drawings for the facility.

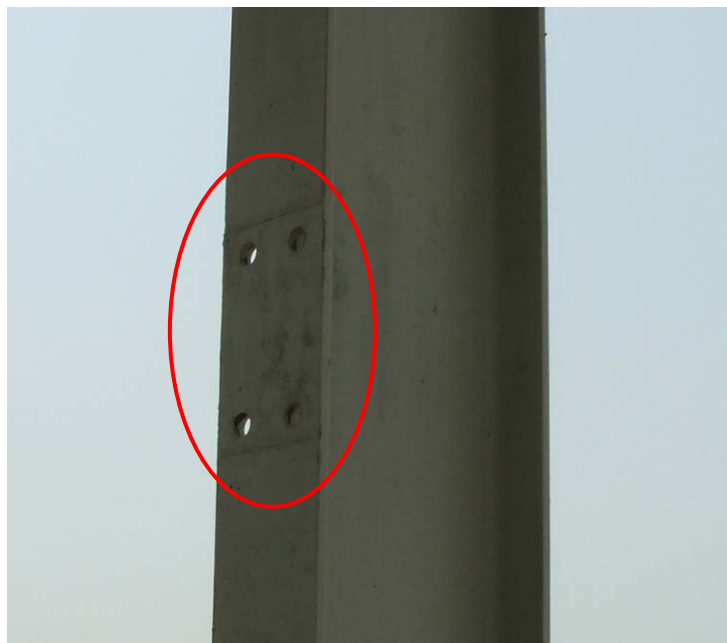
**Site Photo 22. Bolt holes in flange of a steel H-column at the motor pool**

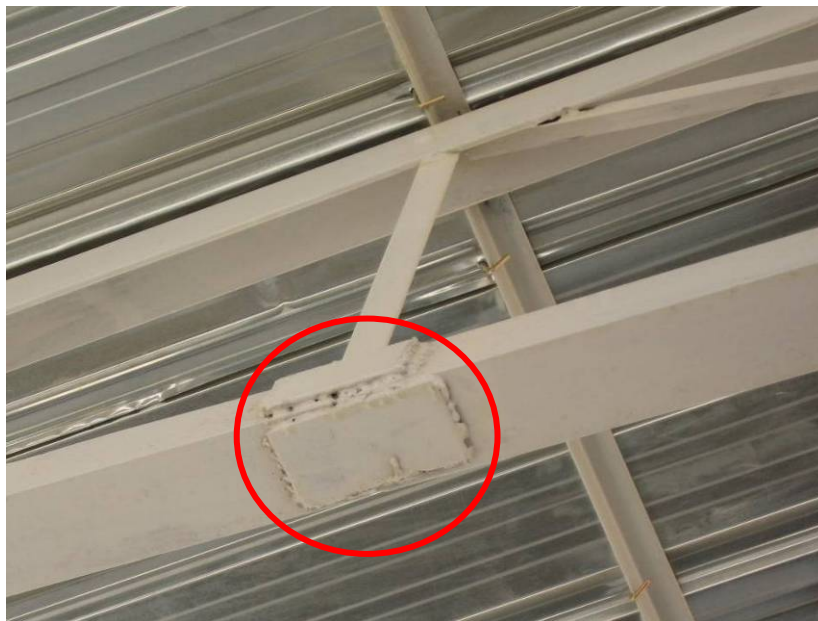
It appeared the roof trusses were adequately constructed; although we observed in several locations, the bottom chord of the truss was spliced between the columns. Site Photo 24 illustrates the spliced bottom chord. It appeared in these locations, the contractor welded plates to the bottom and side of the steel angle to stiffen the spliced connection.

**Site Photo 24. Spliced bottom chord on motor pool roof**

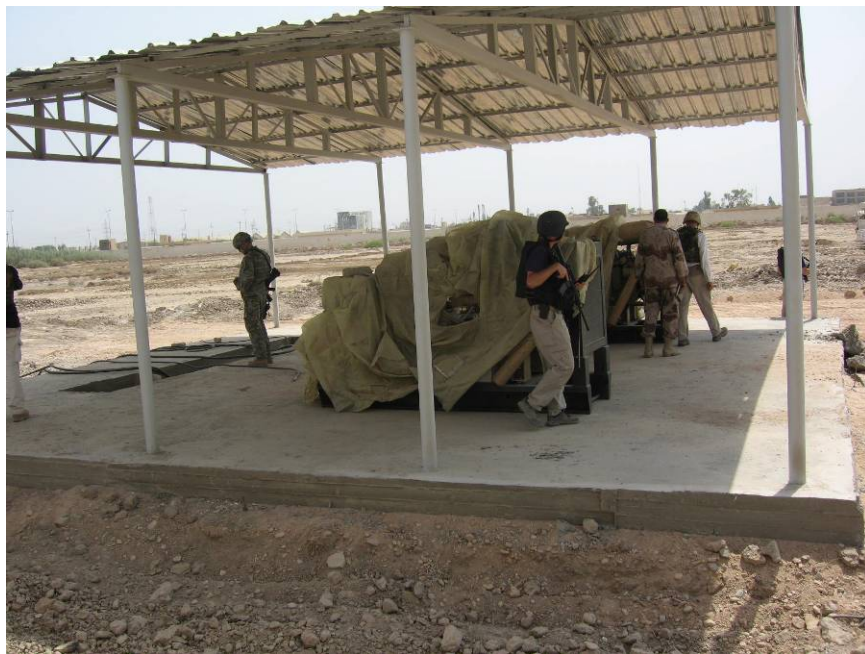
The SOW required the contractor to install two, 200 kilo-volt-amps (kVA) diesel generators in a new generator shed. The SOW also required a fuel tank for the generators (no size provided), manual change-over switch, synchronous panel for 2 generators, and 400 ampere switchgear. We found during our inspection the two new 200 kVA generators covered with tarps and resting on a concrete slab. The generator shed was also constructed, but the switchgear, electrical panel, and external fuel tank had not been installed. Site Photo 25 shows the generators in place under the metal shed.

**Site Photo 25. Generator shed and two generators (covered with tarps)**

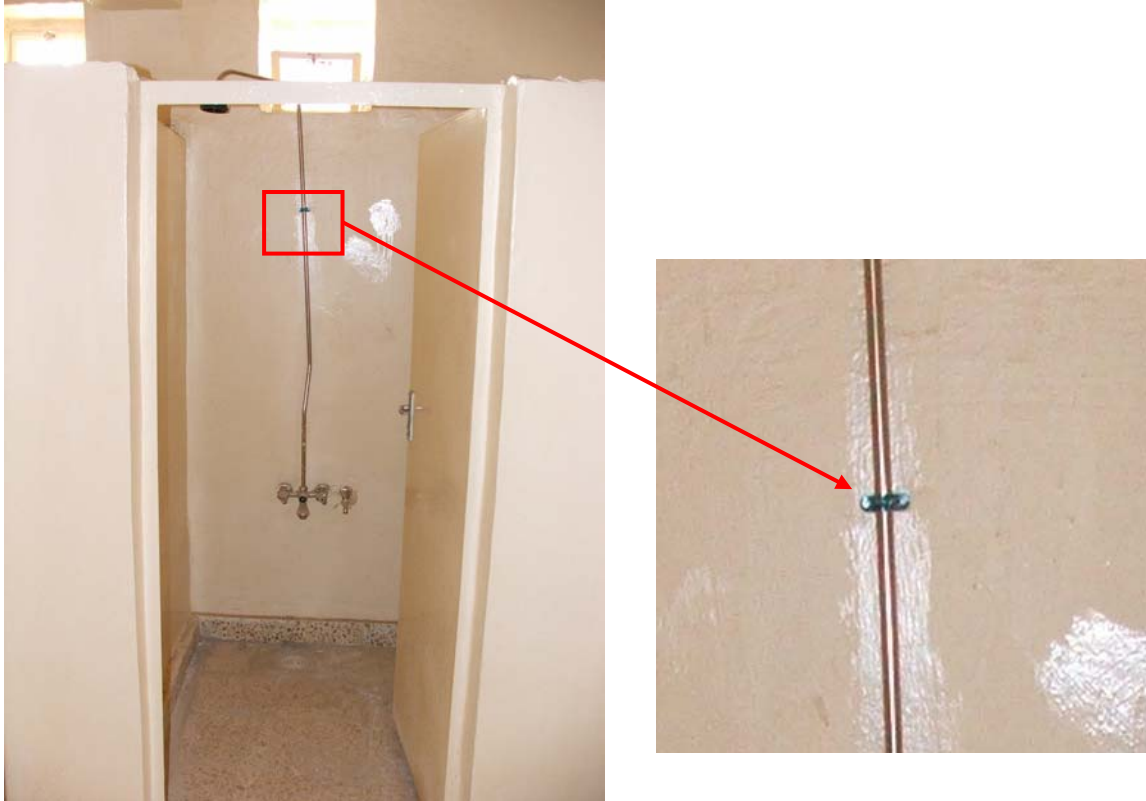
Earlier in this report, we identified potential sustainability issues with the low quality plumbing fixtures in the ablution buildings. For example, the plumbing materials used in the water closets were flexible water hoses, plastic supply tanks, and plastic tubing from the tank to the toilet; while in the showers, the water faucets are susceptible to breaking off and the thin metal water pipe to the shower head is connected to the wall with a one screw clamp (Site Photos 26 and 27). Over time, the clamp will dislodge from the wall and the shower water pipe will dangle. Considering the heavy usage the ablution buildings will receive, the low quality material will pose continual maintenance problems for the Iraqi Army.

**Site Photos 26 and 27. Single screw clamp holding the thin metal water pipe to the wall.**
