AL HILLAH POLICE FIRING RANGE
AL HILLAH, IRAQ

SIGIR PA-06-076
JANUARY 08, 2007

SUBJECT: Report on Project Assessment of the Al Hillah Police Firing Range,
Al Hillah, Iraq (Report Number SIGIR-PA-06-076)

Al Hillah Police Firing Range, Al Hillah, Iraq

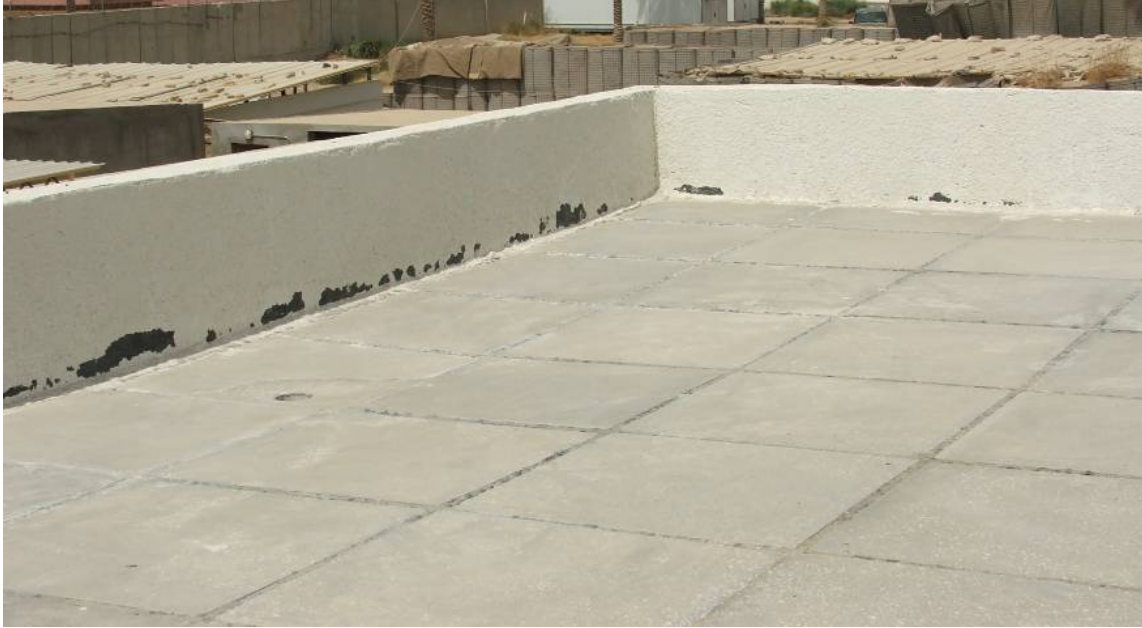
The roof construction consisted of concrete tiles and mastic joints, and a plastered and textured parapet. Site Photo 2 shows the roof. The roof appeared adequately constructed, although we did notice a portion of the finish coat of paint peeling away from the interior of the parapet wall.

Site Photo 2. Range control building roof

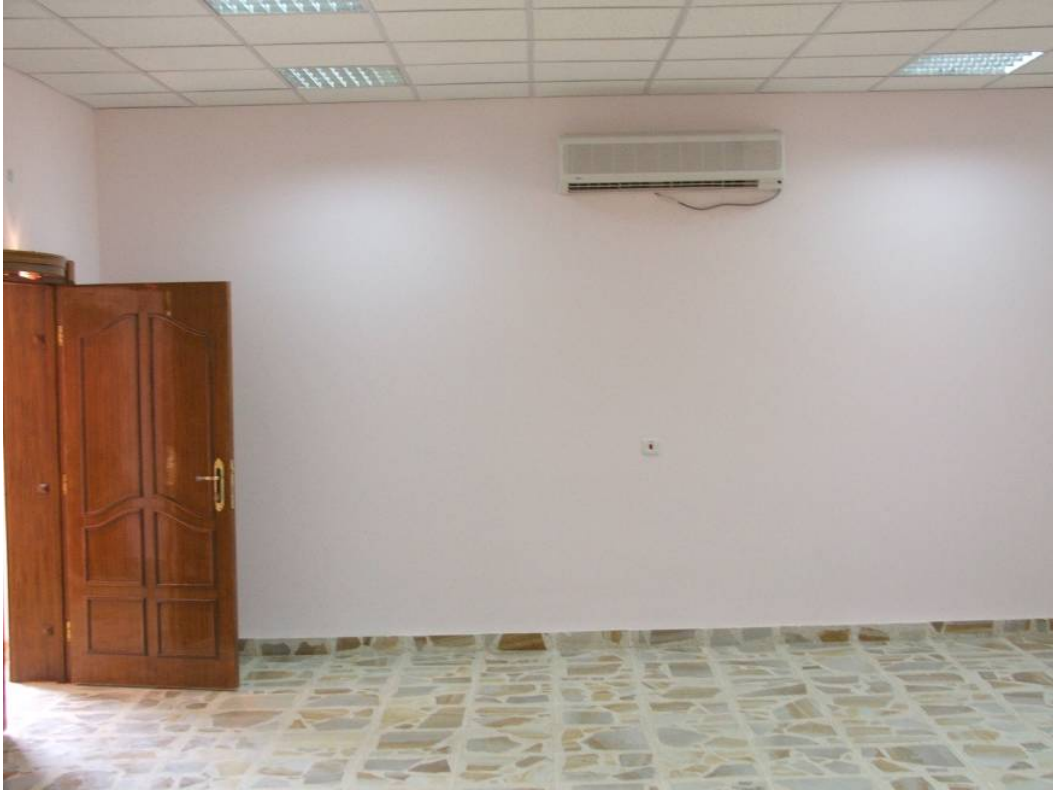
In summary, we did not observe any significant deficiencies with the range control building construction. Site Photos 3-5 provide examples of the features in the building observed during our inspection.

Site Photo 3. Range control building waiting room

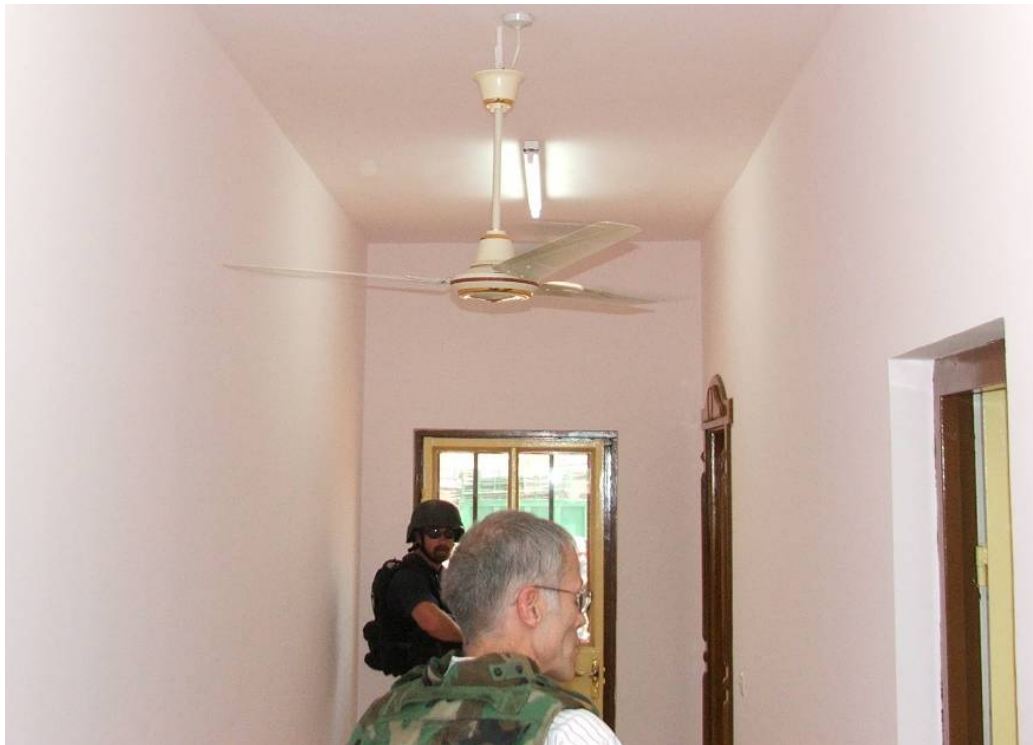
Site Photo 4. Hallway in range control building

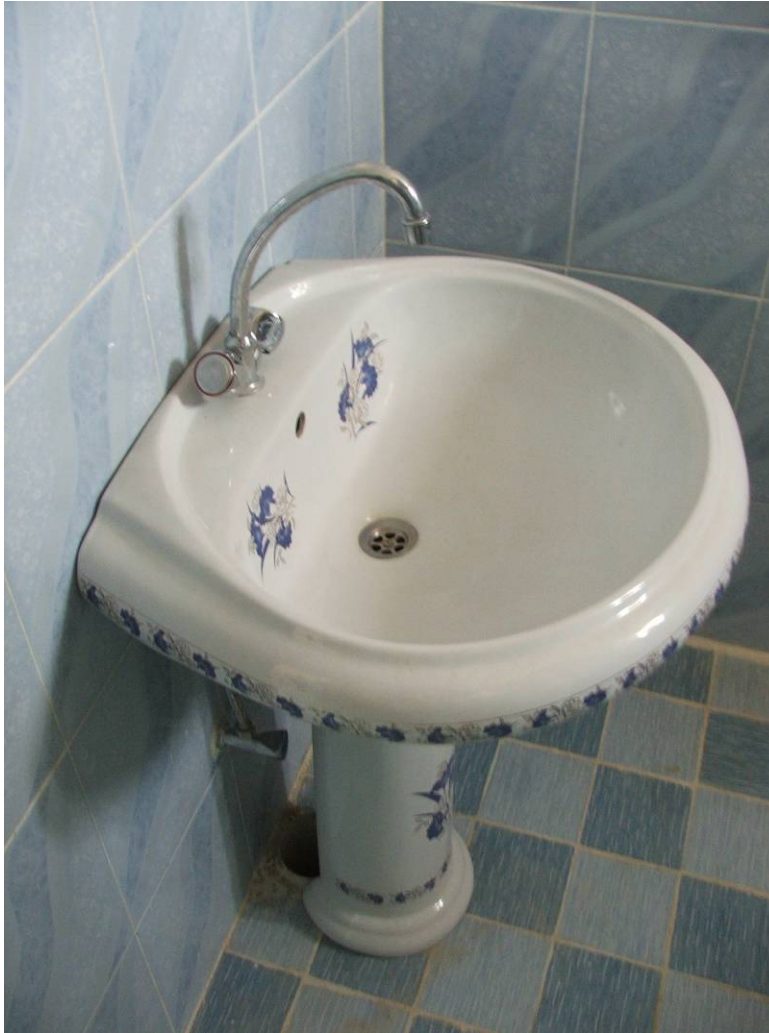
Site Photo 5. Wash basin and tile work in one of the range control building bathrooms

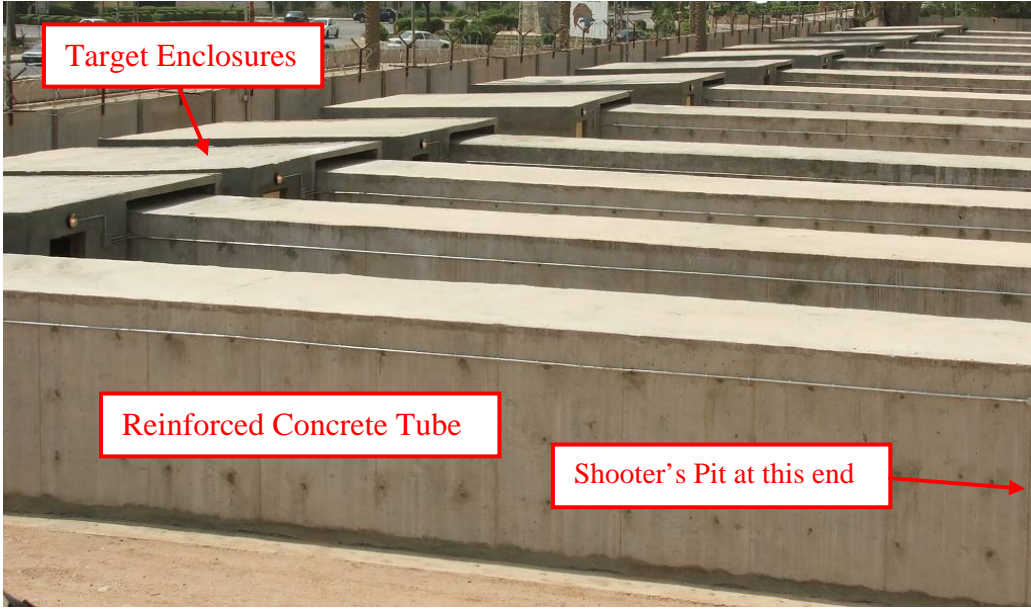
The design for the rifle firing tubes shown in Site Photos 6, 7, and 8 called for a reinforced concrete tube, 25 m in length. The target was housed in an enclosure constructed with grout filled masonry sidewalls and a reinforced concrete back wall and cover. The 2 m wide by 2.1 m high firing tube was designed with reinforced concrete side walls, floor, and cover, each 10 centimeters (cm) thick.

Site Photo 6. Rifle firing tubes

Overall, we did not observe noticeable deficiencies associated with the rifle firing tubes. We also verified the dimensions of the rifle firing tubes, which were in accordance with the design requirements.

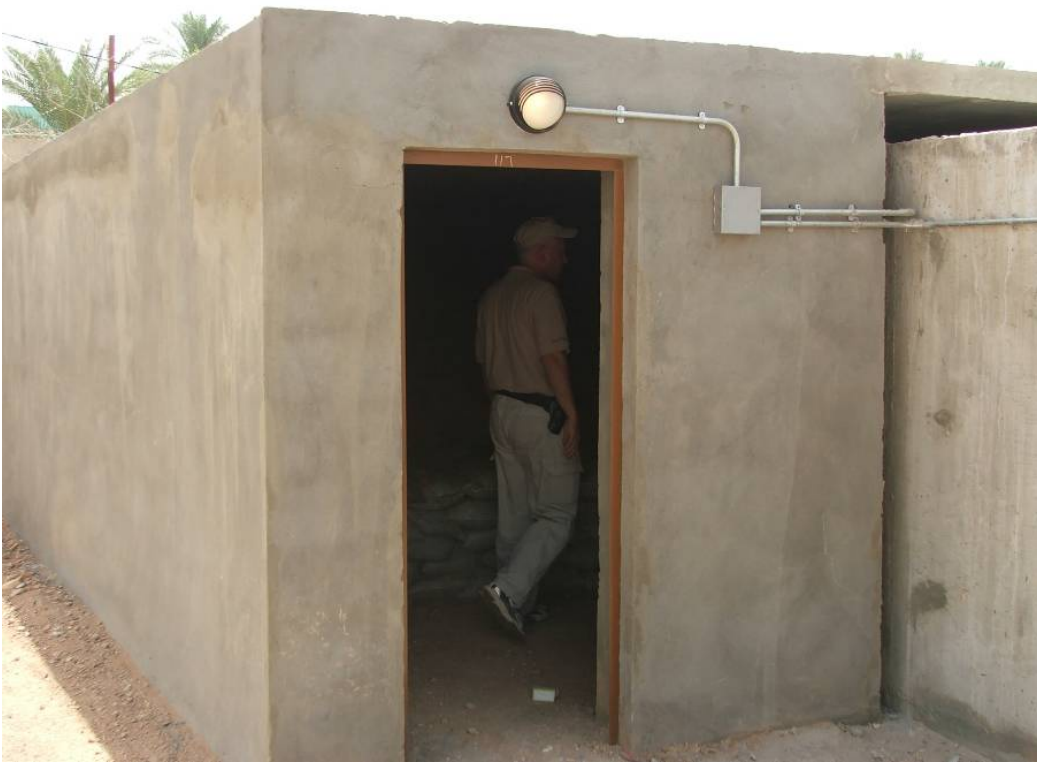
Site Photo 7. Target enclosure entrance

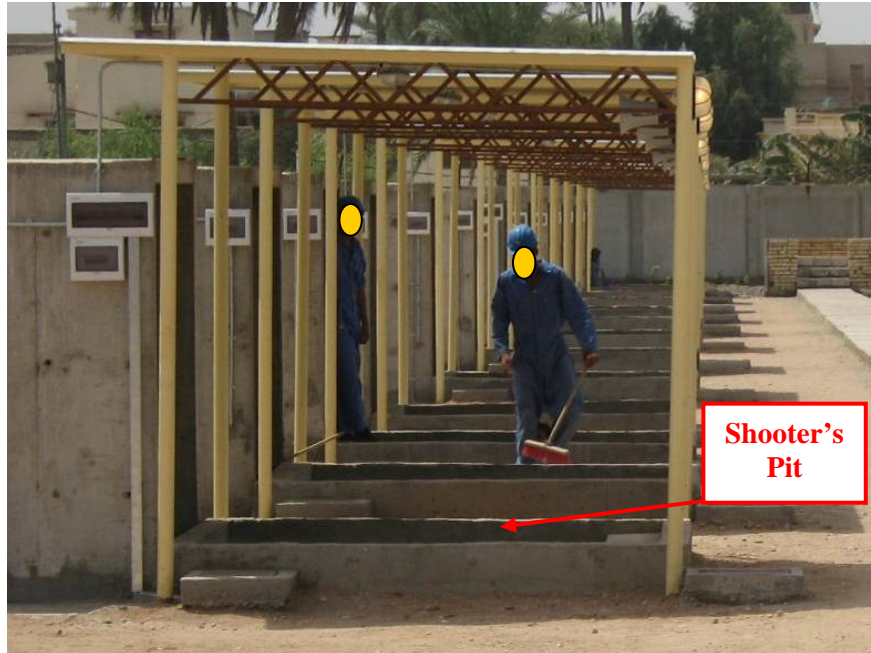
Site Photo 8. Shooter's pit at rifle firing tubes

The reinforced concrete shooter's pit at the end of the firing tube was below grade so that the pit floor was 0.75 m below the floor of the firing tube. The outside dimensions of the pit were 2 m wide by 3 m long, and the pit was covered with a metal cover supported by truss frame and four steel posts. The shooter's pit contained an overhead fluorescent light fixture as well as an exterior light mounted to the outside of the metal cover frame.

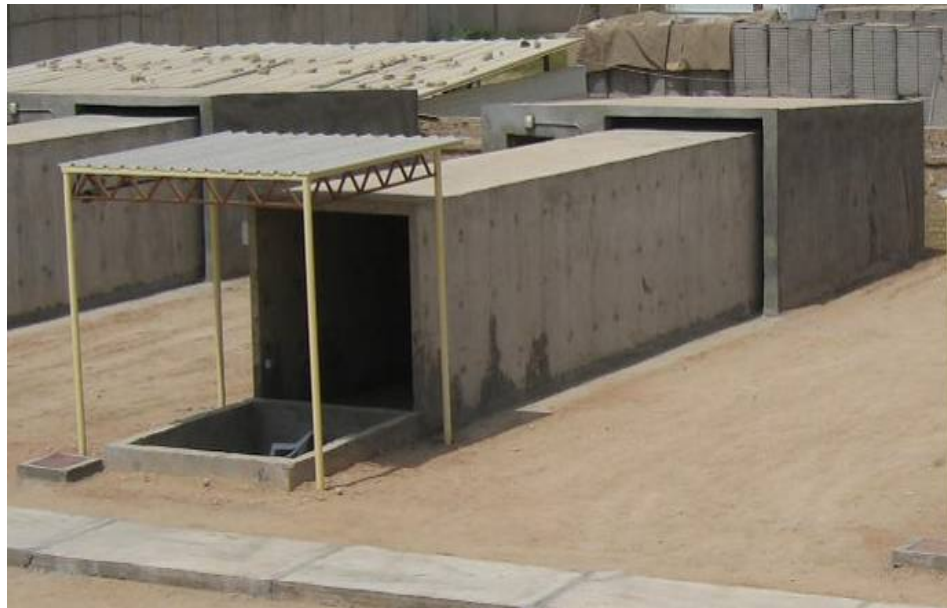
The design for the pistol firing tubes was similar to the rifle firing tubes except the reinforced concrete tube length was 10 m. Site Photo 10 shows one of the 12 pistol firing tubes. During our inspection, we verified the correct dimensions associated with the pistol firing tubes. The construction appeared to meet contract requirements.

Site Photo 10. One of the 12 pistol firing tubes

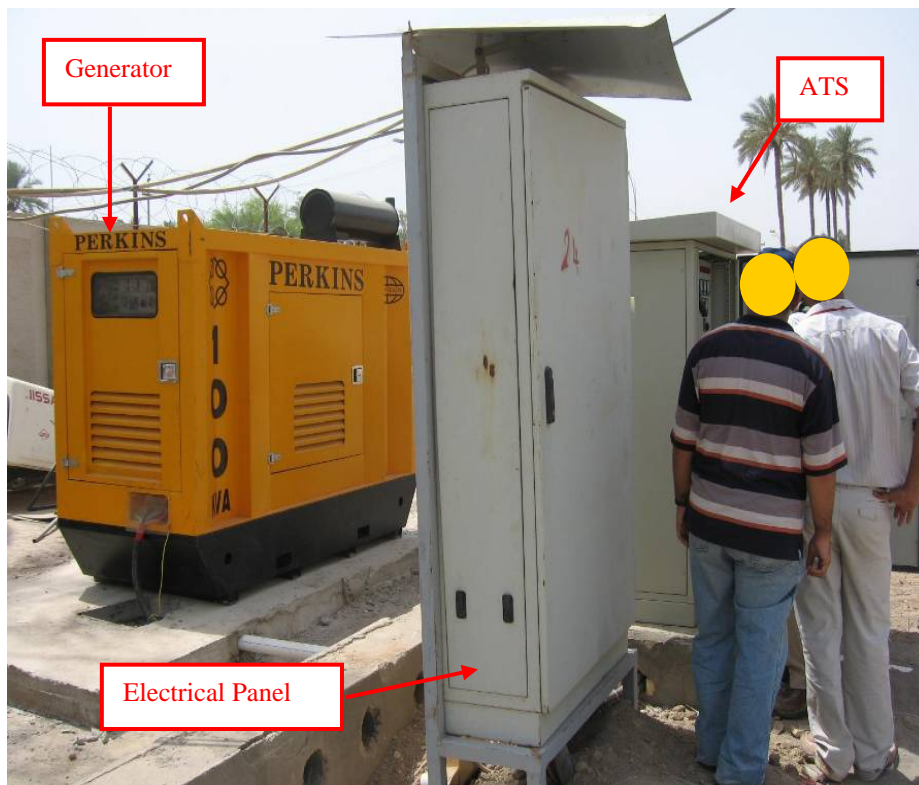
Site Photo 11 shows the 100 kVA generator installed on the concrete slab, the electrical panel, and the automatic transfer switch (ATS). The generator cover and the external fuel tank were not yet installed.

Site Photo 11. Generator, electrical panel, and automatic transfer switch (ATS)
