402ND BATTALION IRAQI ARMY
HEADQUARTERS BARRACKS
AL HILLAH, IRAQ

SIGIR PA-06-077
JANUARY 29, 2007

SUBJECT: Report on Project Assessment of the 402nd Battalion Iraqi Army Headquarters
Barracks, Al Hillah, Iraq (Report Number SIGIR-PA-06-077)

402nd Battalion Iraqi Army Headquarters Barracks Al Hillah, Iraq

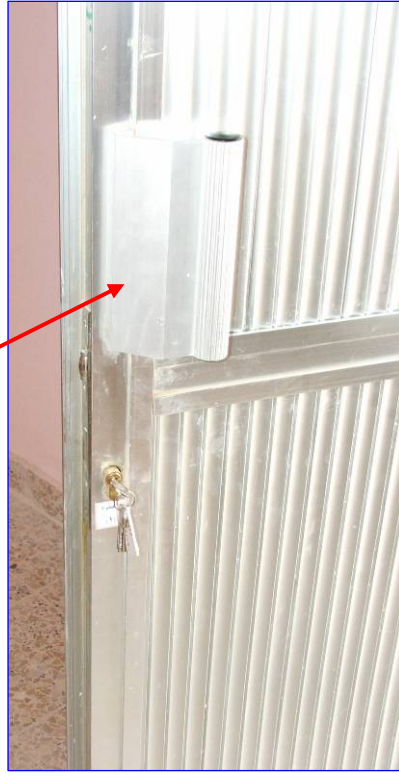
Although the interior appeared satisfactory, the two entry/exit aluminum doors in the barracks sleeping quarters did not appear to be "good quality," especially for the high traffic expected with a 75-man barracks. Site Photos 1 and 2 provide closer views of one of the aluminum doors and associated hardware. In addition, the doors did not have sweeps. Noticeable gaps were present between the thresholds and bottom of the doors as seen in the door shown in Site Photo 3.

Site Photo 2. Barracks entrance door

In addition, we also identified the poor quality aluminum doors in the barracks sleeping quarters. As with the ablution buildings, considering the heavy traffic expected in a 75-man barracks, a higher quality type door was needed. Another concern is that during a strong windstorm, the aluminum doors may fly off.

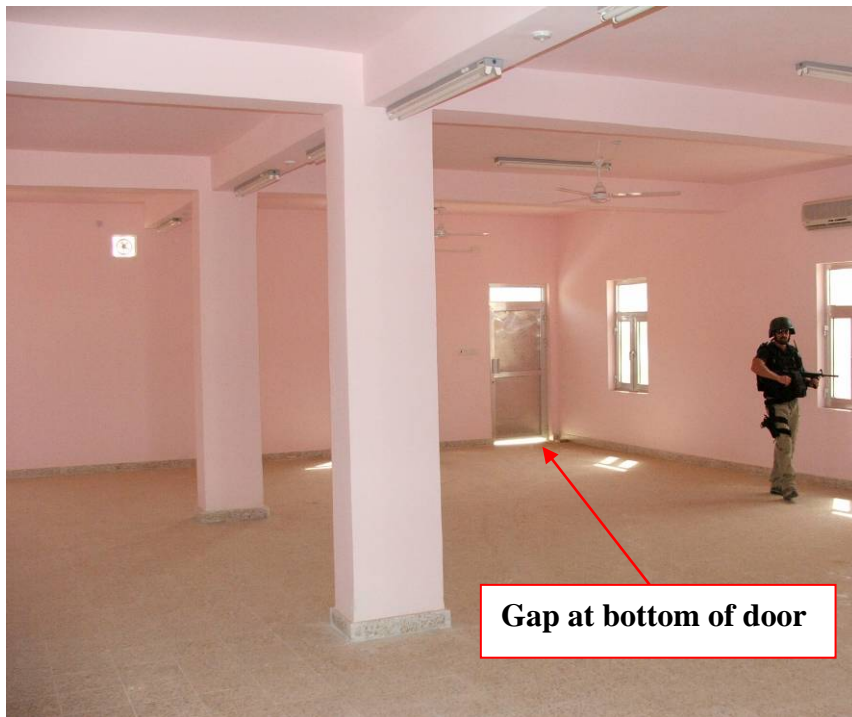
Site Photo 3. Interior of one of the two barracks

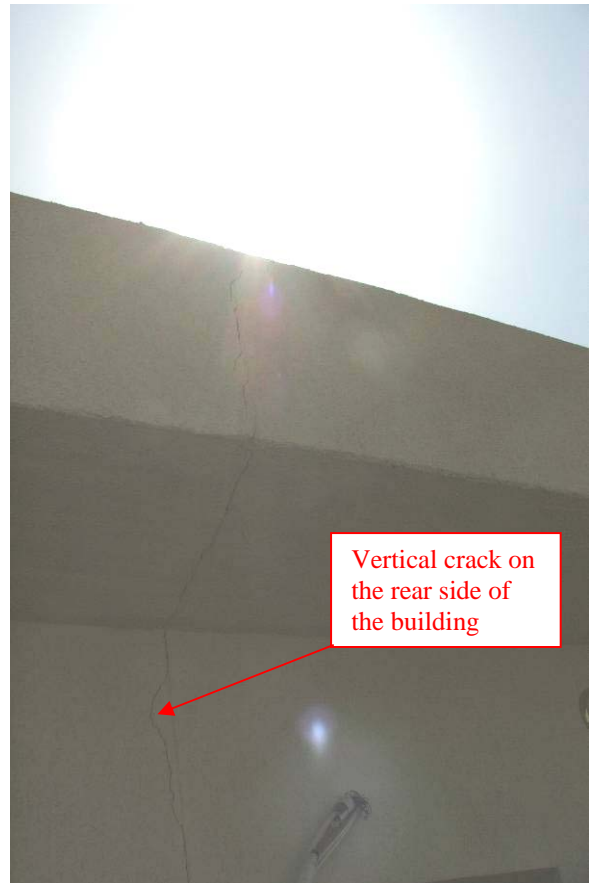
The design included two, two-ton HVAC units in each classroom augmented with a ceiling fan, and two wall exhaust fans, which we verified as installed. Overall, the building appeared satisfactory, except we did observe a noticeable crack in the exterior near the center of the building. The crack ran on both sides of the building, beginning at the sidewalk and continuing vertically in the wall and along the soffit and parapet as shown in Site Photos 5 and 6. The structural design for the building shows in the center of the building, a 480 mm masonry wall consisting of two, side by side masonry wall sections, each 240 mm thick. The design also shows the dual masonry walls supporting two adjoining bond beams, each 250mm thick. The design does not show any tying mechanism between the dual masonry walls or connecting reinforcing steel or dowels in the two concrete beams. Based on this design and the presence of the vertical crack along the building centerline, it appears there should be an expansion joint in the center of the building to allow for the differential movement of each side of the building.

Site Photo 6. Vertical crack in opposite side of classroom building exterior

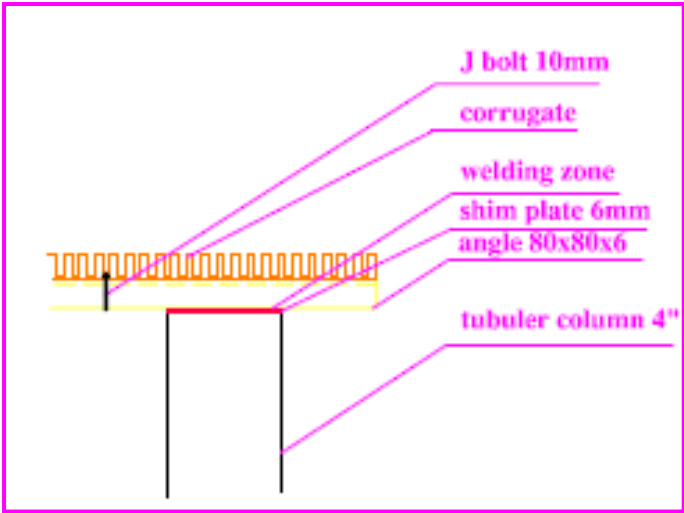
The design detail for the structural frame supporting the corrugated roof sheeting (Figure 1) showed an 80 x 80 x 6 angle supporting the roof sheeting. No units were provided for

the angle, although it is assumed the dimensions are in millimeters. Figure 1 also shows the angle welded to a shim plate at the top of the column. There were no details provided on the type or size of weld or the type and thickness of the corrugated roof sheeting. The design also did not show any lateral cross bracing perpendicular to the angle support shown in Figure 1.

Figure 1. Design detail for covered parking (sunshade)

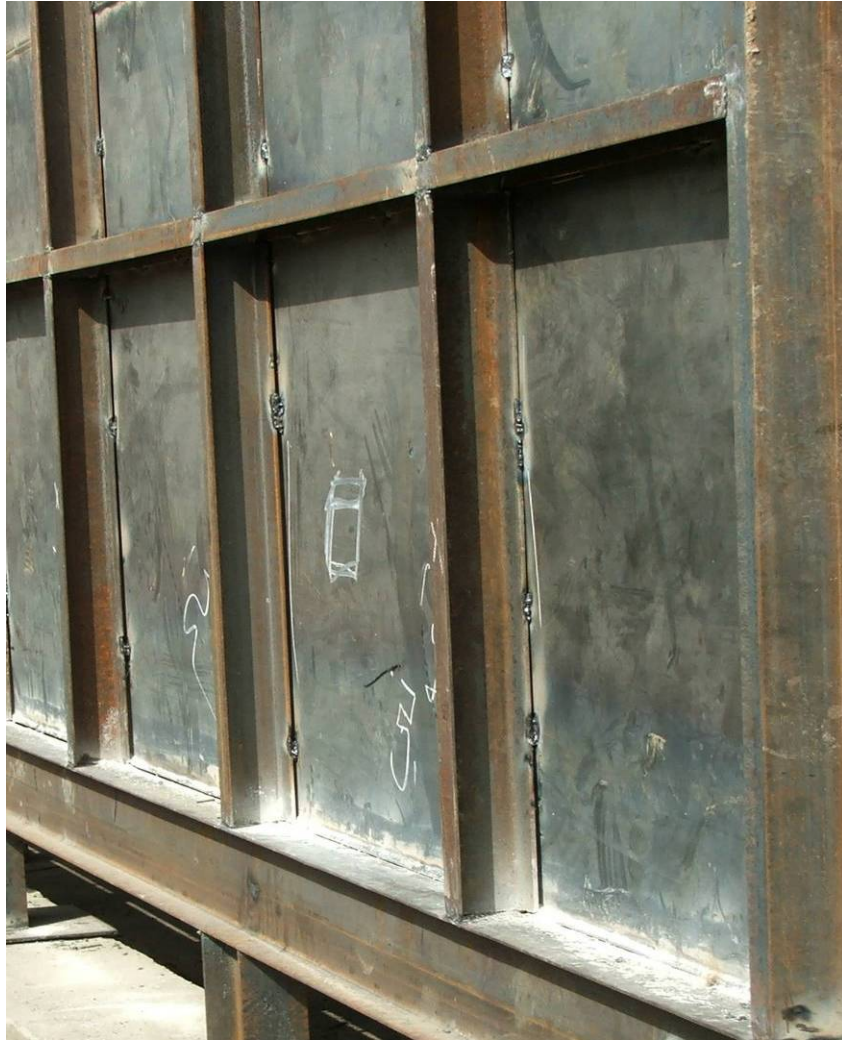
During our assessment, we observed a partially completed water tank as shown in Site Photo 14 that met the size requirements for a 300 m³ tank. The tank was supported by a concrete foundation and structural steel frame. The tank sides consisted of steel plate, spot-welded to the structural steel supports. Site Photo 15 shows the spot welding along one side of the tank. The steel plates appeared to be approximately 0.25 inches thick.

Site Photo 15. One of the tank's sidewalls showing steel plates spot welded to frame

Given the lack of details in the design, the assessment team could not determine whether the water tank construction met the standards of the design. However, we were concerned with the quality of the spot welds and if there was sufficient steel plate thickness to withstand the hydrostatic pressures associated with a fully filled 300 m³ water tank. We discussed our concerns with the USACE Babil RE and PE. We also recommended the USACE GRS structural engineer assess the adequacy of the water tank construction.

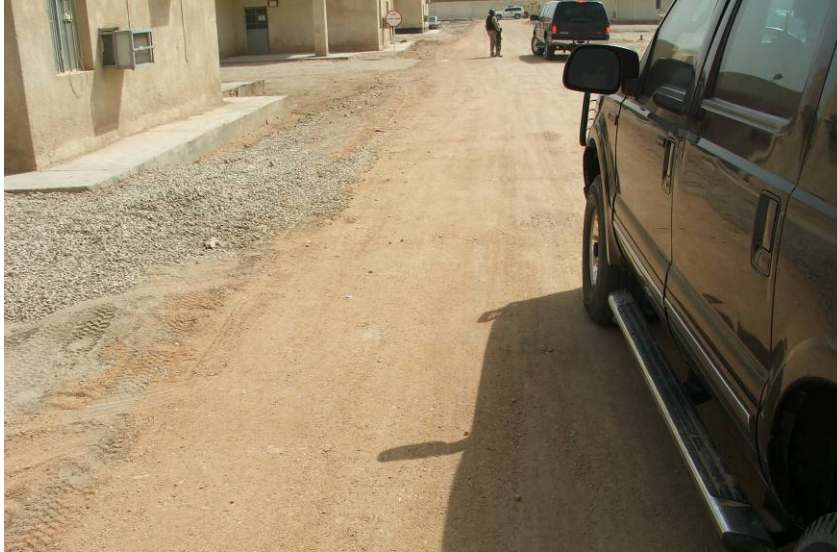
observed compacted subbase material in place at various locations on the compound. Site Photo 16 shows one of those locations in front of the medical clinic. The USACE PE indicated the contractor would construct the required amount of paved surfaces specified in the SOW (i.e., 2,540 m²).

The surface of the subbase appeared to consist of compacted granular material. Although we could not measure the depth of the subbase, the sections of new roadway we observed appeared adequate.

Site Photo 16. Compacted subbase material for one of the new roads under construction

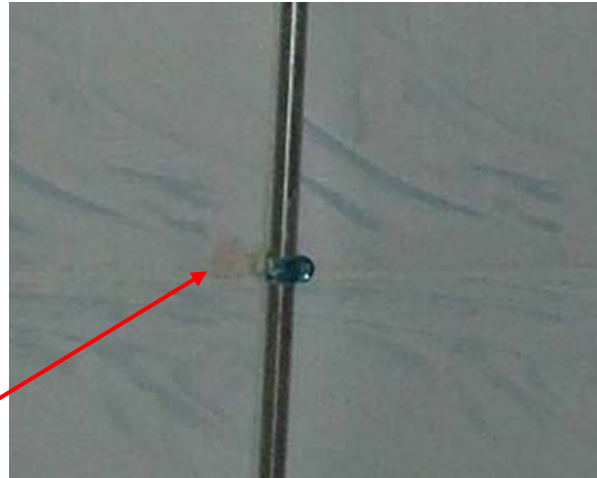
Earlier in this report, we identified potential sustainability issues with the low quality plumbing fixtures in the ablution buildings. For example, the plumbing materials used in the water closets included flexible water hoses, plastic supply tanks, and plastic tubing from the tank to the toilet; while in the showers, the water faucets are susceptible to breaking off and the thin metal tubing to the shower head is connected to the wall with a one screw clamp (Site Photos 17 and 18). Over time, the clamp will dislodge from the wall and the shower water pipe will remain unsupported. Considering the heavy usage the ablution buildings will receive, the low quality material will pose continual maintenance problems for the Iraqi Army.

Site Photo 18. Close up view of clamp
