**BAGHDAD POLICE COLLEGE  
BAGHDAD, IRAQ**

**SIGIR PA-06-078.2**

**SIGIR PA-06-079.2**

SUBJECT: Report on Project Assessments of Reconstruction Work Performed Under Task Orders 06 and 29 at the Baghdad Police College, Baghdad, Iraq (Report Numbers SIGIR PA-06-078.2 and PA-06-079.2)

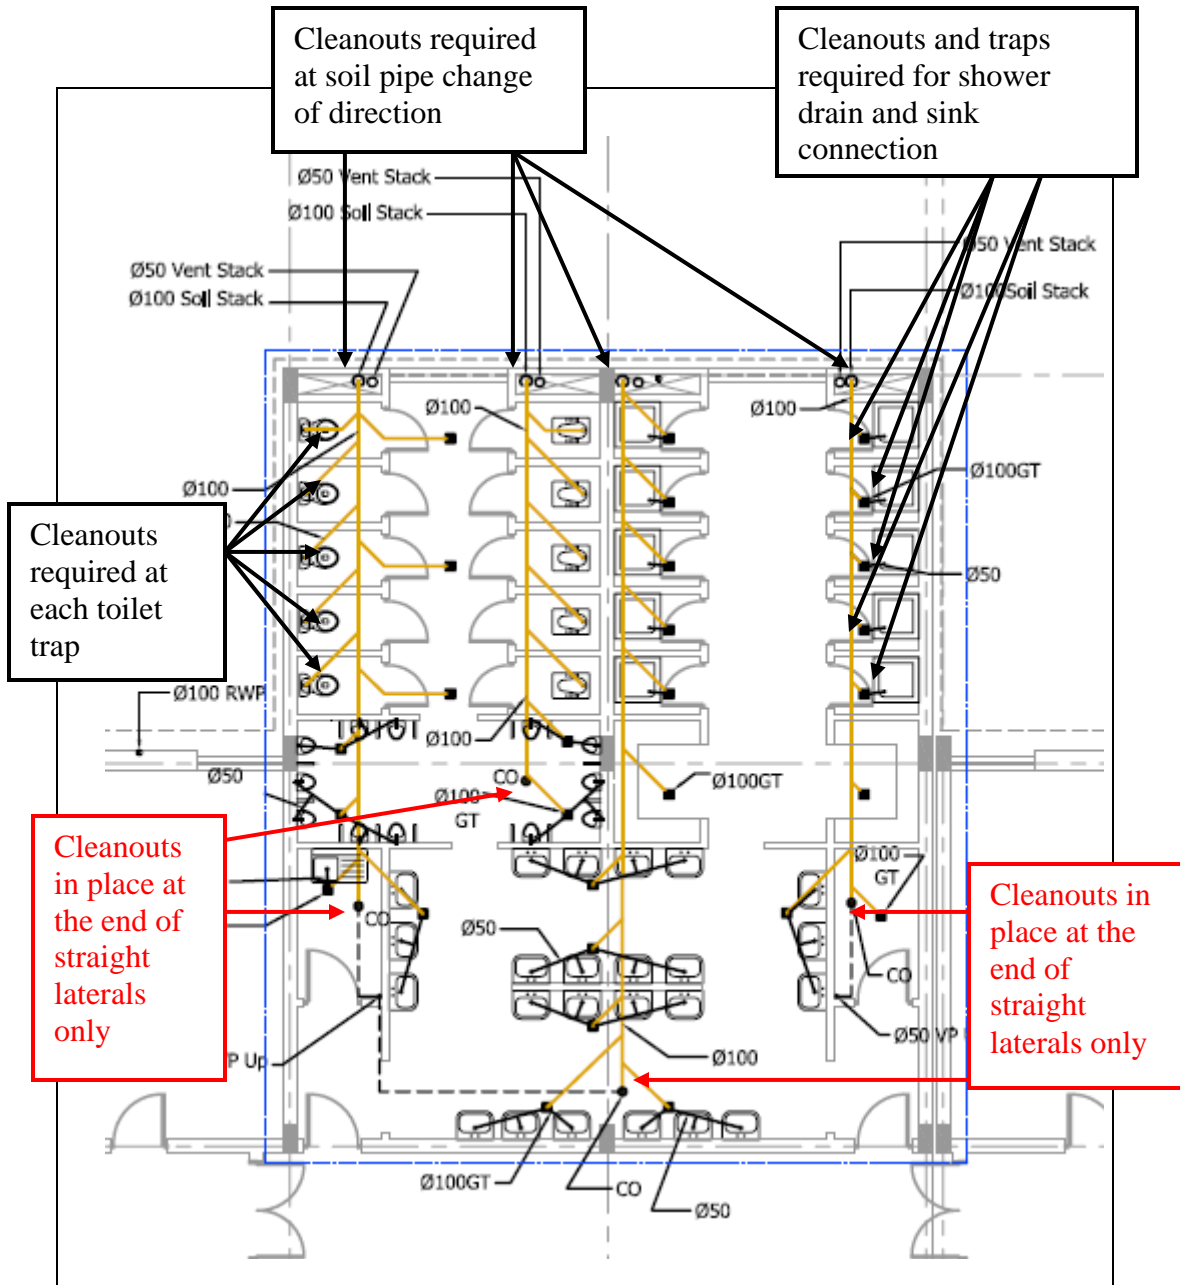
Figure 2. Floor plan and soil pipe detail for a typical cadet barracks facility

The as-built drawings for the cadet barracks indicate cleanouts were only used at the far end of a straight run of soil pipe, not for every toilet trap and change of direction (Figure 2). The government engineers reviewing the cadet barracks design drawings failed to detect and identify the lack of a sufficient number of cleanouts and traps at the correct locations. As a result, not only did the contractor not follow the specific code requirement, which is compounded by the contractor's poor plumbing installation and construction, but the likelihood of the sewer lines backing up increased significantly, even under normal use.

1. Require the contractor to replace all existing plumbing fixtures and fittings in all newly constructed buildings to comply with the International Plumbing Code in accordance with contract specifications. Specifically, eliminate the use of cemented joints, abnormal fittings, and improperly sealed pipe connections. In addition, require the use of cleanouts, traps, and proper sealing techniques.

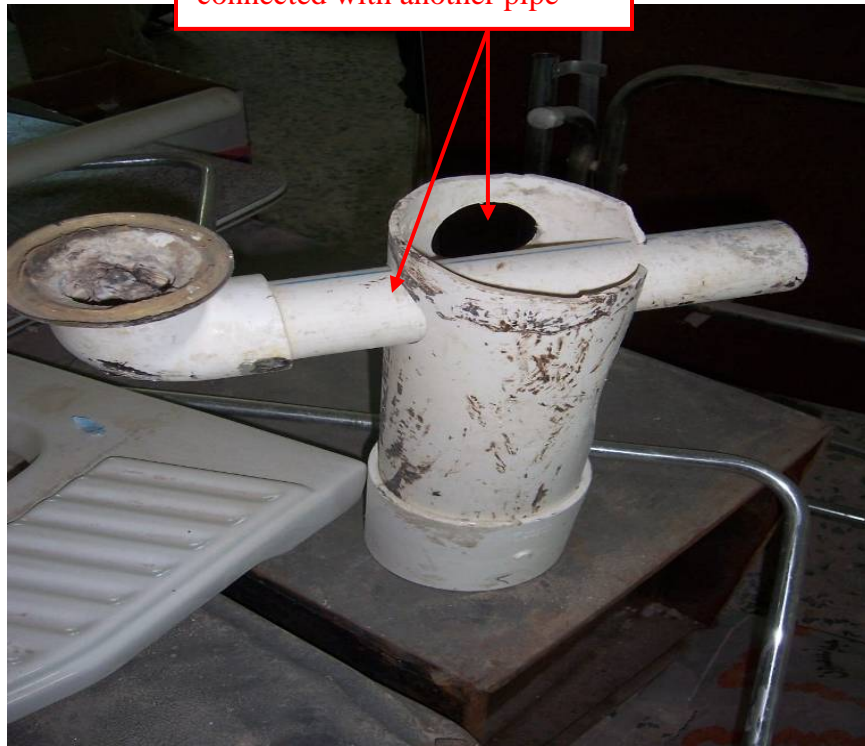
**Site Photo 3. Typical cadet barracks plumbing fixture**

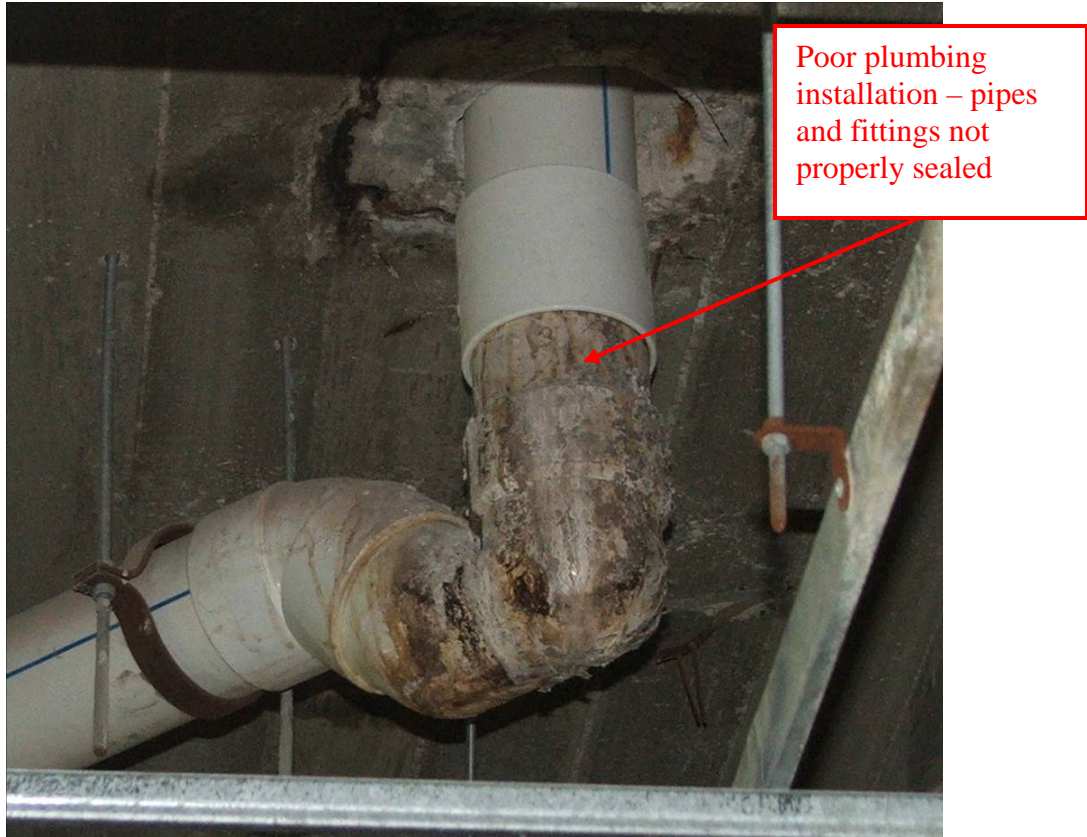
Poor plumbing installation – pipes and fittings not properly sealed

**Site Photo 4. Improper pipe sealing in cadet barracks**

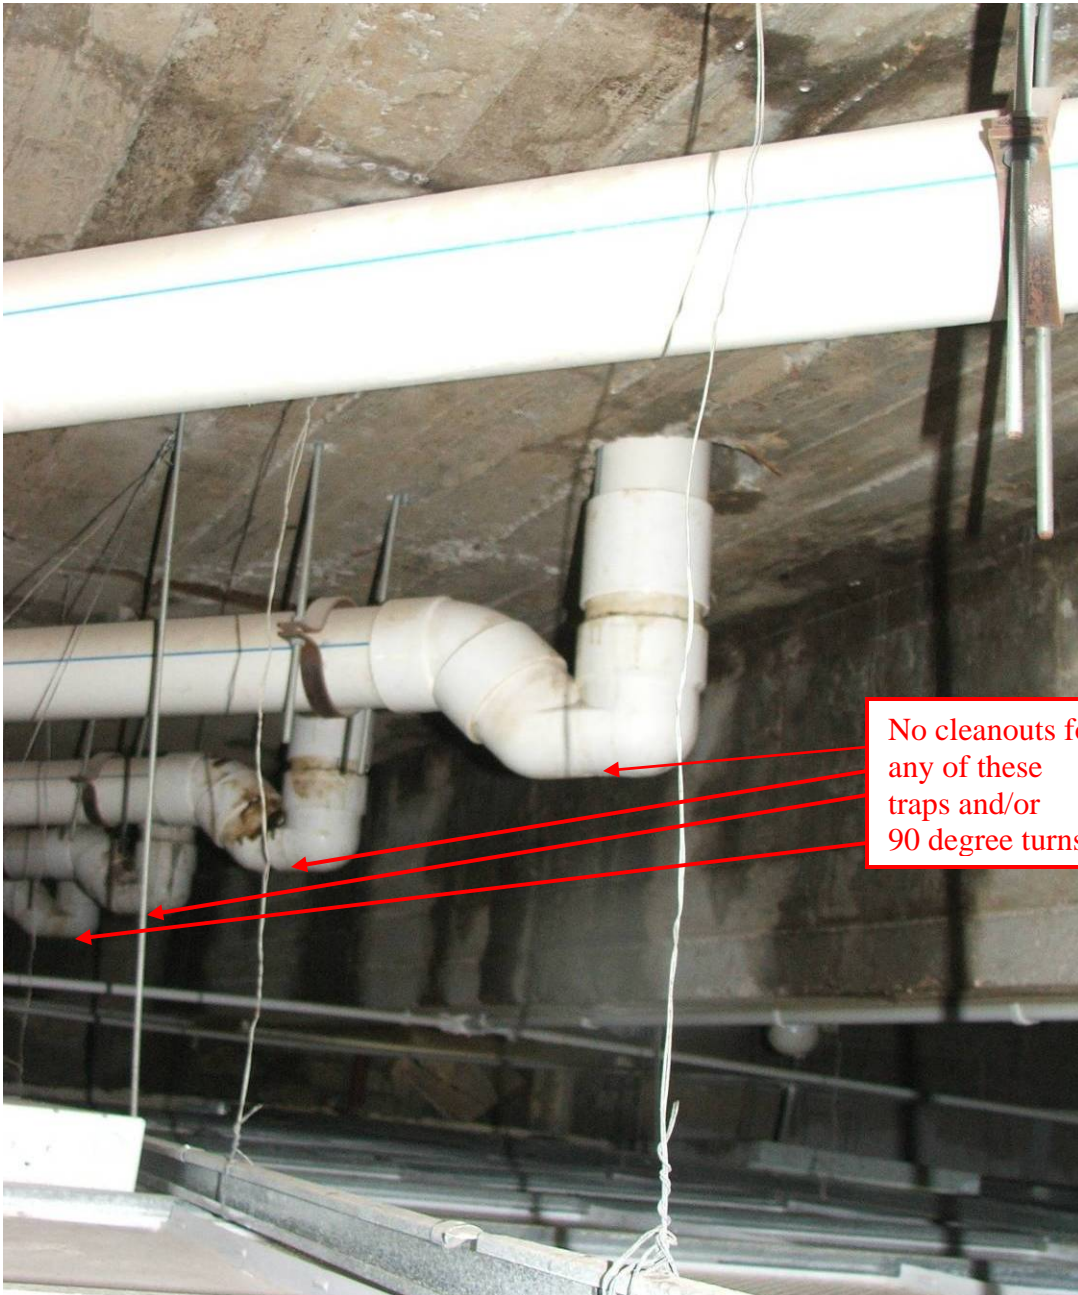
**Site Photo 10. View of plumbing for first floor toilets**

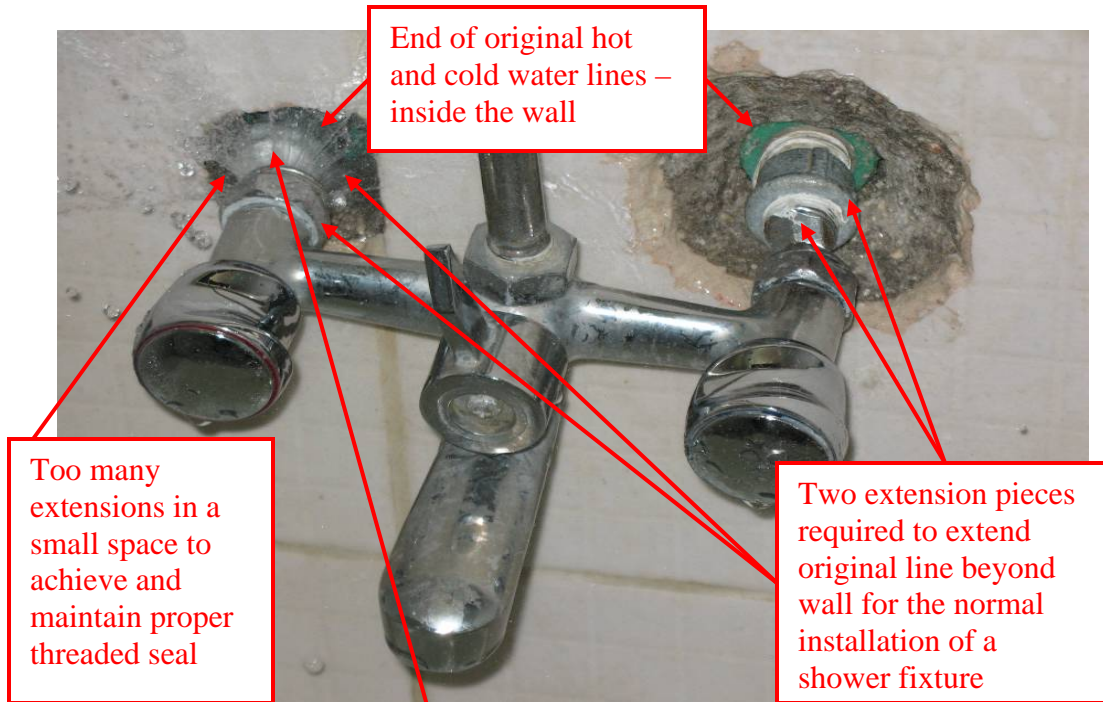
the ground floor (Site Photo 12). A third floor plumbing fixture was leaking and apparently was not correctly installed and sealed to the wall, which consequently allowed water to flow down to the ground floor.

Site Photo 11. Leaking shower fixture in cadet barracks

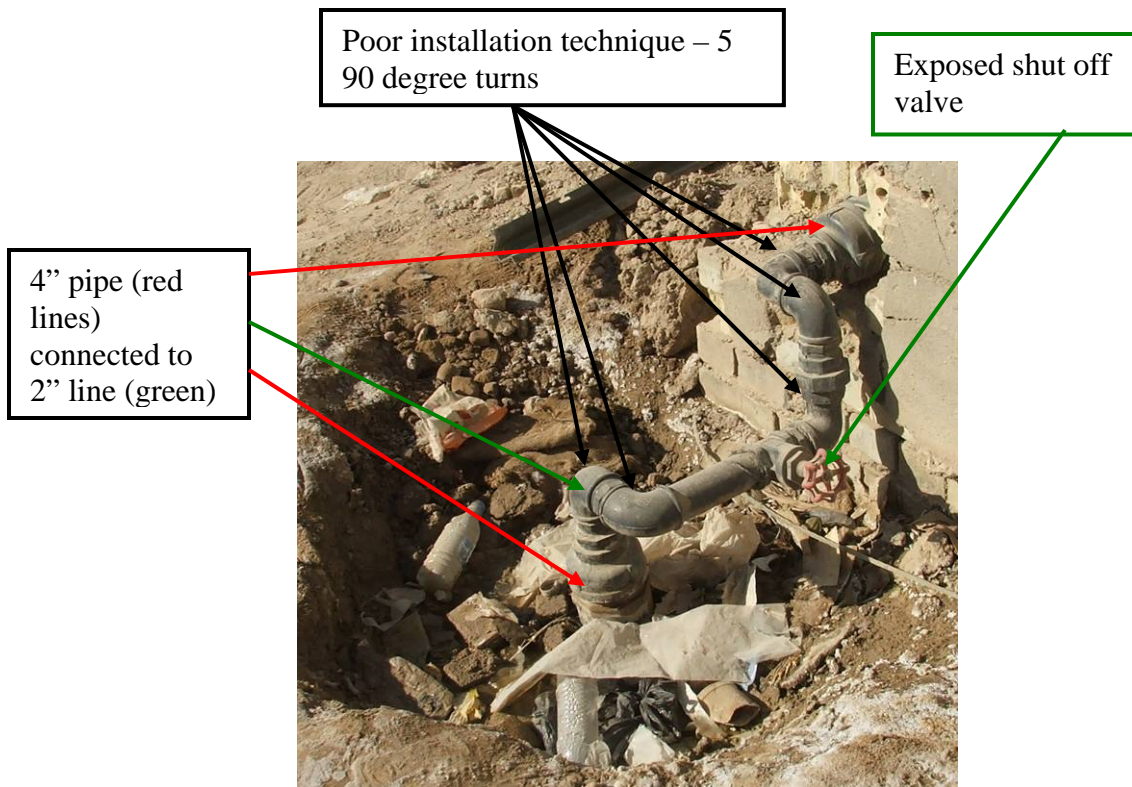
Site Photo 13. Installed main water line to instructors' barracks

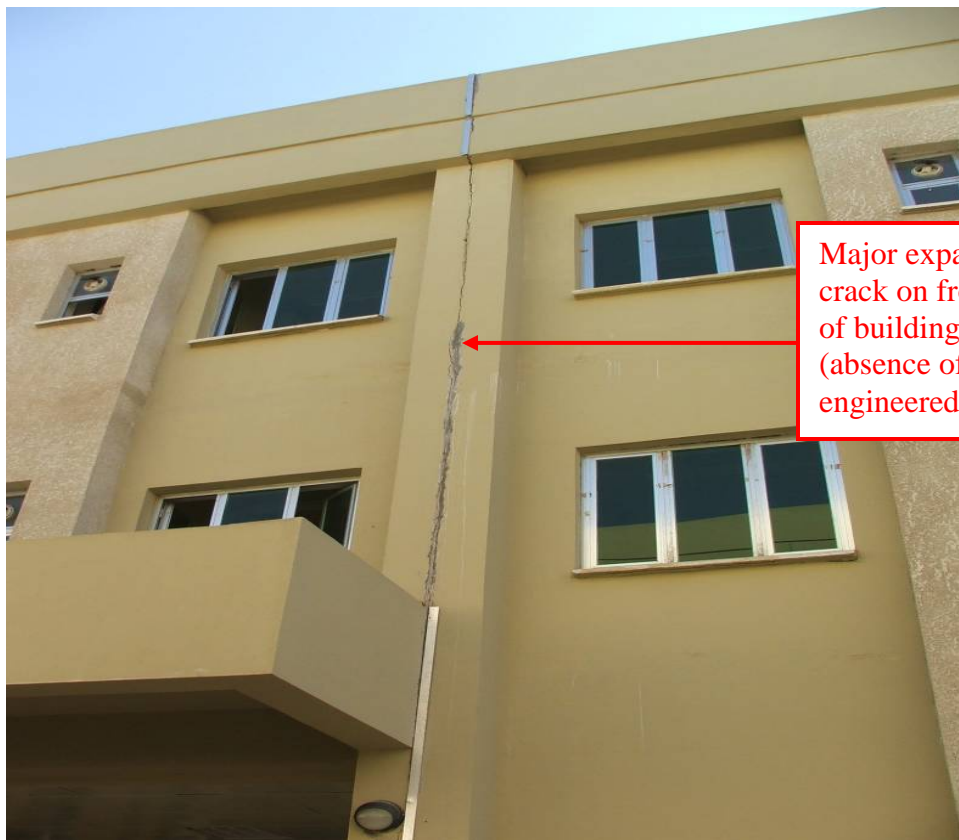
More importantly, we discovered significant expansion cracks on the exterior and interior of the buildings (Site Photos 17-20). We determined that the contractor's as-built drawings (Figure 4) do not reflect the reality of what was actually constructed at the instructors' barracks.

**Site Photo 17. Exterior expansion crack on the instructors' barracks**

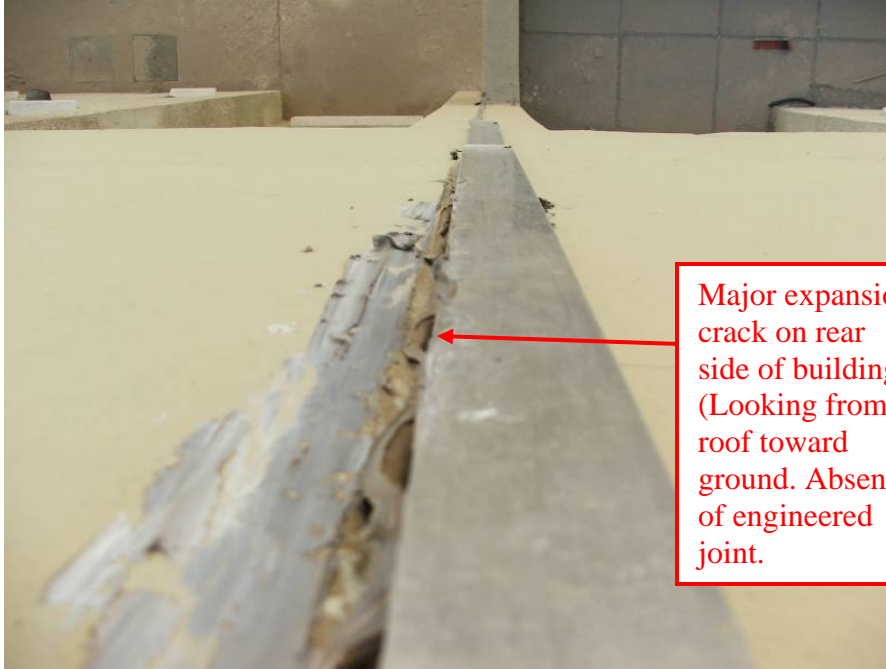
Site Photo 18. Exterior expansion crack on rear side of instructors' barracks

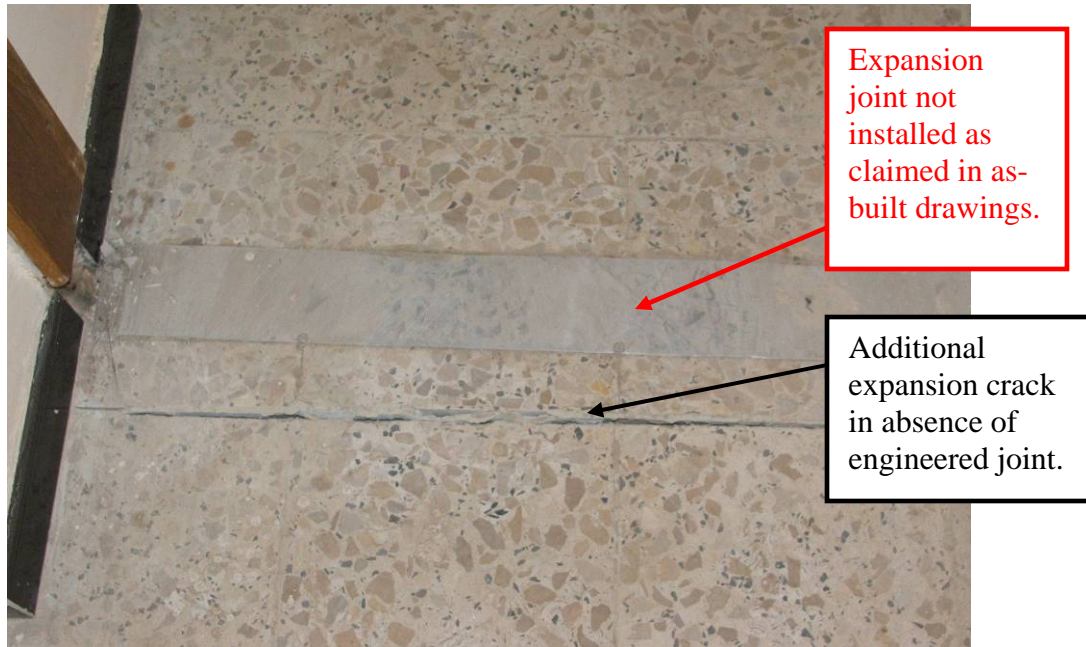
**Site Photo 19. Interior expansion crack in instructors' barracks**

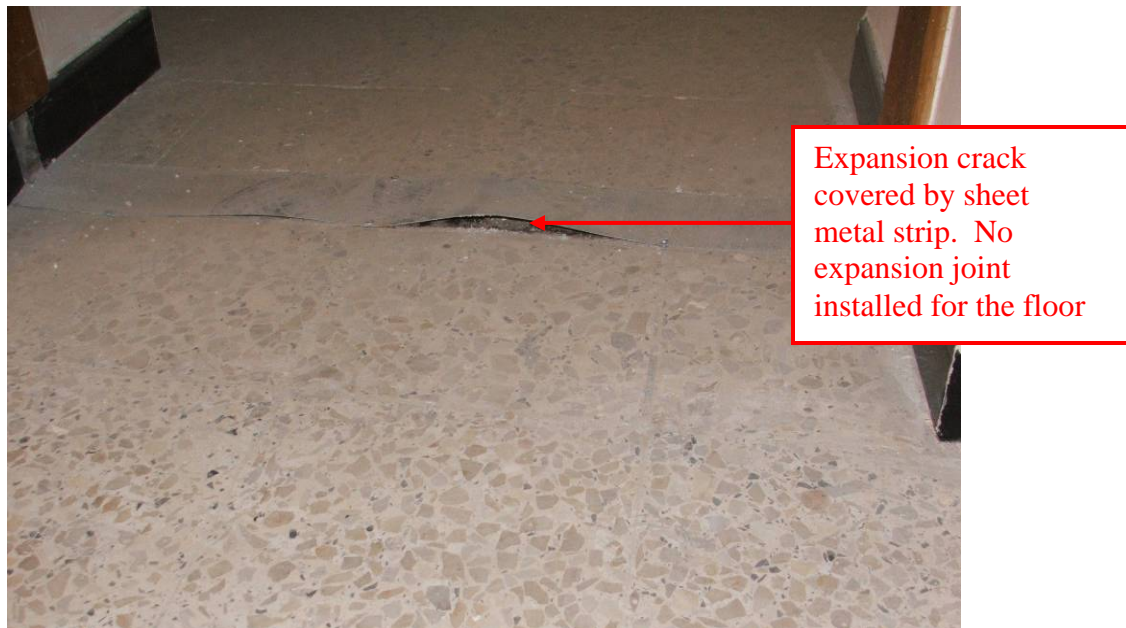
**Site Photo 20. Interior expansion crack inside the instructors' barracks**

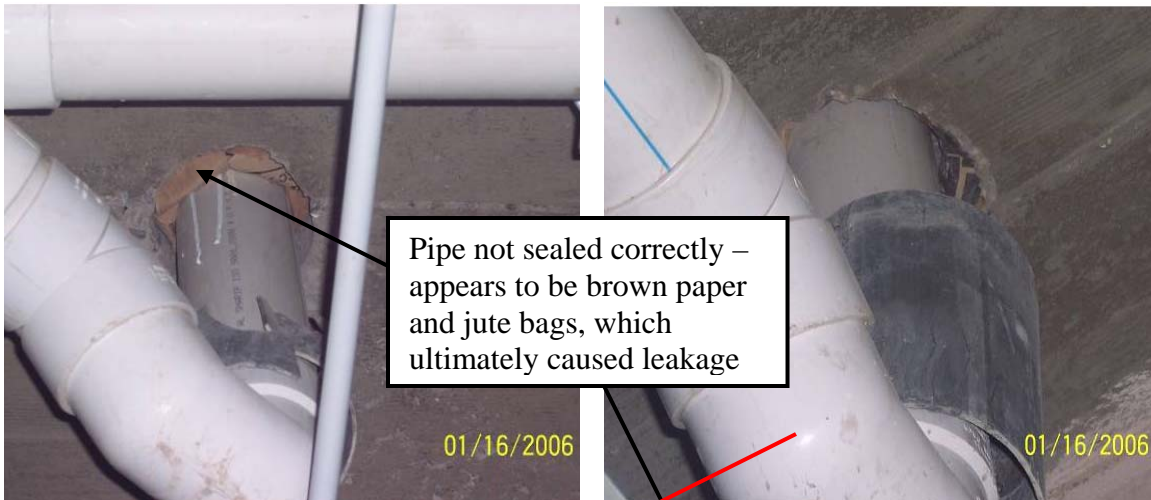
Pipe not sealed correctly – appears to be brown paper and jute bags, which ultimately caused leakage

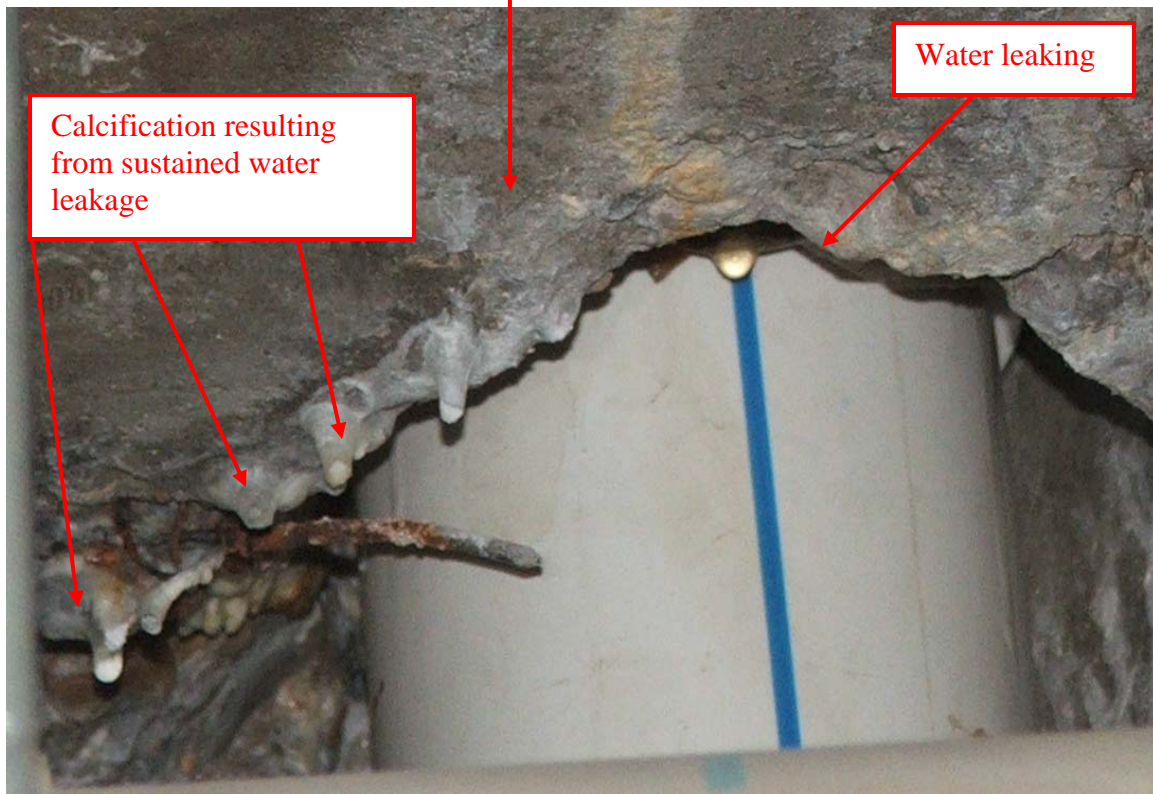
During our return site visits in November and December 2006, we again identified water leakages in the cadet barracks (Site Photos 41-44). While it appears this time the contractor did not use the non-industry standard pipes that contributed to the original leakage problem, the continuing issue of poor quality installation and inadequate seals between the soil pipe and fittings remained. The contractor QCR and/or project engineer failed to adequately perform oversight of the plumbing installation to ensure quality workmanship. As a result, the problem identified in the NCR in January 2006 continues to exist today.

**Site Photo 42. Enlarged view of Site Photo 41**

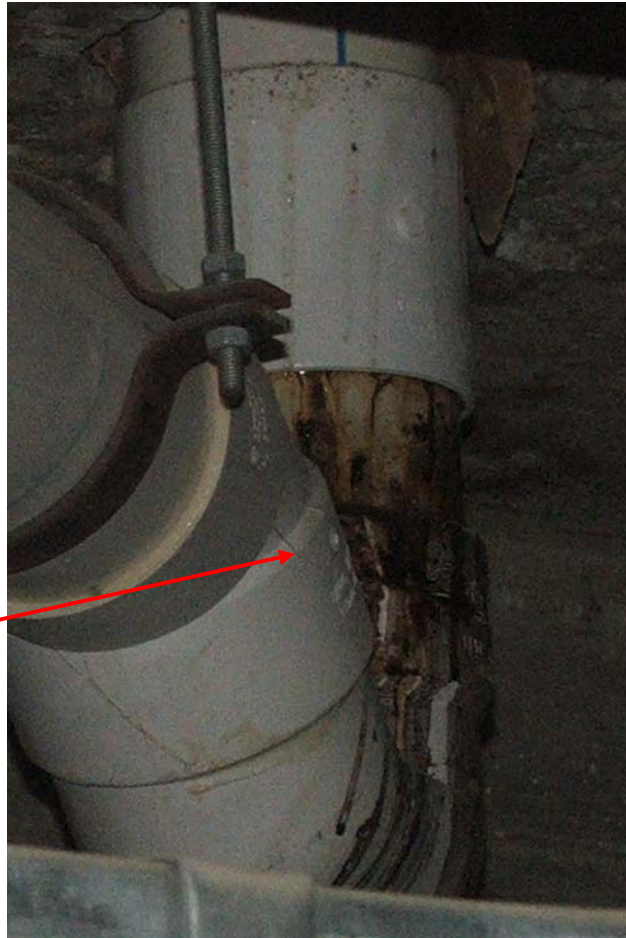
Site Photo 44. Enlarged view of Site Photo 43

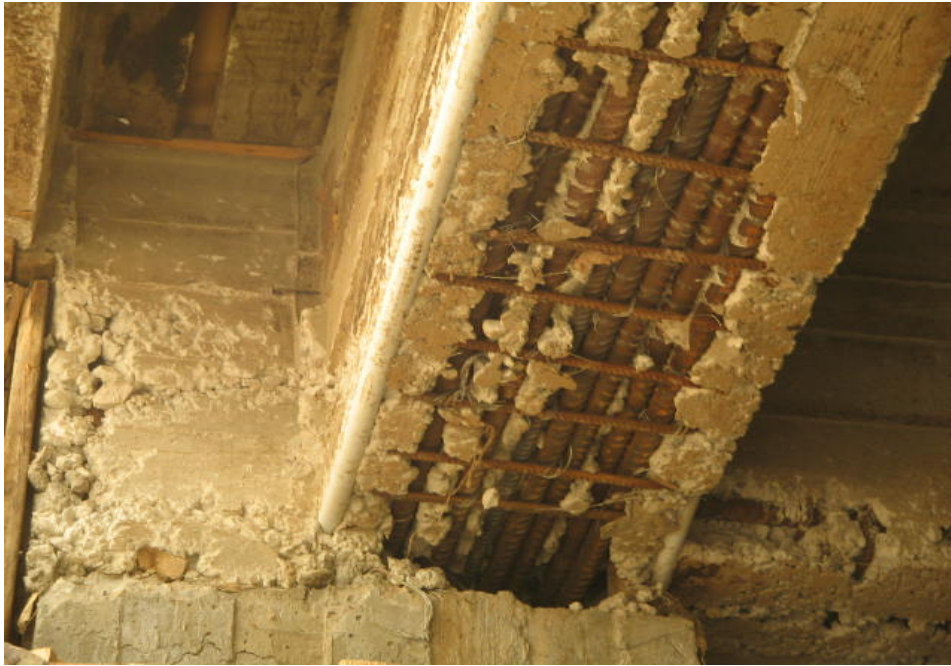
Site Photo 45. Improperly placed and exposed reinforcement bar, PVC conduit, and rust

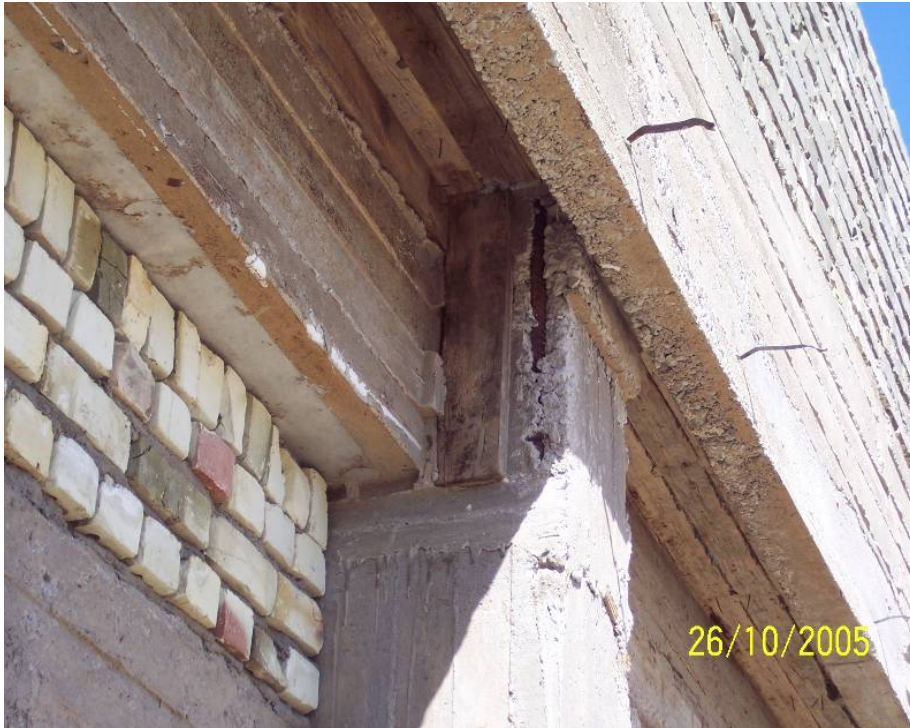
**Site Photo 46. Concrete segregation and exposed reinforcement bar  
(Photo courtesy of the USACE)**

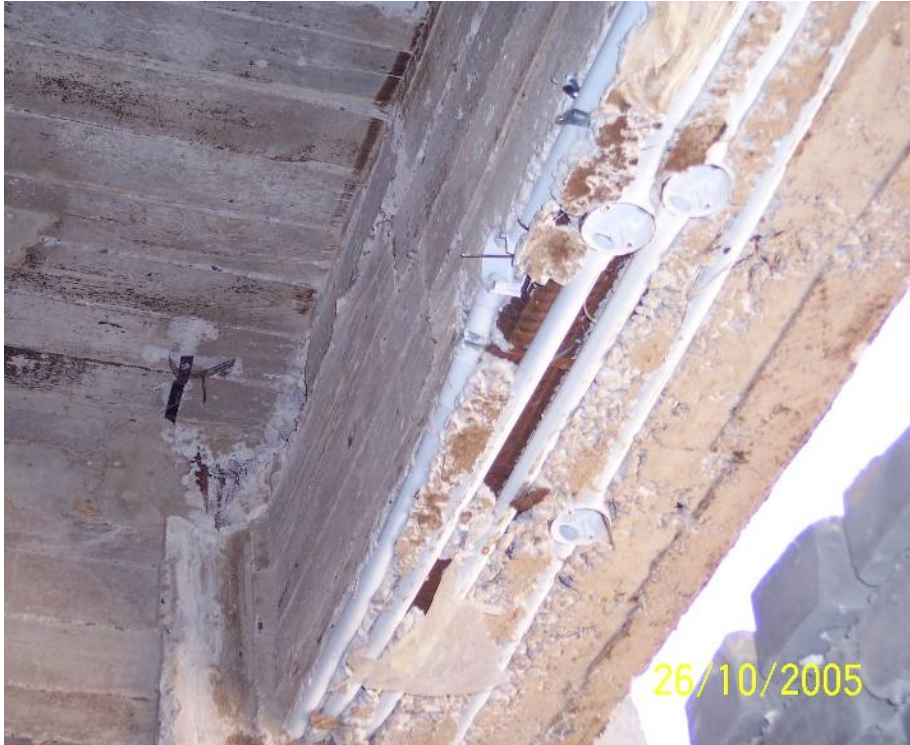
**Site Photo 48. Electrical conduit exposure and reinforcement bar rust  
(Photo courtesy of the USACE)**

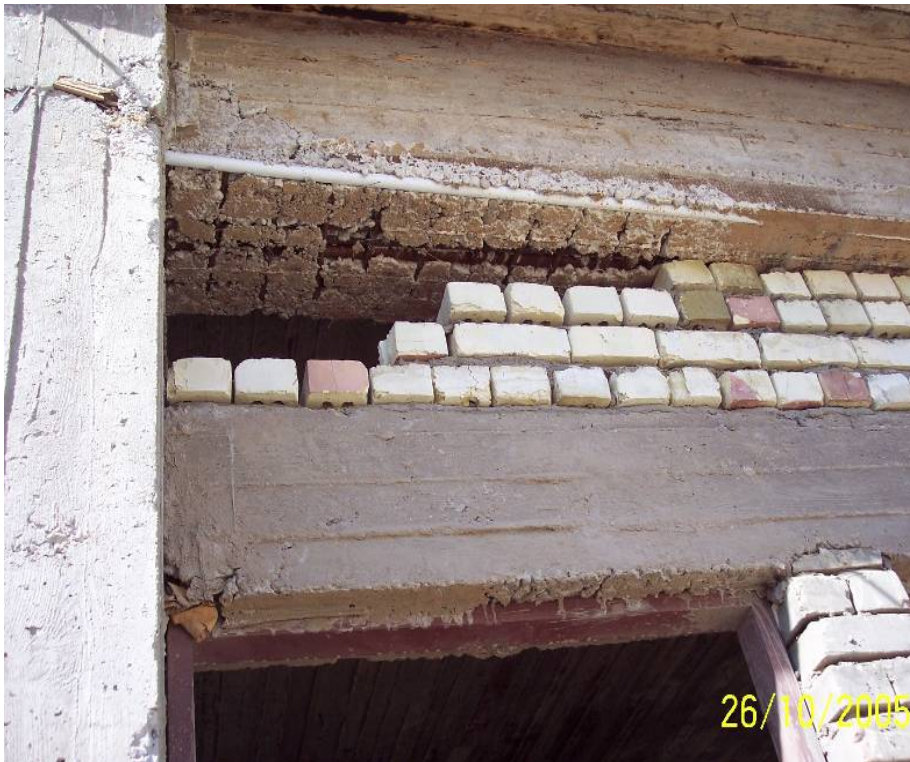
**Site Photo 49. Concrete segregation and electrical conduit exposure  
(Photo courtesy of the USACE)**

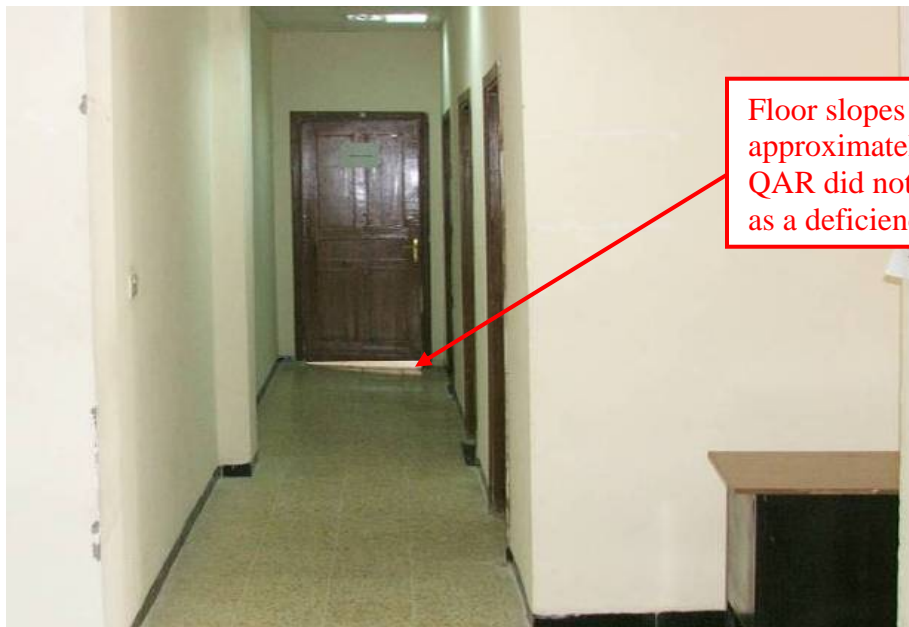
Floor slopes to the right approximately 4” – the QAR did not identify this as a deficiency

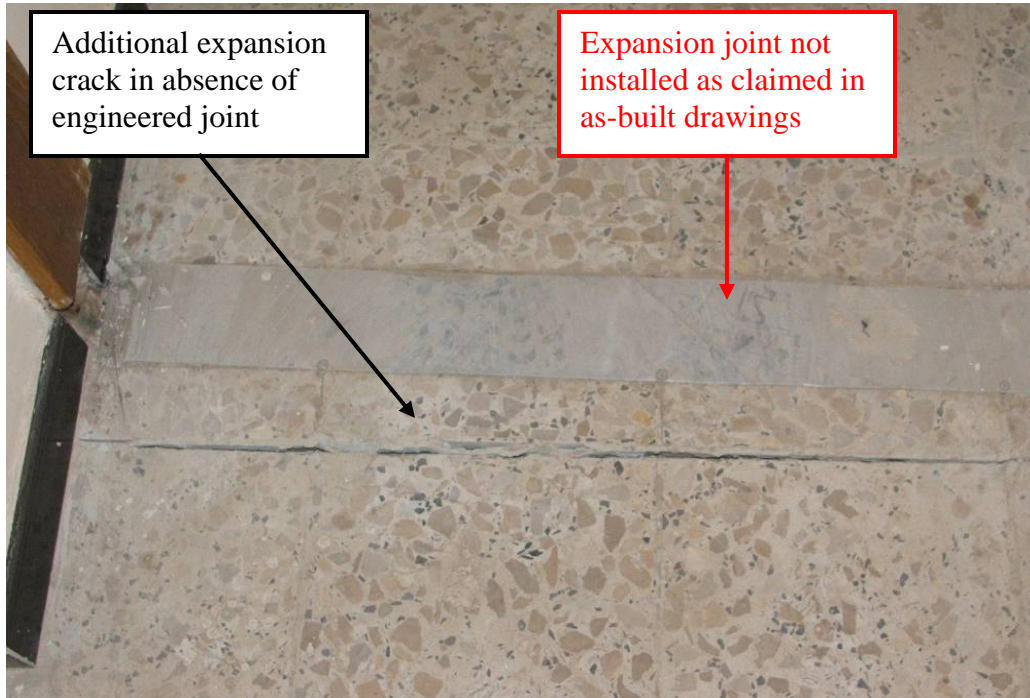
**Site Photo 65. Interior expansion crack in the instructors' barracks**

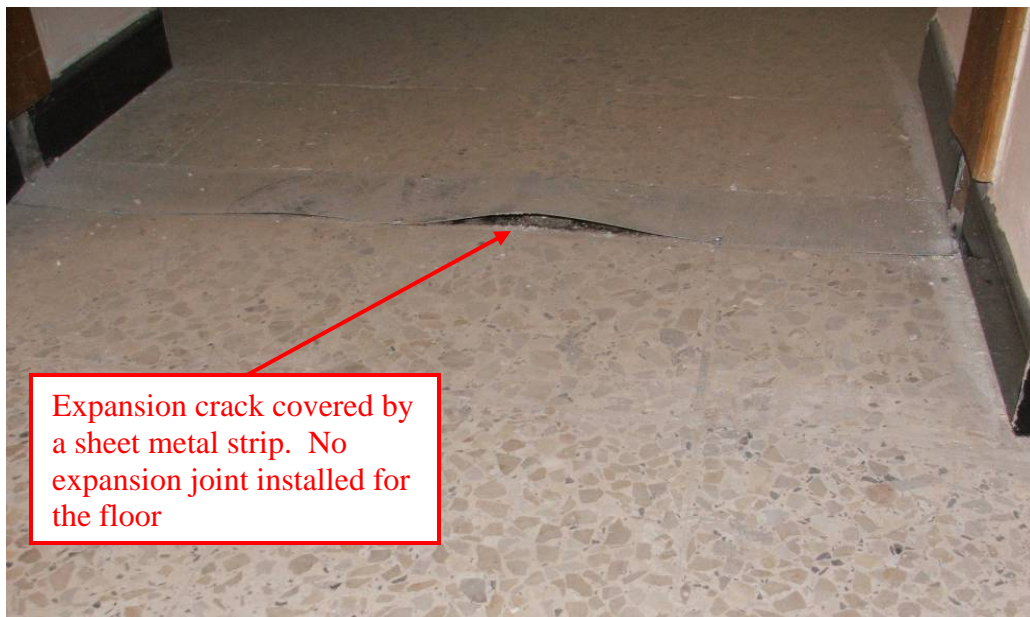
**Site Photo 66. Interior expansion crack in instructors' barracks**

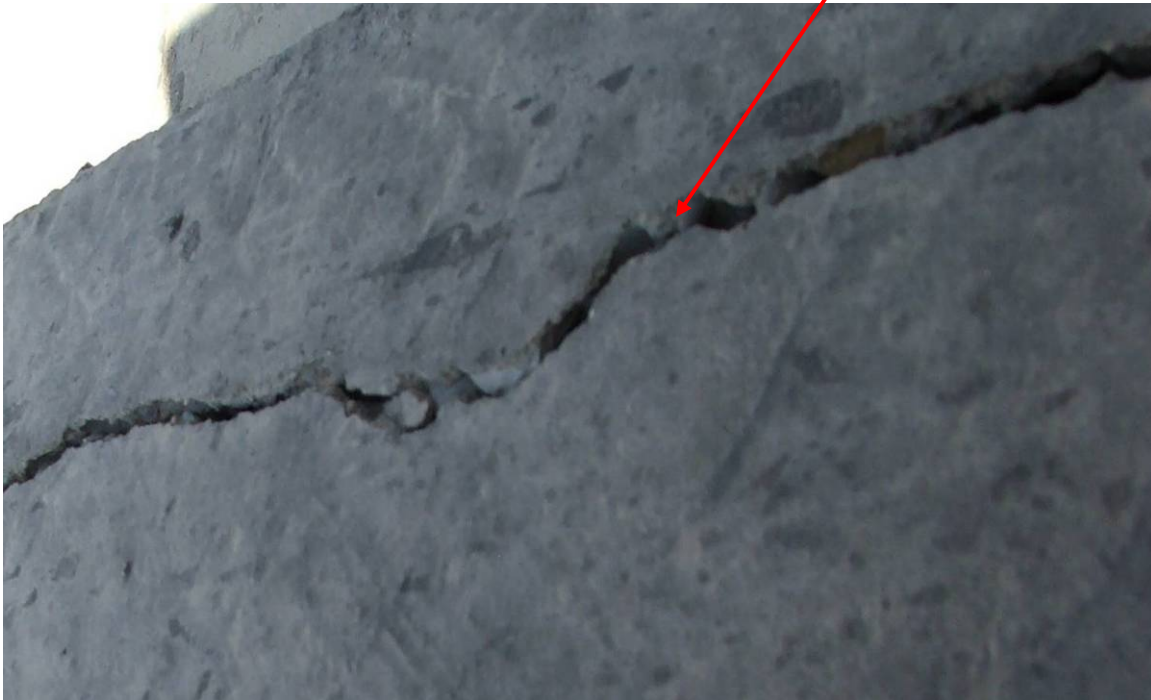
**Site Photo 68. Enlarged view of Site Photo 67.**

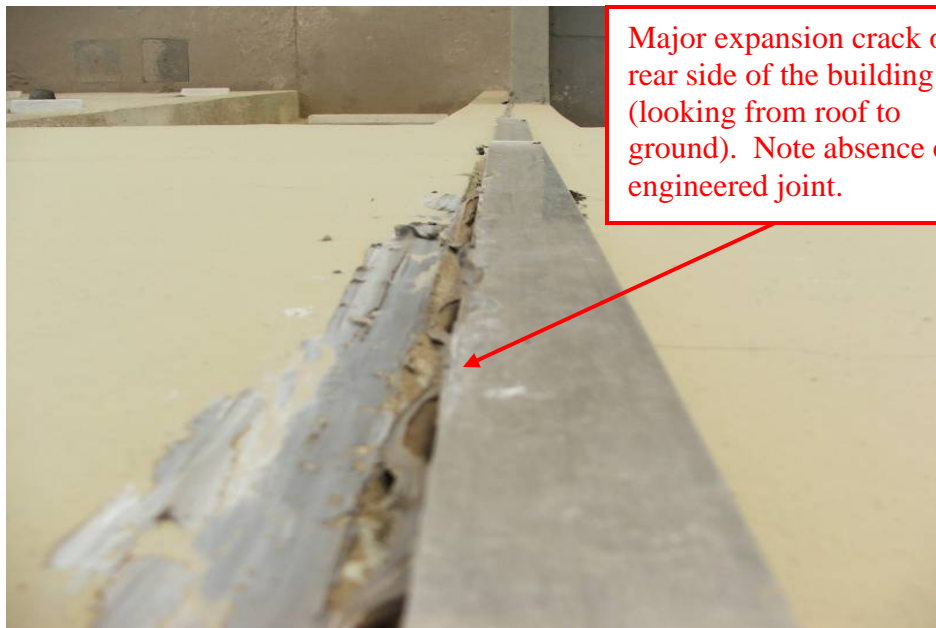
Major expansion crack on rear side of the building (looking from roof to ground). Note absence of engineered joint.

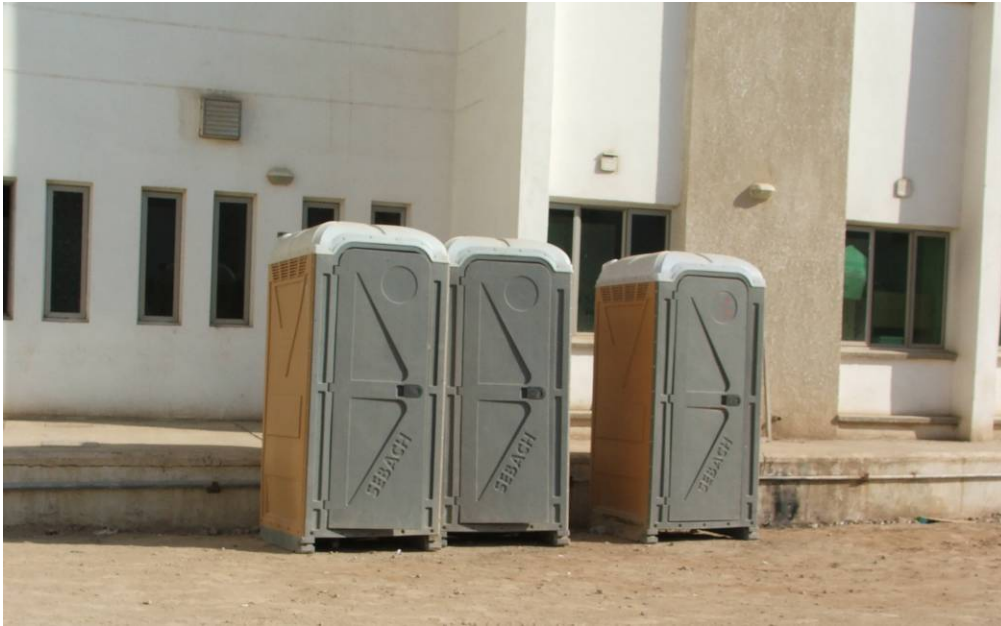
On at least two of our site visits, the BPC campus was shut down due to water system problems, causing the cadets to lose valuable classroom instruction time. In fact, on our last visit, 8 December 2006, we observed port-a-pots outside the cadet barracks. BPC representatives stated this was necessary because the water was turned off due to problems with the system and plumbing issues within the cadet barracks (Site Photo 72). During this time frame, the BPC was shut down for several days, again causing the cadets to lose valuable instruction time.

**Site Photo 72. Port-a-pots located outside the cadet barracks in December 2006**

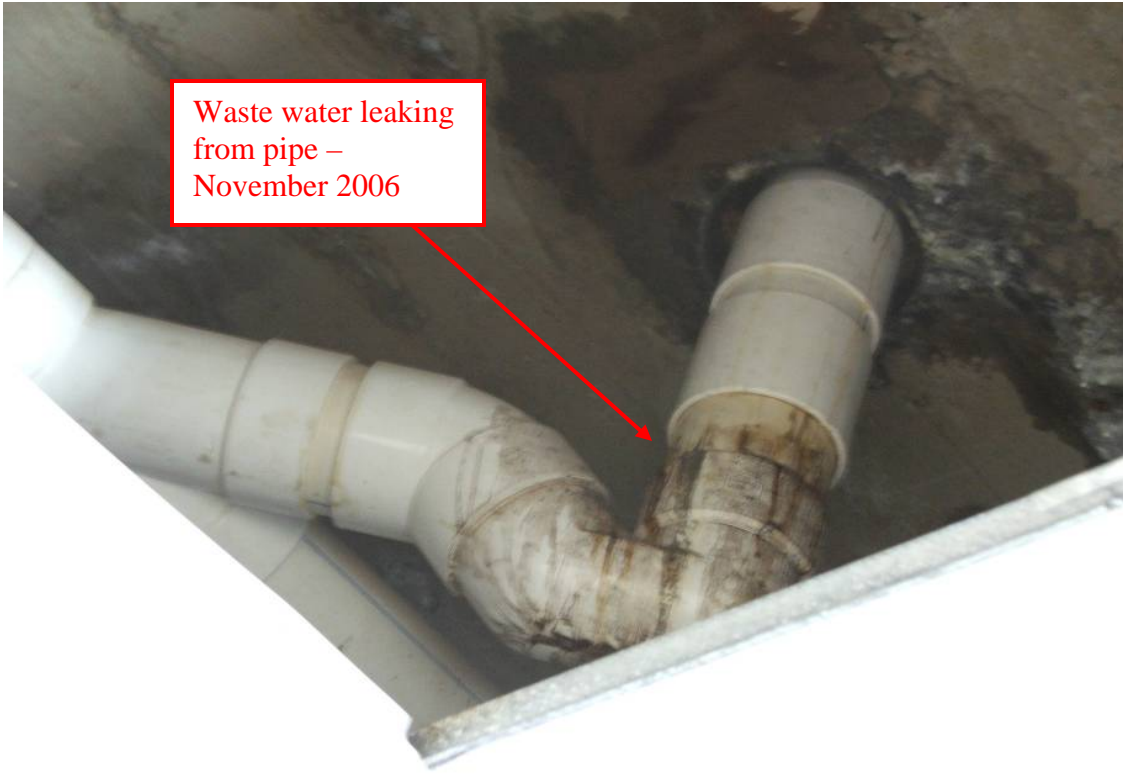
**Site Photo 75. Effect of leaking waste water on plumbing pipes**

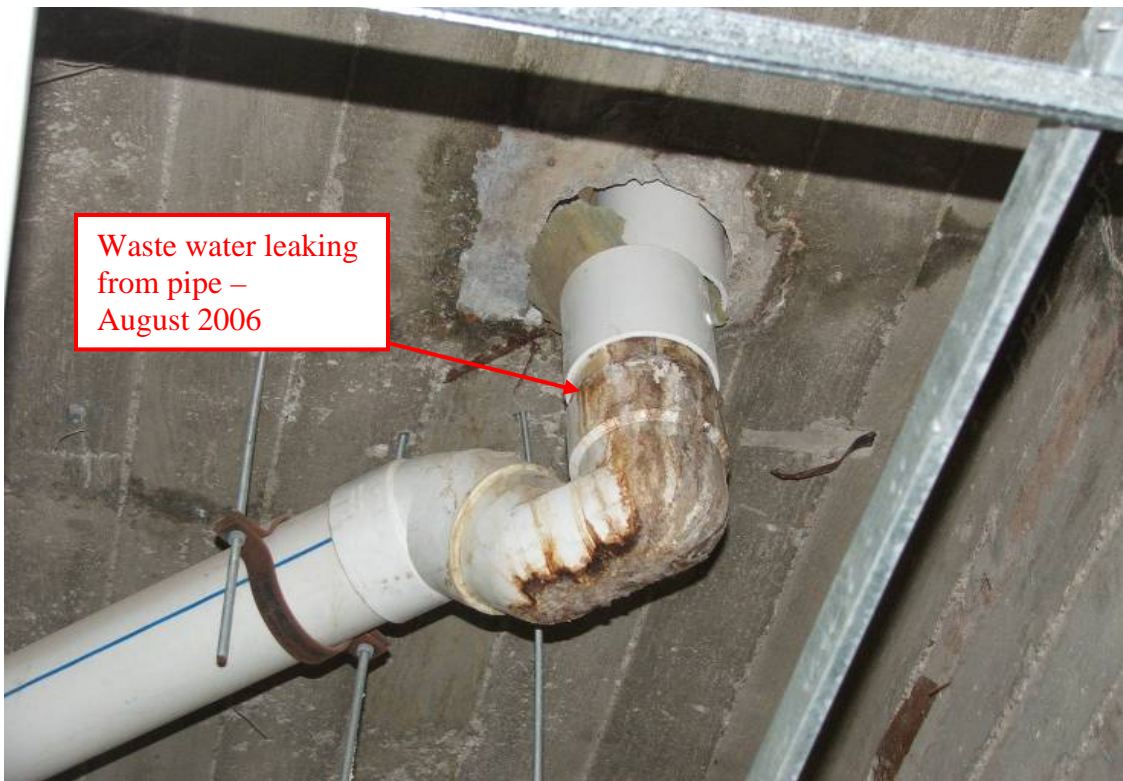
**Site Photo 76. Effect of leaking waste water on plumbing pipes**

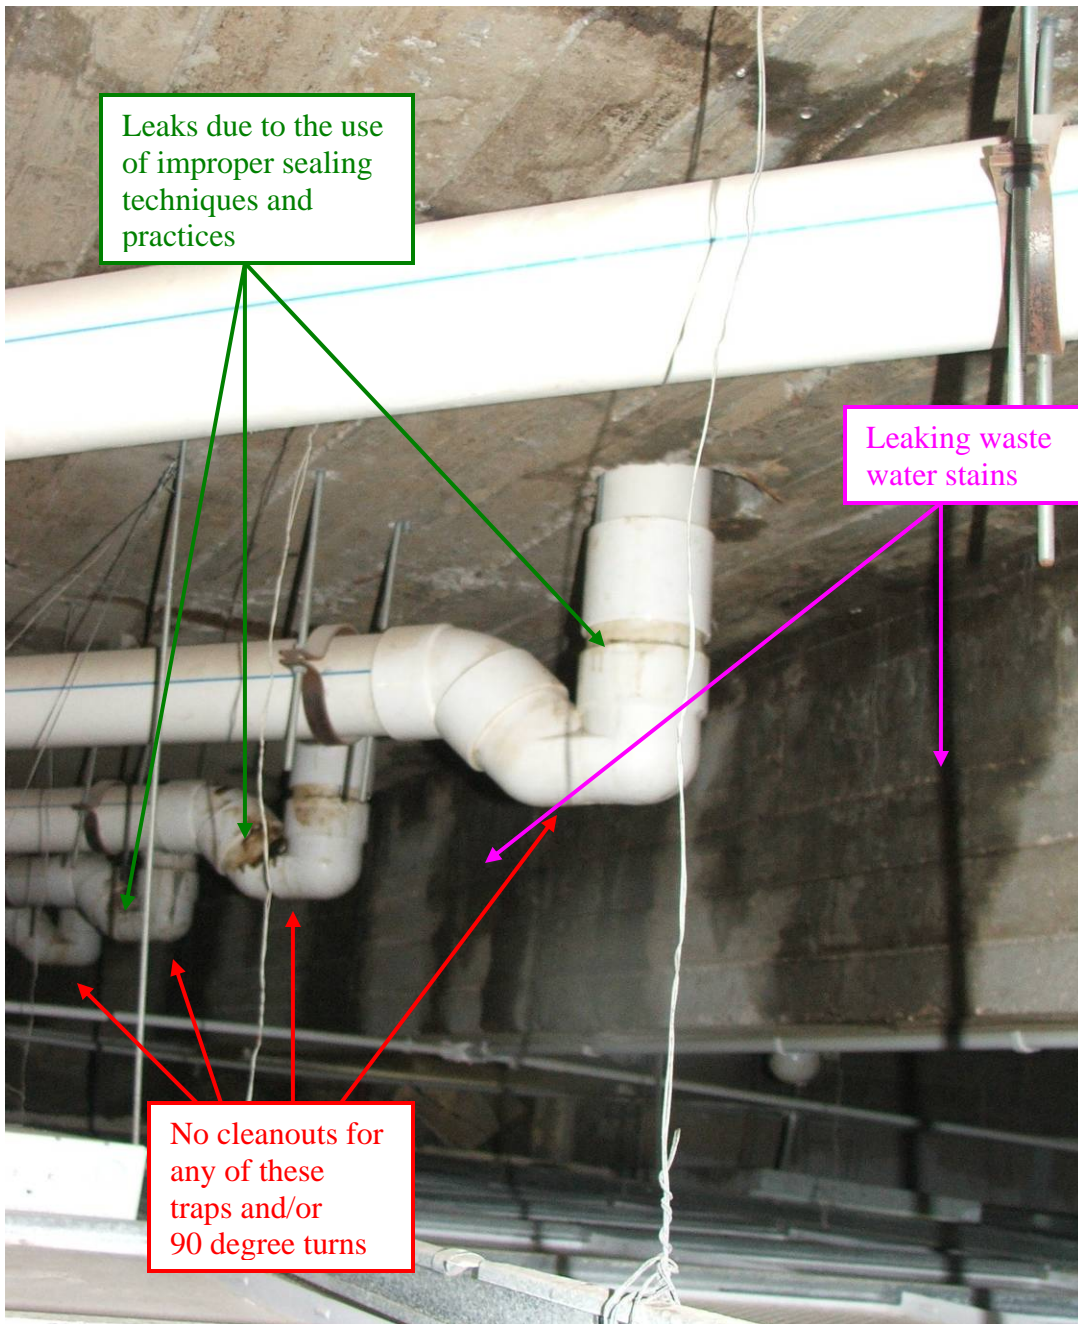
**Site Photo 77. View of plumbing for first floor toilets without cleanouts and proper sealing practices**

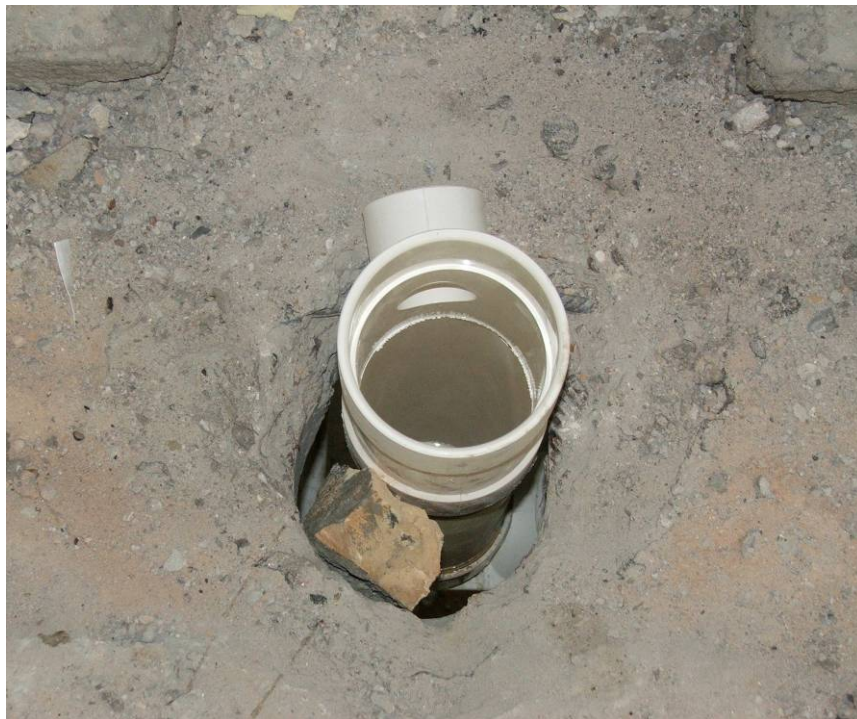
**Site Photo 79. Example of poor sealing technique used by the contractor during rework construction**
