**BAGHDAD POLICE COLLEGE  
BAGHDAD, IRAQ**

**SIGIR PA-06-078.2**

**SIGIR PA-06-079.2**

SUBJECT: Report on Project Assessments of Reconstruction Work Performed Under Task Orders 06 and 29 at the Baghdad Police College, Baghdad, Iraq (Report Numbers SIGIR PA-06-078.2 and PA-06-079.2)

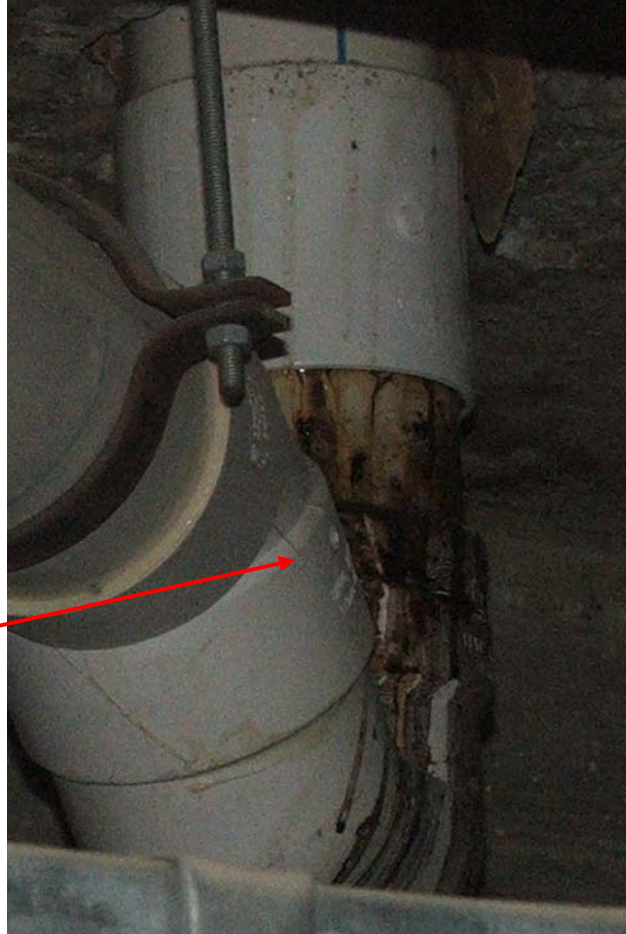
**Site Photo 81. Enlarged view of Site Photo 80**

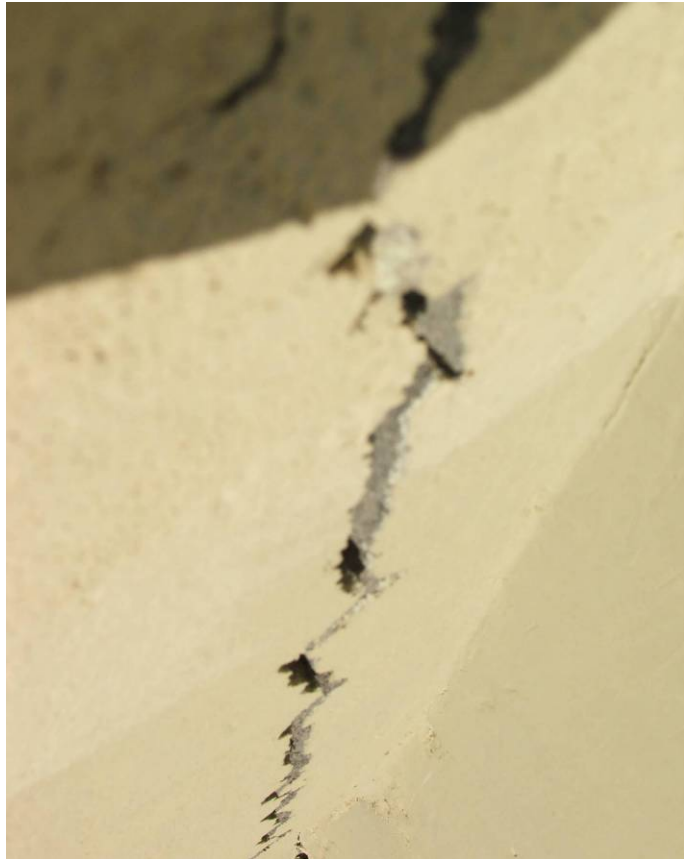
**Site Photo 82. Exterior expansion crack**

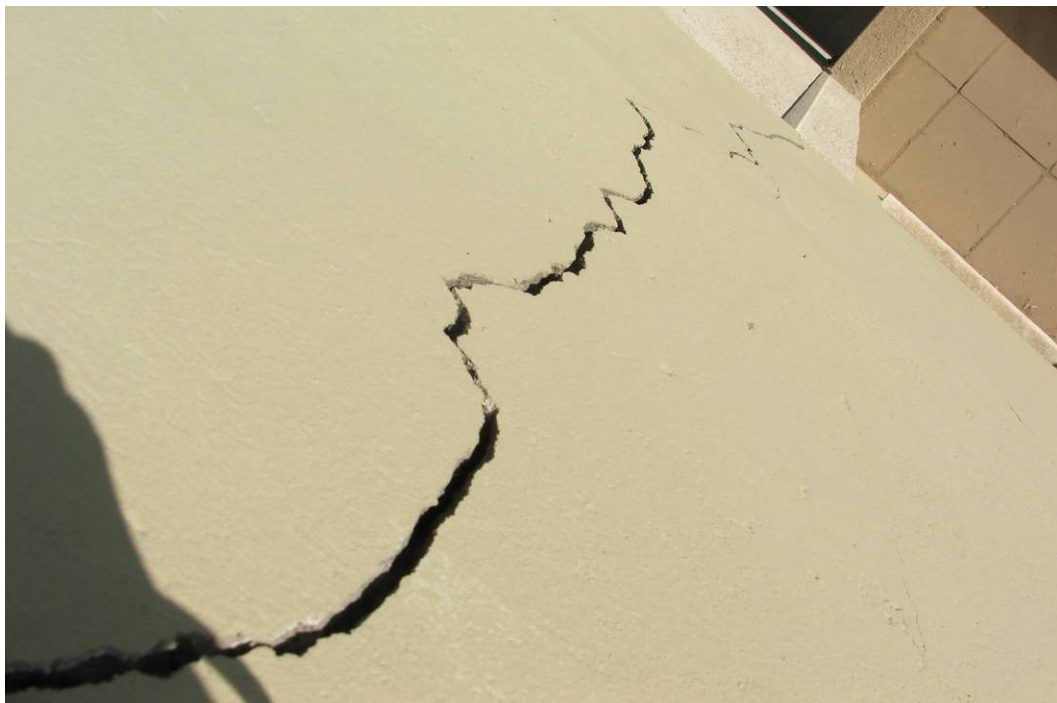
**Site Photo 83. Substantial exterior expansion crack**

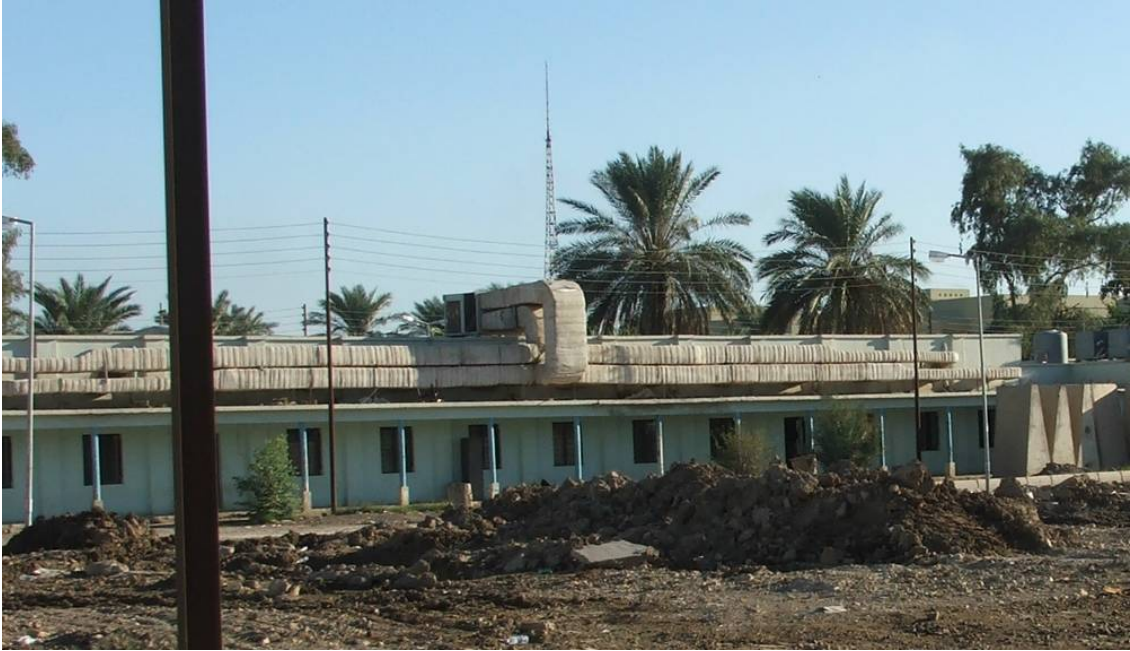
**Site Photo 84. Example of typical existing BPC building exterior**

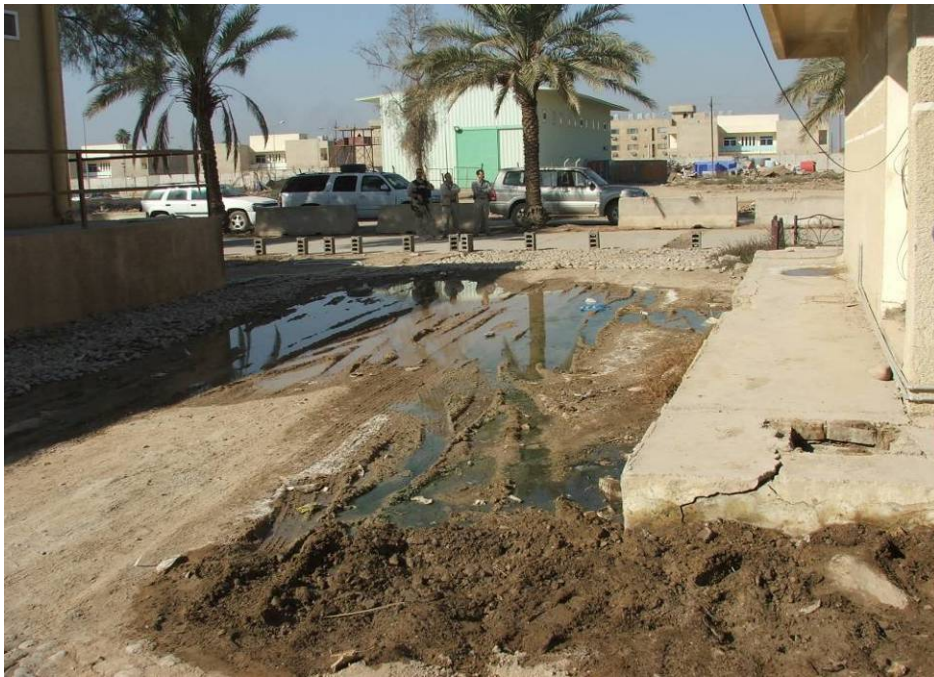
**Site Photo 90. Significant standing sewer water outside the BPC security office**

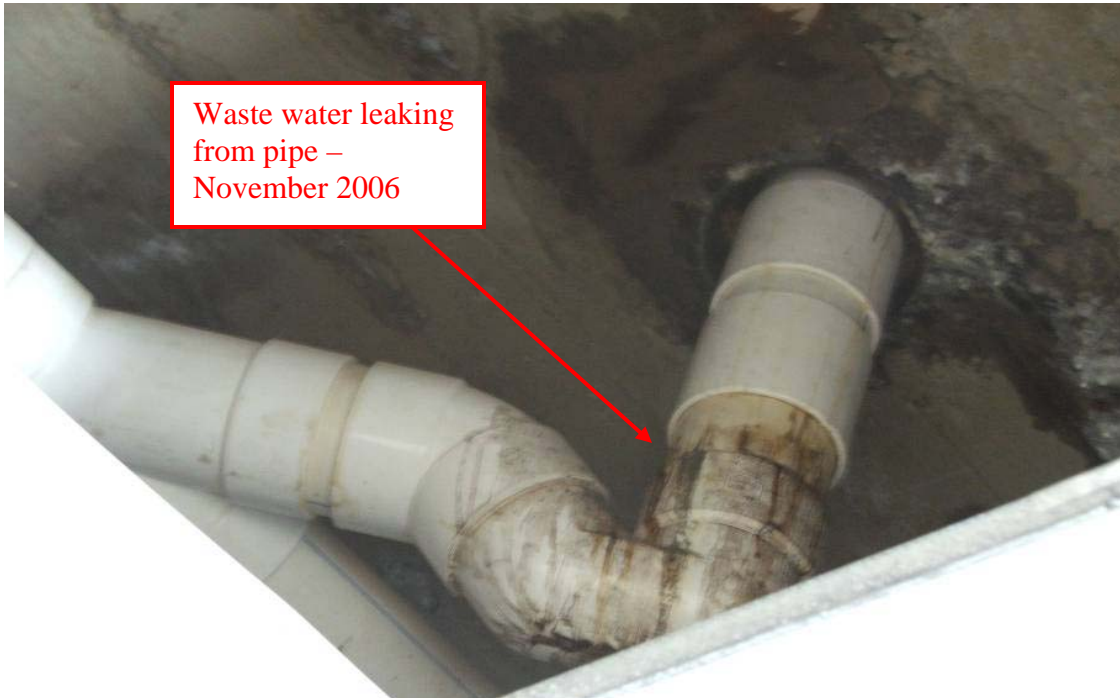
during this site visit as we did in our earlier site visits, such as water leaking from the ceiling. In addition, we noticed leaking waste water in the same location on the pipes (Site Photos 95 and 96). It is apparent that the subcontractor did not properly connect the pipes together, which allowed waste water to drain on the outside of the pipes.

**Site Photo 95. Effect of leaking waste water on plumbing pipes**

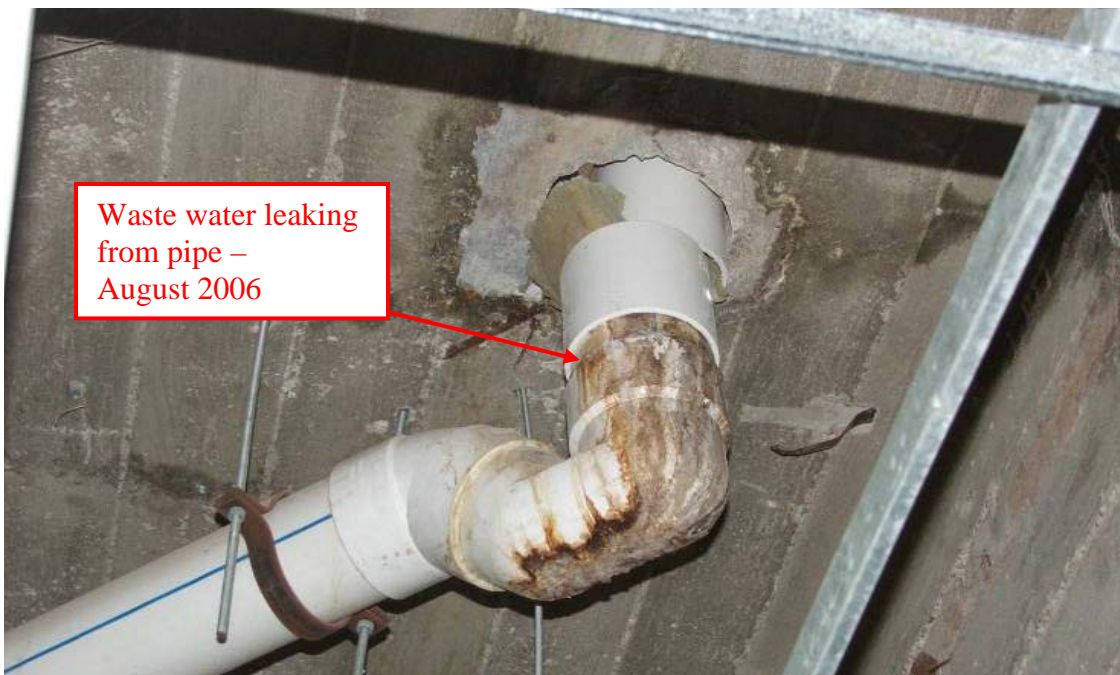
**Site Photo 96. Effect of leaking waste water on plumbing pipes**

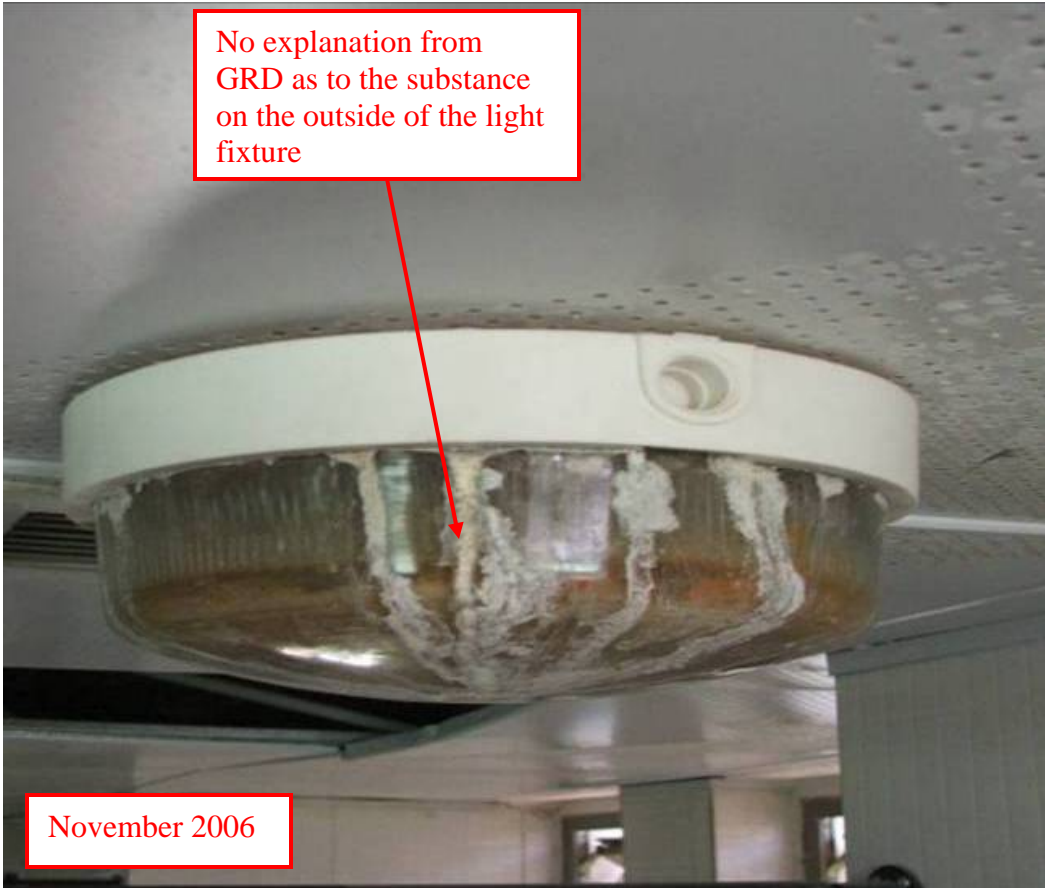
Whether the liquid substance is urine and fecal matter or "dirt-filled fresh water," GRD needs to realize that the plumbing system is not only tremendously flawed, but the cadets may be supplied with hazardous water. We continue to believe that GRD needs to deal with the more important issue of the continual problems arising from poor construction techniques.

**Site Photo 97. Urine-filled light fixture in cadet barracks bathroom after rework**

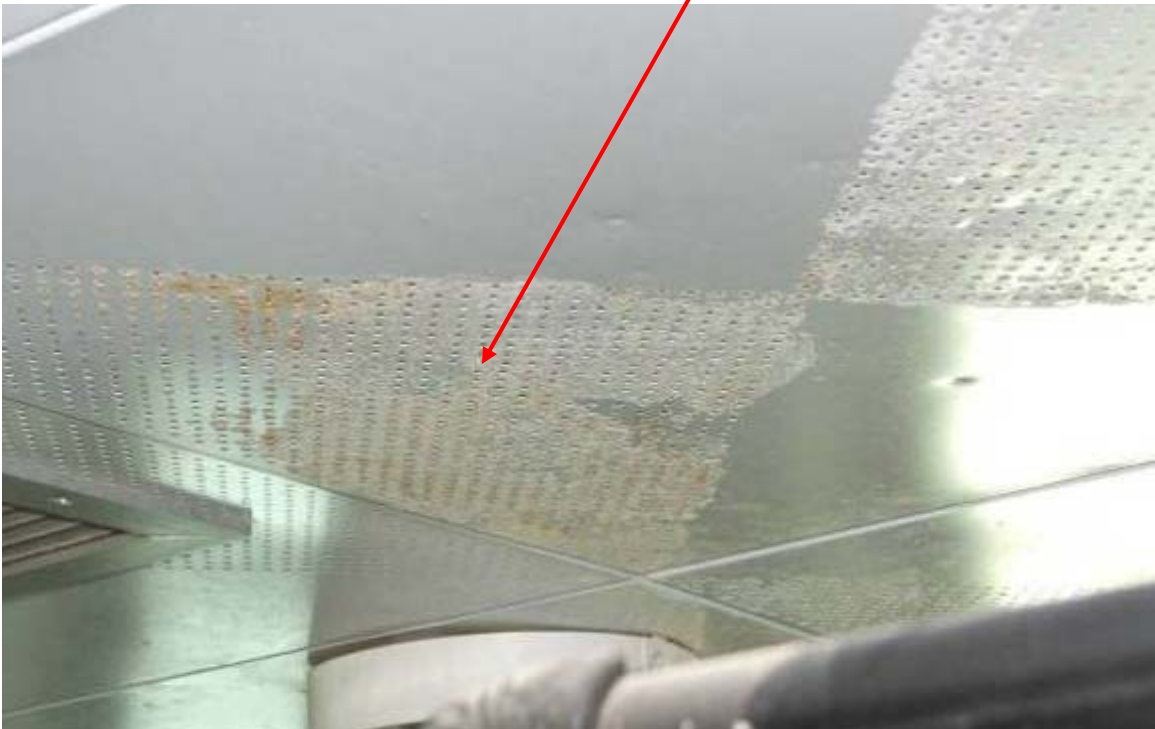
Site Photo 102. Enlarged view of Site Photo 101

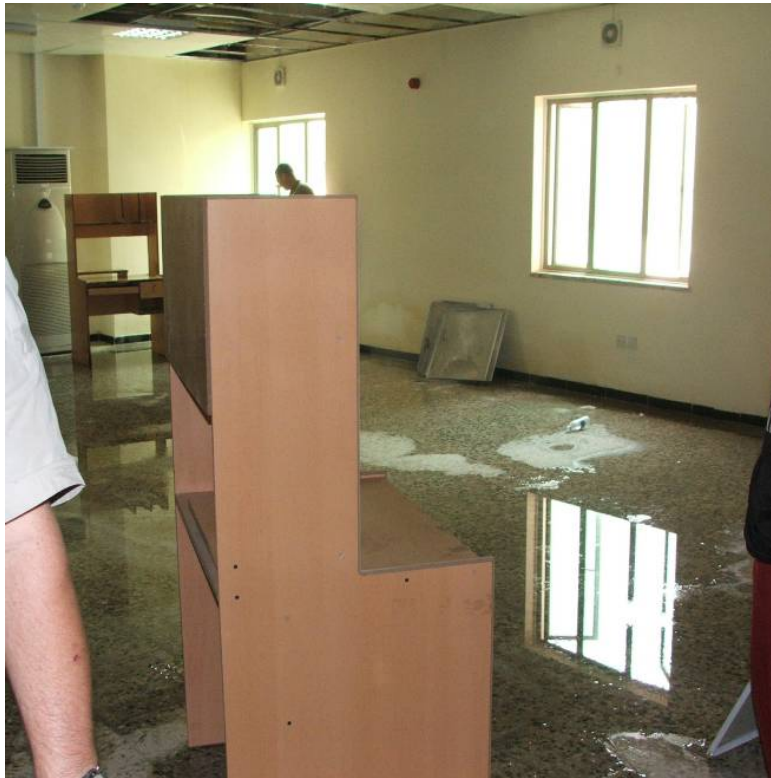
**Site Photo 119. Cadet barracks common area used for storage of miscellaneous items due to continuous water leakage**

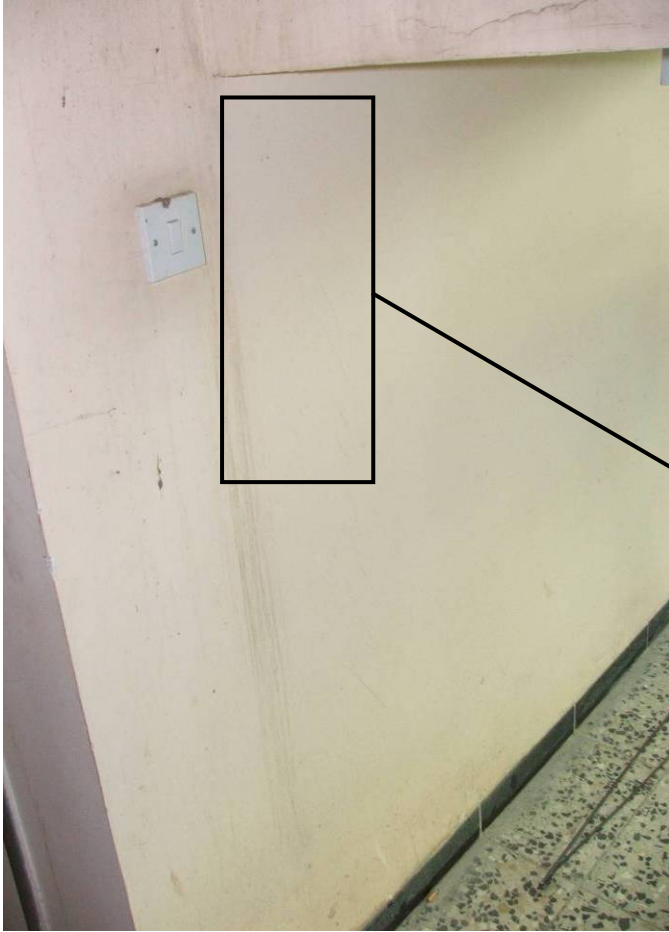
**Site Photo 122. Stress cracks underneath staircase**

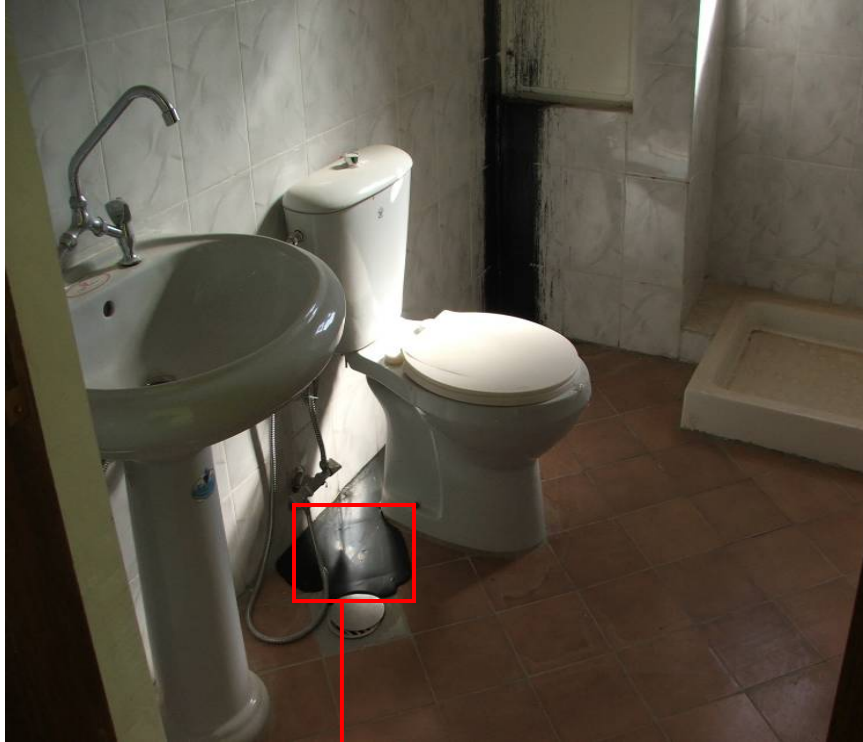
The ground floor consisted of single bedrooms with private bathrooms. We identified tar damage in the bathrooms, which leaked from the roof down to the ground floor (Site Photos 127-130). We also identified poor quality construction of an electrical outlet (Site Photo 131). This electrical outlet was not only painted over, it was plastered over with mortar as well. As a result, this electrical outlet will never be operational. Because neither building has generator power or water and sewer connections, we were unable to determine if the electrical fixtures or the plumbing systems worked correctly.

**Site Photo 127. Tar damage on wall and floor of an instructors' barracks bathroom**

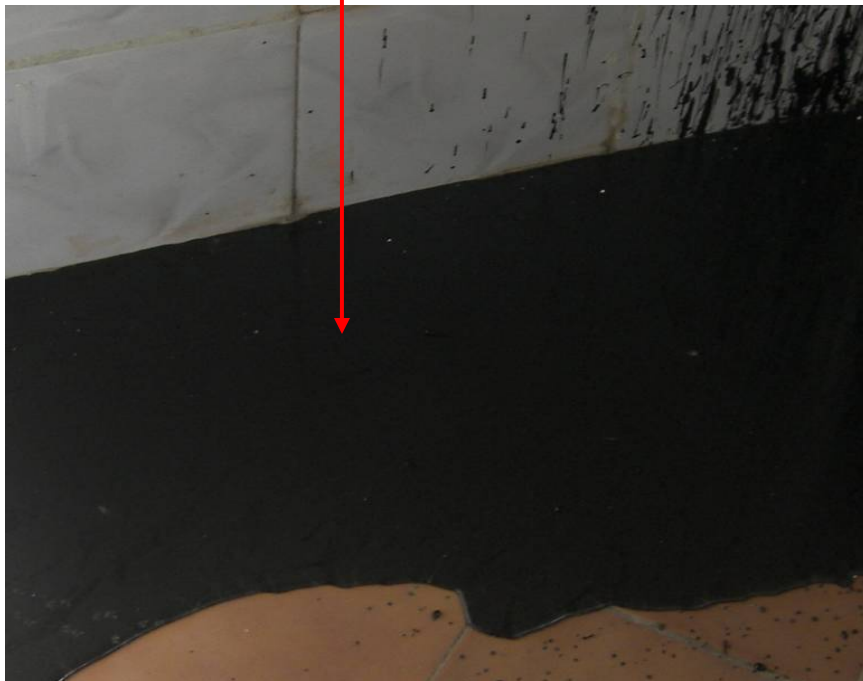
**Site Photo 128. Close-up view of tar damage from Site Photo 127**

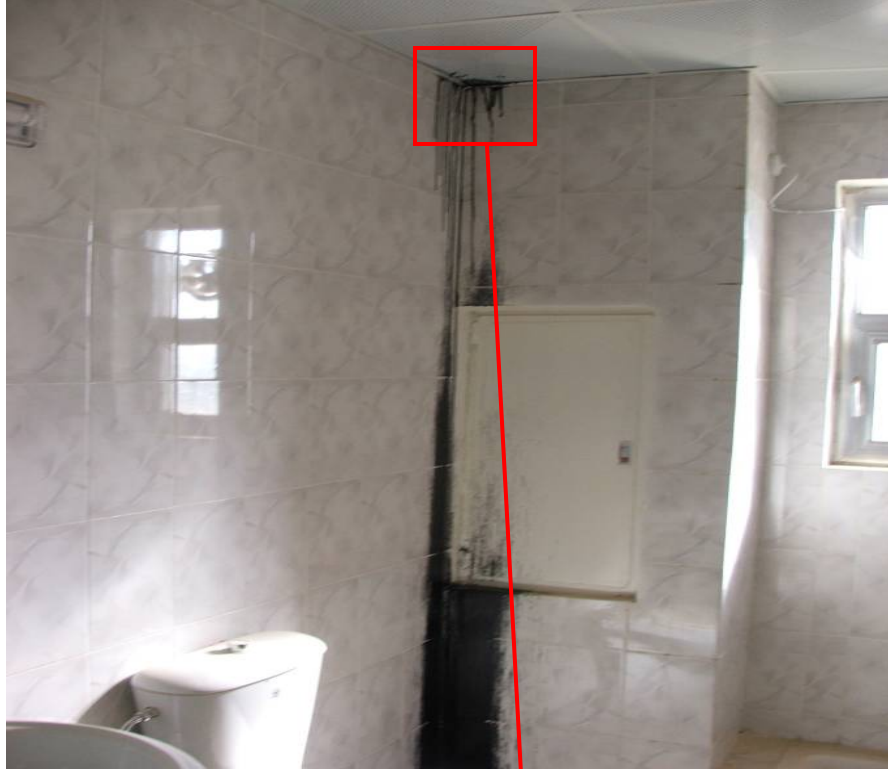
**Site Photo 129. Ceiling and wall damage in bathroom**

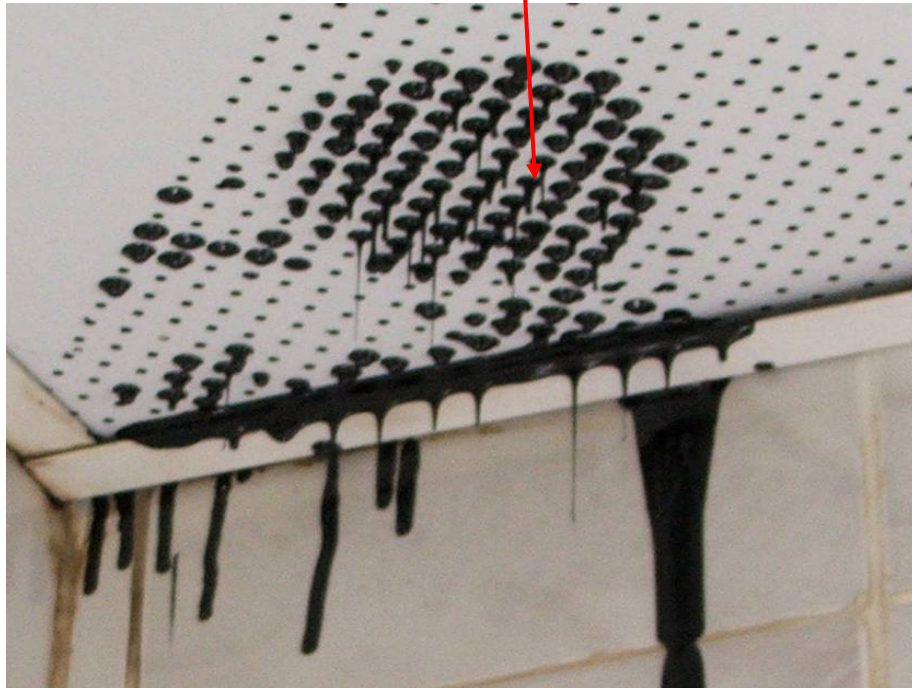
**Site Photo 130. Enlarged view of ceiling damage seen in Site Photo 129**

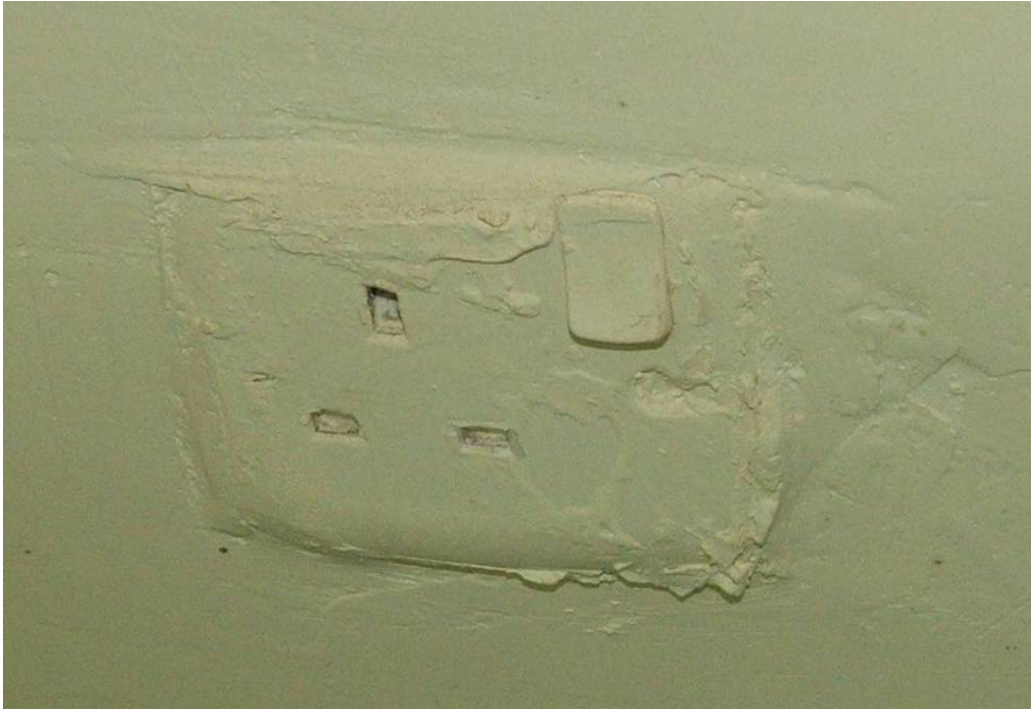
**Site Photo 131. Electrical outlet covered with mortar and paint**

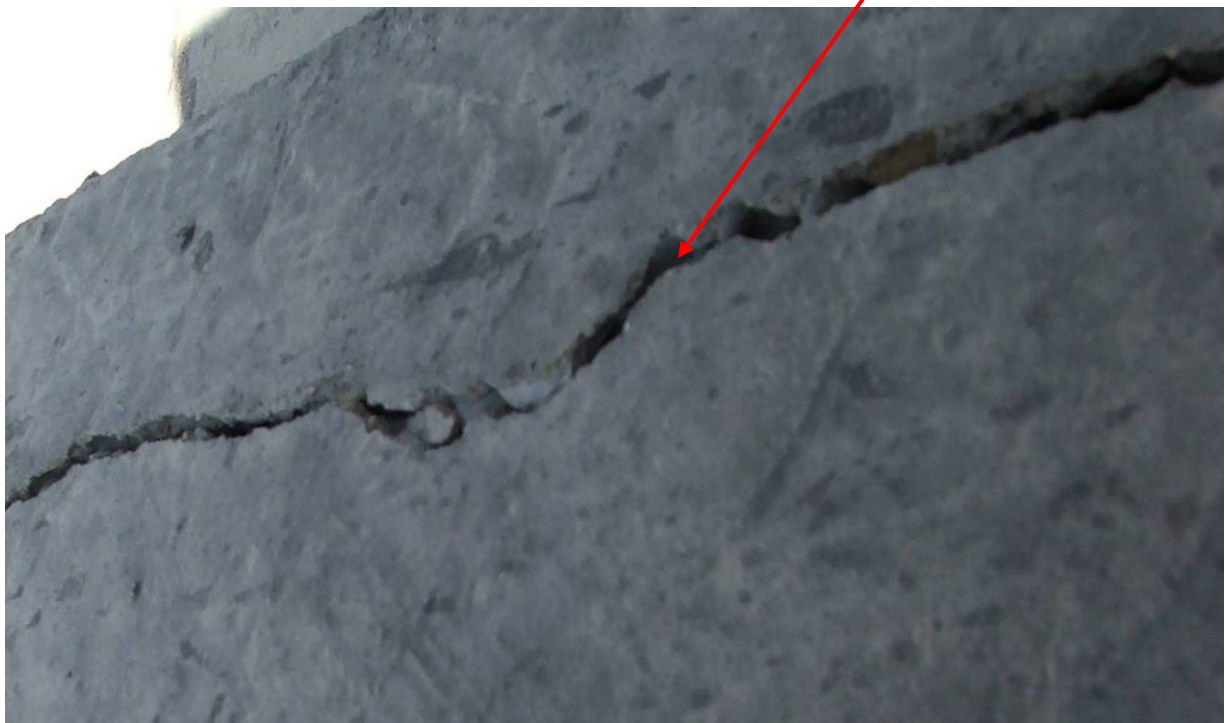
Site Photo 135. Enlarged view of expansion crack from Site Photo 103

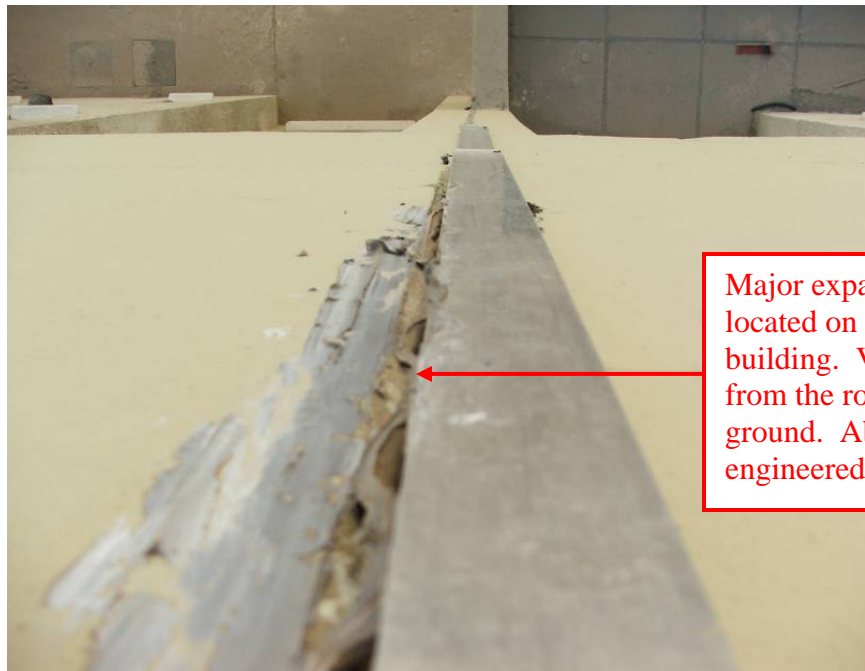
Major expansion crack located on rear side of building. View is looking from the roof toward the ground. Absence of engineered joint.

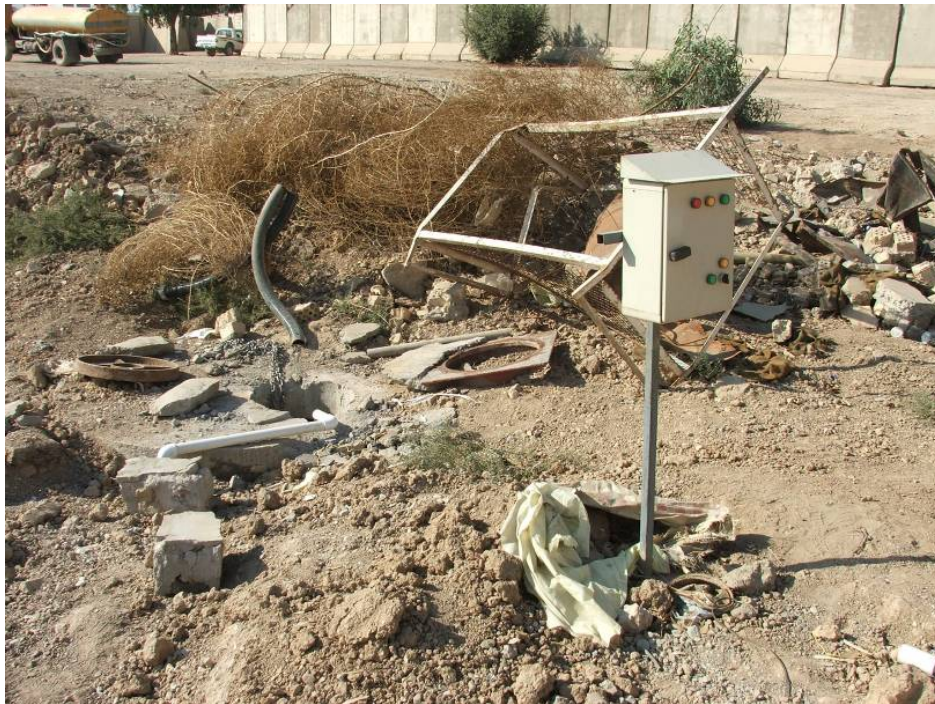
**Site Photo 160. Original single pump station installed by Parsons but never connected to power**

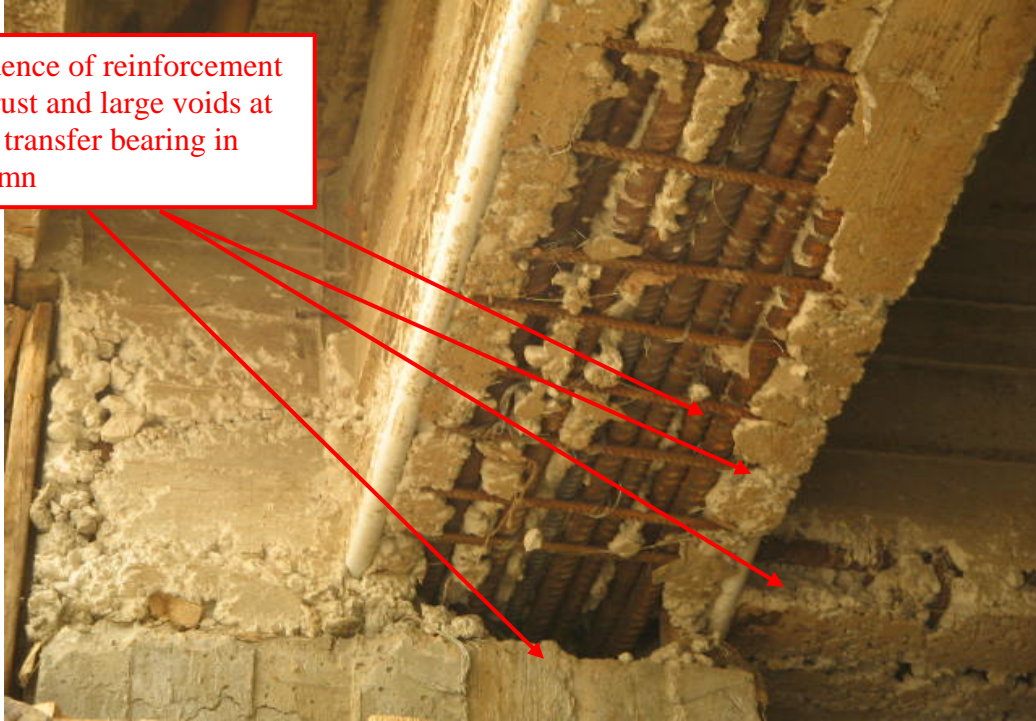
Evidence of reinforcement bar rust and large voids at load transfer bearing in column

Site Photo 178. Construction deficiencies within the central laundry facility

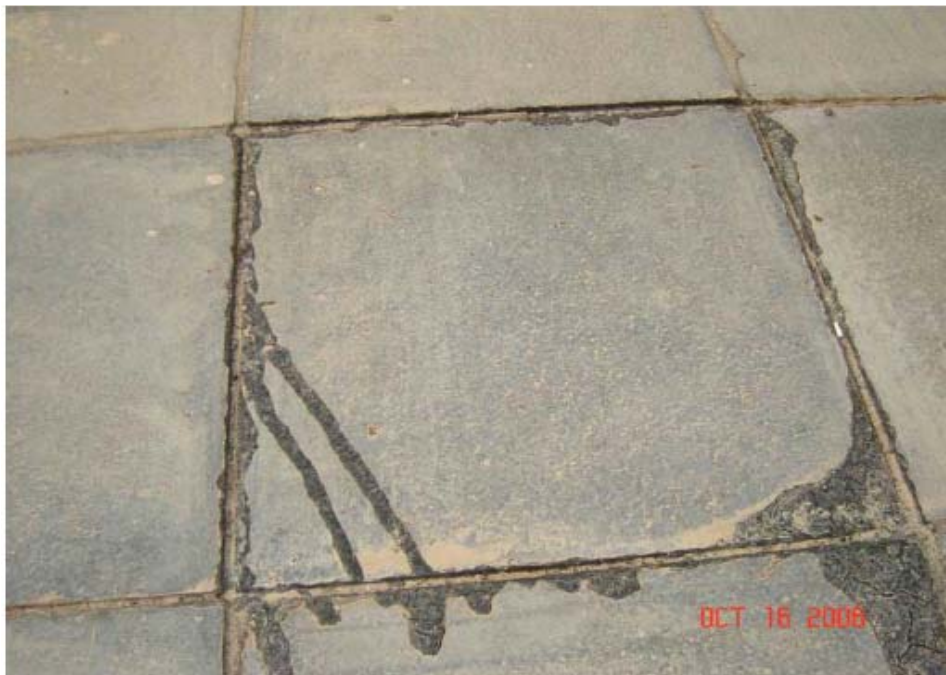
Site Photo 202. Example of poor mastic work on the roof

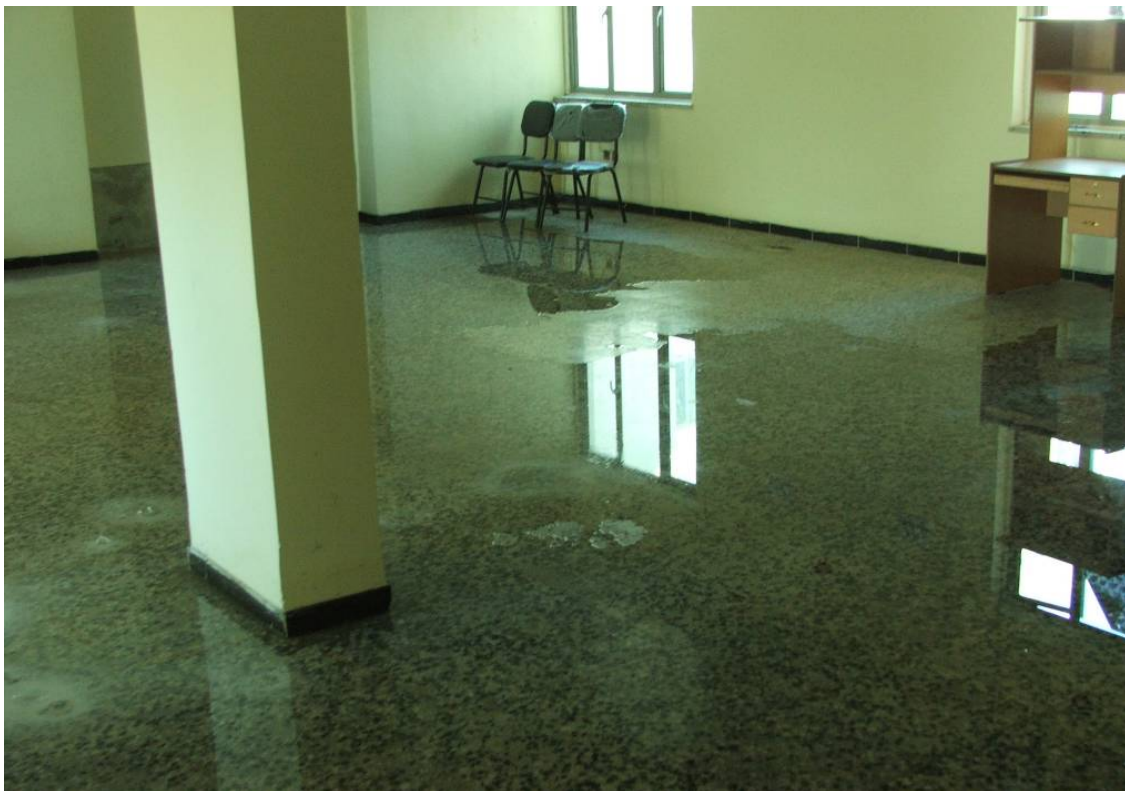
**Site Photo 205. Leaking water on floor of the cadet barracks common area room**

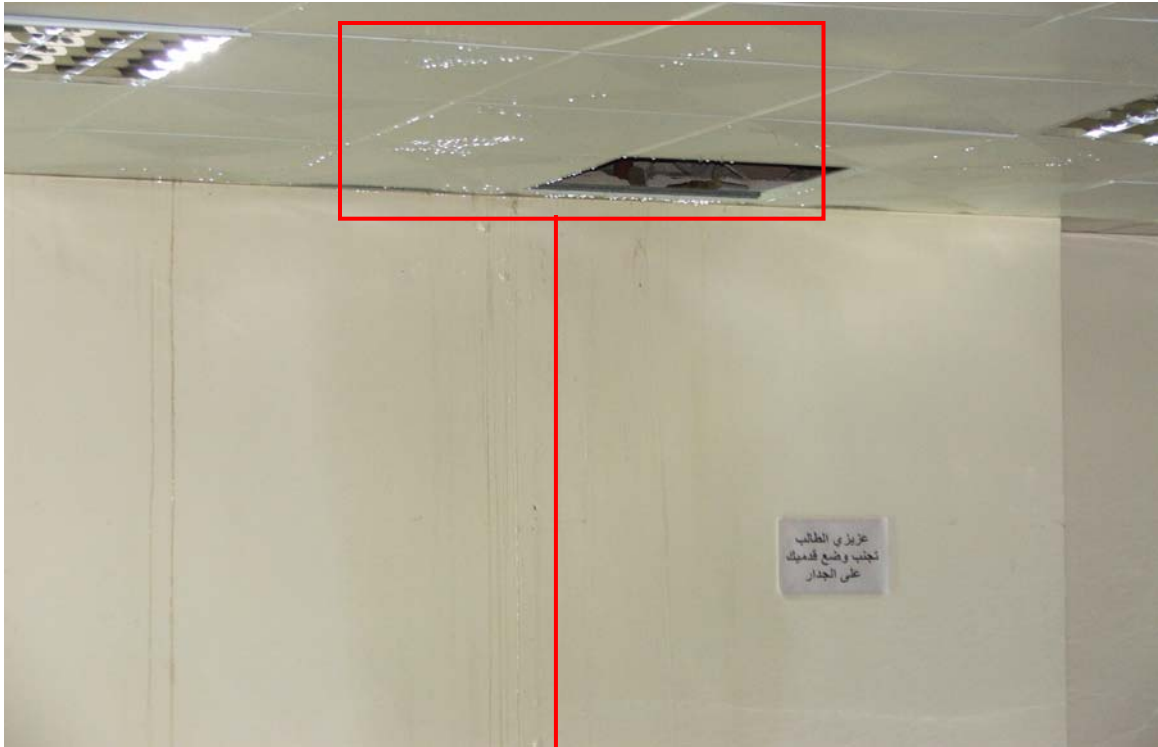
**Site Photo 206. Water leaking from ceiling of cadet barracks**

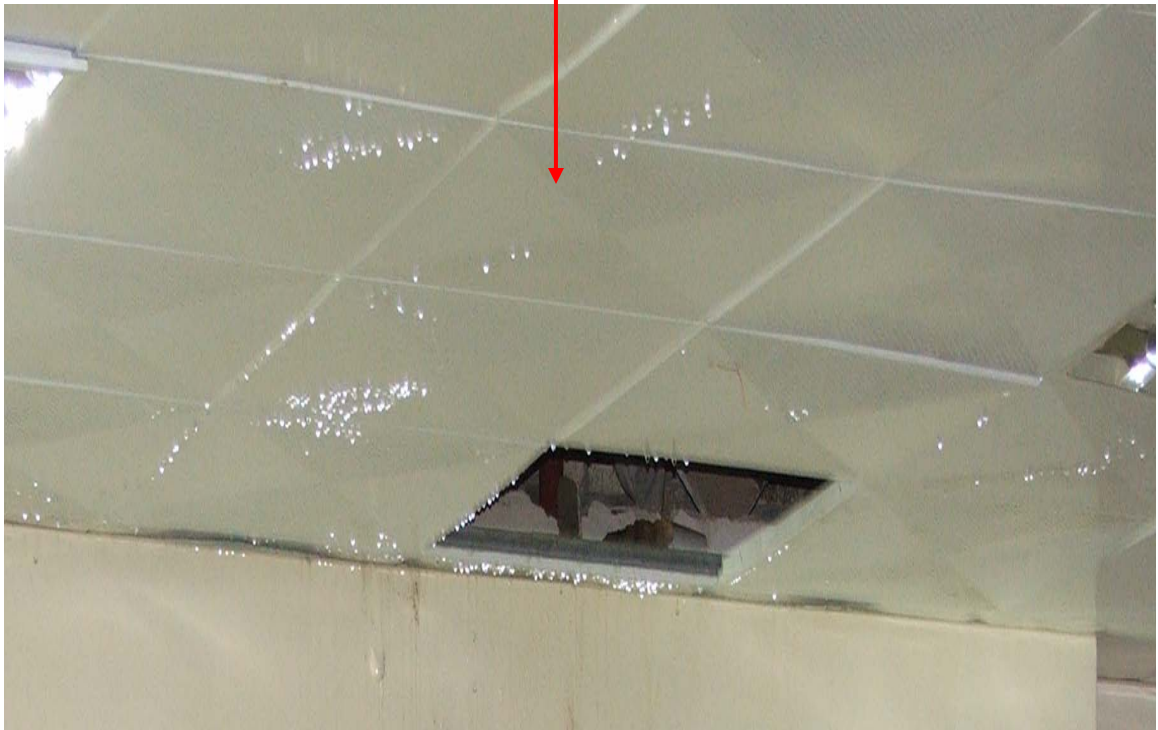
**Site Photo 207. Close-up view of the water leaking from the ceiling of Site Photo 206**

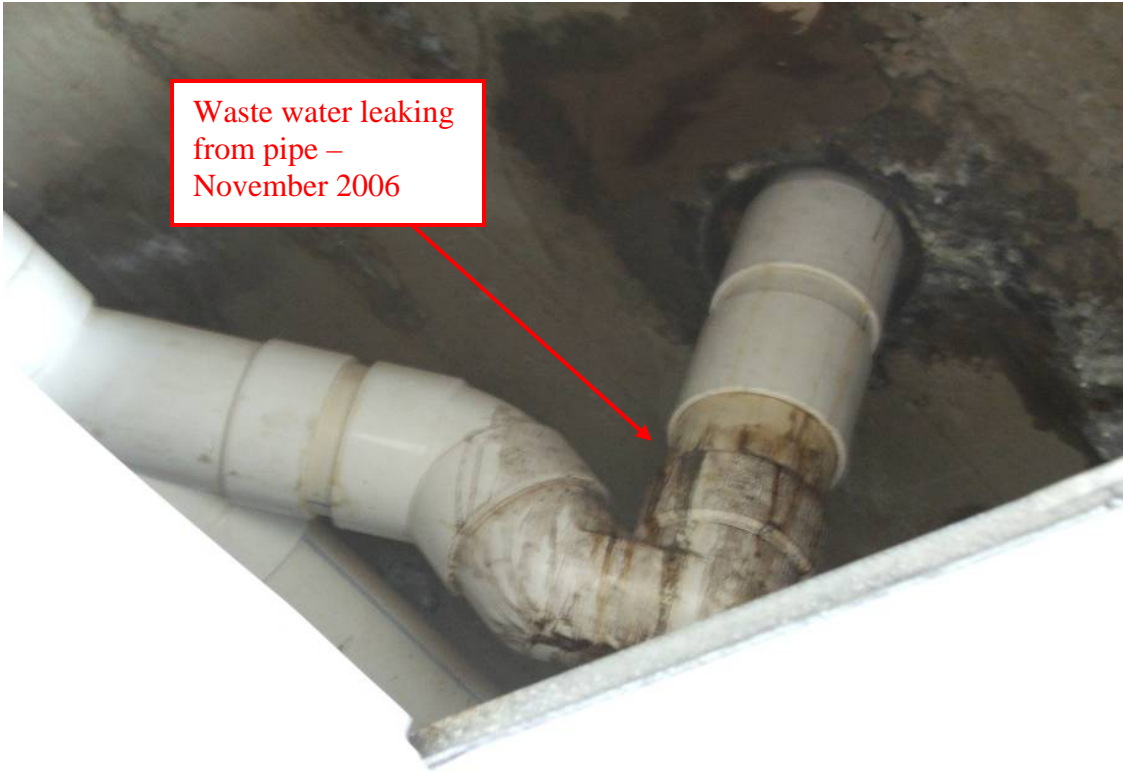
**Site Photo 208. Effect of leaking waste water on plumbing pipes**

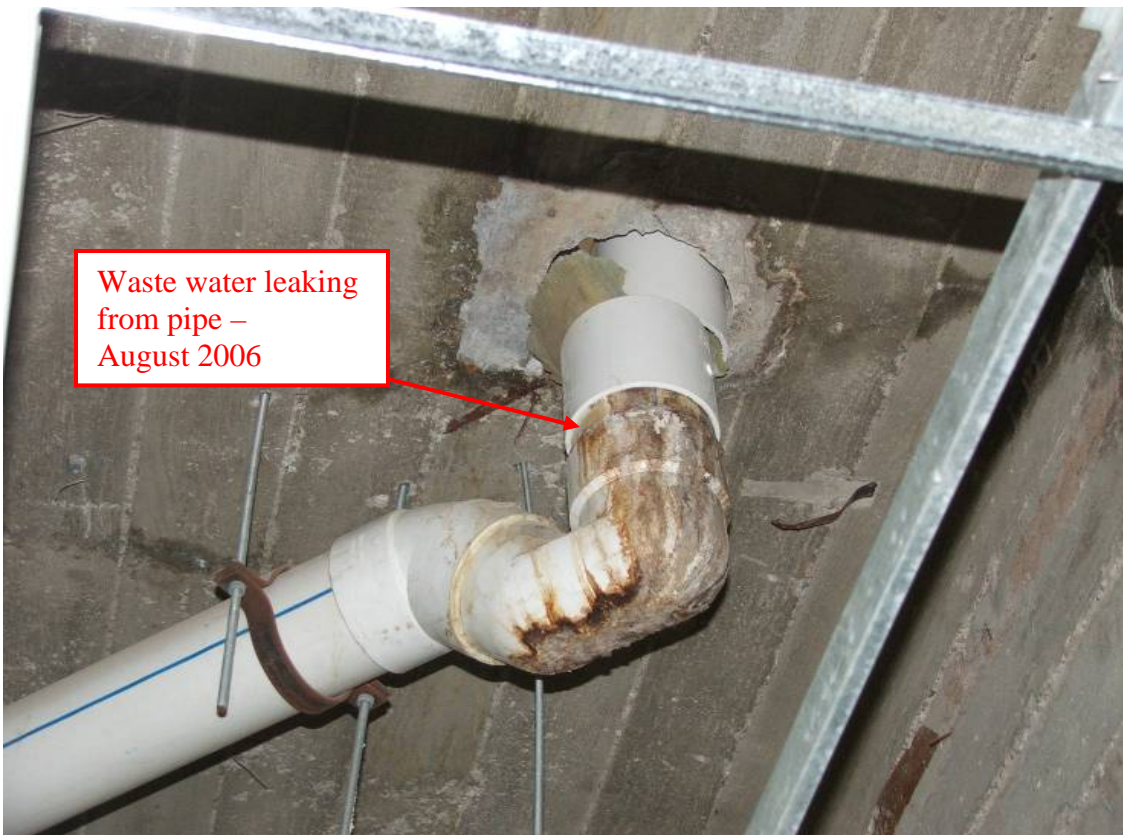
**Site Photo 209. Effect of leaking waste water on plumbing pipes**

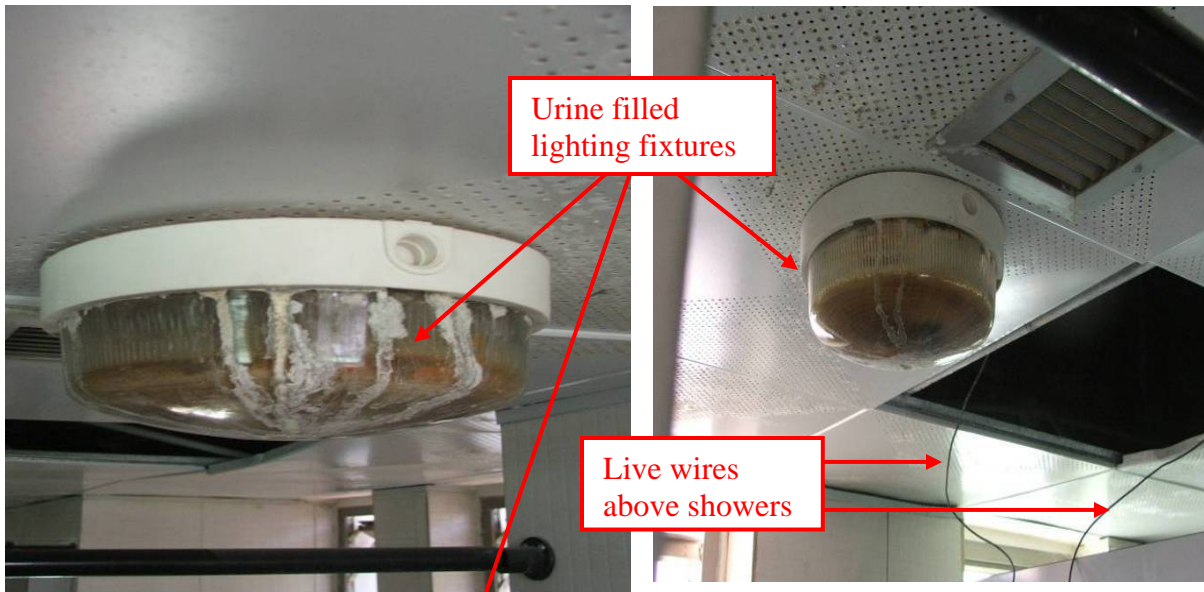
**Site Photo 212. Urine-filled ceiling light**

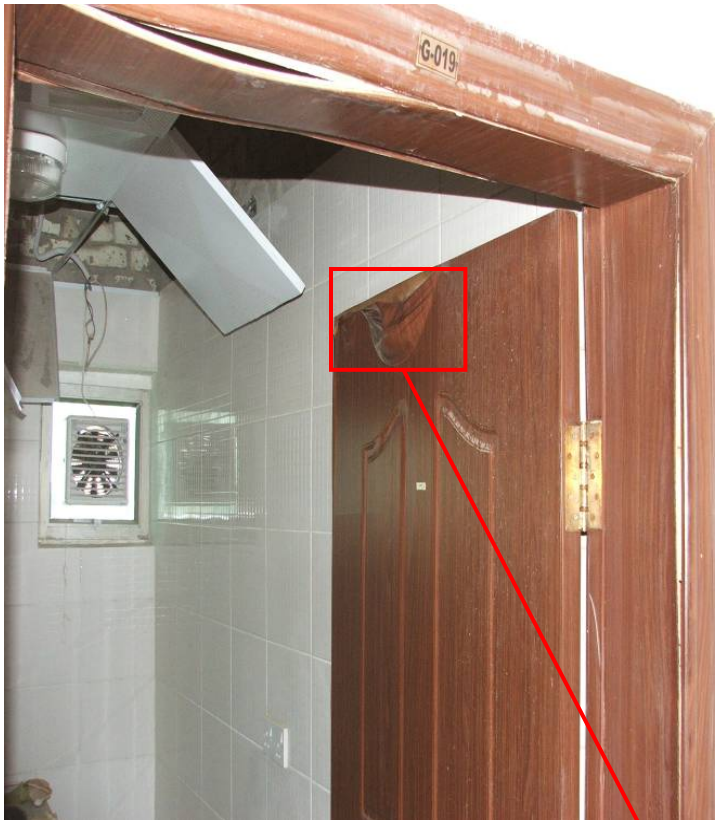
**Site Photo 220. Door frame and door damage resulting from water leaks in cadet barracks**

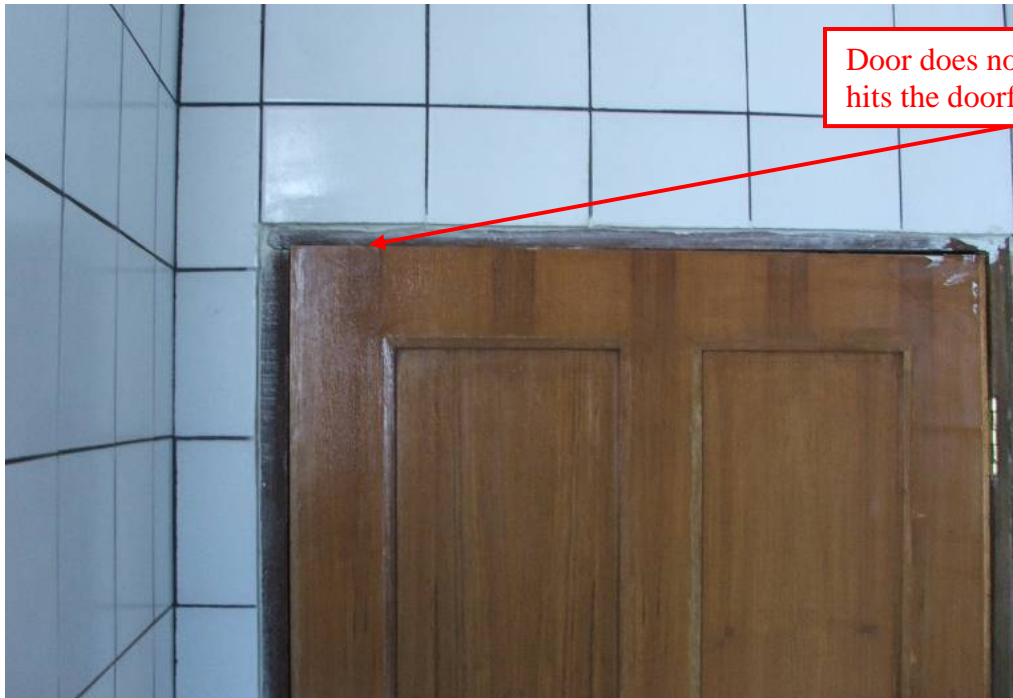
Door does not shut – it hits the doorframe
