QUICK REACTION REPORT ON THE
BAGHDAD POLICE COLLEGE
BAGHDAD, IRAQ

SIGIR PA-06-078.1

SEPTEMBER 27, 2006

Quick Reaction Report on the Baghdad Police College, Baghdad, Iraq

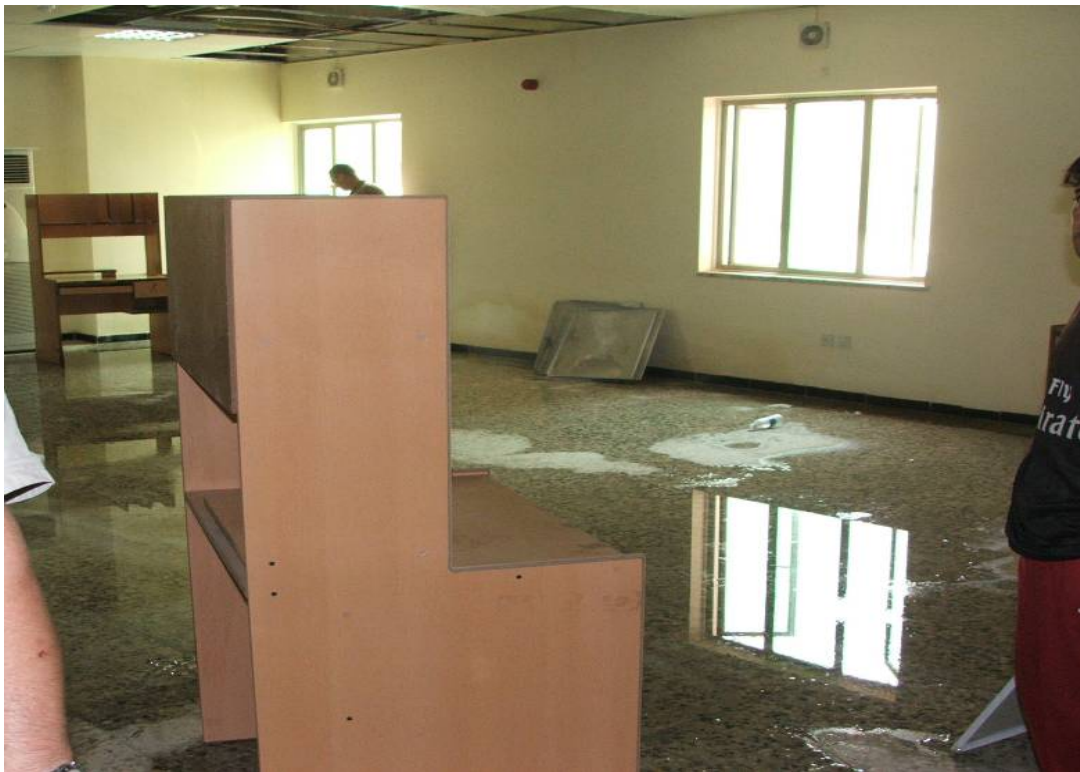
Site Photo 10. Water damage from leaking ceiling

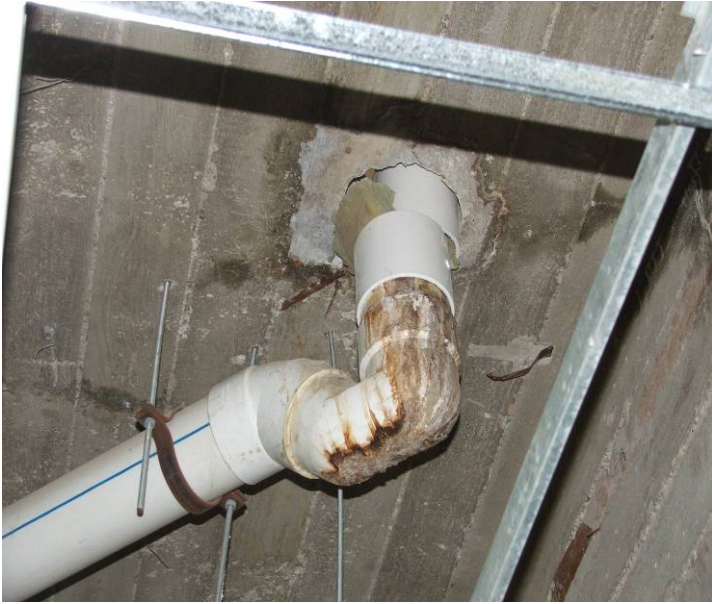
- Floor drains are not adequately sealed to the floor surface and/or properly affixed to adjacent fittings with the proper adhesive or sealant, which causes water to drain outside rather than inside the drain collectors (Site Photo 12 and 13)
- Drains were assembled without the specified molded plastic fittings, which resulted in water and waste materials flowing from the collection trees through the improperly fabricated joints directly into the concrete floors. The contractor used pipes with holes that were hand cut with secondary pipes inserted (Site Photo 14) rather than the appropriate type of pipe (Site Photo 15).

Site Photo 12. View of wastewater leaking from pipe

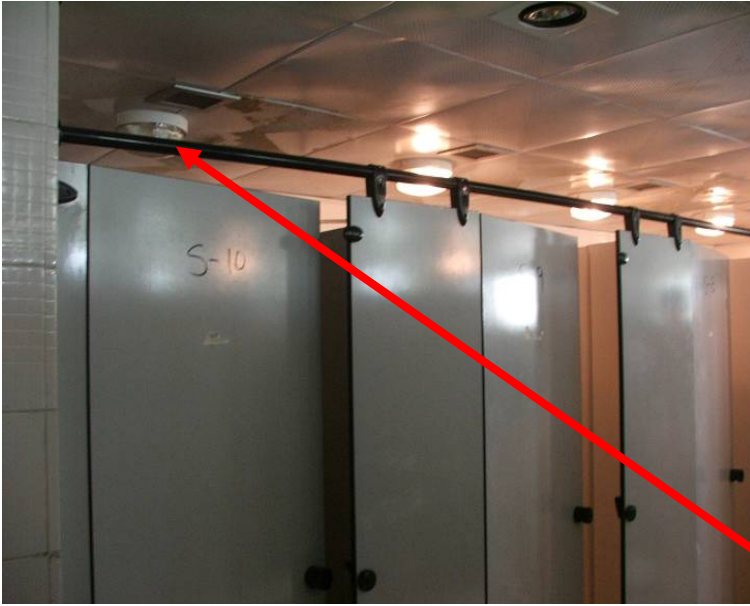
As a result of the inferior plumbing techniques, methods, and bonding materials used by the contractor to join the wastewater pipes, water and other waste materials from showers, wash basins, and toilets are continually draining through the reinforced concrete floors, from the top floor to the second floor to the ground floor, permeating and filling light fixtures, showers, and toilet areas, with liquids, including diluted urine and fecal matter. For example, we witnessed a light fixture so full of diluted urine and feces that it would not operate (Site Photos 16 and 17). As we continued

Site Photo 16. Bathroom lights on second floor

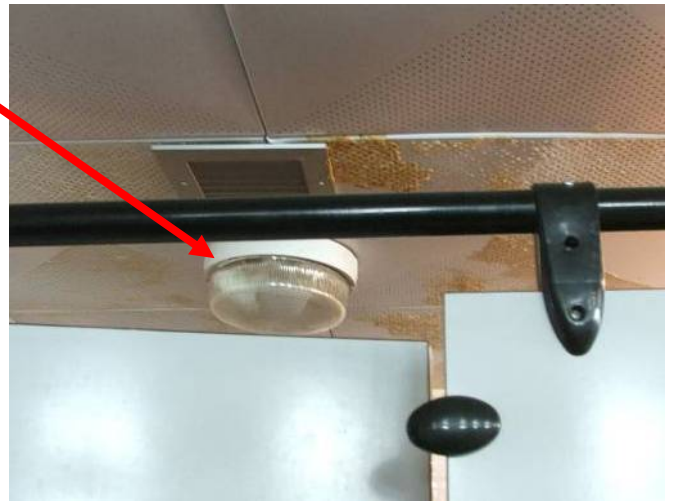
Site Photo 17. Close-up view of far left bathroom light not operating because it is full of diluted urine and fecal matter
