RECRUITING (BABIL VOLUNTEER)
CENTER
AL HILLA, IRAQ

SUSTAINMENT ASSESSMENT

SIGIR PA-06-089
APRIL 17, 2007

Recruiting (Babil Volunteer) Center Sustainment Assessment Al Hilla, Iraq

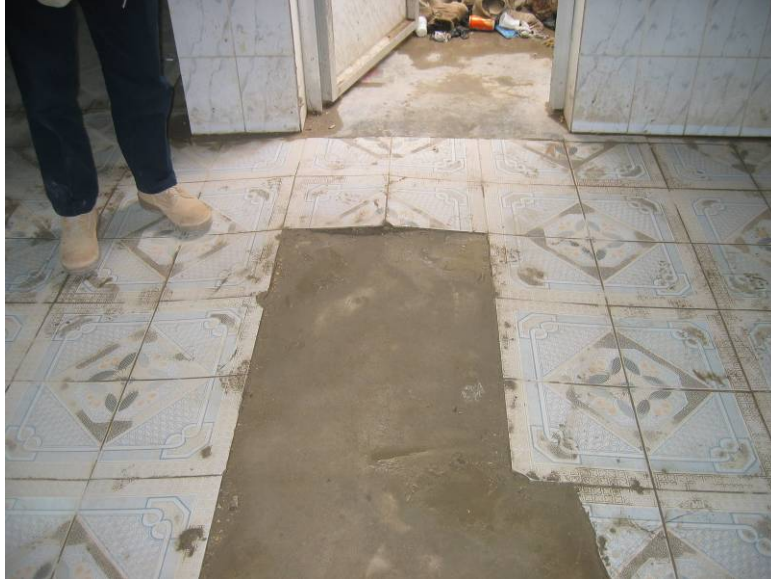
Two bathroom floors buckled causing damage to concrete and tiles. At AFCEE’s request, Weston’s subcontractor visited the site on 17 February 2007 to assess the damage to the floors. The contractor believes that the buckling resulted from water swelled soils surrounding the drain pipes due to wastewater leaking from damaged lines. The contractor noted that because the end user never evacuated the sewage holding tank, effluent backed-up in the drain lines and leaked into the ground beneath the floors. The contractor also stated that drain lines may have been damaged when the end user replaced a western style toilet.

SIGIR concurs that the buckling is likely caused by water leaking into the soil causing it to swell and exert upward pressure on the floors. We also agree that the likely cause for the leakage is failure to evacuate the sewage holding tanks which causes backup through the drain lines. The problem would be mitigated if the sewage holding tank were properly evacuated; however, force protection barriers and internal walls prevent pumping trucks from accessing the tanks. Site Photo 1 shows the buckled floors and tile damage. Site Photo 2 shows the overflowing sewage holding tanks draining raw sewage to the adjacent lot. Site Photo 3 shows the jersey barriers blocking the only vehicle access to the building rear.

Site Photo 1. Bathroom floor tile damage caused by buckling from ground swelling

After being notified of the problem, the contractor committed to provide an access route to the sewage holding tank and have it evacuated for the first time. The IAF will be responsible for subsequent evacuations. The contractor also agreed to repair the buckled floors and damaged drain pipes.

2. The contractor has committed to providing an access route to the sewage holding tanks and evacuating them for the first time. The IAF will be responsible for subsequent evacuations. The contractor will also repair the buckled bathroom floors and repair drainage pipes damaged by the occupants.

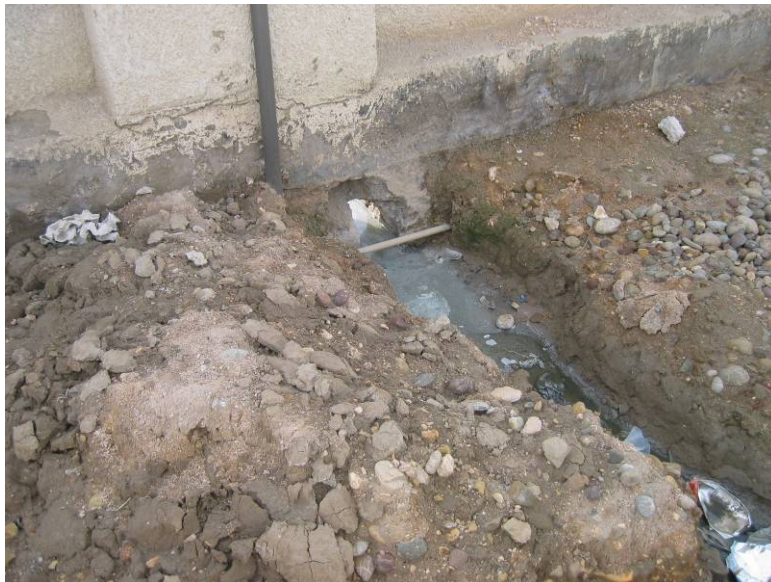
Site Photo 2. Raw sewage draining from the holding tank to the adjacent property.

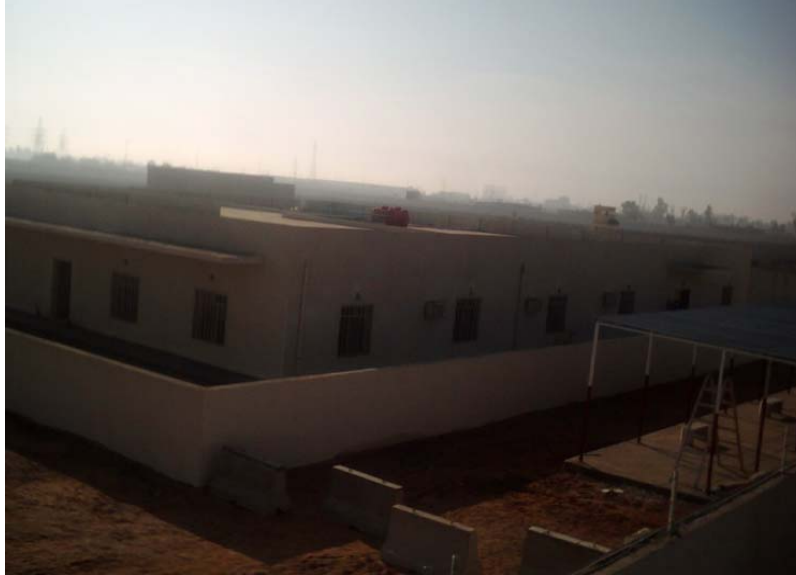
Site Photo 3. Jersey barriers blocking vehicle access to the building rear where the sewage holding tanks are located. (From Weston Photo Log)

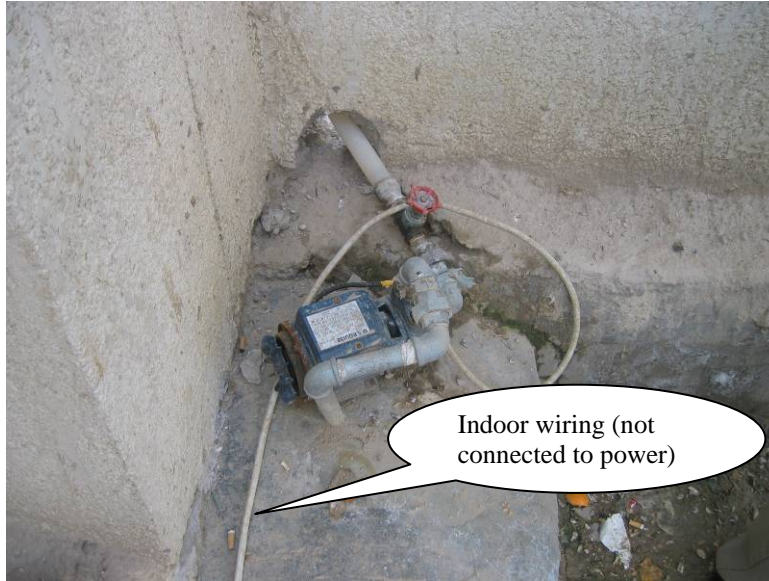
Site Photo 6. Exposed water pump connected to the main water supply line using indoor wiring. (Wiring is not connected to electrical power.)

3. It is uncertain who is responsible for the unprotected water pumps and inferior wiring. Action should be taken to insure that outdoor wiring is installed, the water pumps are protected from the elements and the disconnected pump is connected to a power source.

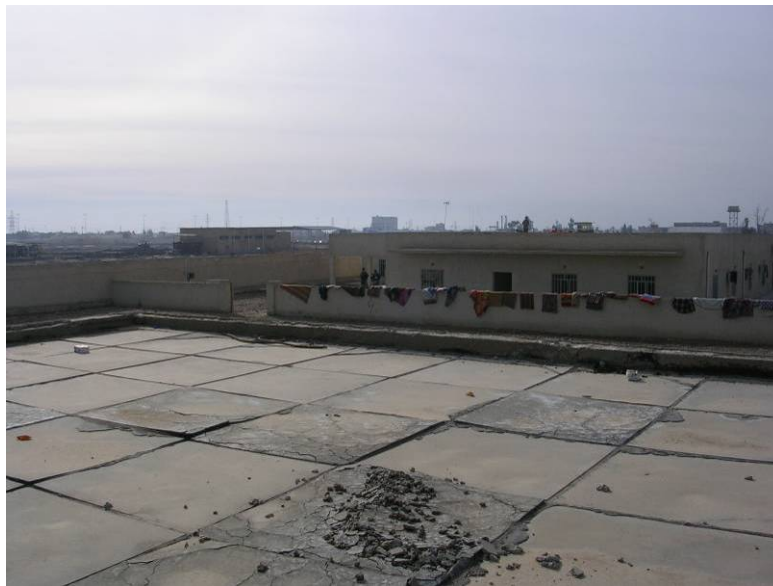
The guard house roof deteriorated prematurely and the water tank on the roof apparently overflowed causing damage to the interior walls. After being notified of the problem, the contractor visited the site and repaired the roofs at the guard house and the main building. Site Photo 7 shows the deteriorated roof tiles and Site Photo 8 provided by the contractor on 17 February 2007 shows the repair work on the roof.

Site Photo 7. Deteriorated roof tiles on the guard house

1. Upon hearing about the deficiencies the subcontractor visited the site, made an assessment of the deficiencies and repaired the guard house roof as a warranty item.

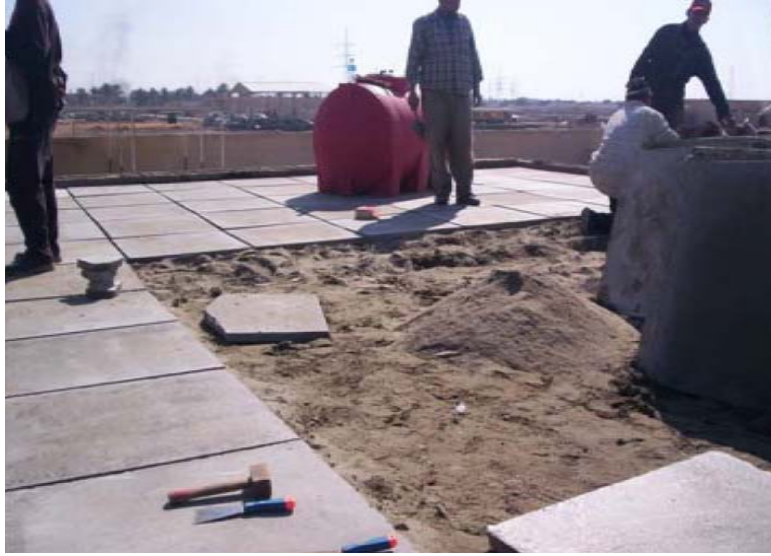
**Site Photo 8. Contractor repairing the guard house roof after being notified by SIGIR
(From Weston photo log)**

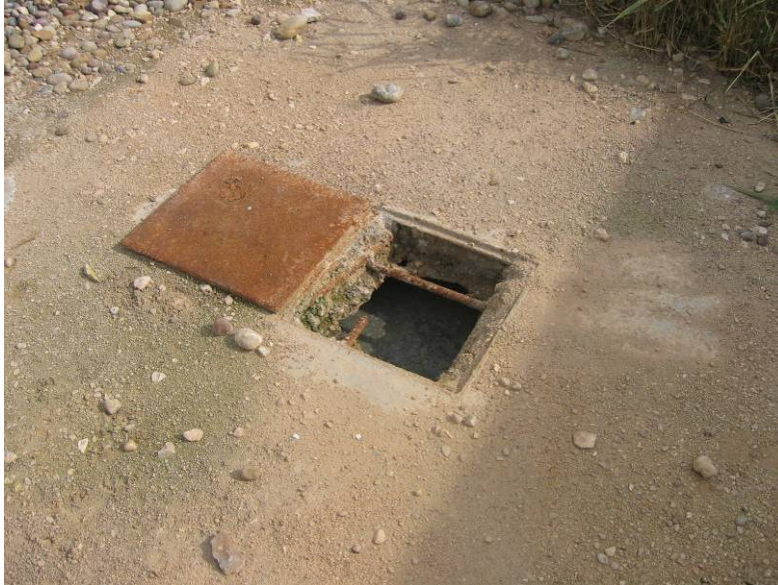
Site Photo 10. Sewage holding tank filled to capacity and draining to the adjacent lot

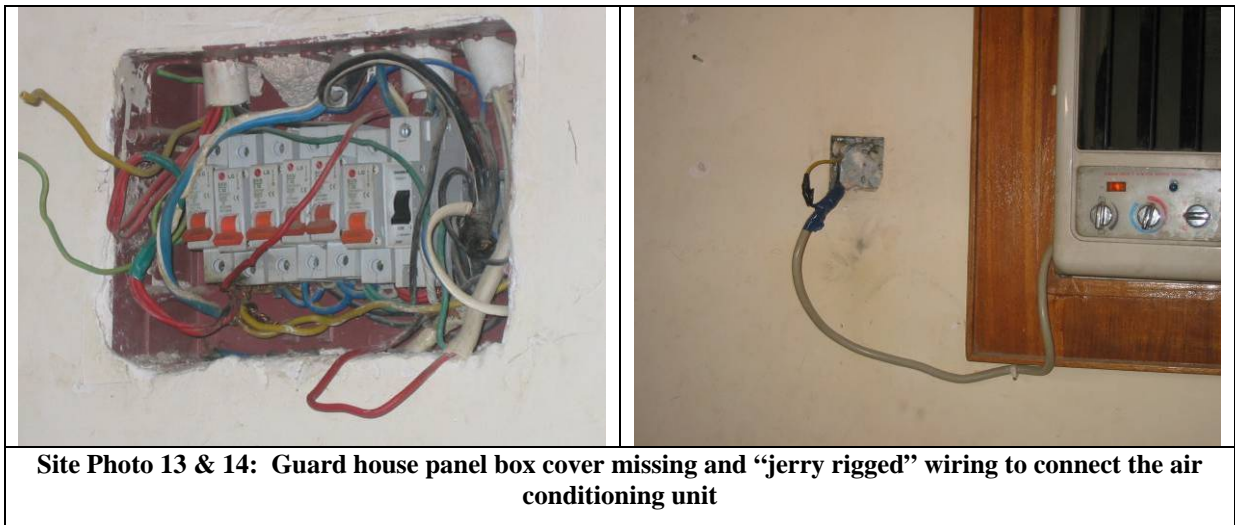
Site Photo 13 & 14: Guard house panel box cover missing and “jerry rigged” wiring to connect the air conditioning unit
