BAGHDAD INTERNATIONAL AIRPORT
POWER SYSTEM ENHANCEMENT
BAGHDAD, IRAQ

SUSTAINMENT ASSESSMENT

SIGIR PA-07-097
APRIL 26, 2007

Baghdad International Airport Power System Enhancement Baghdad, Iraq

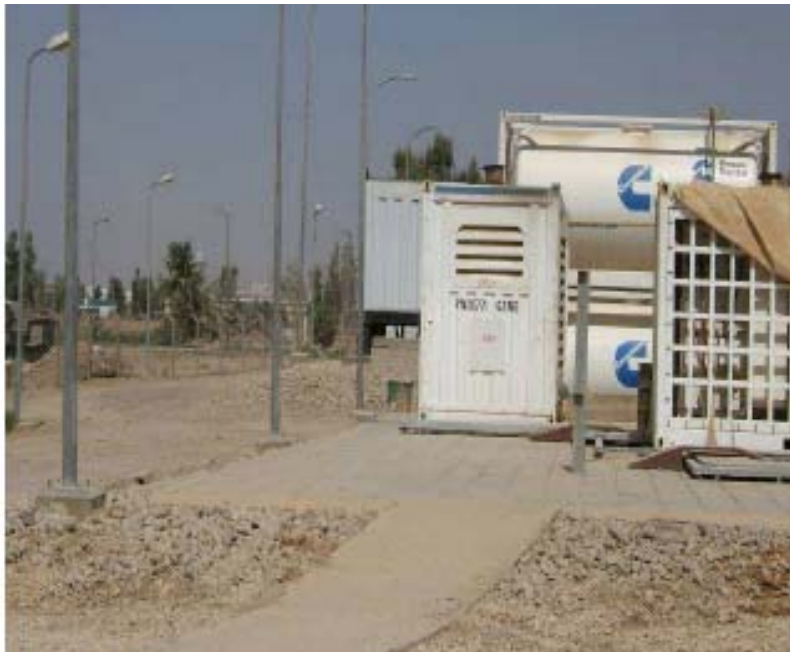
Site Photo 5. Cummins generator sets (Photo provided by USAID)

8. Page 5, site photo 5: The generators pictured are Caterpillar, not Cummins.
9. Page 9, first paragraph, fourth sentence: We recommend that the sentence which reads “However, the BIAP power plan management claimed that the commissioning and startup of the GE generators sets were not completed and were not accepted” be revised to read as follows: “During SIGIR’s March 3, 2007 site visit, the BIAP power plant manager indicated that commissioning and startup of the GE generators sets were not completed and that these generators were not accepted by the GOI. However, information presented by USAID verified that these generators were fully installed and commissioned at the project’s completion and were included in the package of 17 generators USAID turned over to the Government of Iraq under the project.”

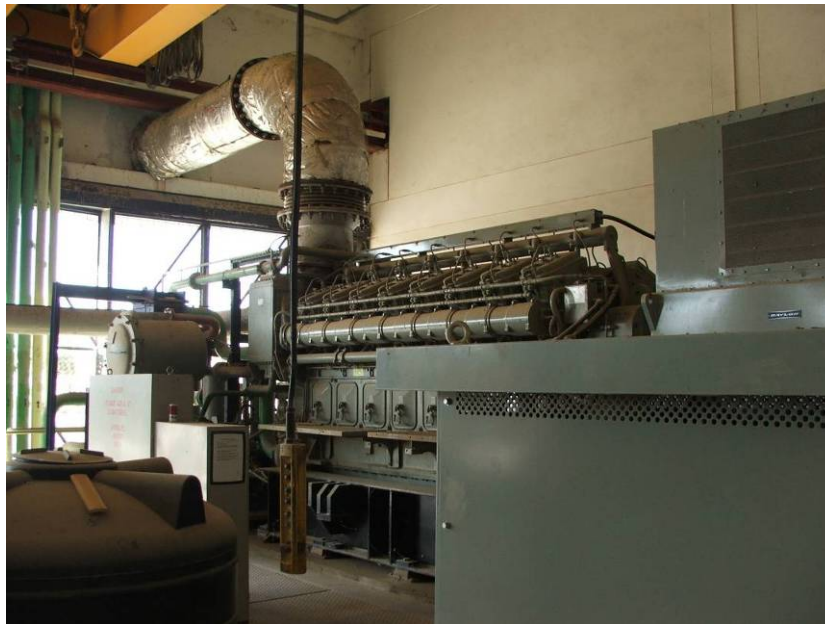
Site Photo 11. General Electric generator

During the 3 March 2007 visit, the GE generator sets were not operational. The USAID and GRD representatives were unaware that the GE generator sets were not operational, and the BIAP power plant manager stated that the GE generator sets have been non-operational for approximately 17 months (September 2005 through March 2007). The three GE generator sets are necessary for the electrical power requirement at BIAP.

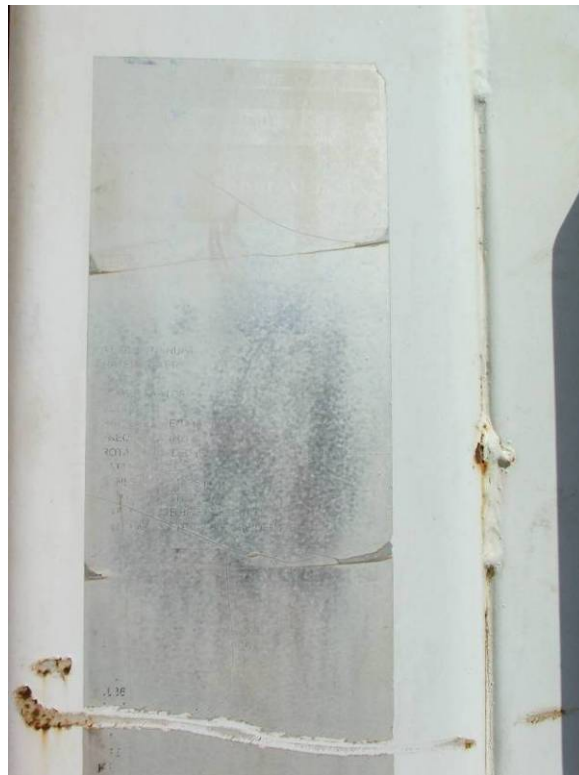
Site Photo 19. Cummins generator set 1 ID plate faded from direct sunlight

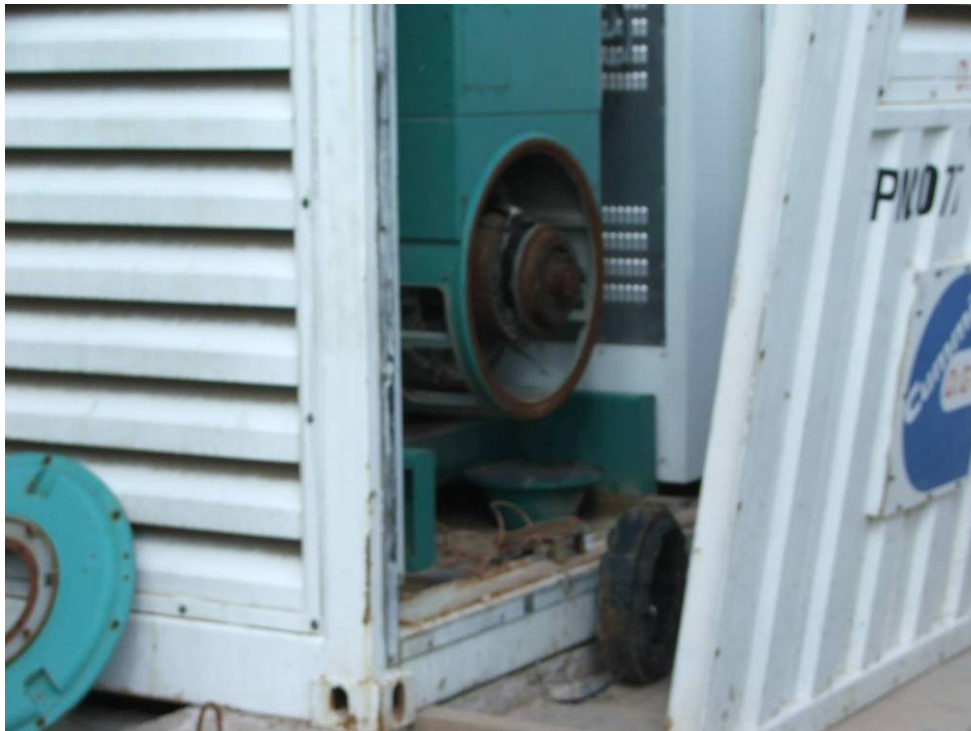
Site Photo 33. Cummins generator set 2 disassembled & unprotected from weather

Significant maintenance and repairs on the Cummins and Caterpillar generator sets are now required in order to achieve and sustain needed power production capability for operation of the BIAP power plant. Full load operation at the BIAP power plant complex has not been realized as of this report. The sustainability of the power plant facility will not be achieved unless all of the equipment is properly operated, the operators trained, and the generator sets maintained using an O&M or PM plan.

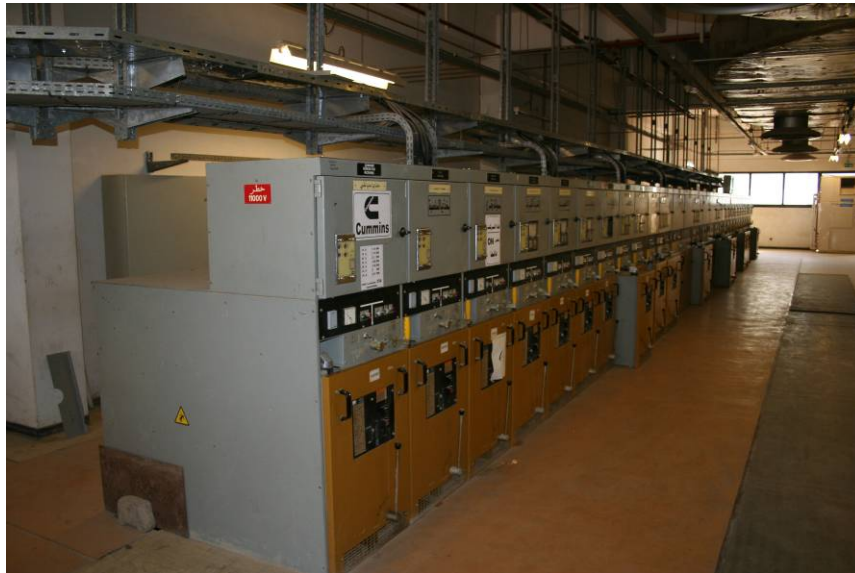
Site Photo 48. System for Cummins generator sets

Cummins and CAT generator sets, respectively. The systems appeared to be working at the time of the SIGIR visit.
