IRAQI C-130 BASE
BAGHDAD, IRAQ

SUSTAINMENT ASSESSMENT

SIGIR PA-07-099
JULY 24, 2007

SUBJECT: Report on Sustainment Assessment of the Iraqi C-130 Base, Baghdad, Iraq
(Report Number SIGIR PA-07-099)

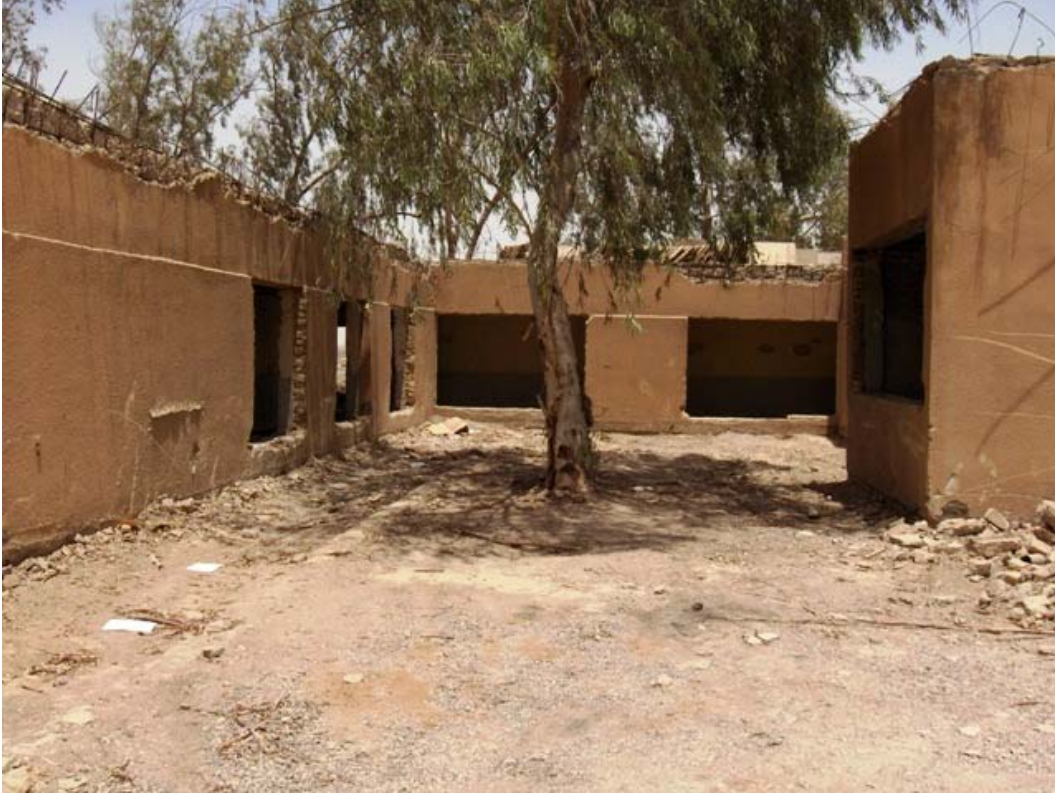
Site Photo 2. Pre-construction state of building B-230 courtyard, extensive renovations needed. (Contractor provided photo)

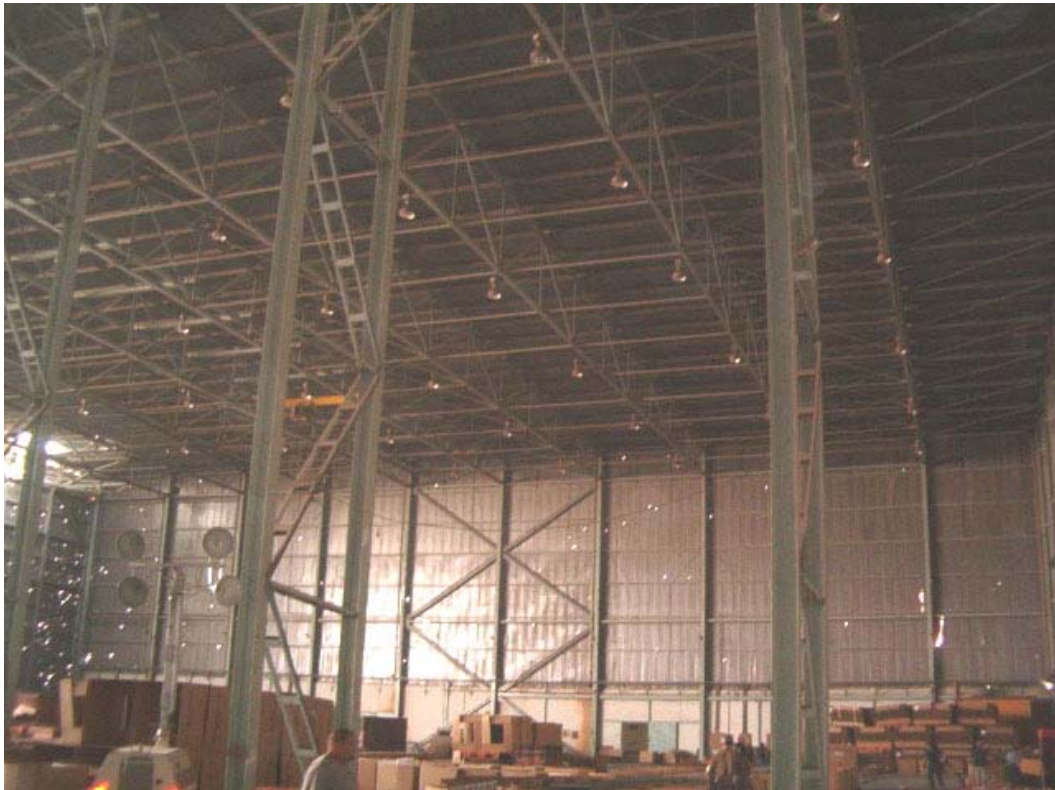
The largest structure in the renovation, the aircraft hangar that measures 80.55 meters by 135.86 meters, is shown in Site Photo 3. The pre-construction hangar needed new metal sheeting and roofing as well as renovation of the attached surrounding offices.

Site Photo 3. Pre-construction state of the hangar B-260, replacement metal needed on walls and roof. (Contractor provided photo)

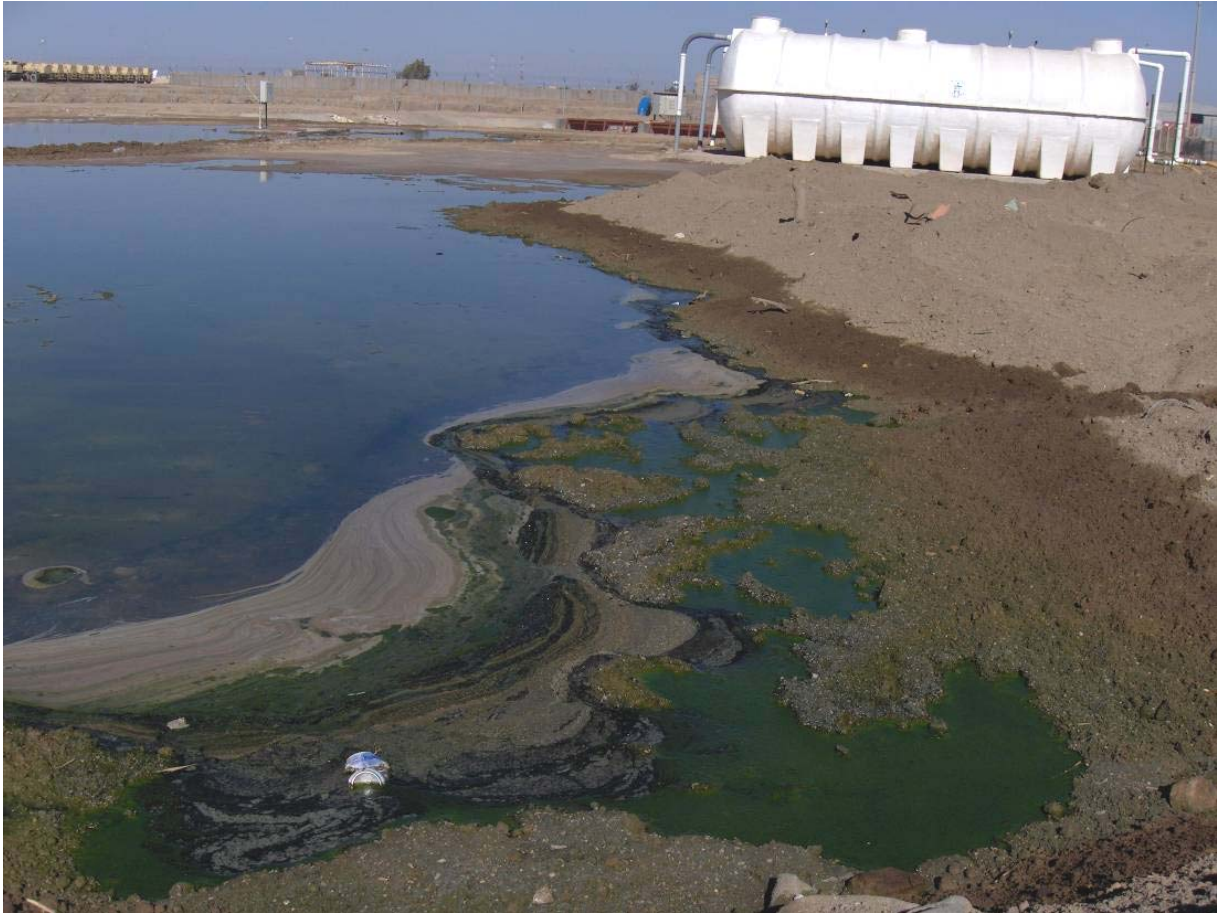
The sewer holding tanks were not sufficiently pumped. Routine tank O&M did not appear to be effectively performed. The prime contractor documented the overflow issue with pictures and an email regarding a discussion with the O&M contractor. The resulting sewage puddle overflowed to the storm water collection pond. Site Photo 4 shows sewage overflow on 24 February 2006. The issue was resolved when adequate pumping was reinstated as a result of the prime contractor and MNSTC-I intervention.

Site Photo 4. Sewage overflows around the holding tanks. (Contractor provided photo)

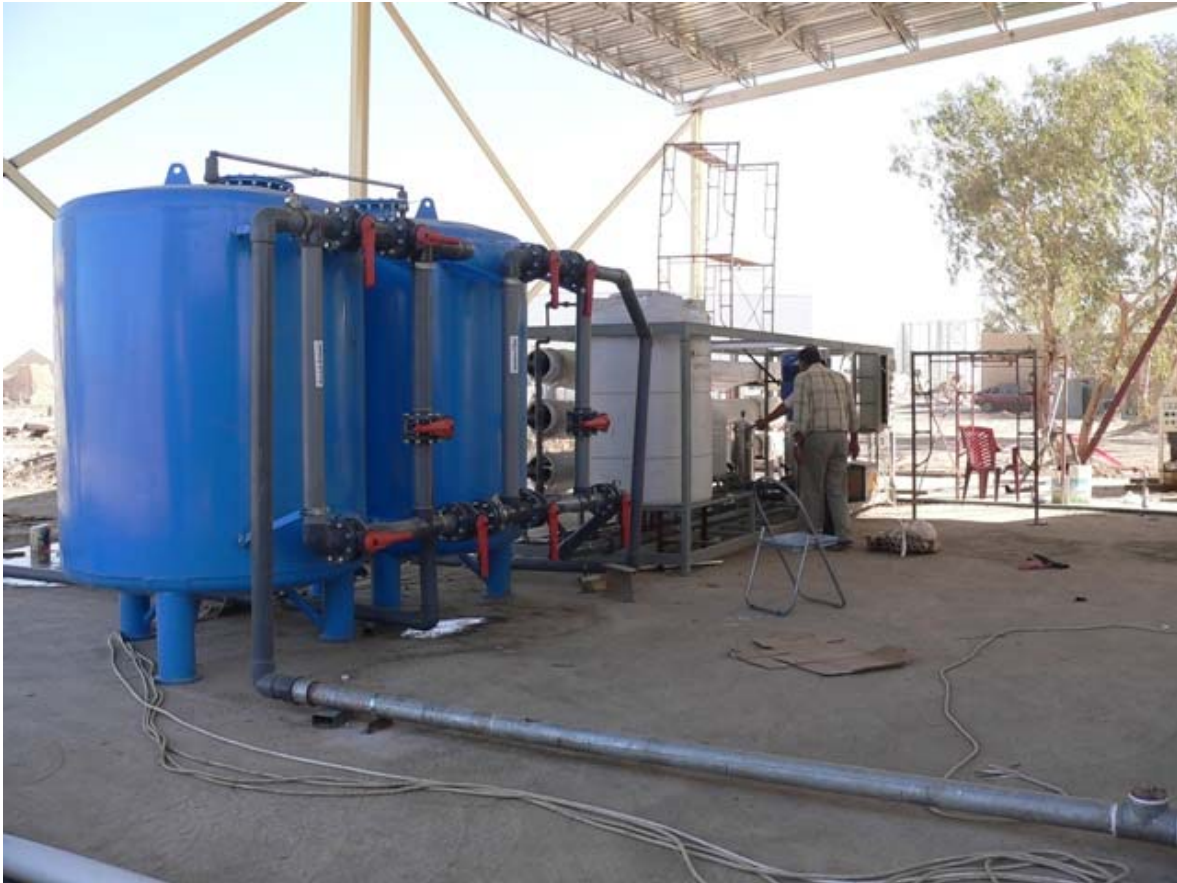
In February 2006, the contractor documented that the reverse osmosis (RO) unit had no spare filters, anti-scaling chemical, testing kits, and other various maintenance items available on site. The contractor also reported that regular filter changes had not been performed, the chlorine dosing did not meet requirements, and the RO system pressures were not within the recommended range. This likely occurred because the recommended O&M was not being performed on the RO unit. This caused the RO unit to malfunction with a possibility of damage to the RO membranes. Poor O&M on the RO unit directly impacted water quality.

Site Photo 6. Reverse osmosis unit at installation. (Contractor provided photo)

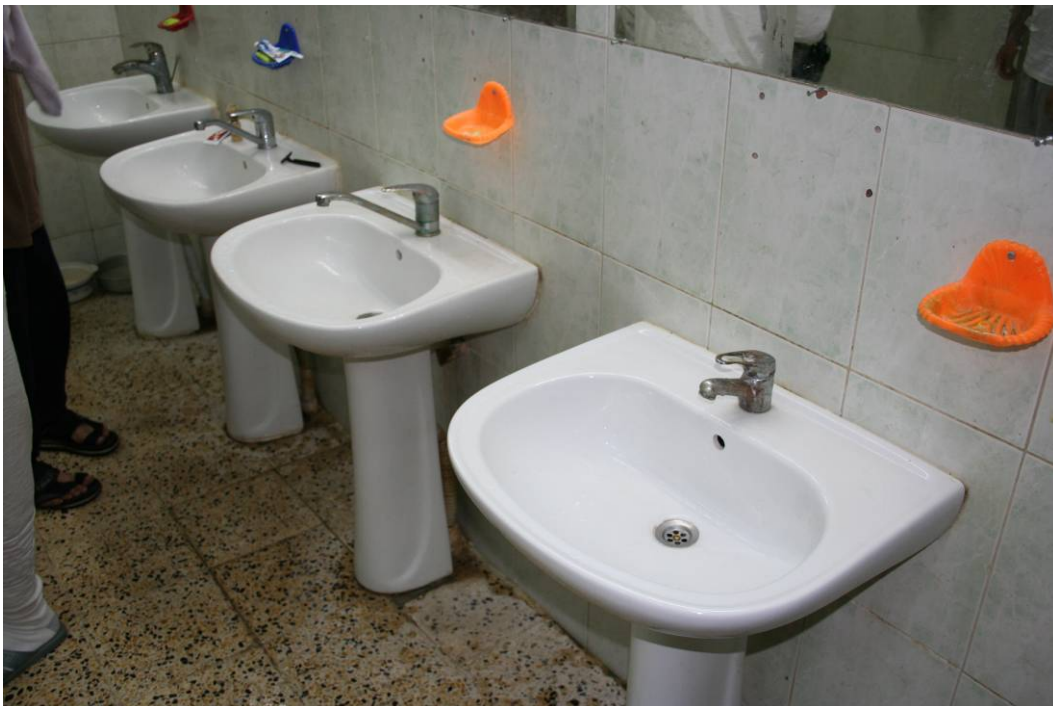
SIGIR visited the base barracks as part of the inspection. Site Photo 9 shows the sinks in the barracks bathroom. The bathroom sinks, showers, and toilets all worked at the time of the visit. Additionally, bathroom tile work, suspended ceiling, lights, mirrors, and shower doors all appeared to be in good condition.

Site Photo 9. Barracks bathroom in functional condition. Tile work, floors, sinks, and mirrors appeared in good condition.

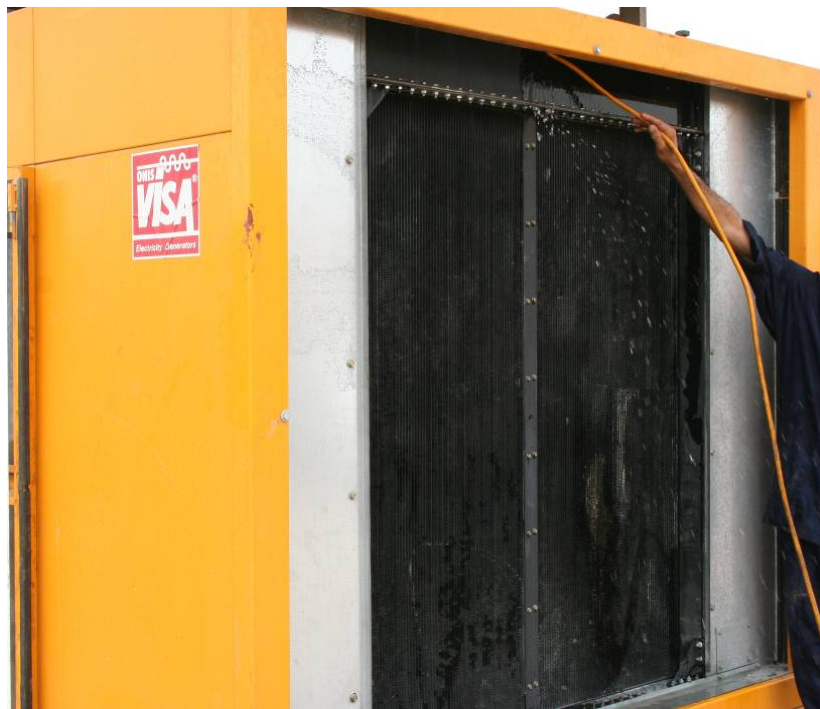
The electrical power distribution system included a total of eight generators. The design was for four slabs and two 800-kilowatt generators on each slab. Two generators operated during the site visit, three appeared broken, and three were not functioning for unknown reasons. Two slabs contained one generator, one slab contained two generators, and one slab contained four generators. Two of the generators had been moved from their original location and located to one of the other slabs. It was also noted that one of the broken-down generators had parts removed on 27 October 2006, 216 days before the site visit and the parts had not been replaced at the time of the site visit.

The working generators appeared clean and the inoperative generators contained adequate oil. During SIGIR's visit, a worker sprayed one of the operating generator's radiator with a water hose (Site Photo 12). According to the worker's supervisor, the water was employed to cool the radiator. Water on the ground and on the radiator prevented inspectors from observing any possible coolant leak from the radiator.

Site Photo 12. Worker cools a running generator with water.

Poor O&M was the primary cause of the generator's poor condition. This situation was compounded by resource issues. One of the generators had parts removed but not replaced. Discussions with MNSTC-I personnel verified that supply and distribution issues exist in the Iraqi supply system. Poor O&M practices on the generators will eventually result in sustainability problems as failures occur.

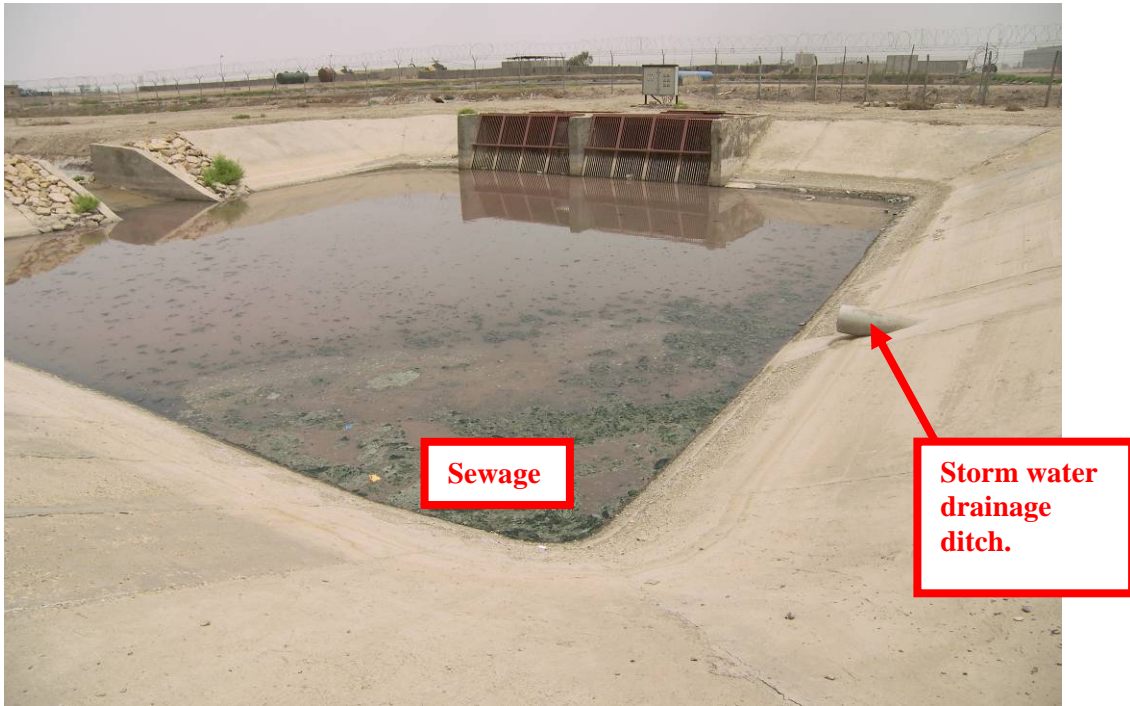
Raw sewage filled the storm drainage collection pit (Site Photo 14) and connecting drainage ditch (Site Photo 15). A small wet soil trail was evident in the soil in front of the sewage tanks to the drainage ditch, where it appeared that a hose leaked. The holding tank design only allows sewage removal by pump. Waste removal required a pump truck to transfer sewage from the collection tanks to the drainage ditch. From the evidence on site, the inspectors concluded that the pump trucks were used to pump the holding tanks into the drainage ditch.

The lack of O&M on the sanitary sewage system resulted in reduced performance of the storm overflow system and also caused a potential health hazard.

Site Photo 14. Storm drainage collection pond containing raw sewage.

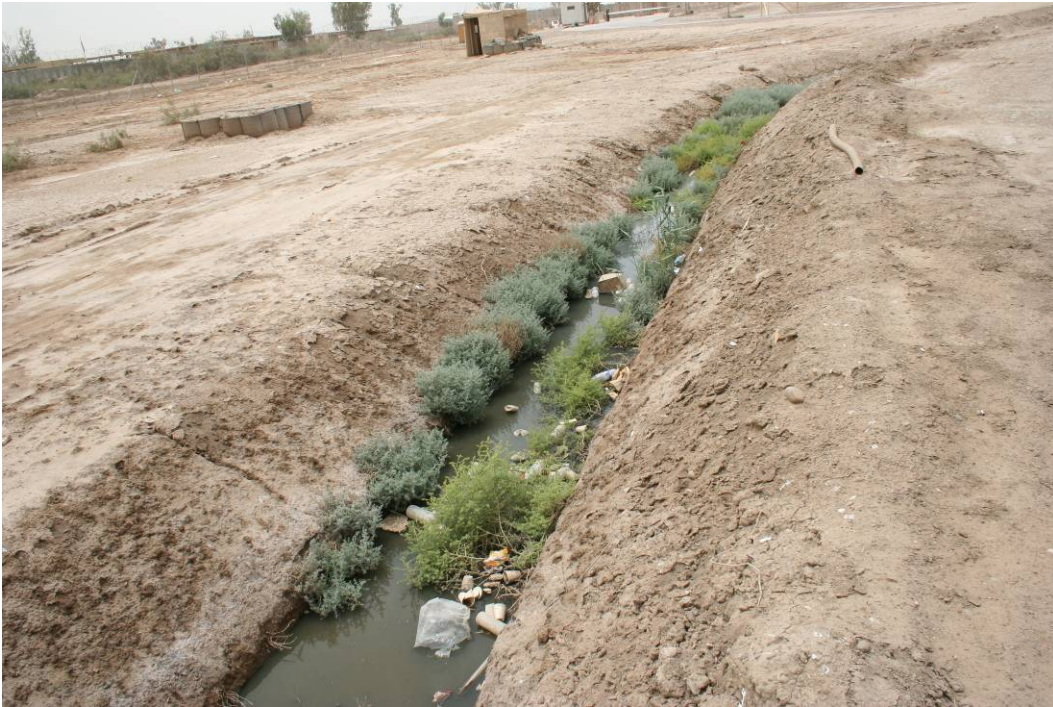
Site Photo 15. Raw sewage is pumped from sewage holding tanks into storm water runoff ditch

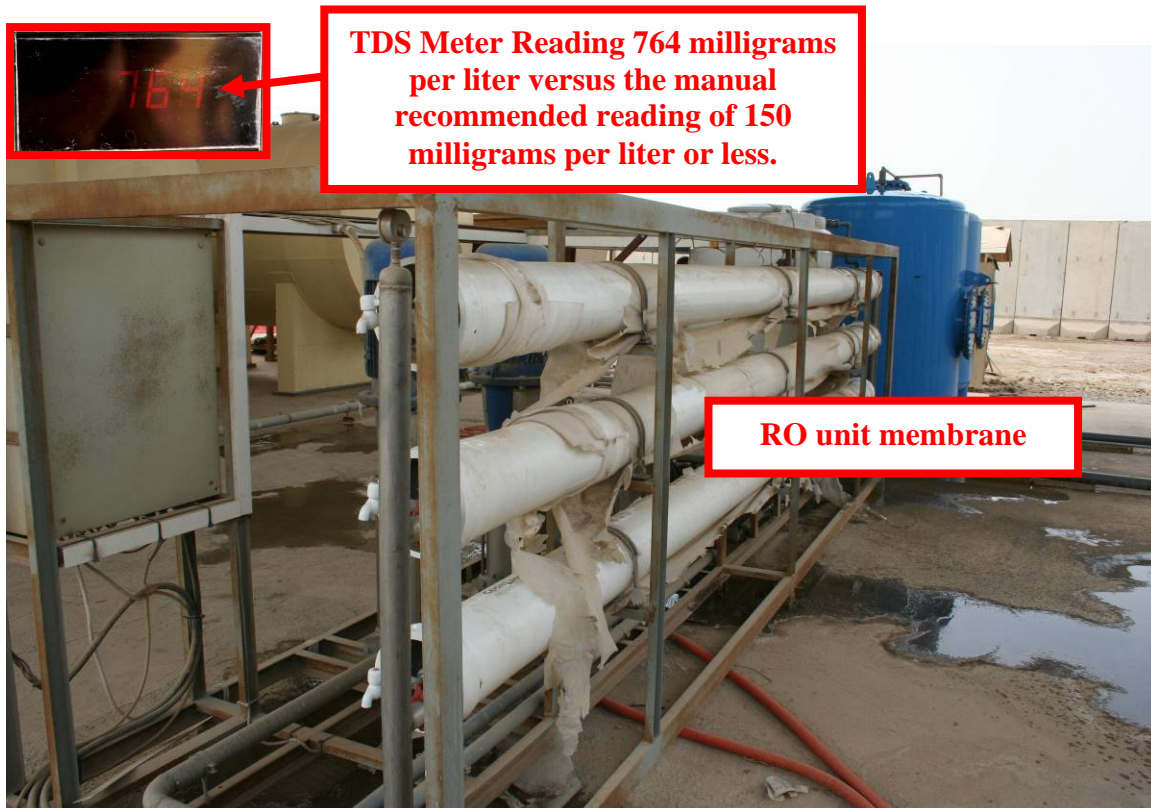
SIGIR noted that the RO produced water outside of the recommended total dissolved solids (TDS) range by a factor of five. The TDS meter read a TDS of 764 milligrams per liter, while the O&M manual recommended a reading of 150 milligrams per liter or less (Site Photo 16).

The RO maintenance worker stated that the permeators (the reverse osmosis membrane elements) were "no good". According to the O&M manual, the permeators only require periodic cleaning and fouling is the primary reason for permeator destruction.

The deteriorated condition of the RO unit was due to the lack of O&M. No records of current water tests, filter changes, periodic readings, chemical tank fillings, or other O&M activities were available. This could, be in part, a resource issue. No replacement filters were available at the time of the inspection. Spare parts were not readily available on site. The maintenance supervisor stated that only the base's general officer could grant access to, or order spare filters and replacement parts.

Site Photo 16. RO unit malfunctioning.
