WEST BAGHDAD INTERNATIONAL  
AIRPORT SPECIAL FORCES BARRACKS  
BAGHDAD, IRAQ

SUSTAINMENT ASSESSMENT

**SIGIR PA-07-100**  
**APRIL 24, 2007**

## West Baghdad International Airport Special Forces Barracks Baghdad, Iraq

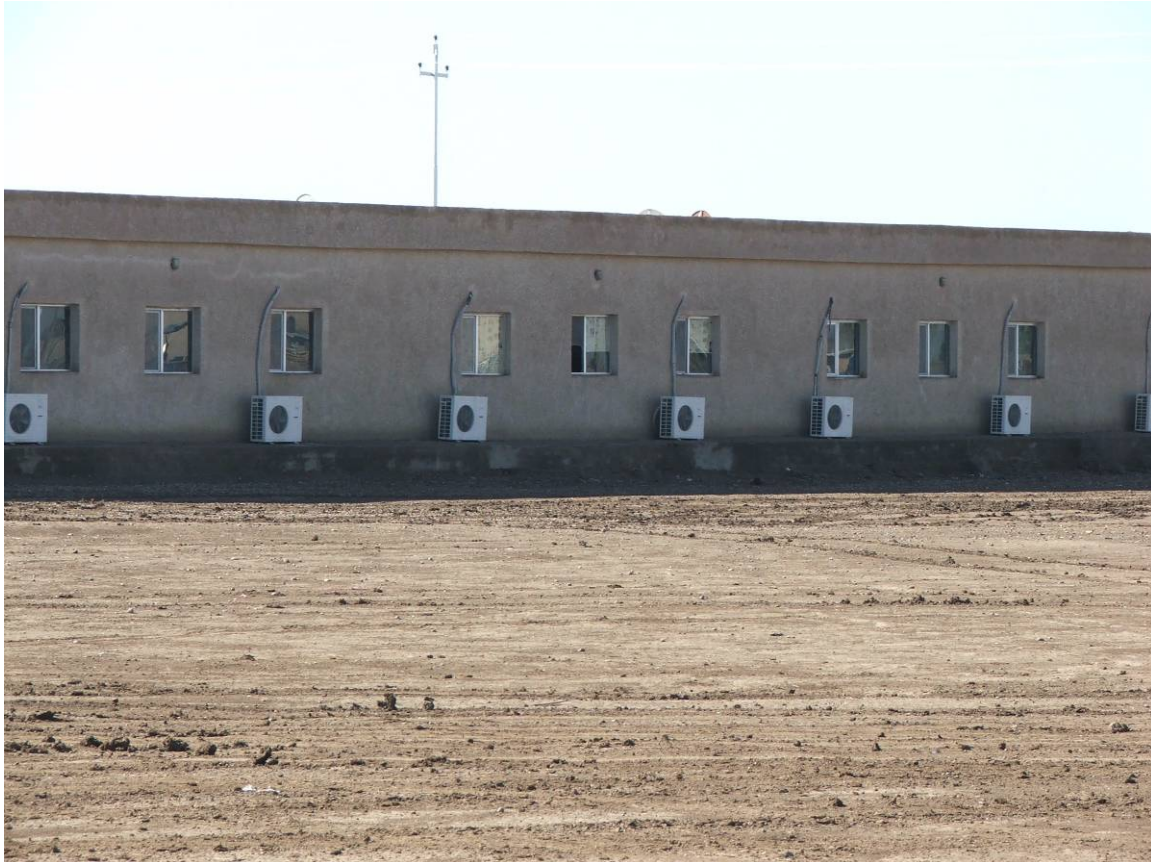
SIGIR inspectors found during their on-site inspection that the exterior of the barracks appeared to be in good condition. The exterior stucco was applied sufficiently thick and without noticeable cracks. Window and door frames were square and fit well enough that moving hinges operated freely. Site Photo<sup>2</sup> 1 shows an example of acceptable stucco work, windows, and split heating and cooling unit condensers.

**Site Photo 1. Barracks exterior appeared to be in good condition and did not show signs of settling or other major construction problems.**

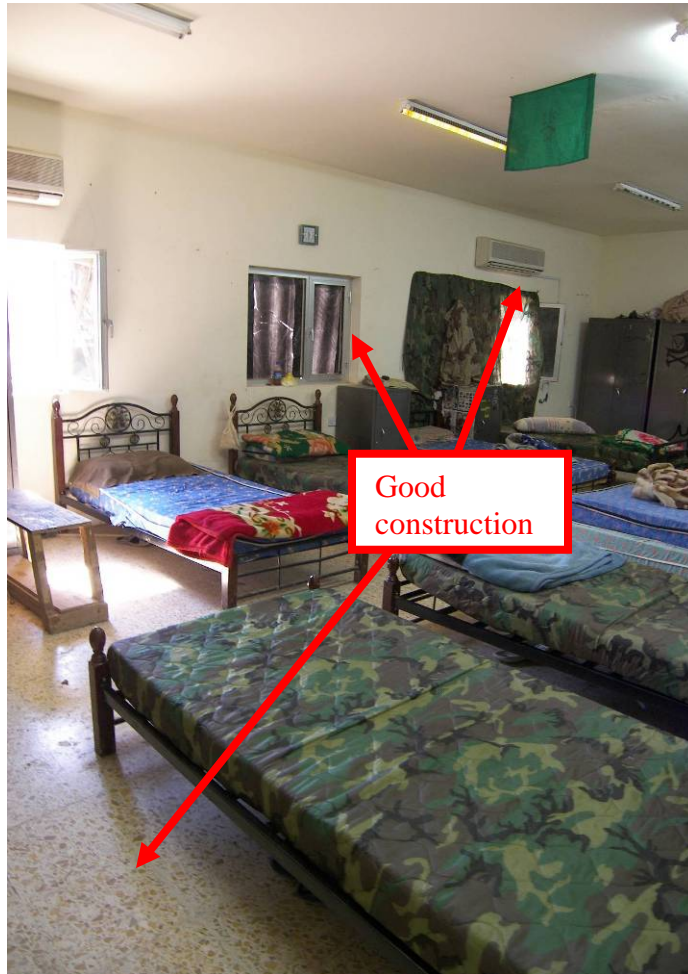
Site Photo 2 shows a typical residential area of a barracks. The inspectors observed that the windows opened and closed properly because they were proportionately framed and in good condition. In addition, the air conditioning unit was properly installed and the wiring was secured to the wall in a conduit. The floor tile also appeared to be installed properly.

**SIGIR Site Photo 2. Barracks residential area without noticeable construction or maintenance deficiencies.**

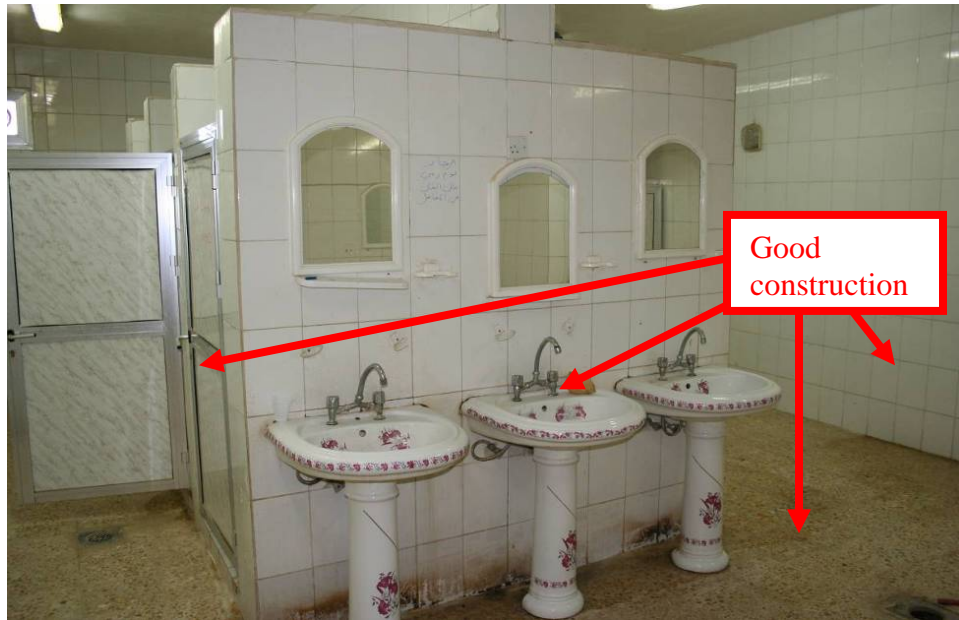
As required in the SOW, the senior barracks restroom shown in Site Photo 3 was tiled from the floor to the ceiling. Approximately 17.5 months passed since the barracks complex was turned over to Iraqi officials and the SIGIR site inspection. At the time of the inspection, the bathroom tile work appeared in good condition. Showers, sinks and water closet toilets all appeared to be in working order. In addition, the inspectors observed that the bathroom drains worked well.

**SIGIR Site Photo 3. Senior barracks bathroom with working sinks, showers, toilets and drains.**

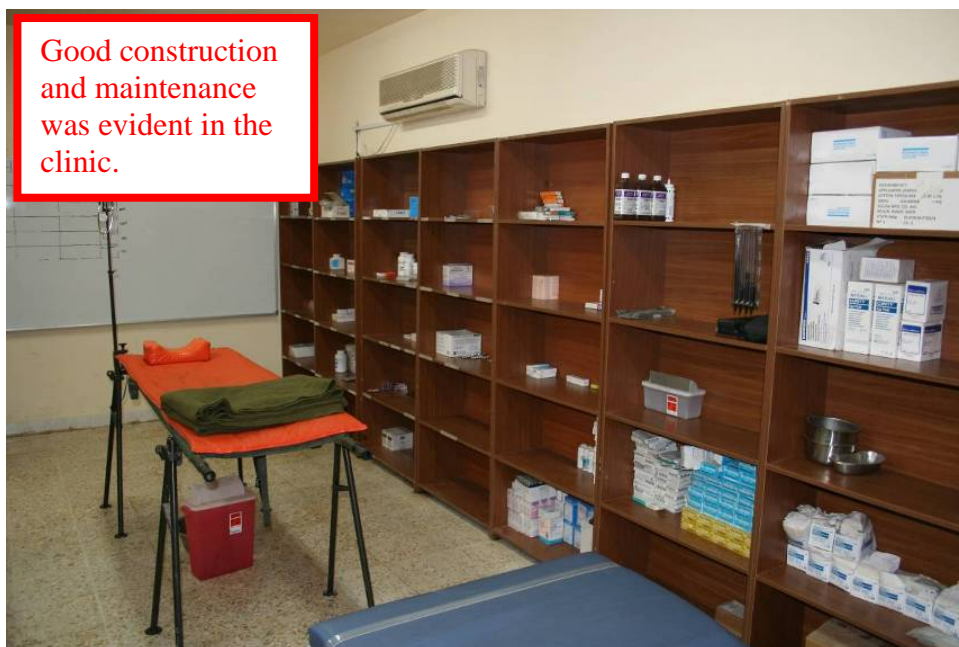
The barracks clinic is shown in Site Photo 4. As shown, the air conditioning unit appeared to be in good condition and installed properly. As in other rooms observed throughout the complex, painting and floor tile workmanship appeared to be satisfactory.

**SIGIR Site Photo 4. Clinic appeared properly built.**

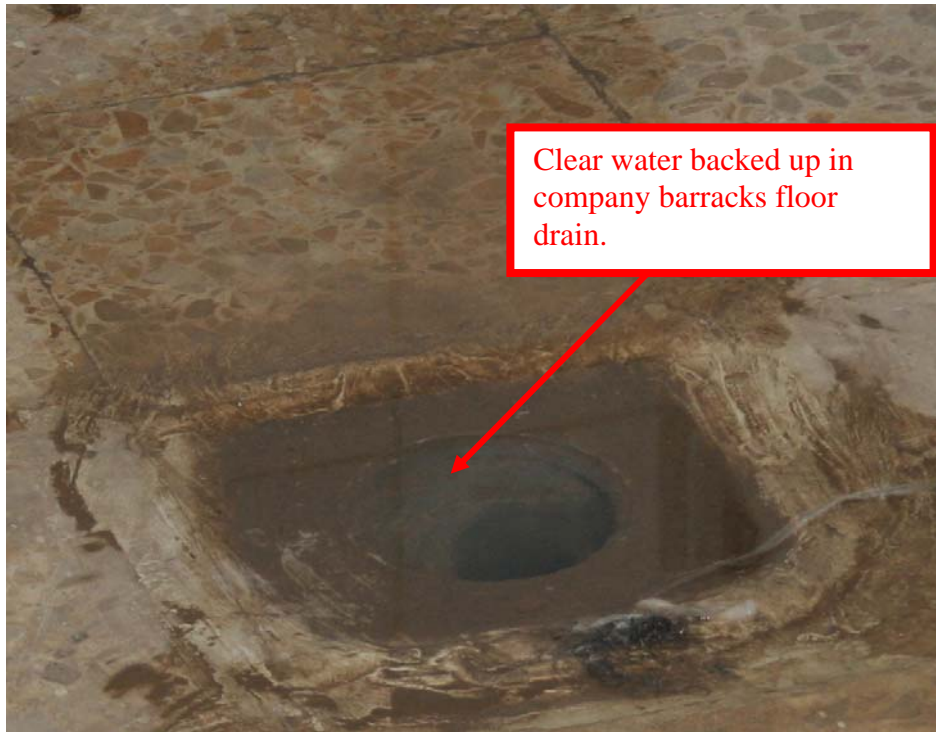
Site Photo 6 shows the clear standing water on the floor of a barracks bathroom.

**Site Photo 6. Clear water backed up in floor drain of company barracks.**

The problems with drainage and backup in the bathrooms were likely caused by an inadequate water supply to the bathroom. If insufficient water is provided to flush drains, clogs can occur as material is not transported out of the pipes. Continued use of a water based sewage and waste water collection system without adequate water will render drains unusable as buildup grows in the pipes. In order to correct the issue of drainage to nondraining bathrooms an adequate flow of water is required.

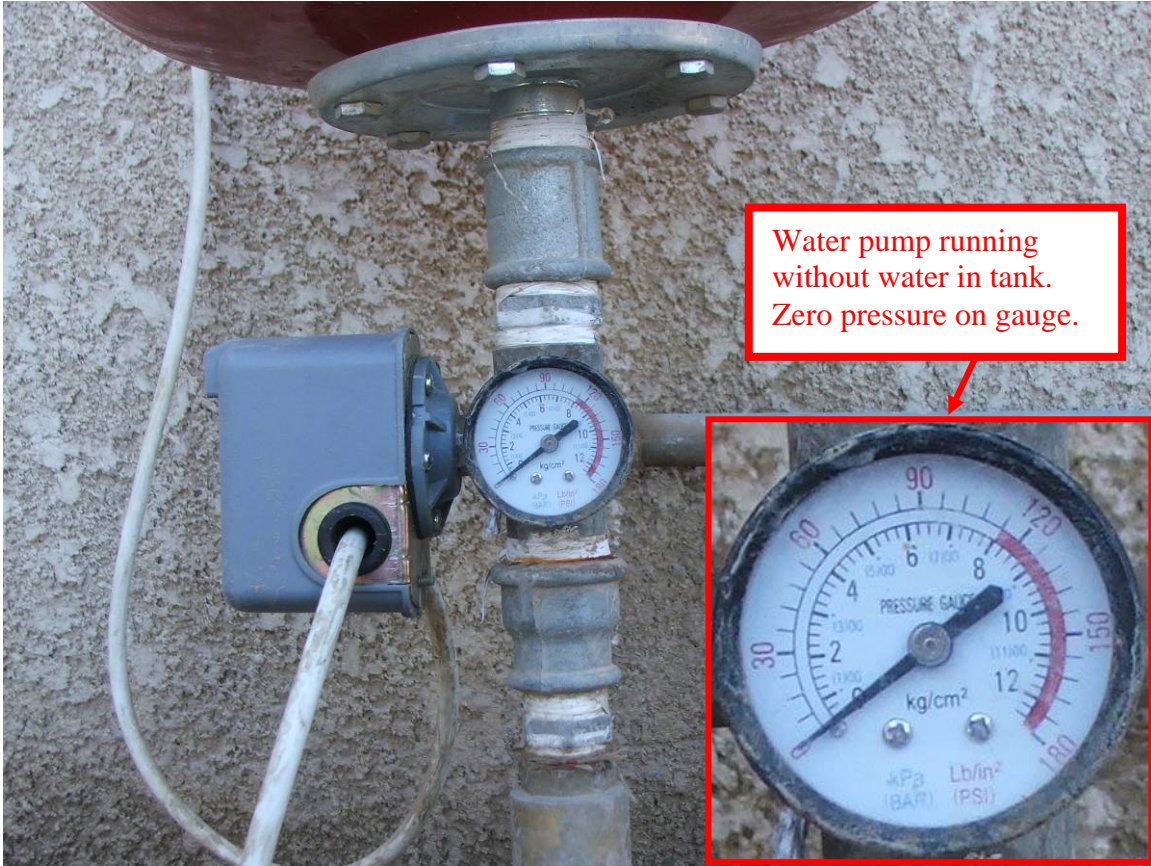
The water supply tank beside the septic tank appeared to be empty and SIGIR inspectors noted the pump was running despite the empty tank. Site Photo 8 shows the water pump pressure gauge with no pressure.

**Site Photo 8. Water pump pressure gauge reads zero while running with no water**

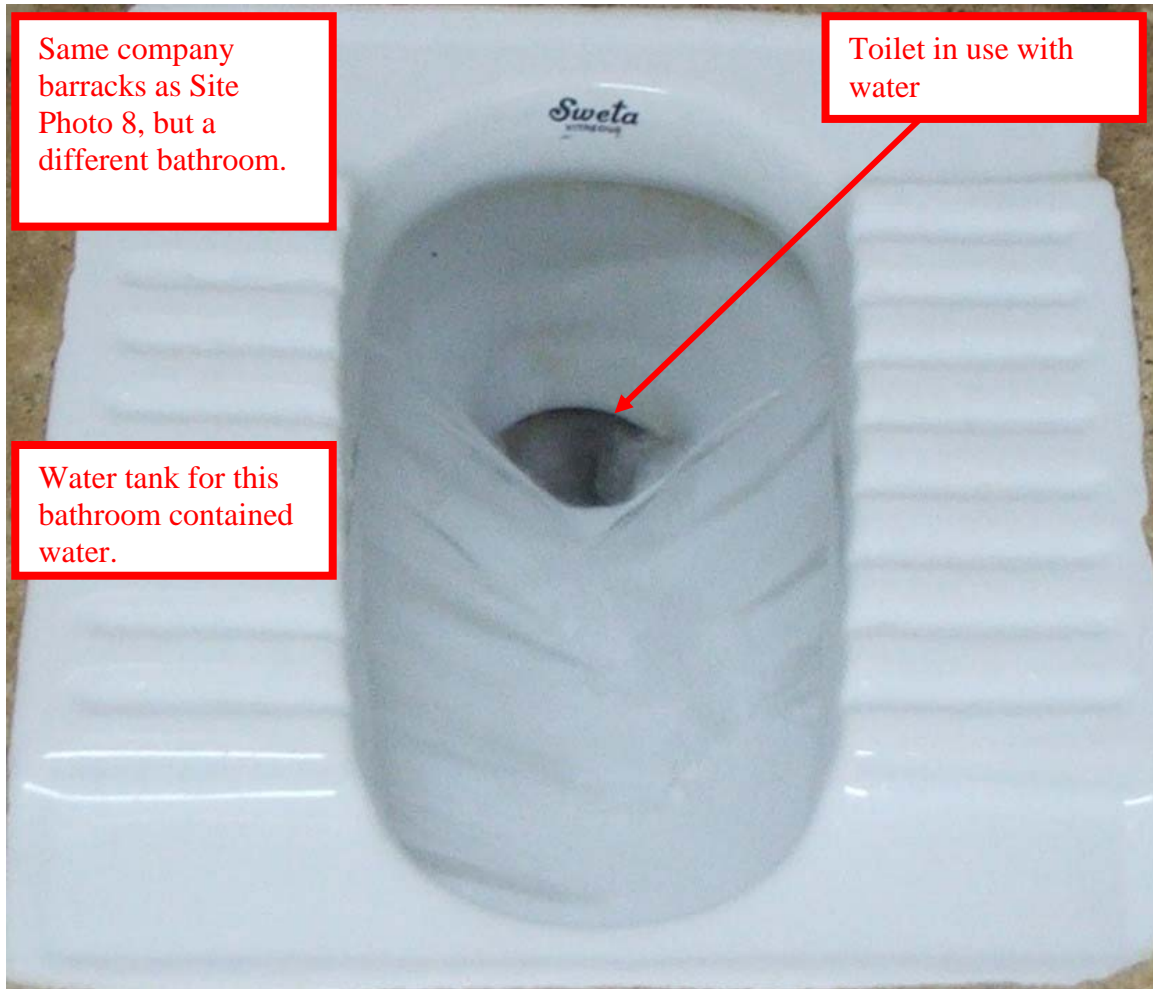
Although water tanks beside one company barracks bathroom contained no water, the barracks other bathroom water tanks were observed to contain water. The bathroom drains, as did the toilets, with flowing water. Site Photo 9 shows water flowing in the other barracks bathroom toilet. This toilet was free from material and dirt.

**Site Photo 9. Toilet in use with water in the company barracks.**

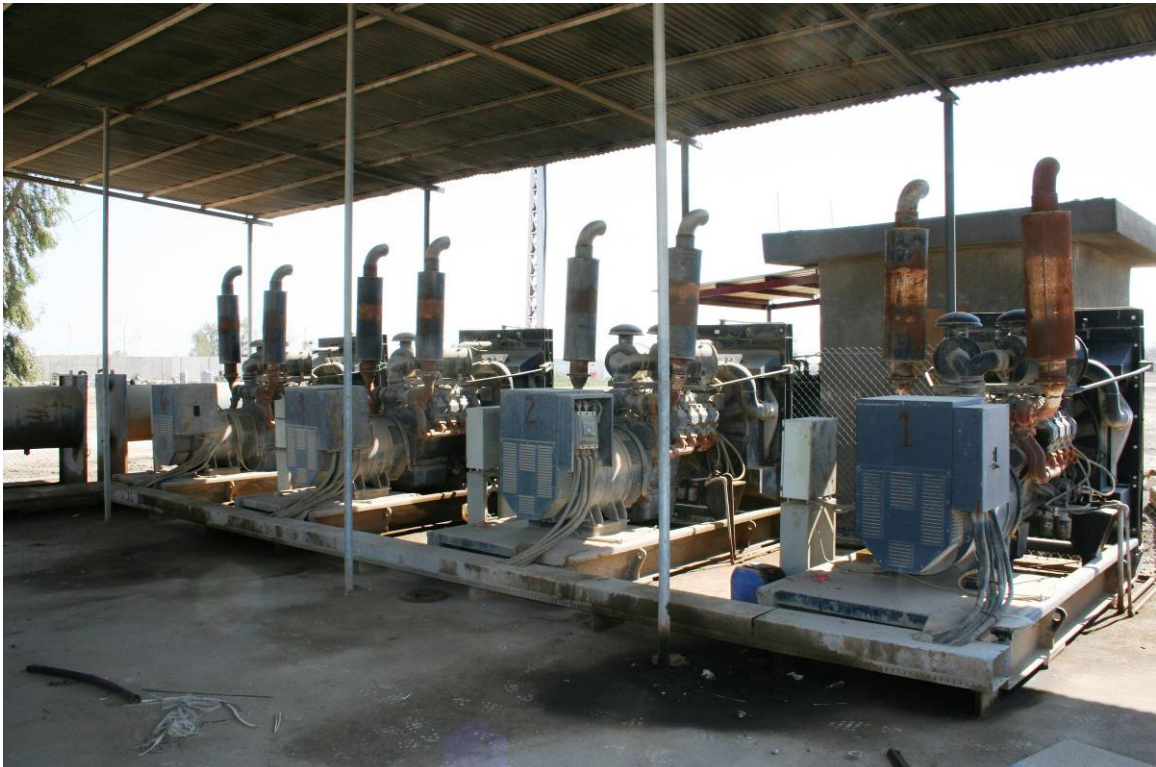
SIGIR inspectors found four 150 kilovolt generators present on site (Site Photo 10.) According to USACE provided documentation, each generator cost approximately \$50,000. The generators included three fuel storage tanks and electrical switching equipment.

All four generators did not function when inspected. Inspection of the generators revealed missing or nonfunctional batteries in all generators. The generators also contained an inadequate amount of oil. In Site Photo 11, a generator shows an empty battery and a dipstick with no oil.

It is likely that the generators were functioning at one time as spots of oil were visible under generators one and three. The exhaust pipes and mufflers on generators one and three also contained a higher degree of rust than generators two and four, which indicated that generators one and three ran more than generators two and four. The nonfunctional generators lacked batteries and oil, and the fuel tanks were empty.

**Site Photo 10. Four generators installed but not operational during site visits.**

Recommendation 2: The recommendation by SIGIR to have fully operational generators is valid. The Iraqi Joint Headquarters Logistics Directorate and Ministry of Defense Directorate of Contracting developed a Life Support Contract which requires the vendor to provide “Level 1 [routine/recurring] maintenance” to the West BIAP generators. This requires the contractor to maintain the generator oil and filters in accordance with the manufacturer’s specifications. It also requires the contractor to maintain a two month supply of repair parts, filters, and oil for all generators. Again, the vendor appears to have fallen short of meeting the obligation. To resolve this issue, Multi-National

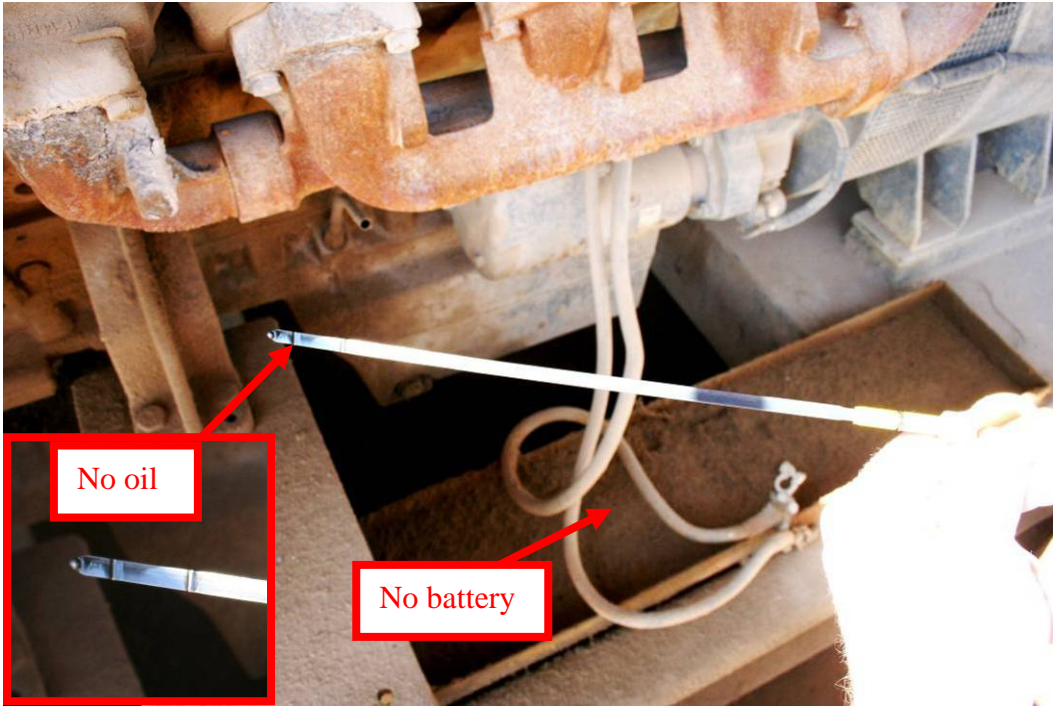
**Site Photo 11. All four installed generators were not operational.**

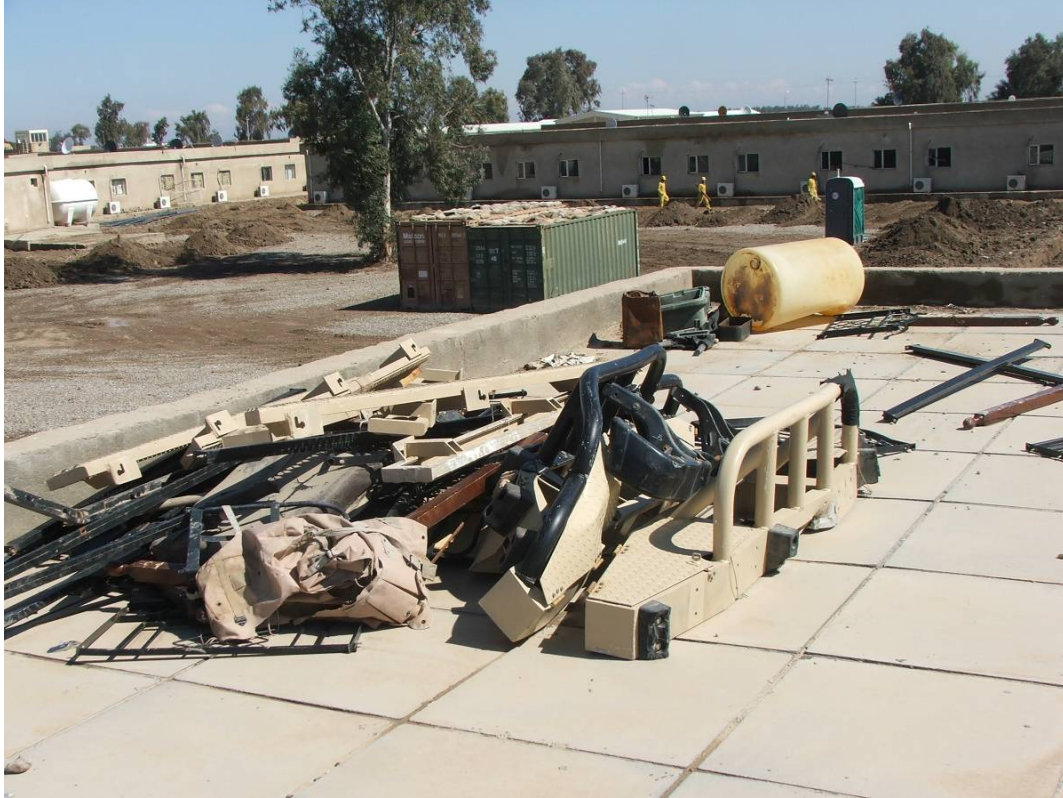
SIGIR inspectors noted that although a good roofing system existed, the roofs of the barracks were used for storage of various items. Site Photo 12 shows parts of beds, heavy vehicle bumpers and other items on the roof of a company barracks. Site Photo 13 shows metal cabinets/lockers and bed frames on the roof of a company barracks.

**Site Photo 12. Old vehicle components, bed frames and other items were placed on the barracks' roof.**

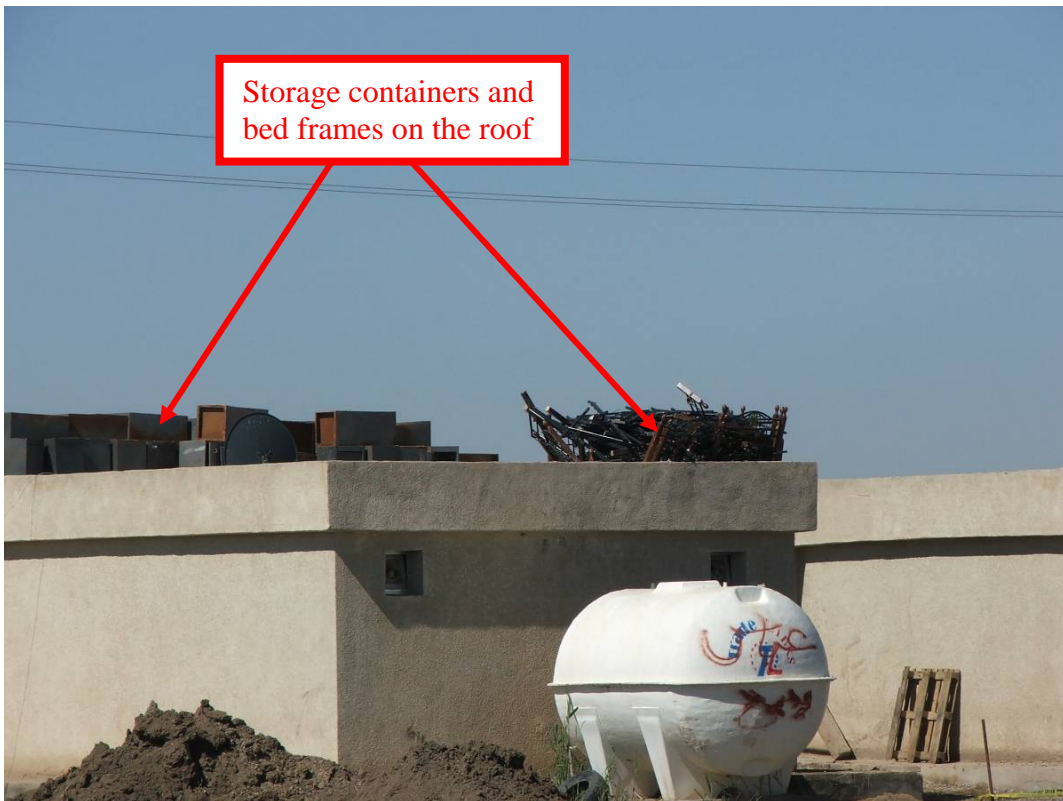
**Site Photo 13. Various items visible on the roof of a company barracks.**

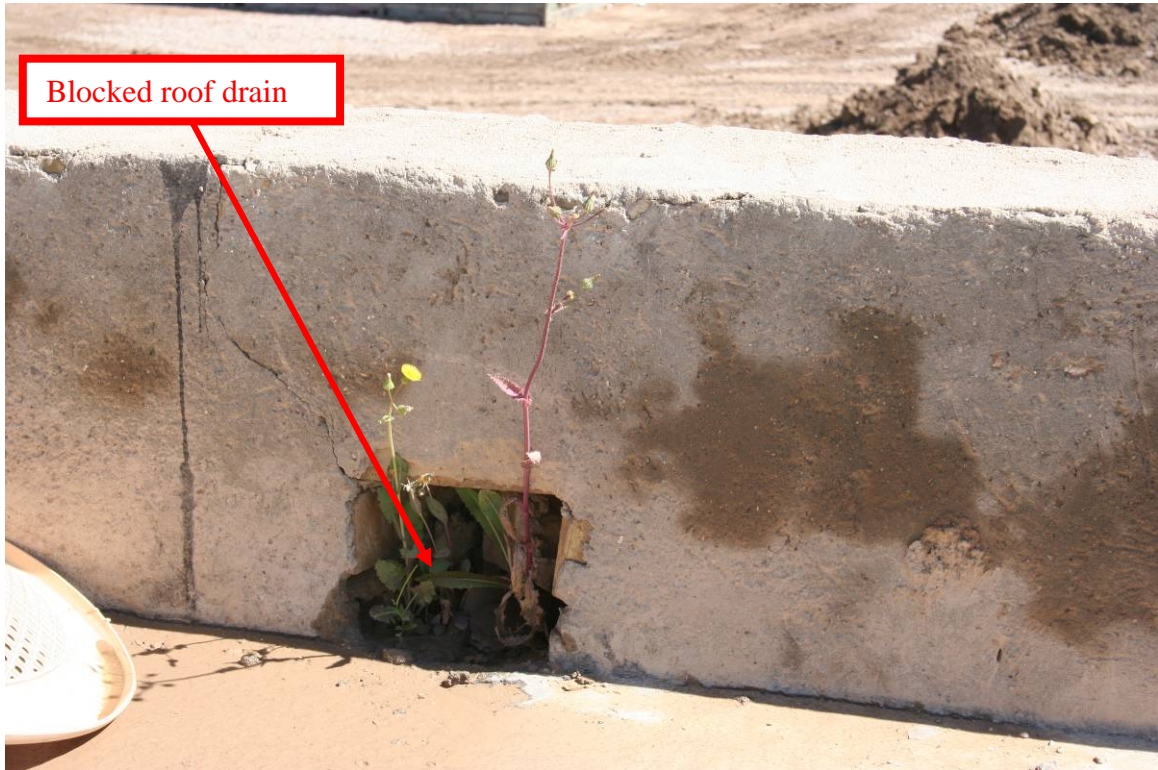
Drains for the roof were found to be blocked by cans, plastic bottles and other debris. Site Photo 14 shows a flowering plant growing from one drain. Site Photo 15 shows another drain area that contained a number of bottles, cans and debris. A number of water stains were noted in this particular barracks. For example, Site Photo 16 shows the ceiling corner of the clinic below the drain seen in Site Photo 15. Water seepage stains were observed, along with what appears to be biological growth.

**Site Photo 14. Plant growth in roof drain blockage.**

The water leaks and stains observed in at least three barracks were likely the result of water migrating through the walls from the roof. This was likely due to the debris on the roofs that blocked drains and plugged downspouts, which allowed standing water to seep into the walls. To eliminate water damage, it's recommended that all cans, bottles, and debris be removed from the roofs.

Recommendation 3: SIGIR’s recommendation to ensure that drains are clear and debris is removed is valid. The Iraqi military leadership must play a role in preventing abuse of infrastructure, to include proper disposal of waste in order to ensure proper hygiene as well as to prevent damage. The use of the roof as a waste disposal area is completely unacceptable and must be addressed and enforced by the Iraqi base leadership. Multi National Security Transition Command – Iraq advisors will inform Iraqi leaders of this issue so they can work the resolution, to include repairs.

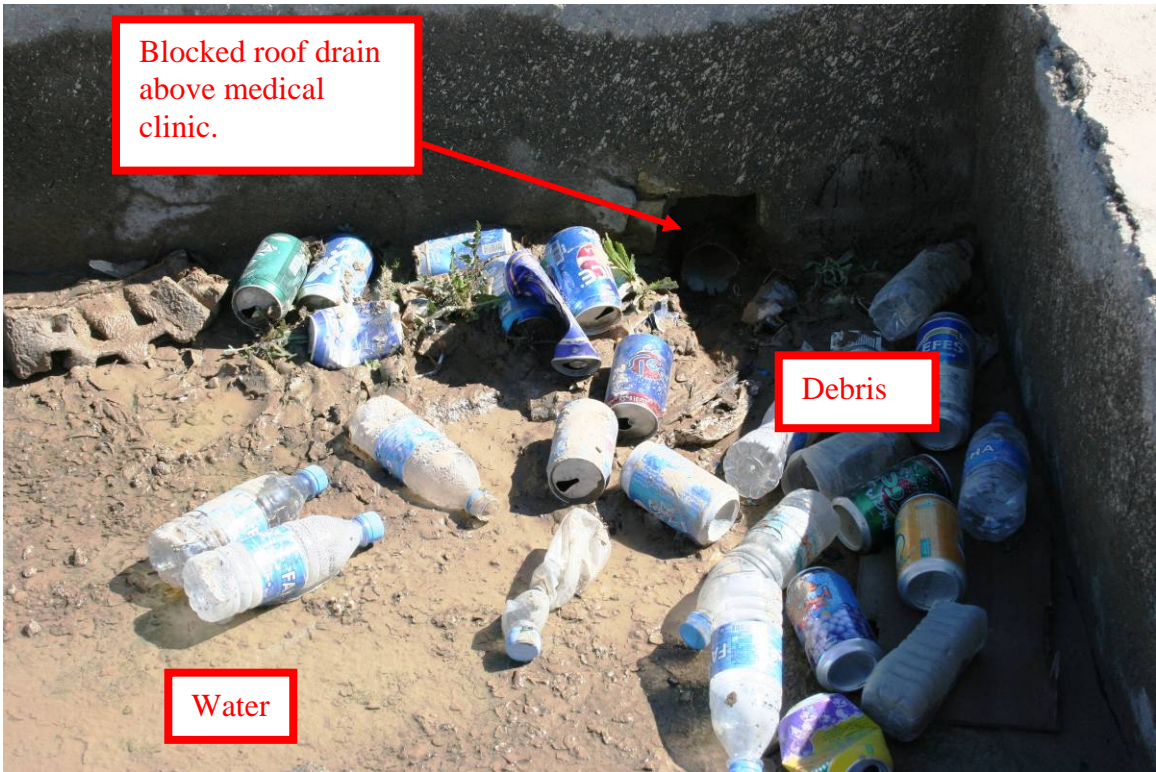
**Site Photo 15. Roof drain blocked above clinic.**

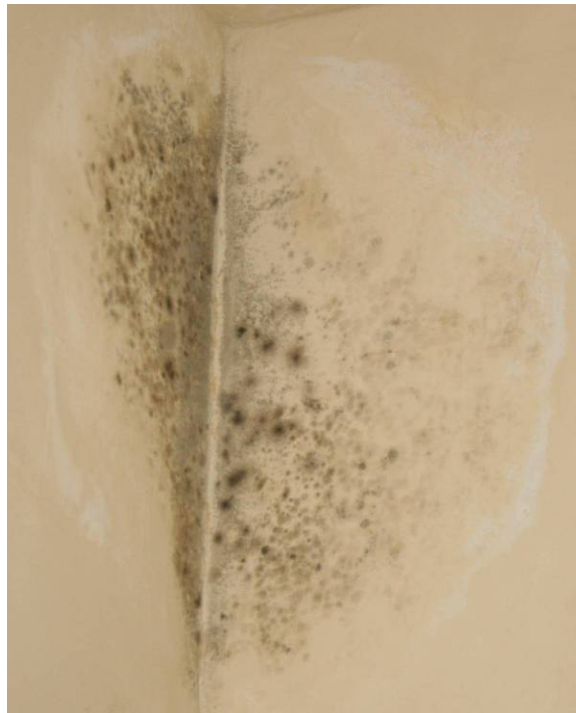
**Site Photo 16. Water stain and biological growth in a barracks clinic.**

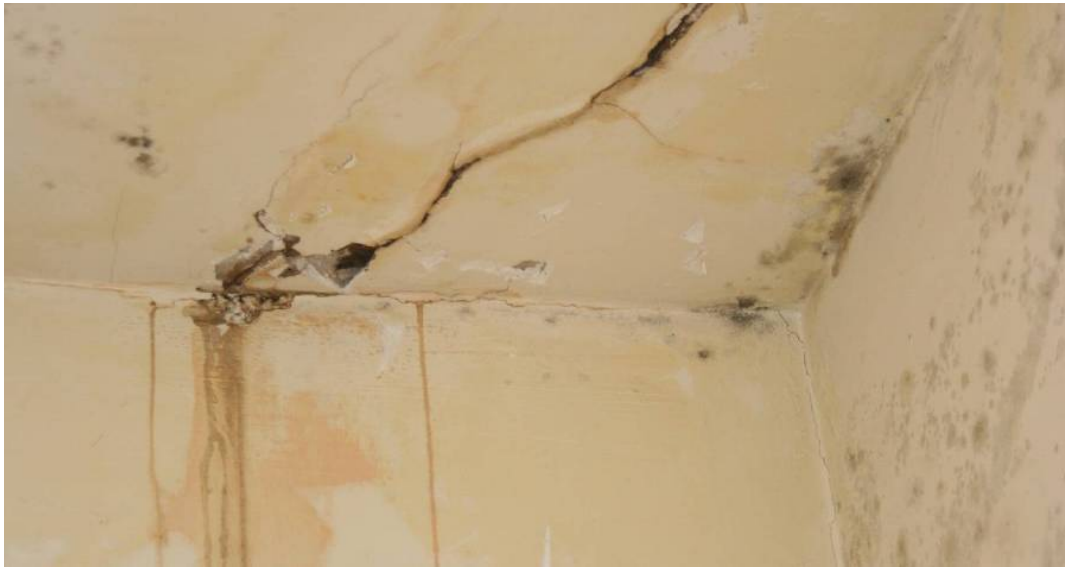
Another example of the water problem within the barracks is shown in Site Photo 17.

**Site Photo 17. Evidence of water problem inside the senior barracks.**
