DOURA POWER STATION
UNITS 5 AND 6
BAGHDAD, IRAQ

SUSTAINMENT ASSESSMENT

SIGIR PA-07-103
JULY 18, 2007

SUBJECT: Report on Sustainment Assessment of Doura Power Station Units 5 and 6,
Baghdad, Iraq (Report Number SIGIR PA-07-103)

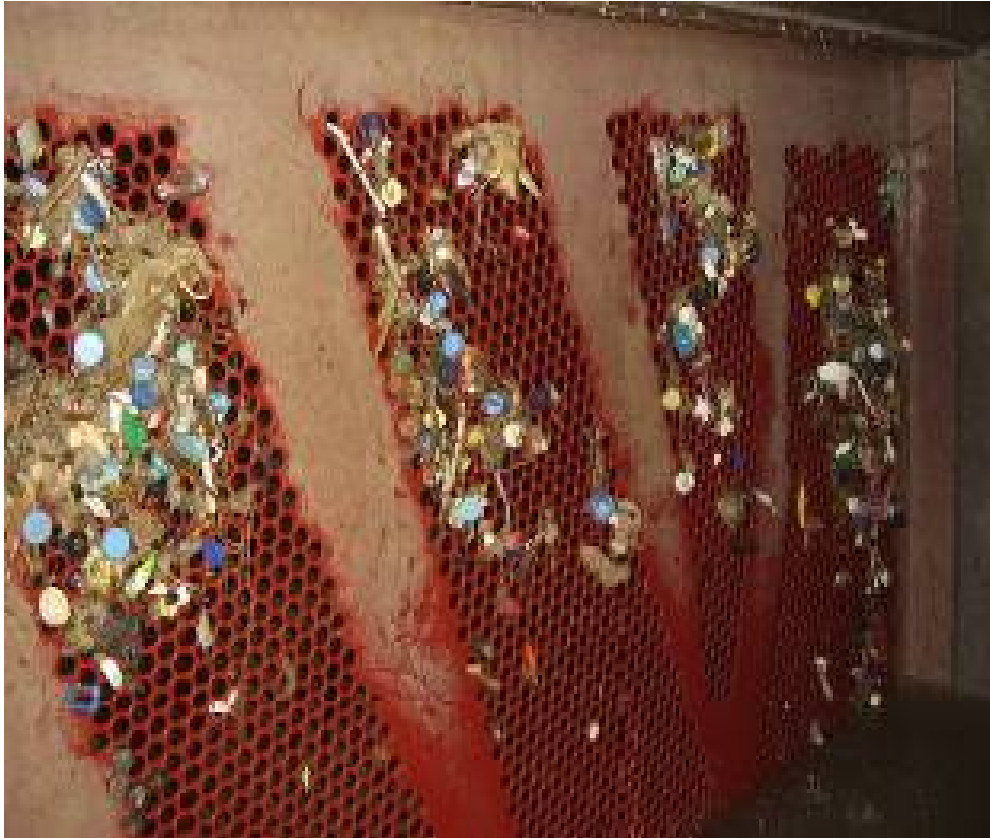
The lack of required maintenance on river water intake screens is an example of the negative effect of not having implemented a proper or formal maintenance program at the Doura Power Plant. Routine non-technical cleaning of the screens was not scheduled. These cleanings are needed to avoid high torque situations on the main water pump. Instead, the maintainers removed the screens designed to collect debris at the water source. As a result, the pump pushed unscreened debris through, resulting in the cooler equipment tubing being plugged, damaged, and rendered substantially less efficient (Site Photos 1 and 2). When a cooling system is not 100% efficient, chances of heat related follow-on damage to equipment or mechanical system components is greatly increased.

Site Photo 1. Condenser clogged with debris (Photo courtesy of GRD Electricity Sector)

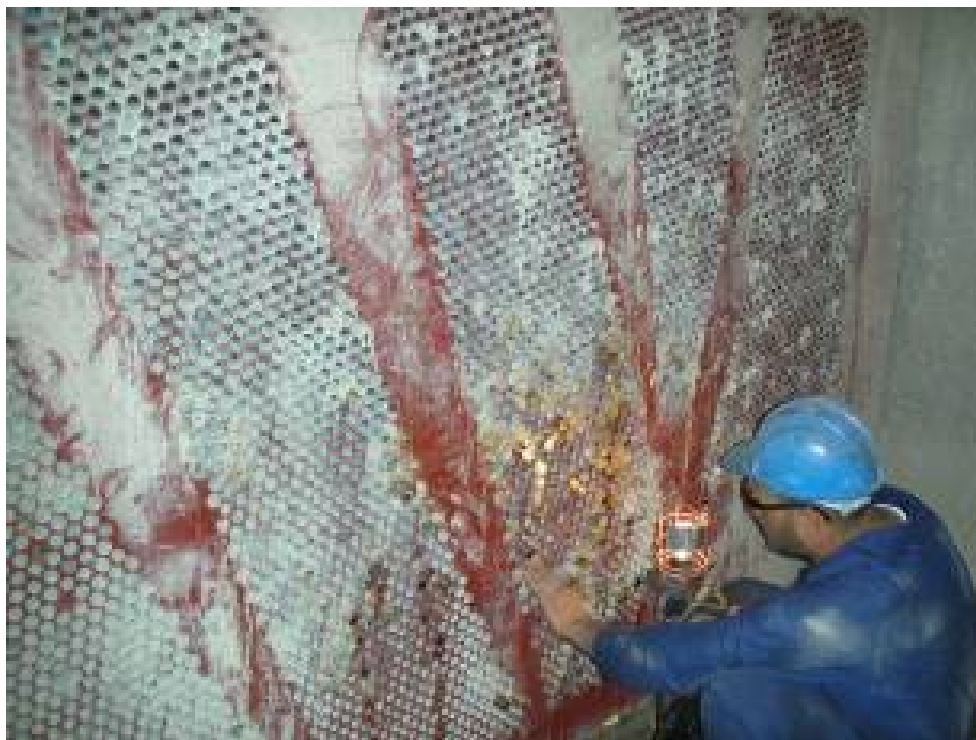
Site Photo 2. Condenser cleaning and repair. (Photo courtesy of GRD Electricity Sector)

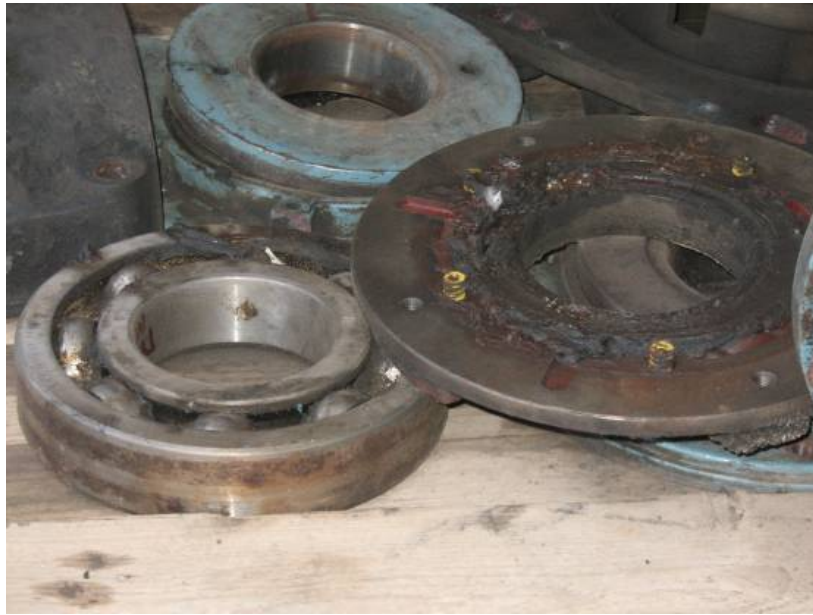
In addition, ineffective general maintenance of the exciter resulted in an oil and dust accumulation in the rotor end windings and rectifier wheel areas. The film of oil, dust, and mud created short circuit paths between the end winding connectors of the exciter. When combined with other operational problems, a short circuit (flashover) occurred and the exciter was rendered inoperable when the rotor windings were damaged. SIGIR observed a large bearing that failed and damaged the shaft on a piece of component equipment because of inadequate lubrication. One of the resident Electricity Sector managers agreed that lubrication is a key component of any effective preventative maintenance program. In this case, the bearing ran nearly dry and generated so much heat that it had to be cut for mechanics to remove the bearing from the rotating shaft (Site Photos 3 and 4).

Site Photo 3. Inadequate lubrication caused bearings to fail. (10 June 2007)

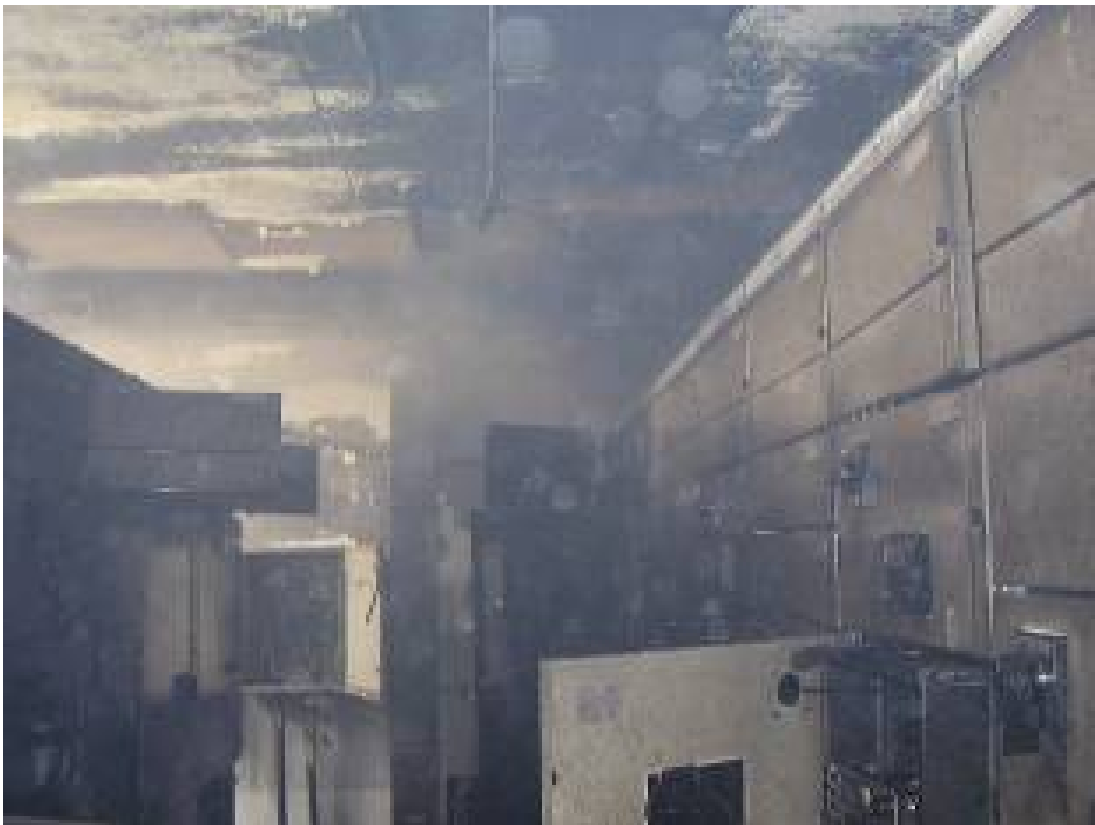
plant to the community surrounding the power station. While on site, SIGIR observed the control center for Unit 5 and 6 main oil pumps after it was ruined by a devastating fire on 31 May 2007 (Site Photo 5).

An ad-hoc cable tap caused the fire, which rendered the control center inoperable. As a result, approximately 100 village houses that previously obtained power directly from the ad-hoc cable tap or circuit have been and will be without power until the control center is rebuilt and Unit 5 is re-started and operational. Although discussed with the MOE, GRD Electricity Sector managers stated that they were not certain whether the MOE would authorize disconnecting the ad-hoc cable taps throughout the plant. In the meantime, to prepare for restarting Unit 5, inspectors observed that contractor personnel have been and were attempting to minimally repair the control center (Site Photo 6).

Site Photo 5. Oil Station control center after May 2007 fire. (Photo courtesy of Electricity Sector)

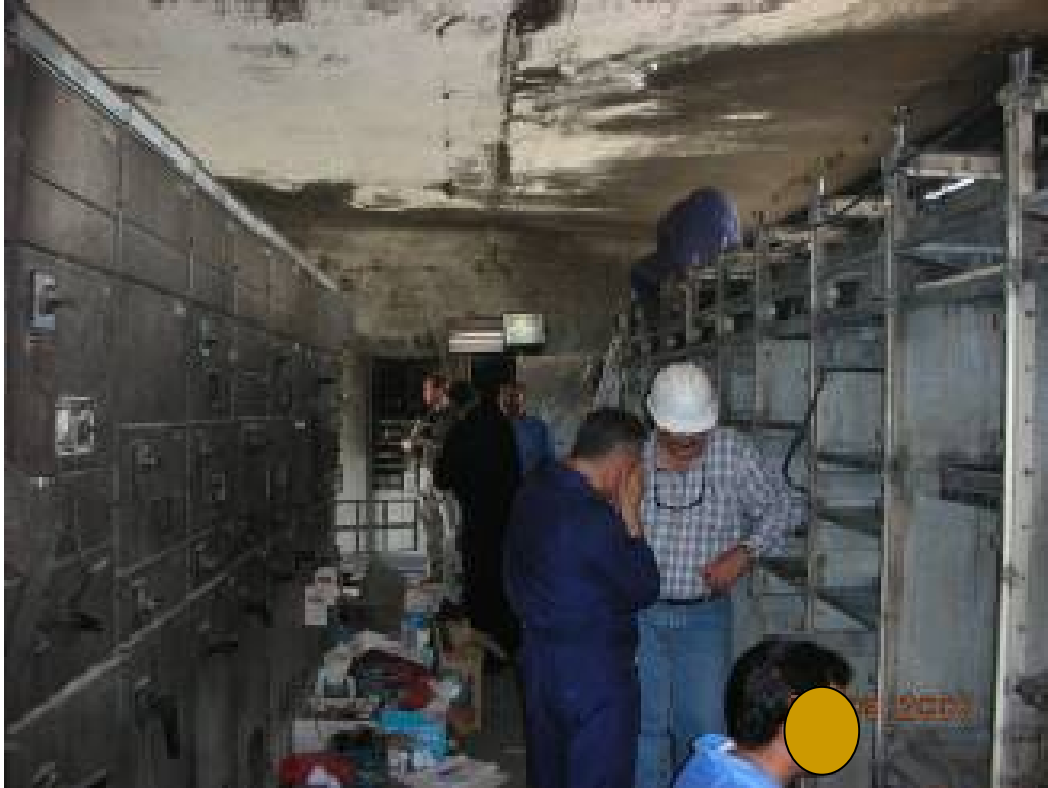
Site Photo 6. Control center cleanup and repair work in progress.
(Photo courtesy of Electricity Sector)

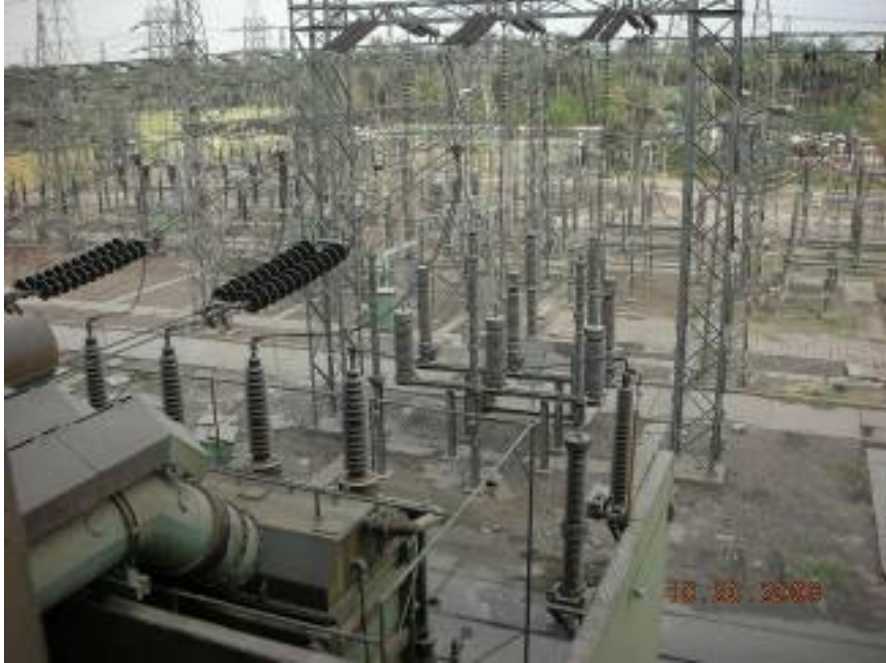
Switchyard. While operational at the time of our site visit, the switchyard should be overhauled. GRD Electricity Sector managers explained that, in the past, several insulators have been damaged from bullets and shrapnel and that most of the insulators need to be cleaned. The breaker control and protection circuits need to be tested (Site Photo 7). Resident GRD Electricity Sector managers, while working on the Unit 5 and 6 section of the switchyard, observed that several protections and controls have been bypassed and some high voltage breakers would not work remotely or were leaking SF6 insulating gas. Additionally, GRD Electricity Sector managers were not aware of any switchyard control or standard operating procedures (SOP) utilized by the MOE. Nonetheless, the MOE has total control of the switchyard and only allows contractor personnel to work on the Unit 5 and Unit 6 section(s) of the switchyard. Based on discussions with the resident GRD Electricity Sector manager, the switchyard lineup should be changed to ensure that power is distributed evenly from Units 3 through 6 to each outgoing line to avoid overloading any particular line section in the switchyard. At the time of our site visit, the resident GRD Electricity Sector manager stated that such a recommendation would be made in a timely manner before restarting Units 5 and 6.

**Site Photo 7. Unit 5 transformer and 132 kV switchyard is in questionable condition.
(Photo courtesy of Electricity Sector)**
