MAHALLA 824 SEWER COLLAPSE PROJECT
UNDER THE COMMANDER'S EMERGENCY RESPONSE PROGRAM
BAGHDAD, IRAQ

SIGIR PA-07-112
JANUARY 16, 2008

SUBJECT: Report on the Rehabilitation of the Mahalla 824 Sewer Collapse Project in
the Doura governorate of Baghdad, Iraq (Report Number SIGIR PA-07-112)

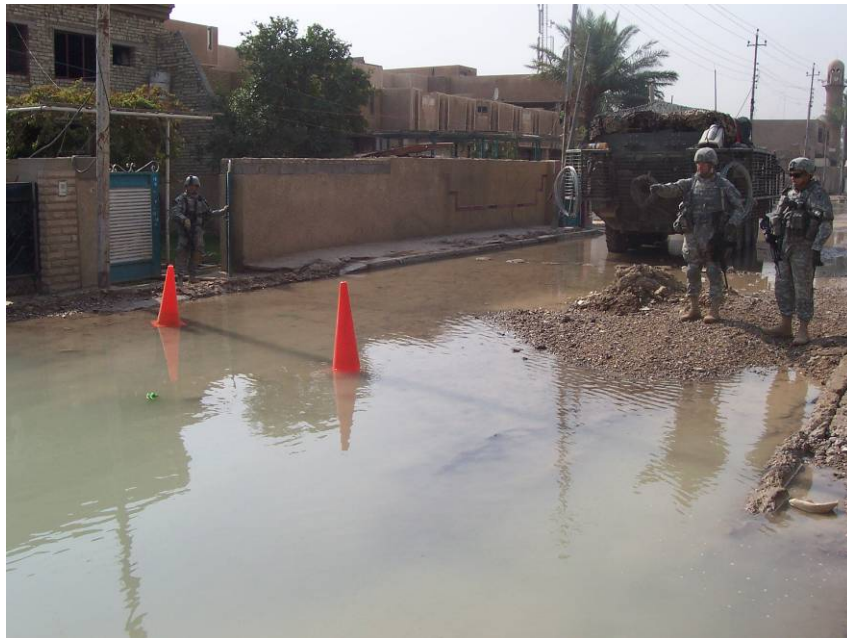
Site Photo 1. Sewage pond (Photo courtesy of USACE)

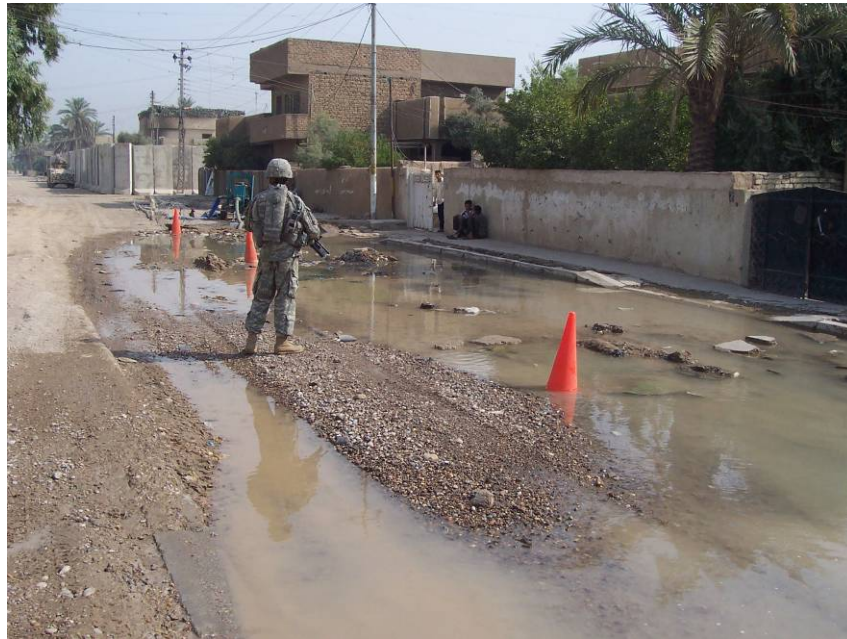
Site Photo 2. Sewage pond (Photo courtesy of USACE)

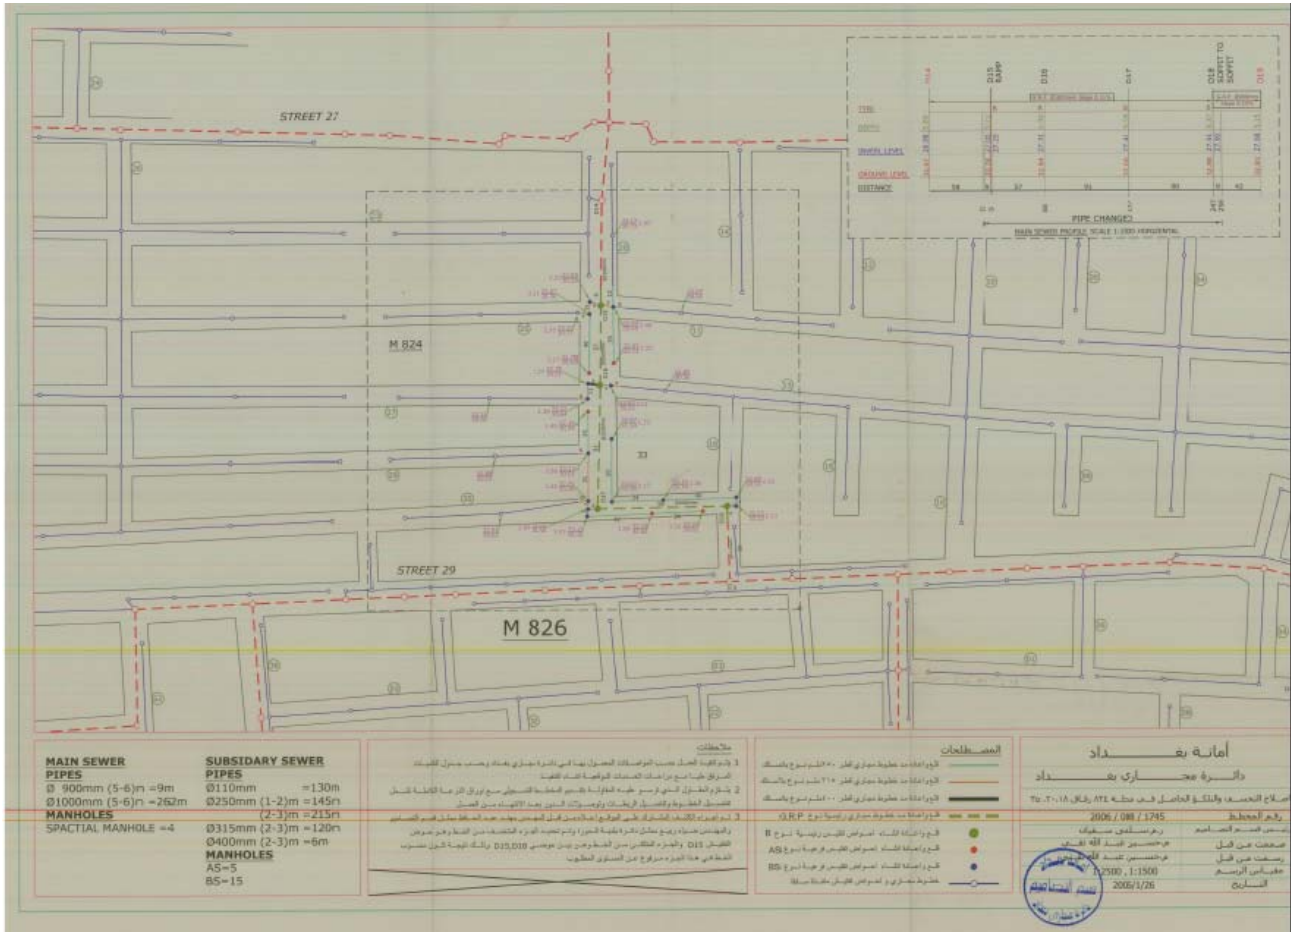
Figure 2: Mahalla 824 Sewer network and profile (Courtesy of USACE)

The contract did not require the contractor to provide a design. The existing design drawing (Figure 2) provided typical details for the main and subsidiary sewer pipes.

The contract did not require the contractor to provide a design. The existing design drawing provided typical details for the main and subsidiary sewer pipes. The contract required the contractor to replace the failed/collapsed and old, existing pipes. The new pipes were to match the existing diameter and slope of the current pipes and manholes. Therefore, the design drawing was adequate.

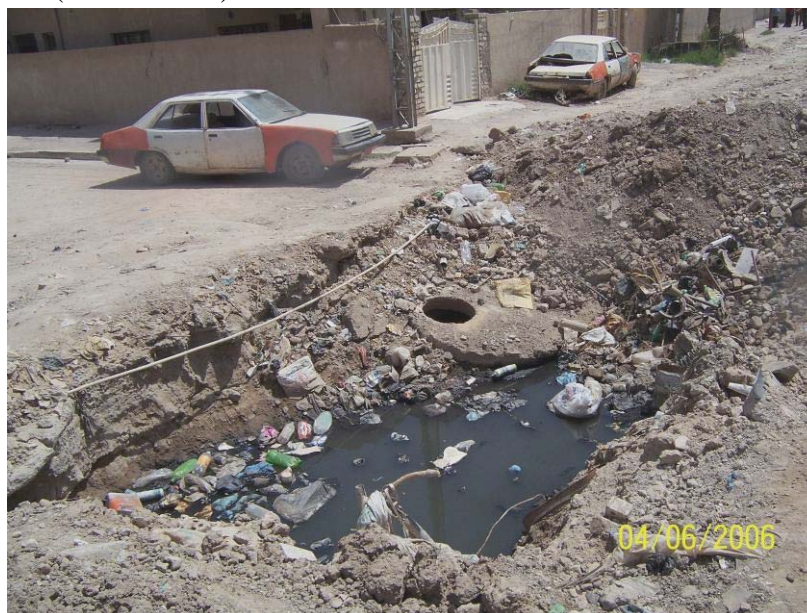
According to the USACE, the contractor had removed the existing pavement in the areas to be trenched and removed and replaced the contaminated soil from the sewage spill below the pipe grade. Then the contractor placed bedding material in the trench, installed the new sewer line, and backfilled the trench. In addition, the four existing manholes were removed (Site Photo 3), and four new manholes were constructed (Site Photo 4).

Site Photo 3. Collapsed existing manhole (Photo courtesy of USACE)

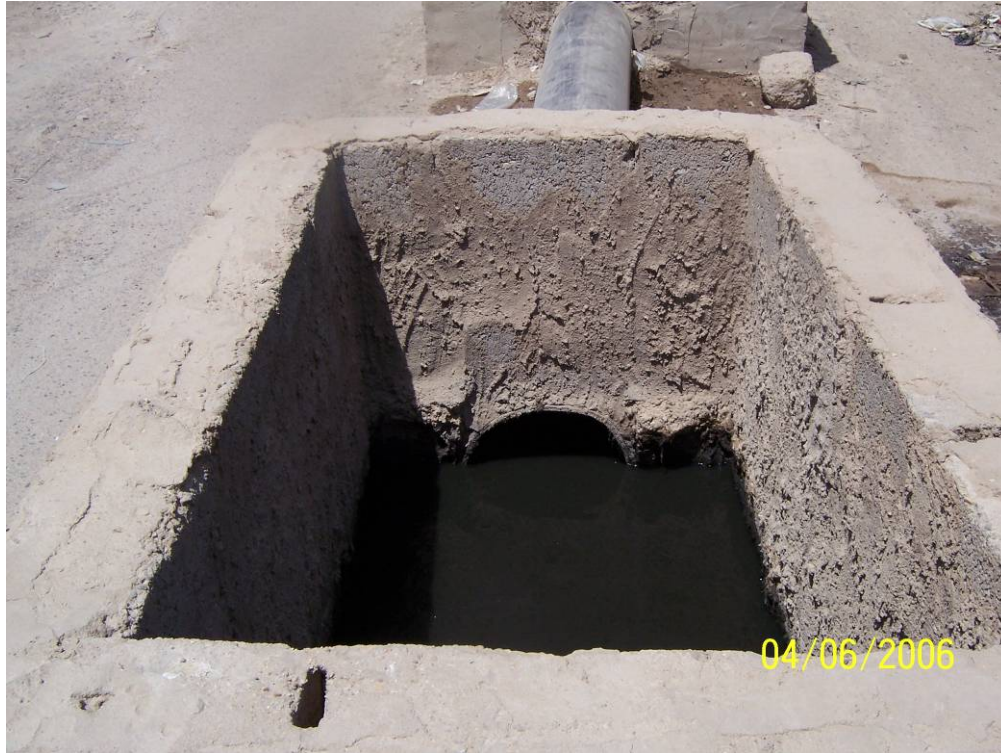
Site Photo 4. Constructed new manhole (Photo courtesy of USACE)

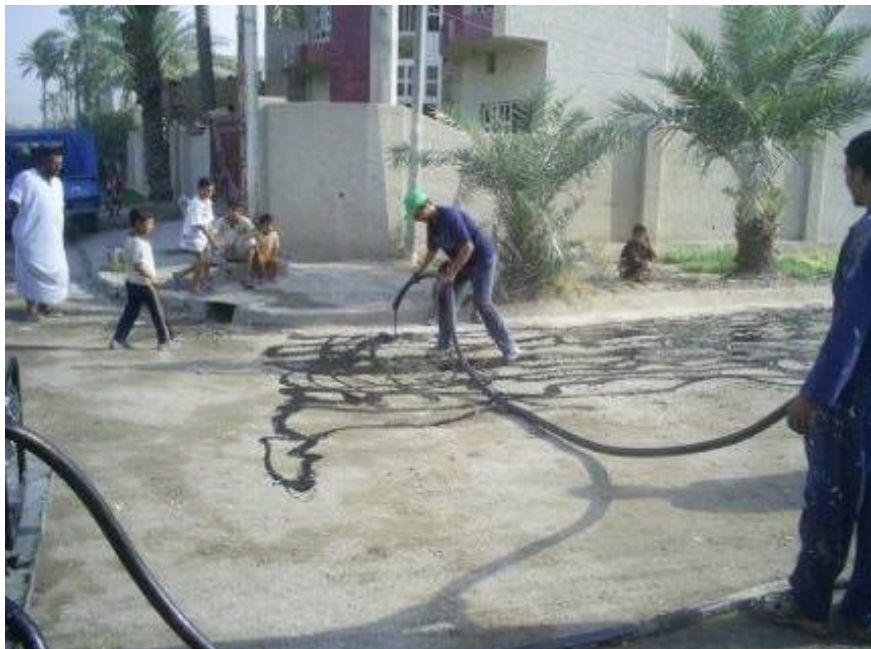
At the time of the assessment, the USACE stated that the contractor was completing the road. The contractor had filled in the trench, compacted the base material, and was in the pre-stages of paving the road (Site Photos 5 and 6).

Site Photo 5. Preparing base for asphalt concrete pavement (Photo courtesy of USACE)

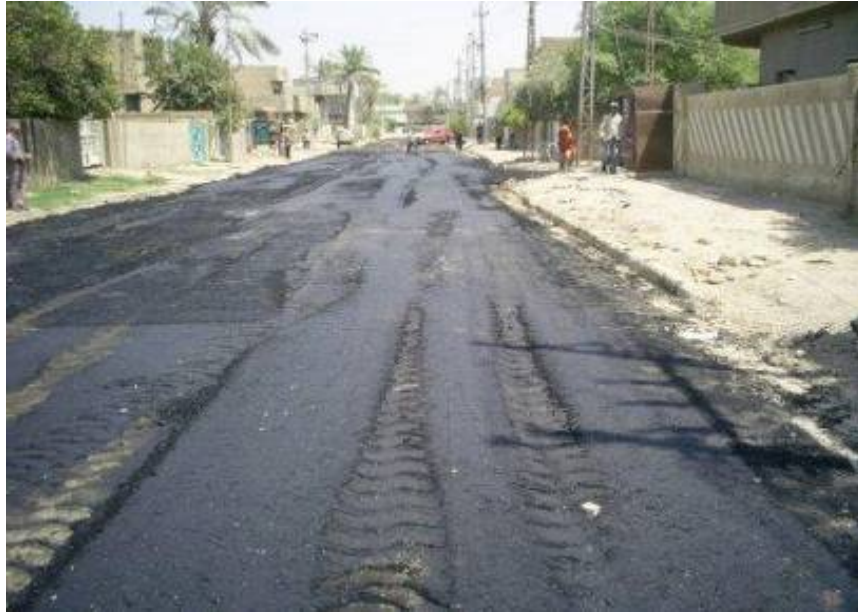
Site Photo 6. Preparing base for asphalt concrete pavement (Photo courtesy of USACE)
