REFURBISHMENT OF THE  
KURDISTAN REGIONAL GOVERNMENT  
MINISTRY OF INTERIOR COMPLEX  
UNDER THE COMMANDER'S EMERGENCY RESPONSE PROGRAM  
ERBIL, IRAQ

**SIGIR PA-08-119**  
**APRIL 17, 2008**

SUBJECT: Report on Project Assessment of the Refurbishment of the Kurdistan  
Regional Government's Ministry of Interior Complex, Erbil, Iraq  
(Report Number SIGIR PA-08-119)

## Refurbishment of the Kurdistan Regional Government Ministry of Interior Complex Erbil, Iraq

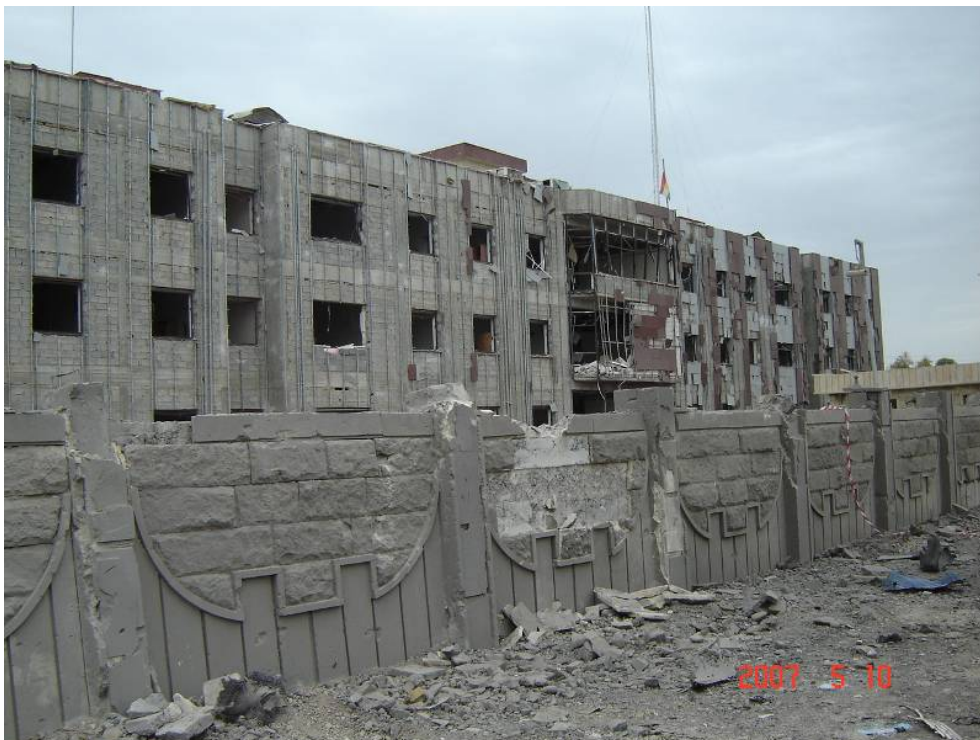
**Site Photo 1. Damage to the north side of the services building & perimeter wall.  
(Photo courtesy of USACE)**

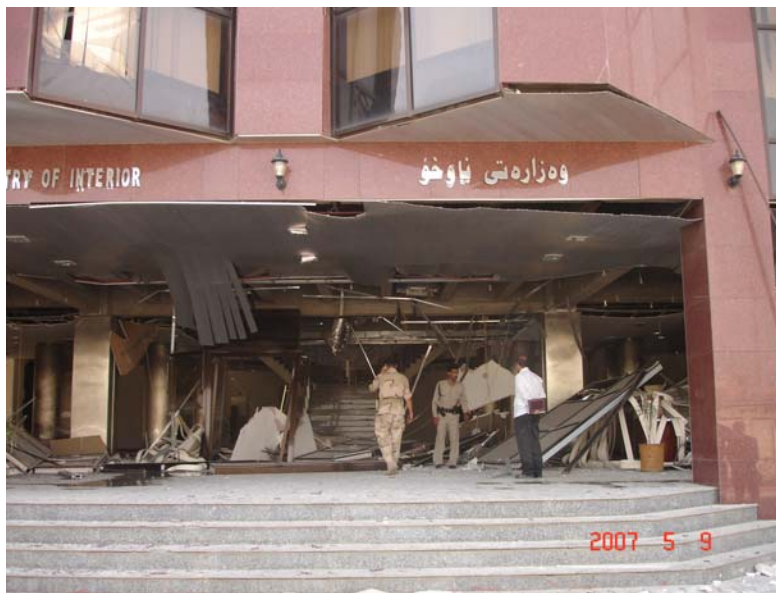
**Site Photo 3: Entryway to MOI building (Photo courtesy of KRG)**

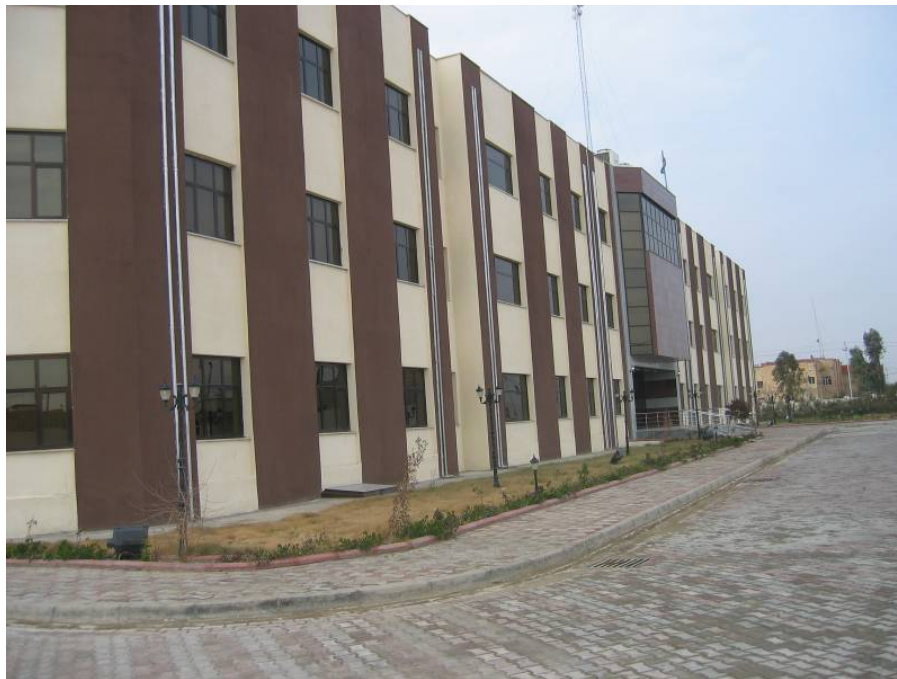
**Site Photo 5: Refurbished services building**

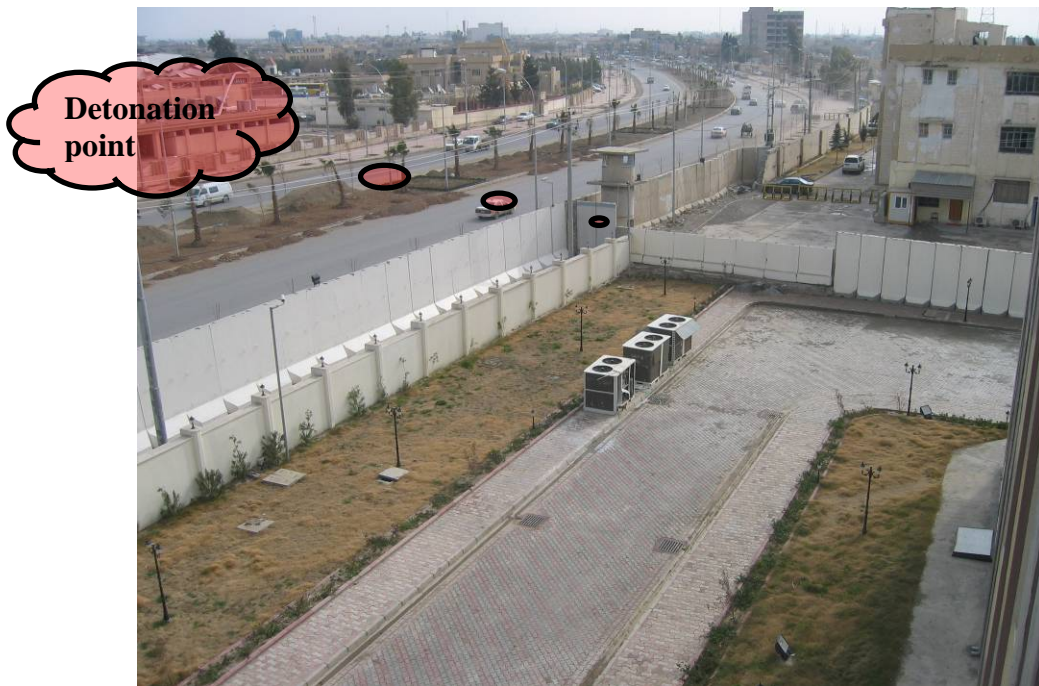
**Site Photo 7: Repaired wall, installed T-walls and reconstructed guard shack.  
Photo taken from the roof of the services building.**

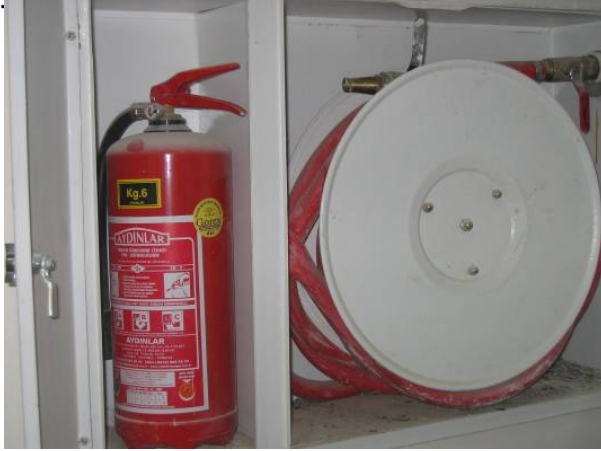
We observed fire alarm sensors and fire fighting equipment and found them to be in good condition. We also tested the alarm system in the services building by holding a burning piece of cardboard to a sensor. The first test did not work and they discovered the system

**Site Photo 19. Fire extinguisher and fire hose**

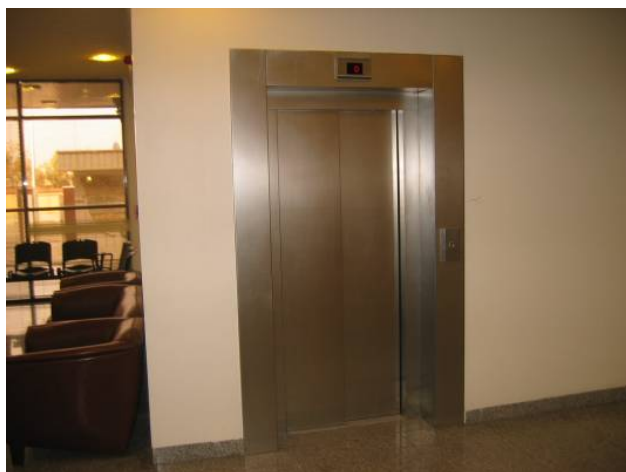
We rode one elevator in the MOI building to the third floor. The ride was smooth and the elevator started and stopped, level with the floor, without jerking. Site Photo 24 shows the elevator condition at the time of our site visit.

**Site Photo 24. Elevator in MOI building**

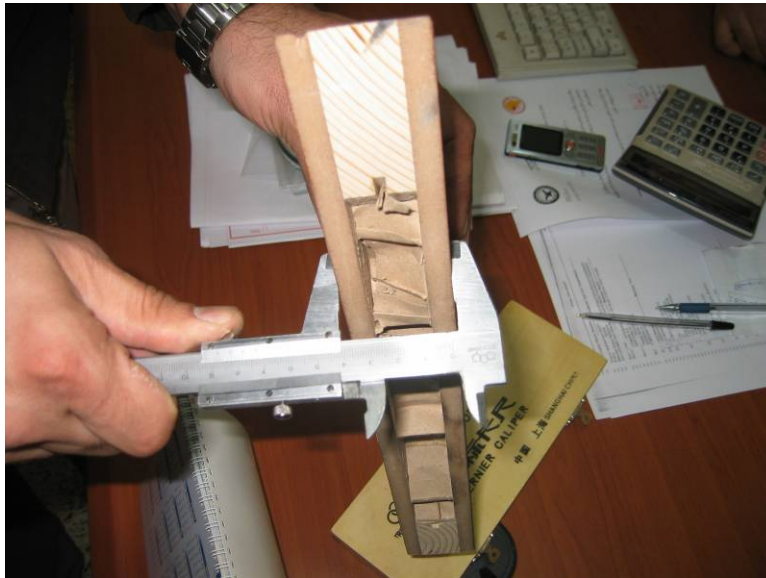
We observed and photographed a crosscut section of a new door (Site Photo 34) and tested a sample of doors which operated properly.

**Site Photo 34. Cross section of an upgraded interior wooden door**
