**33-KILOVOLT POWER LINE
NASSRIYA, IRAQ**

**SIGIR PA-08-127
JULY 22, 2008**

SUBJECT: Report on Construction of the 33-Kilovolt Power Line, Nassriya, Iraq (Report
Number SIGIR PA-08-127)

33-Kilovolt Power Line, Nassriya, Iraq

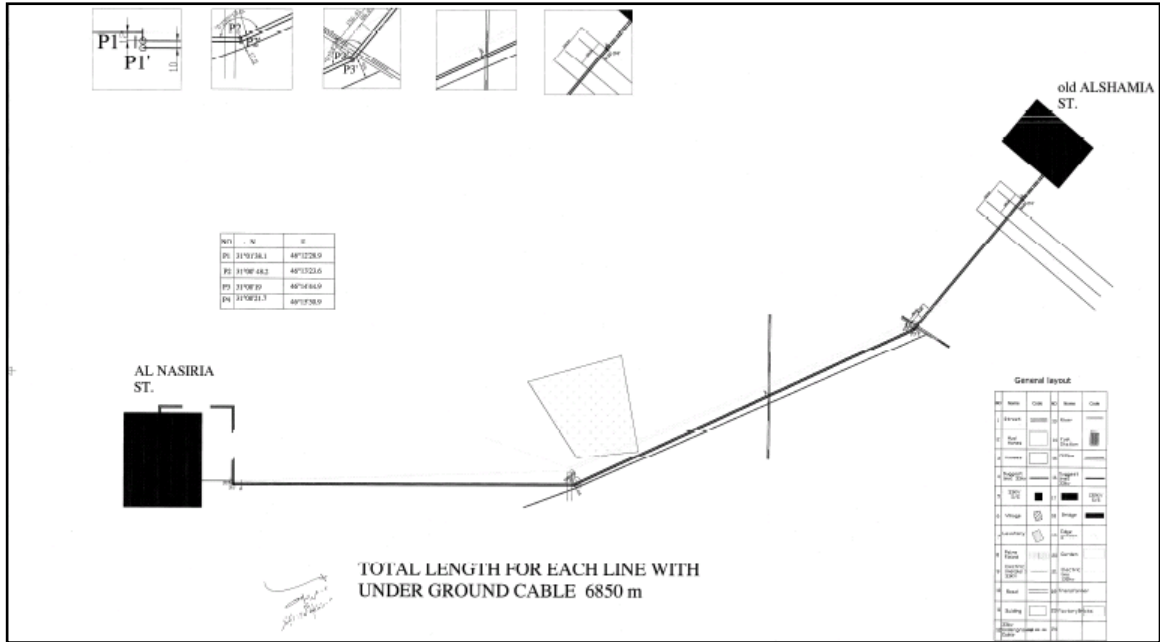
Figure 2. 33-kV power line drawing (Courtesy of the USACE)

The USACE provided SIGIR with the contractor’s 33-kV power line one page “route” drawing and one profile sheet. The design documents consisted of the route drawing (Figure 2), which provided the total length for each line with underground cable and a profile sheet that determined the height and length between structures. The contractor’s design documents did not provide complete engineering drawings, including construction, civil, mechanical, and electrical, or single line diagrams.

After reviewing the design drawings and specifications supplied, SIGIR determined the design package available was not complete; it lacked sufficient details and did not meet the contract requirements. Specifically, the design documents did not provide any preliminary alignment plans with topographic survey, soil reports, right-of-way plans, construction drawings (which typically includes plan and profile sheets, detail sheets, quantity sheets, and environmental protection plan sheets), structural calculations, foundation calculations, technical specifications, catalog cuts of equipment specified, general design notes with assumptions made, or standard drawings referenced.

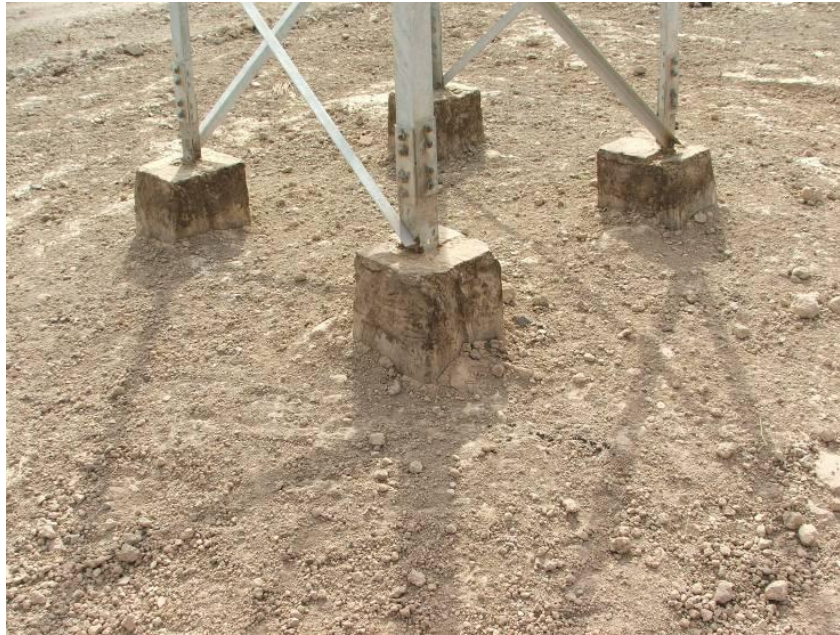
Prior to erecting the completed tower, the contractor performed the required excavation, then formed and poured the concrete foundation for the tower (Site Photo 1). The structural concrete SIGIR observed did not have any noticeable cracking, segregation, or honeycombing areas.

Site Photo 1. Completed tower foundation

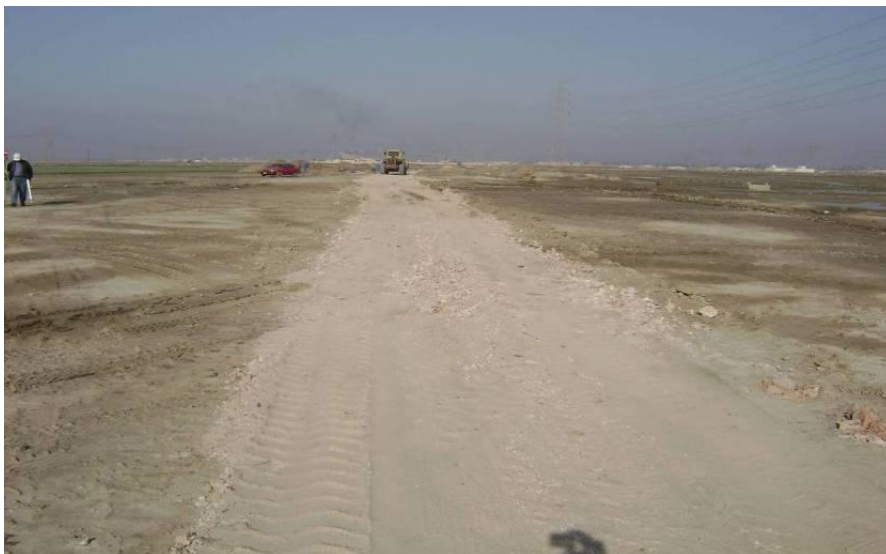
Site Photo 2. Construction of service road (Courtesy of the USACE))

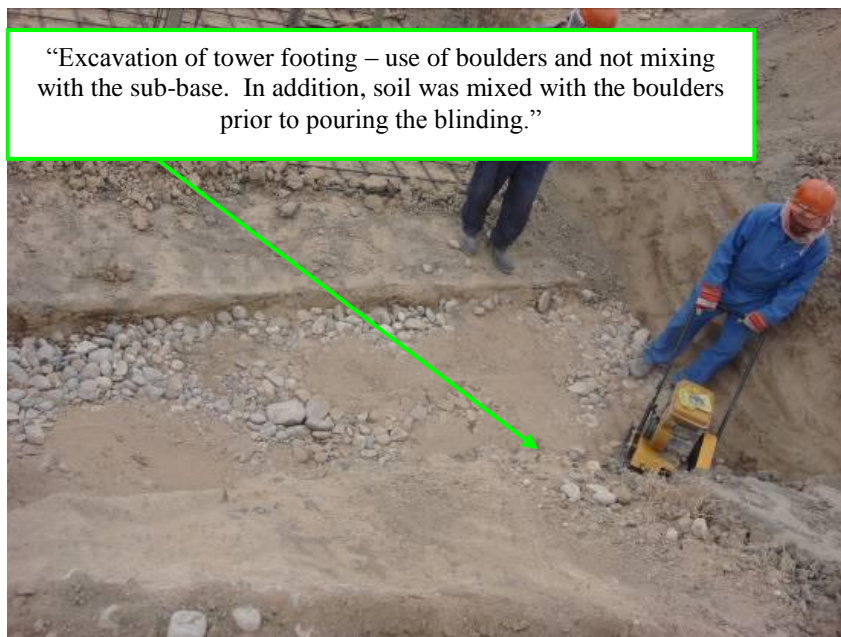
The USACE GRS trained the Iraqi Construction Engineers (ICE), local nationals with engineering backgrounds working for the USACE, and deployed them to the project site to perform QA oversight of the contractor. The ICE were on site during construction events, and monitored field activities and completed daily QA reports, which were forwarded to the USACE GRS project engineer for review. The QA reports documented significant construction activities, such as work performed by building, equipment on site, safety concerns, testing done, and the name and location of the testing facility. In addition, the ICE submits photographs of construction activities taking place throughout the day. Further, the ICE notes any problems/deficiencies identified and the correction actions taken via deficiency logs. Examples of problems noted by the QA representative on site were the “improper excavation and foundation mixing for the tower footing” (Site Photo 11); the potential confusion between the sand that failed the salinity test and the new sand (Site Photo 12); and cube tests (Site Photo 13), which failed the 28-day cure test (Figure 3).

Site Photo 11. Improper excavation and mix for tower footings (Courtesy of the USACE)

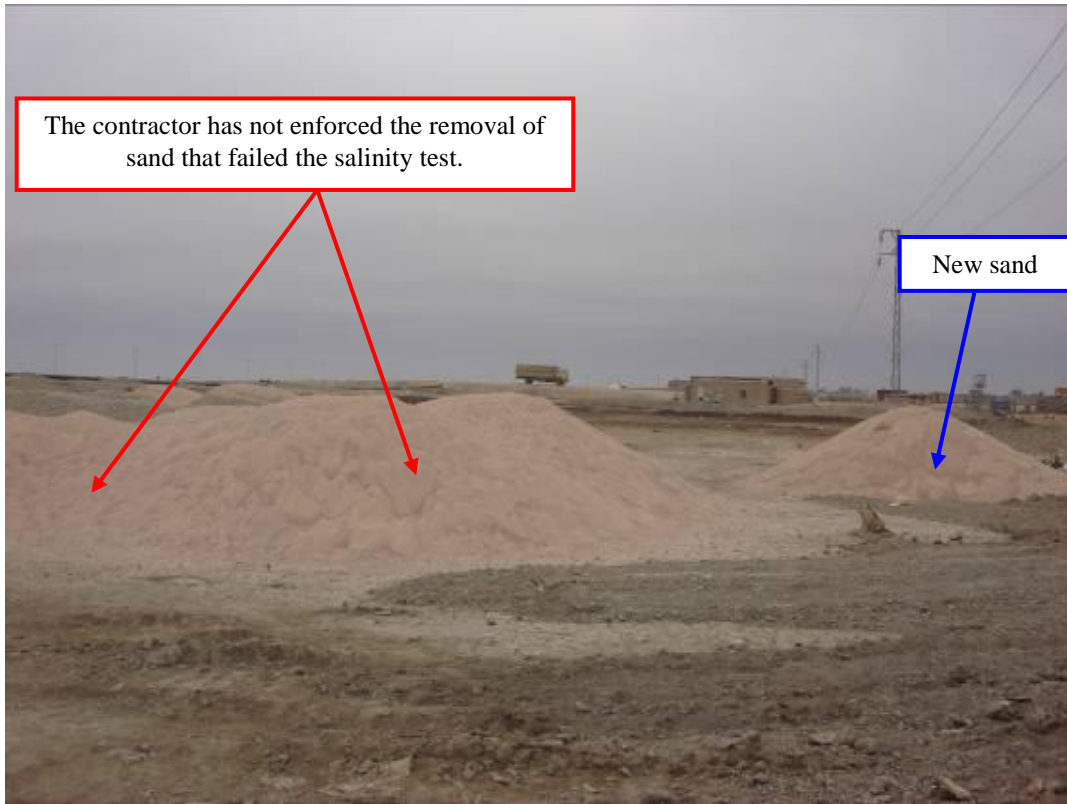
Site Photo 12. Confusion with sand (Courtesy of the USACE)

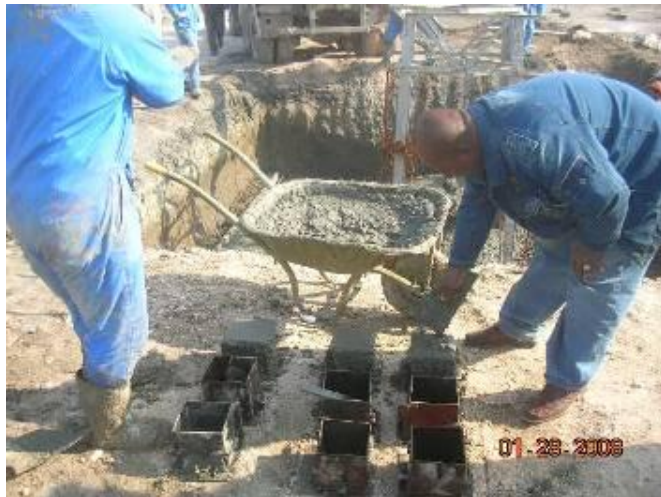
Site Photo 13. Cube test (Courtesy of the USACE)

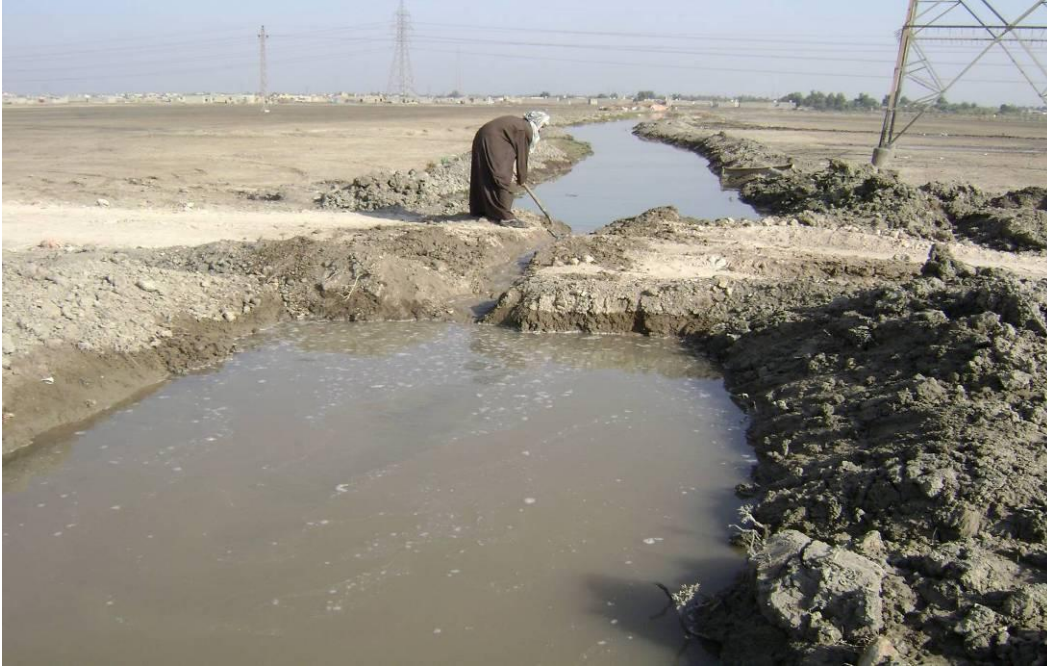
On 2 January 2008, the USACE issued a letter of concern to the contractor regarding the contractor’s failure to install pipe culvert under the service road at points where it crossed irrigation channels (Site Photo 14). As a result local farmers were digging trenches across the service roads at the irrigation canal crossings to allow irrigation water to move from one side of the road to the other. The trenches rendered the service roads unusable. In addition, the QA noted that the contractor’s employees were not QC testing the sub-base material for the service road.

Site Photo 14. No pipe culvert on service road (Courtesy of the USACE))
