**HADITHA GENERAL HOSPITAL**  
**UNDER THE ECONOMIC SUPPORT FUND PROGRAM**  
**HADITHA, IRAQ**

**SIGIR PA-08-132**  
**JANUARY 23, 2009**

## Haditha General Hospital Under the Economic Support Fund Program Haditha, Iraq

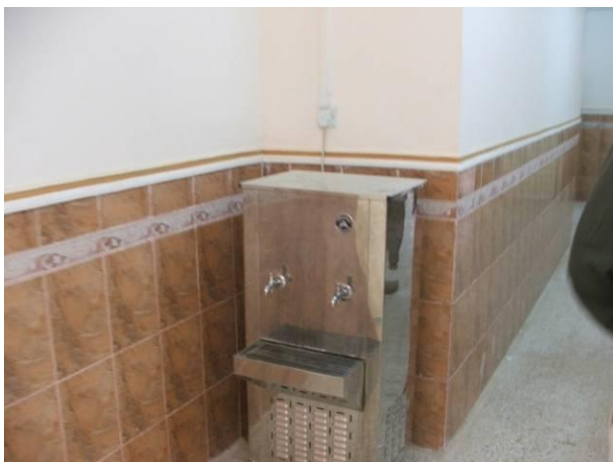
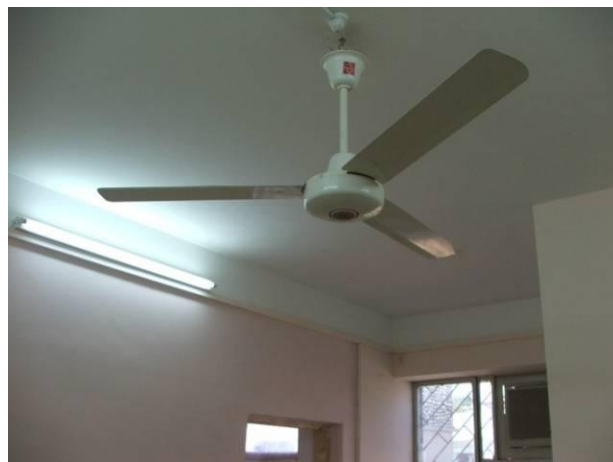
The administrative wing contains the offices for the hospital administration staff. The structure consists of a reinforced concrete frame in-filled with concrete block. In keeping with local practice, all concrete block in the facility is plastered with a cement mortar or gypsum material to create a uniform finish on the exterior and interior of the wall. It appears that most of the renovation work in this area of the hospital has been completed. The walls have been painted and a ceramic tile has been installed in the main corridor to a height of approximately one meter (Site Photo 5). According to the USACE GRC representative, the flooring was in good condition and was not replaced. The renovation of the office included new lighting, ceiling fans, and finishes (Site Photo 6). The contractor representative advised SIGIR that additional renovation was being performed for the administrator’s office under a separate contract with the hospital.

**Photos 5 and 6. Views of the hospital administration building interior**

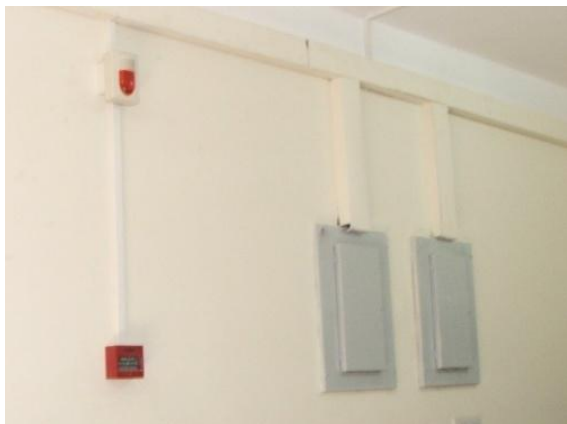
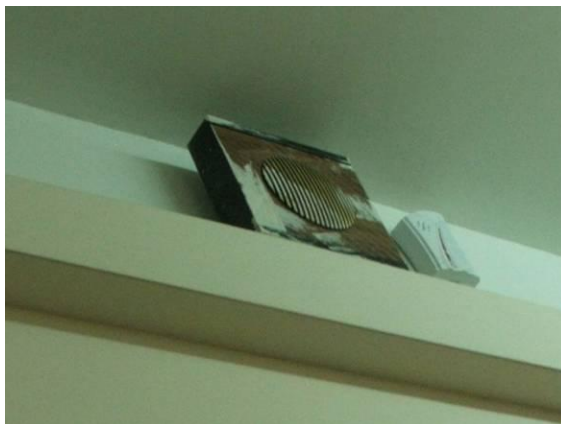
The renovation of the administration wing included an upgrade to the electrical system. SIGIR noted the installation of what appeared to be new wire molding, outlets, light fixtures, and new main distribution panels (MDPs) (Site Photo 7). The MDPs were situated at a reasonable location and were reasonably secure. An intercom system was installed in some areas of the hospital. According to the contractor representative, the system was new; however, due to the careless over-painting of the components, the inspection team could not determine if the equipment was in fact new (Site Photo 8).

**Site Photos 7 and 8. Installation of new wire molding, outlets, light fixtures and new main distribution panels (left) and careless over-painting of intercom system (right).**
