**REHABILITATION OF THE SUROOR
ELEMENTARY SCHOOL
UNDER THE ECONOMIC SUPPORT FUND
HUSSEINIYA, IRAQ**

SUSTAINMENT ASSESSMENT

**SIGIR PA-08-135
APRIL 7, 2009**

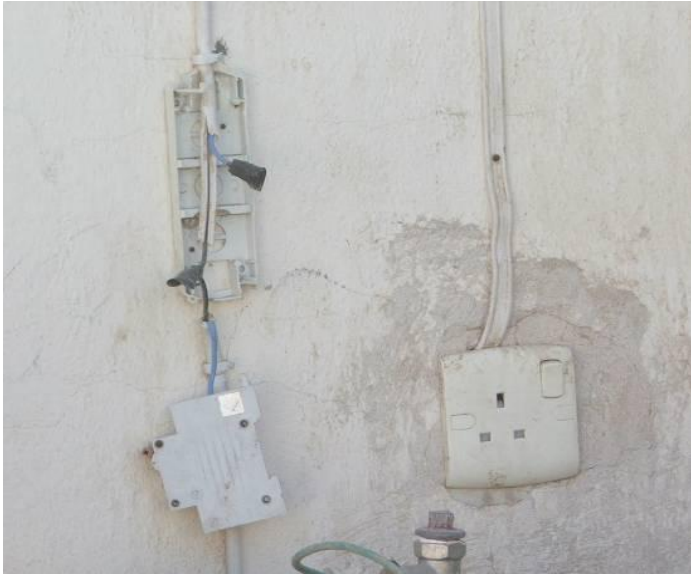
During the site visit, SIGIR identified unsafe electrical wiring and outlets; however, it appeared that someone tampered with the electrical wiring and outlets (Site Photo 7). Also, it did not appear that the contractor corrected existing electrical and plumbing deficiencies addressed under the GOI contract. Further, the wiring and the circuit breaker for the water heater and water pump appeared to be non-functioning, and its electrical wiring was not inside a conduit (Site Photo 8).

Site Photo 7. Unsafe electrical wiring and breaker

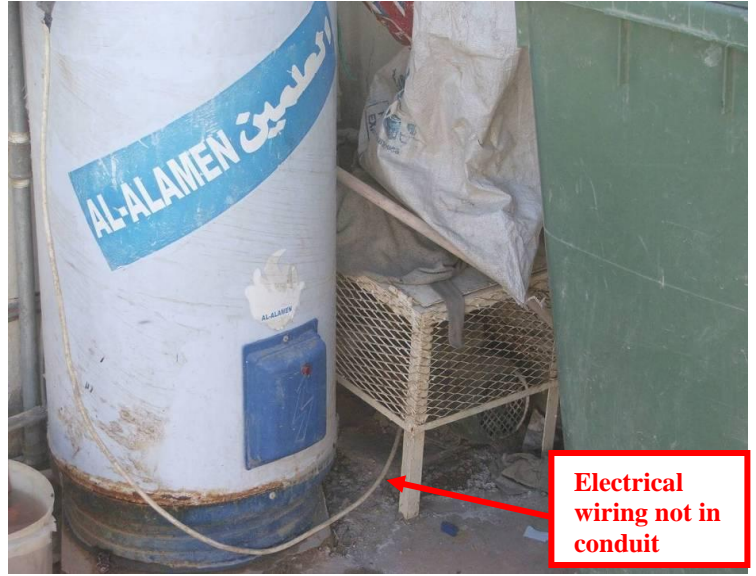
Site Photo 8. Used hot water heater and pump

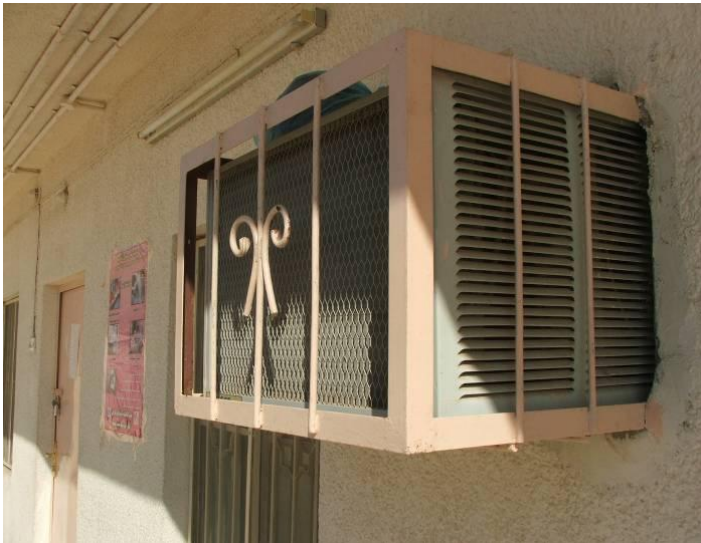
The BOQ required the contractor to provide and install four evaporative coolers, and according to USACE’s final inspection report, all four evaporative coolers were delivered and installed. However, during the site visit, SIGIR only observed one window air conditioning unit (Site Photo 9). After SIGIR briefed GRD that no evaporative coolers were on site, GRD sent representatives to determine the status of the evaporative coolers. GRD subsequently provided SIGIR a photograph of the four evaporative coolers delivered to the Suoor Elementary School (Site Photo 10). In addition, GRD stated that “in October 2008, at the request of a government official, the school principal released three coolers on loan to other schools.” This still leaves one evaporative cooler unit unaccounted for; however, at the time of the site visit, SIGIR was unable to inspect several rooms because they were locked and access to the roof was denied. Therefore, SIGIR cannot definitely state whether or not a single evaporative cooler unit was still at the school.

Site Photo 9. The only window air conditioner observed at the school

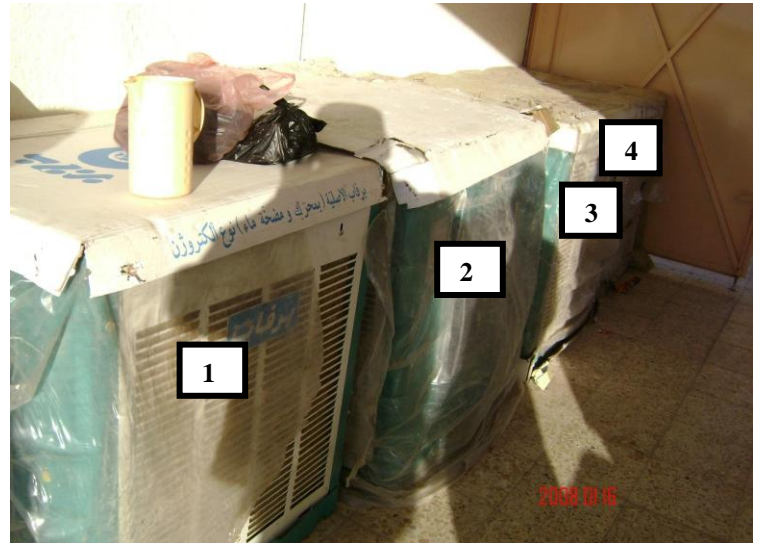
Site Photo 10. Four evaporative cooler units delivered to school (Courtesy of GRC)

1. Draft Report, page ii, first paragraph; page 8, first paragraph; page 10, last paragraph; page 13, third paragraph; and page 14, recommendation 1. These paragraphs refer to the installation of four evaporative coolers. The report states "SIGIR found no evidence that any evaporative coolers were delivered or installed." However the report also states, "According to GRC's final inspection report, all four evaporative coolers were delivered and installed; however, a final inspection photograph documented the existence of only one evaporative cooler (Site Photo 10)."

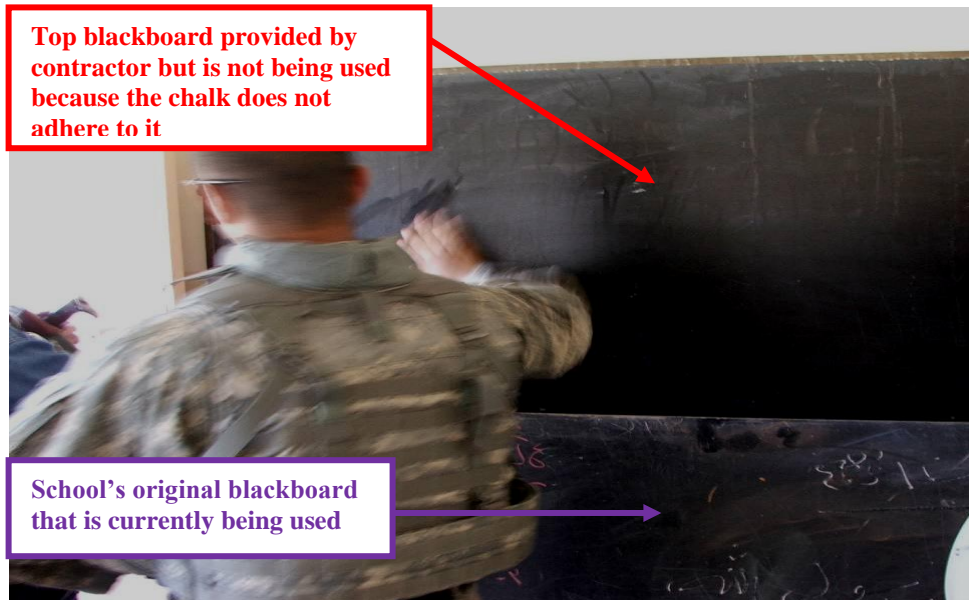
During the site visit, the school's headmaster stated the contractor provided "poor quality" blackboards. Specifically, the blackboards were not properly treated, and as a result, chalk would not adhere well to the blackboards. Consequently, the school's administration decided to use the old blackboards instead (old blackboards were hung over the newly provided blackboards) (Site Photo 11). SIGIR also concluded the newly provided blackboards were of poor quality.

Site Photo 11. New blackboard (top) Original blackboard (bottom)

SIGIR advised GRD about the contractor's poor quality blackboards. A GRC representative subsequently visited the school to inquire about the blackboards. According to GRD, the school recently received 12 new whiteboards. The school maintenance staff plans to "put all blackboards in storage and install the new whiteboards in the classrooms because most Iraqi schools are now using whiteboards." GRD did not provide a photograph of the new whiteboards.

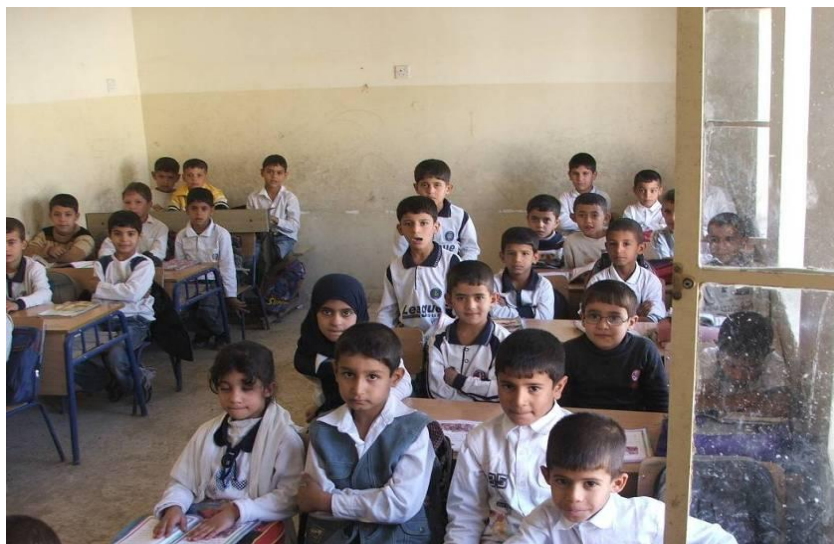
According to the school's headmaster, this school is considerably overcrowded, having to distribute approximately 1,500 students between 10 classrooms over the course of three shifts (which averages to approximately 50 students per classroom). SIGIR observed the second shift and identified the school did not have enough desks, which required some students to sit on the floor during classroom instruction (Site Photo 12). The contract's SOW only required the contractor to provide office desks, chairs, and a sofa for the administration room.

Site Photo 12. Overcrowded classroom and lack of desks

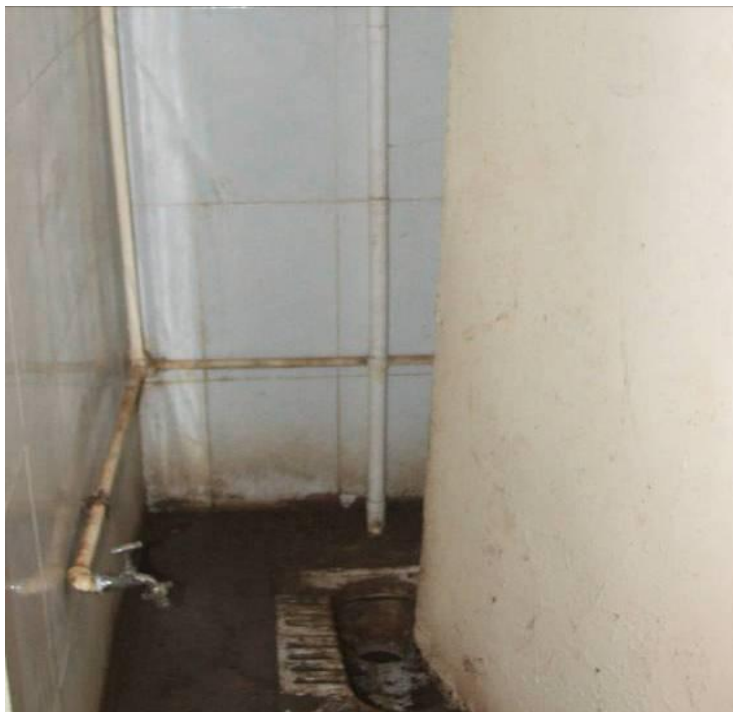
Originally, plumbing work was required by this contract; however, it was deleted once it was determined that a separate GOI funded contractor was to perform the plumbing work. At the time of the site visit, the school's unsanitary conditions presented health and environmental problems to the students and the community. For example, the existing student bathrooms are considerably undersized for a school with a daily capacity of approximately 1500 students (three shifts of approximately 500 students each). In addition, the eastern-style toilets did not have water to flush, which resulted in human waste sitting in the toilets (Site Photo 13). Further, there was no indication that any form of routine maintenance was provided for the bathrooms.

Site Photo 13. Unsanitary condition of school bathrooms

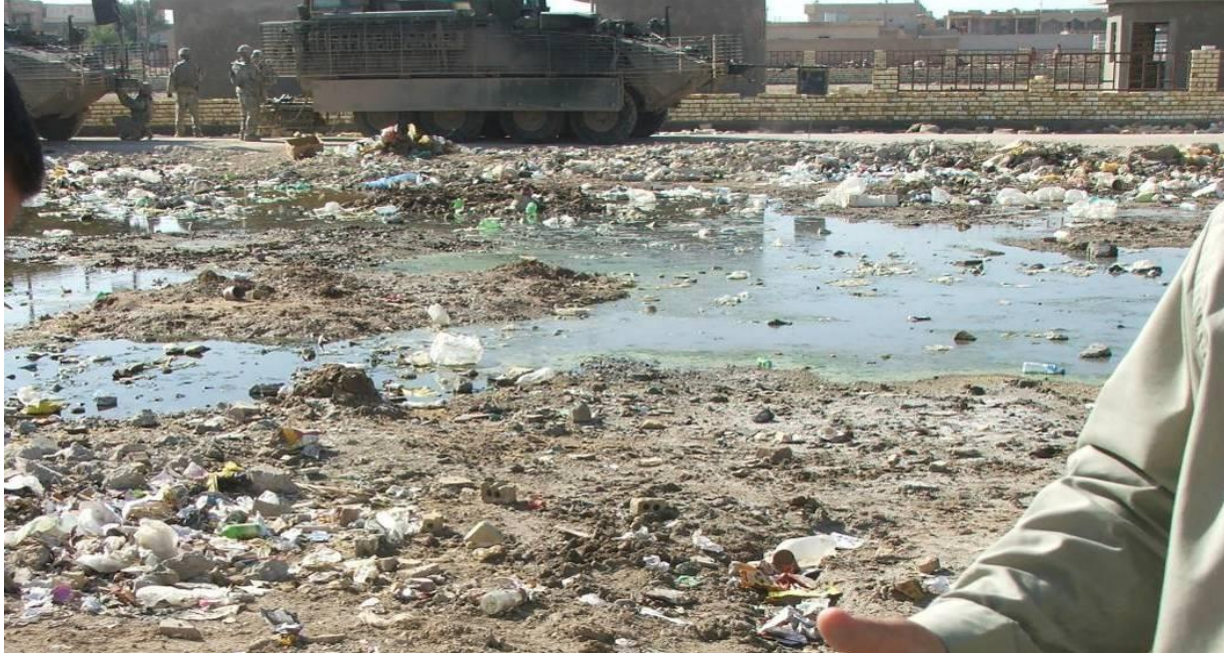
In addition, the sanitary sewer septic system's capacity is not large enough for the school, and according to the headmaster, the septic tank is full because the school does not have a septic cleaning contract. According to the headmaster, a trench was dug to allow discharge out of the full septic tank (Site Photo 14). While this provided an instant relief for the full septic tank, it resulted in large quantities of untreated sewer water being released into the neighboring areas directly bordering the school. As a result, the properties adjacent to the school grounds are unsafe and unsanitary. SIGIR observed

standing water, sewage, and trash surrounding the school. This standing water and sewage can lead to dangerous diseases, such as cholera.

Site Photo 14. Trench dug to allow discharge out of the full septic tank

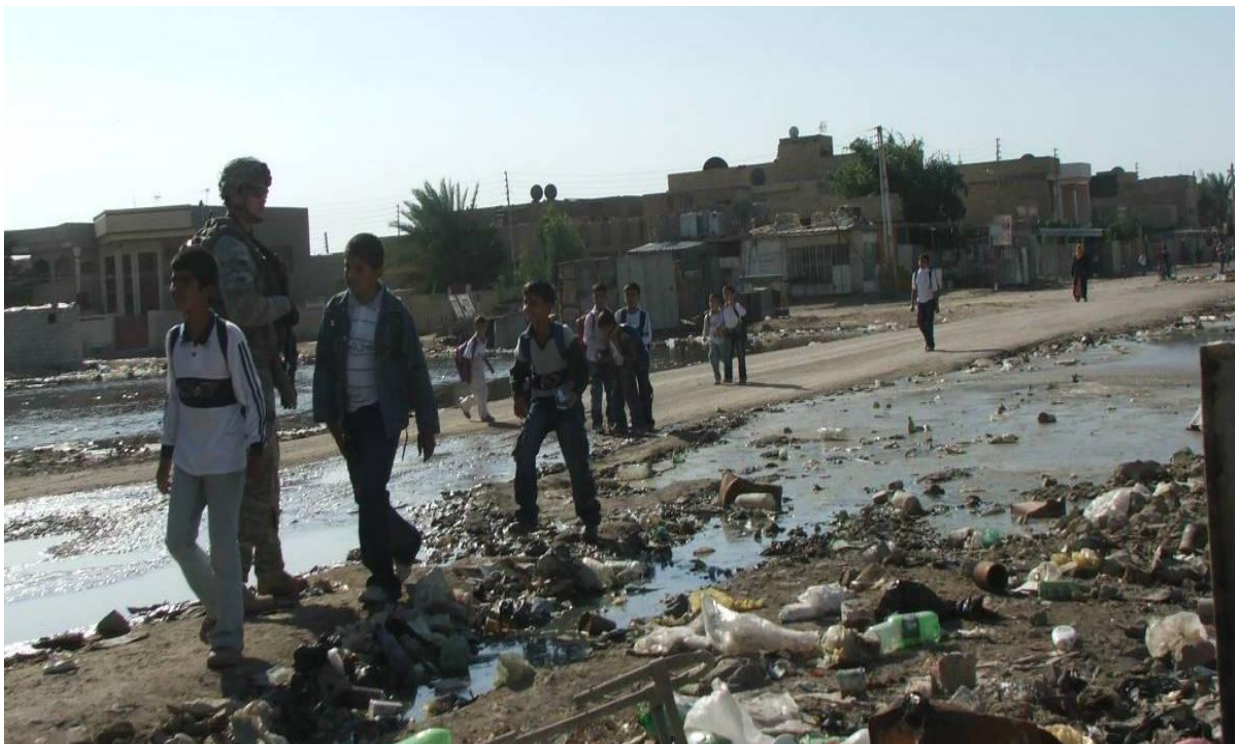
In order to avoid walking through the standing water and sewage from their homes to the school, a make-shift levee was made for the children (Site Photo 15). SIGIR had to use the levee to access this site.

Site Photo 15. Make-shift levee for students to avoid walking through standing water and sewage
