**RENOVATION OF THE KHANDEK
INTERMEDIATE SCHOOL
UNDER THE ECONOMIC SUPPORT FUND PROGRAM
YOUSEFIYA, IRAQ**

SUSTAINMENT ASSESSMENT

**SIGIR PA-08-136
APRIL 21, 2009**

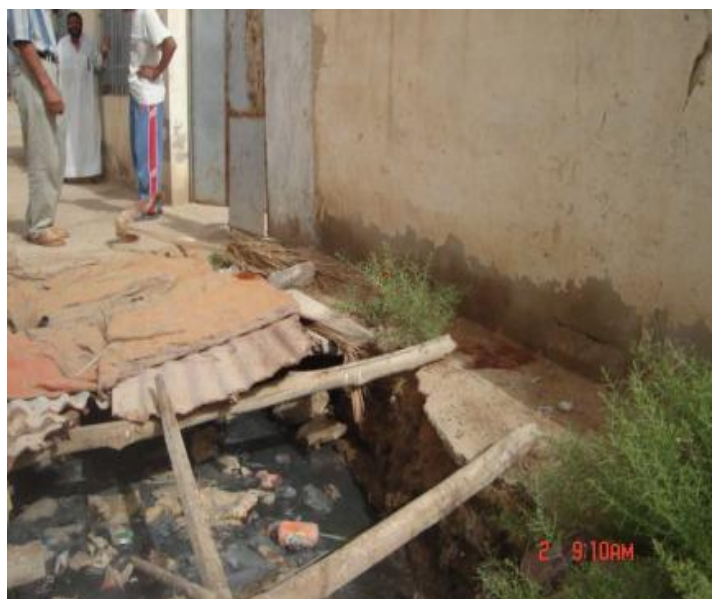
Site Photo 1 documents the poor condition of the school prior to rehabilitation. The school had moderate damage to the interior with cracking and spalling² in the walls and ceilings. Floor tiles were displaced and appeared to be heaving. The school did not appear to have a functioning restroom facility. The restroom facility for the students comprised of four toilets and an exterior common lavatory. The existing

toilets showed a severe lack of maintenance, with some completely blocked with debris. The uncovered septic tank was full of sewage and debris, creating a significant health hazard, especially to the young children.

**Site Photo 1. Open septic tank
(Courtesy of GRC)**

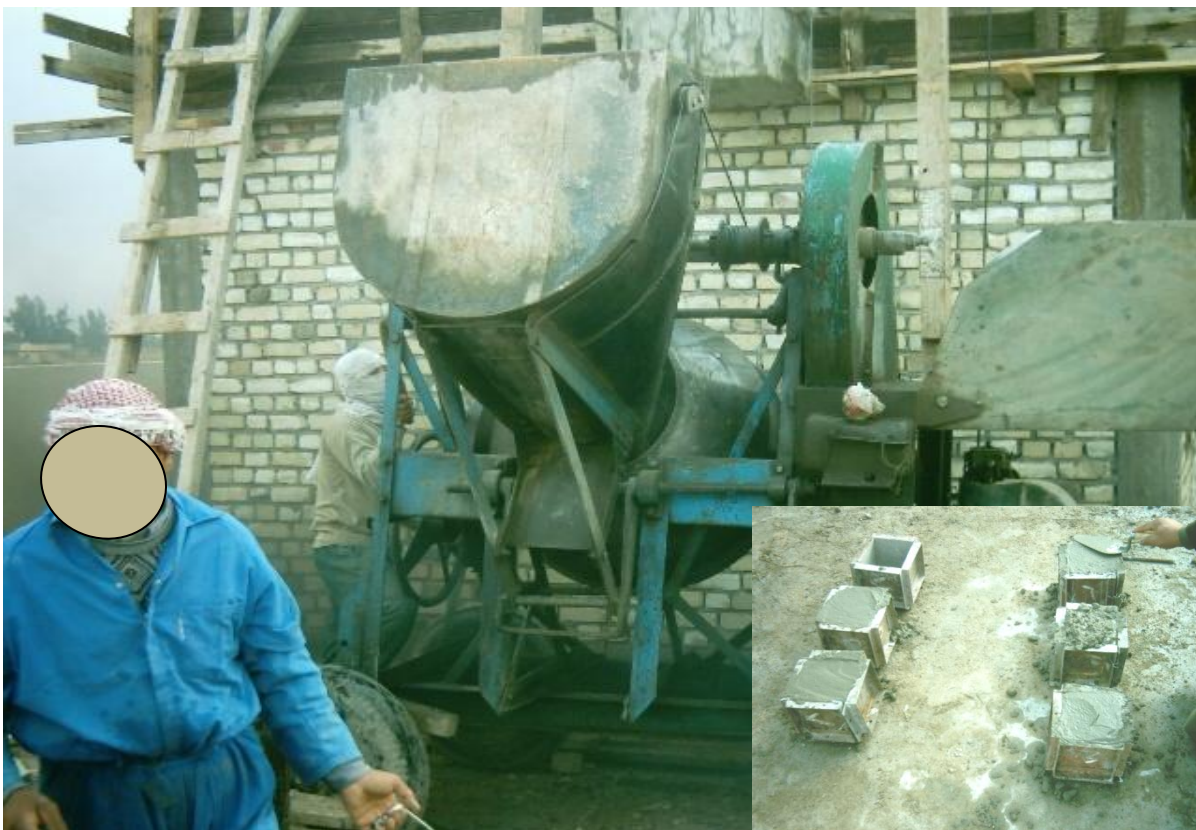
The contractor performed materials inspection and tested the concrete used. The project file documentation lacked concrete mix designs; however, from the available contractor quality control (QC) photos, it appears that the concrete was mixed onsite (Site Photo 2). Concrete test cubes were molded from the concrete used in the project. The BOQ required all concrete incorporated into this project to have a minimum 28-day compressive strength of 25 megapascals (amount of pressure an area can withstand). According to project file documentation, the contractor's compressive strength test results indicate the concrete had a minimum strength of 32.0 megapascals.

Site Photo 2. Site-mixed concrete and concrete test cubes (lower right corner)
(Courtesy of GRC)

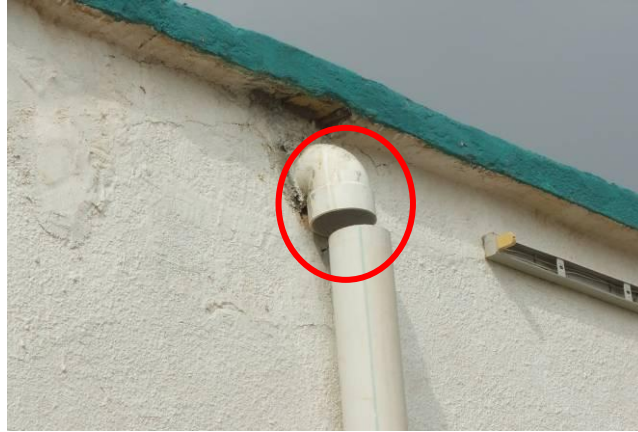
SIGIR did observe one downspout was disjointed from the roof scupper (Site Photo 5). Since this was located in a new construction area, it may have been caused by ongoing construction activities. However, due to the ease of separation of the downspout, it appears that the joints were not solvent welded. In addition, splash blocks or extensions were not provided to direct runoff away from the foundation.

Site Photo 5. Loose connection

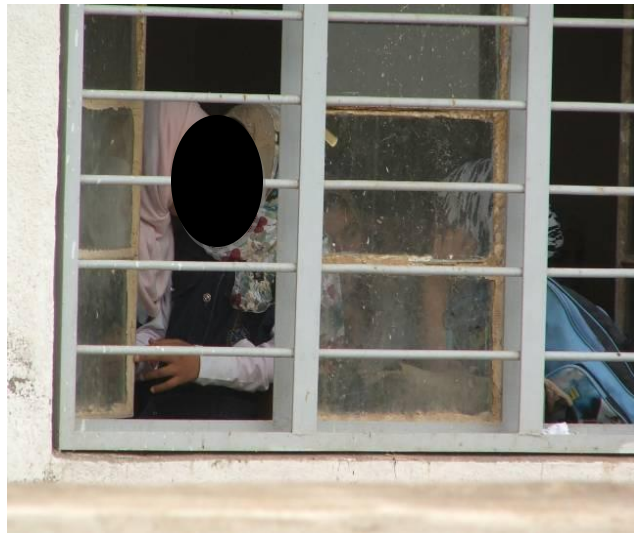
The new steel exterior doors and hardware were installed and functioning. The window glazing appeared to be in-tact. The windows have been painted and latching hardware has been installed. SIGIR did not observe any of the BOQ required window screens (Site Photo 6).

Site Photo 6. Missing window screen

3. Provide the window screens required in the contract.

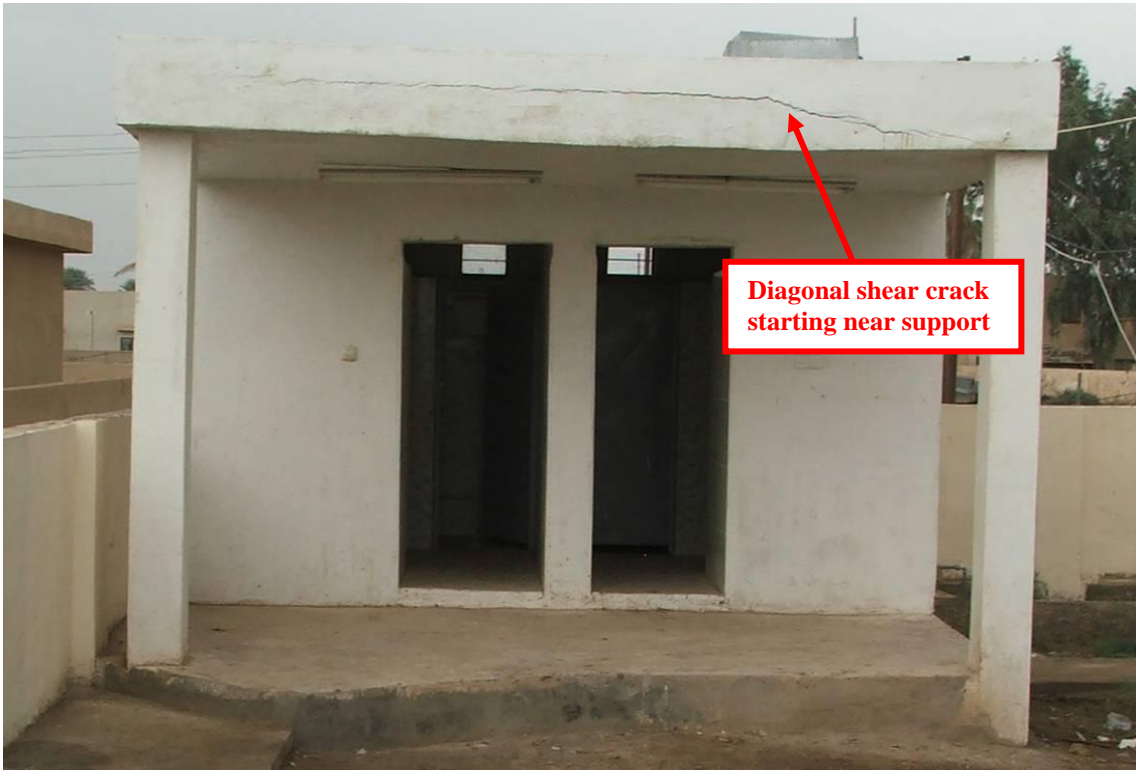
- The reinforced concrete beam along the front of the new restroom facility exhibits significant cracking and deflection.
- One of the septic holding tanks was not equipped with an access hatch.

A new septic tank was constructed along with the new latrine. SIGIR identified a significant shear crack in the main beam along the front edge of the roof on the new latrine building (Site Photo 8).

Site Photo 8. New latrine building with significant shear crack

1. Ensure that the cracking and deflection of the reinforced concrete beam along the front of the new restroom facility does not present a safety hazard.
2. Anchor the water-supply pump to a support and enclose the wiring to the potable water-supply pump in conduit.

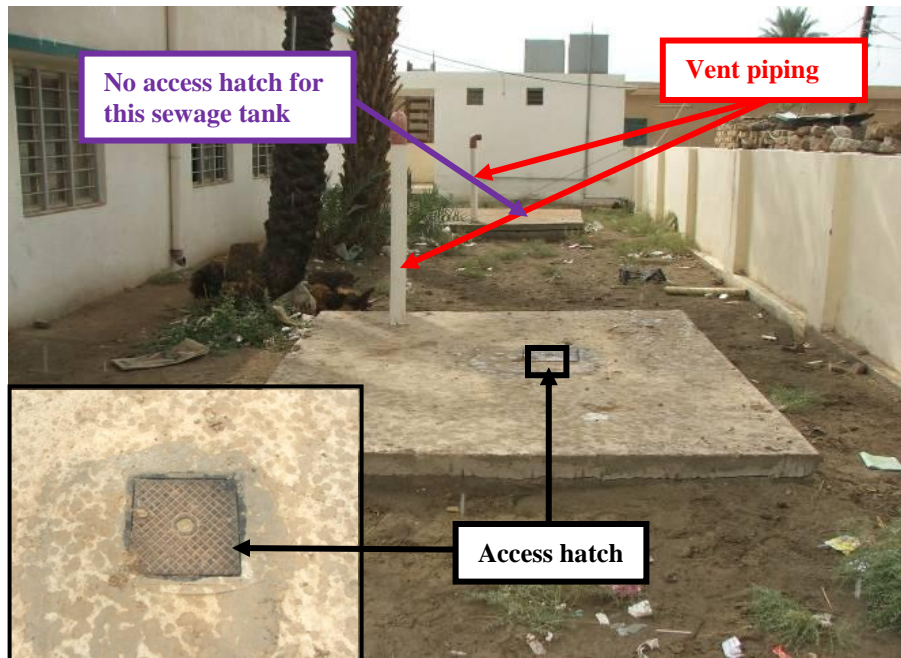
Two septic tanks were constructed on the site to service the two latrines (Site Photo 10). Vent piping was installed in the top slab of the tanks. SIGIR examined the tanks' top slabs, which did not exhibit any cracking or signs of failure; however, there was moderate curling of the top slab. A small access was provided for one of the tanks, which could be used for inspection and pumping; however, there was no access provided for the second tank. SIGIR believes this presents the school with future maintenance problems, since the school will be unable to fully empty the tank and residue will accumulate at the tank's bottom.

Site Photo 10. Septic holding tanks and tank access for one (lower left corner)

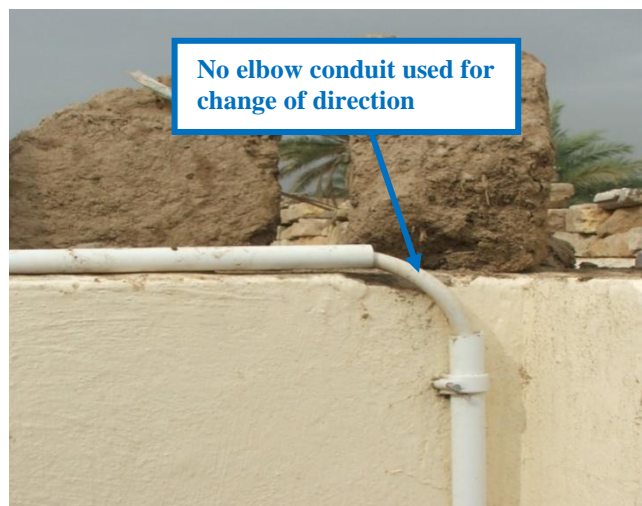
A new main circuit breaker, lights, and ceiling fans were installed in the classrooms (Site Photos 11). At the time of the site visit, the school was operating without power; therefore, SIGIR was unable to verify the operability of the electrical system. It appeared that all wiring was in conduit; however, exterior wiring did not use elbows at changes in direction (Site Photo 12).

Site Photo 12. Exterior conduit

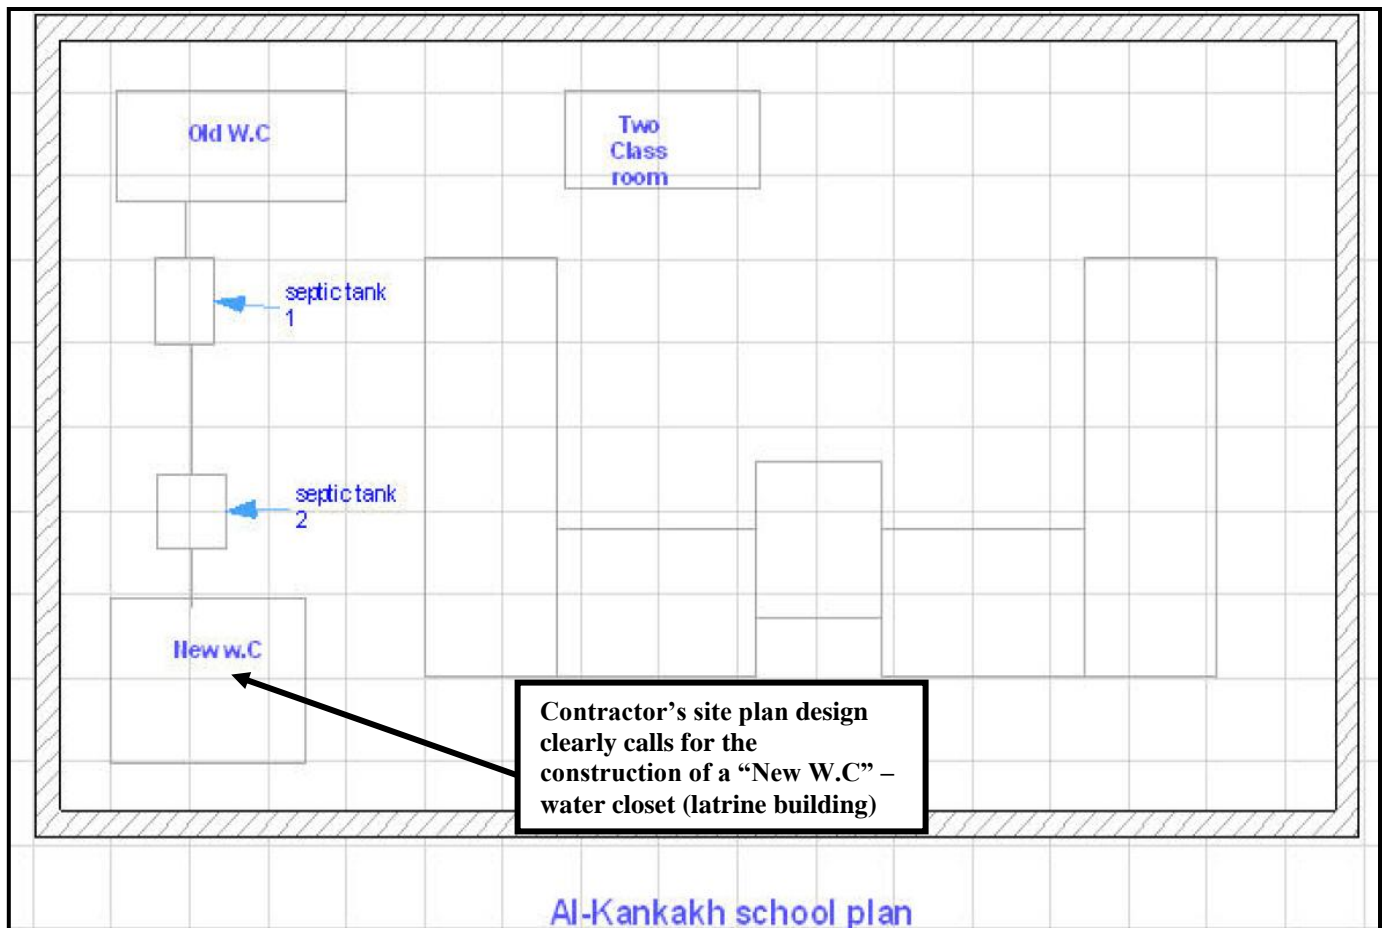
Figure 4. Contractor’s site plan submittal clearly showing the construction of a new water closet (latrine building) (Courtesy of GRC)

Regarding the reinforced concrete beam crack in the latrine building, GRC representatives stated they had "reviewed the contract and the BOQ [bill of quantities] in the contract. There is no mention of a new restroom." The GRC believes that the schoolmaster told the contractor to build the latrine building. However, this statement is contradicted by the contractor's design submittals, which clearly indicated on the school's site plan "New W.C. [water closet]." The design, which the contractor

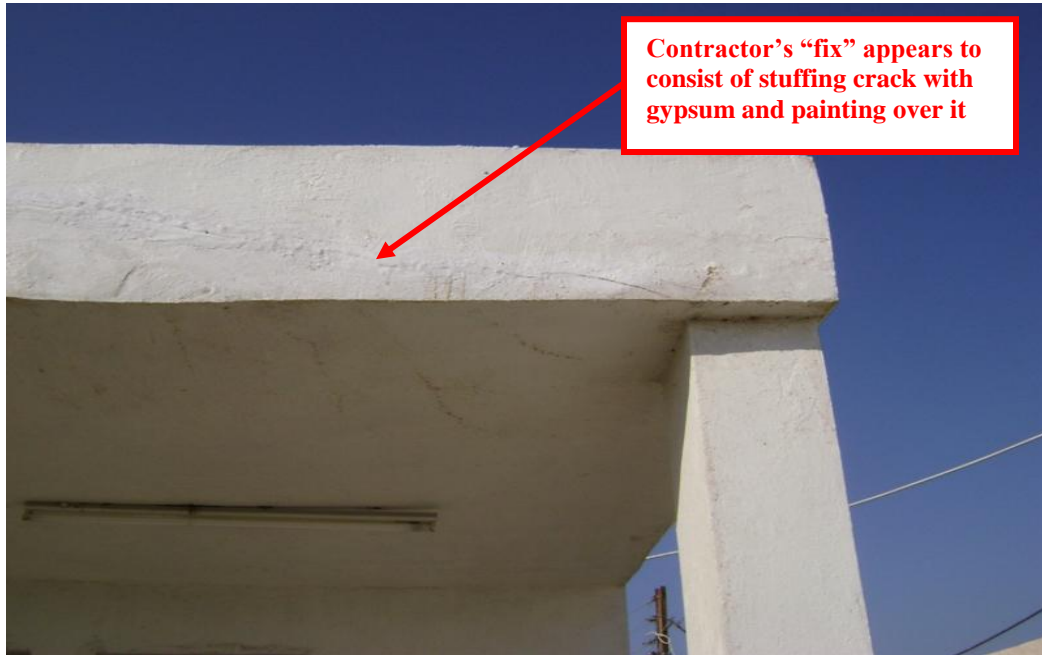
During its site visit, GRC representatives stated that the crack in the concrete beam was “currently being worked” by the contractor. GRC representatives took a photograph of the contractor’s corrections, which appeared to be stuffing the crack with gypsum and then painting over it (Site Photo 13). GRC representatives did not ascertain the depth of the crack.

SIGIR does not believe the contractor’s “fix” is adequate. The depth of the crack needs to be determined in order to identify the most appropriate correction.

Site Photo 13. Contractor's fix for the reinforcement beam crack (Courtesy of GRC)

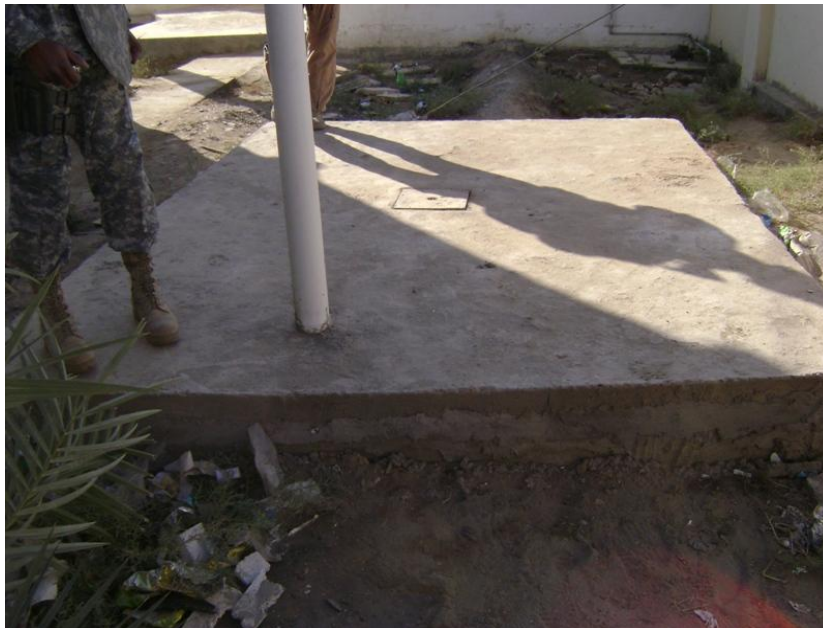
Site Photo 14. Newly installed access hatch for the sewage tank (Courtesy of GRC)

The contractor agreed to install an access hatch for the new sewage tank. GRC representatives verified that the contractor did install an access hatch (Site Photo 14). This access hatch will allow the school to periodically empty the tank so that residue will not accumulate at the tank's bottom.
