**REBUILDING OF THE SAGRAH SCHOOL
UNDER THE COMMANDER'S EMERGENCY RESPONSE PROGRAM
SAGRAH, ANBAR PROVINCE, IRAQ**

SUSTAINMENT ASSESSMENT

**SIGIR PA-08-140
APRIL 15, 2009**

SUBJECT: Report on the Rebuilding of the Sagrah School, Anbar province, Iraq
(SIGIR Report Number PA-08-140)

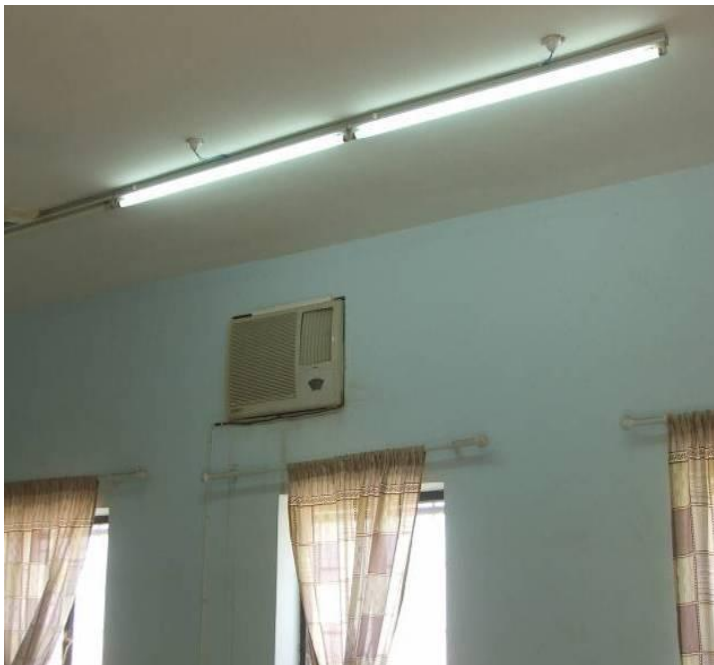
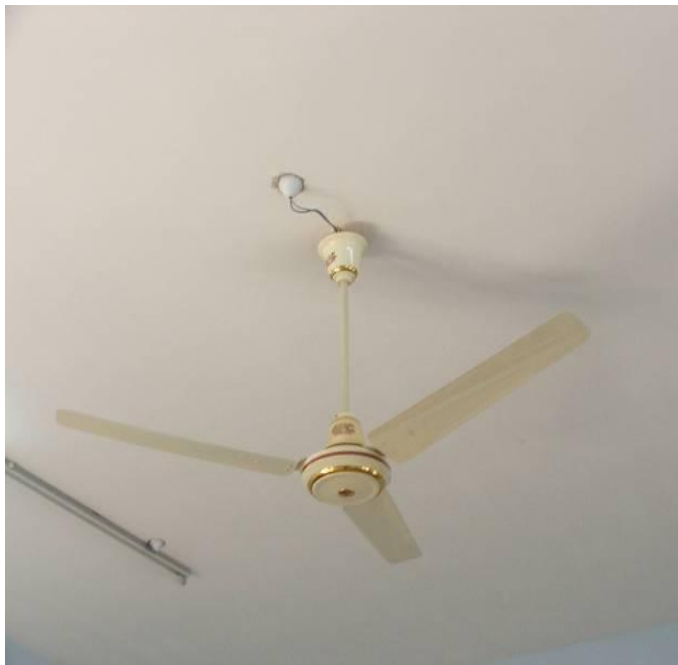
The electrical components were installed and functioning. Most of the wiring was installed in conduits and appeared adequate. Also, the main power panel, fluorescent lighting, and ceiling fans were properly installed (Site Photos 7 and 8).

Site Photos 7 and 8. Fluorescent lighting and ceiling fans inside each classroom

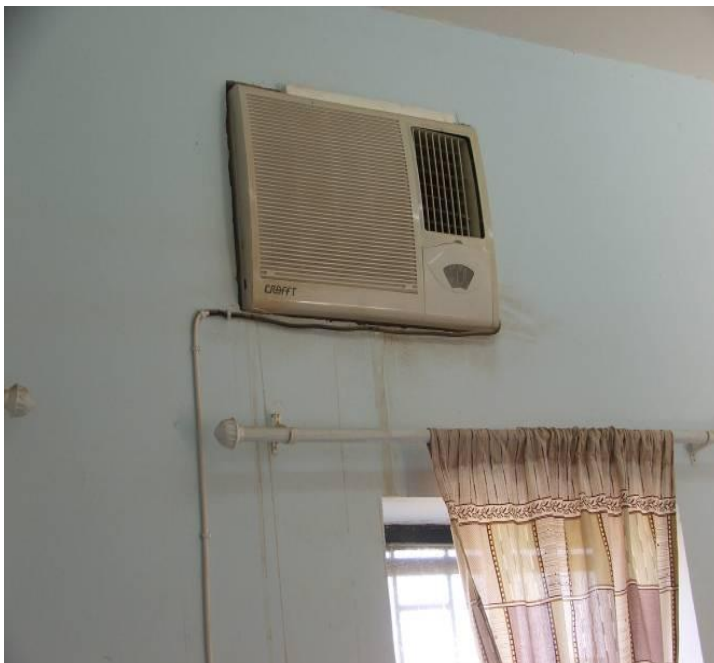
SIGIR observed two types of air-conditioning units installed at the school. The majority of the classrooms were cooled by wall mounted units (Site Photo 9); while some were cooled by split air-conditioning units (Site Photo 10).

Site Photo 9. Wall mounted air-conditioning unit

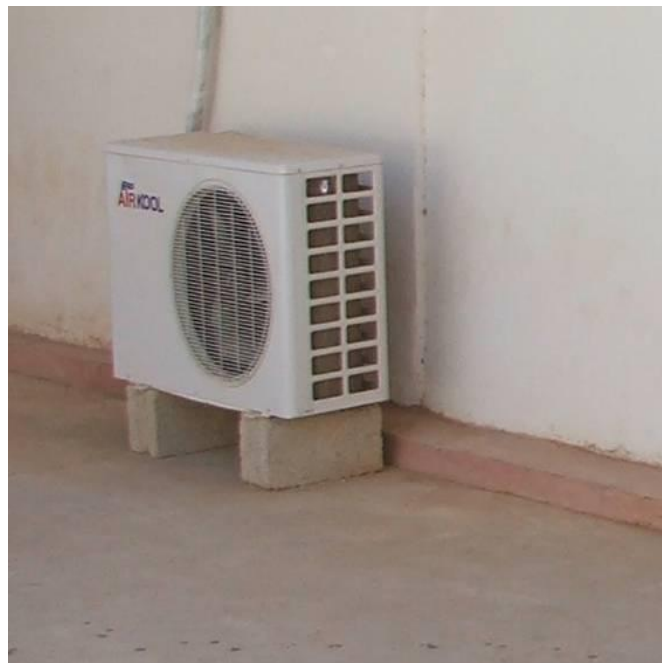
Site Photo 10. Split air-conditioning unit

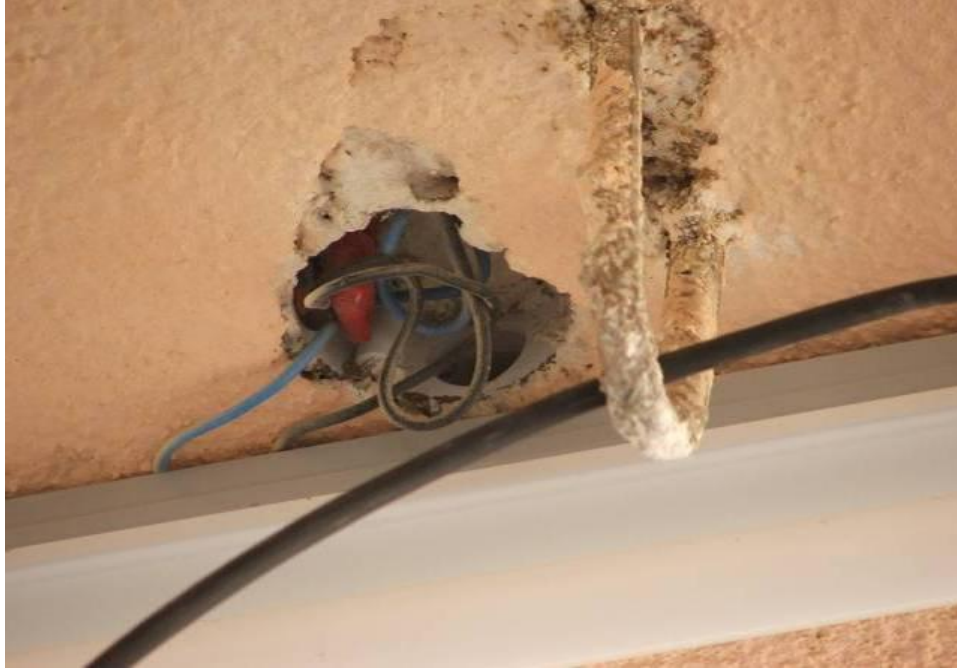
SIGIR noticed several deficient wiring connections (Site Photo 11), which have the potential to short circuit and create a hazard for electrocution and fire.

Site Photo 11. Example of deficient and potentially hazardous electrical connections

The electrical components were installed and functioning. Most of the wiring was installed in conduits and appeared adequate. However, SIGIR noticed several inadequate wiring connections, which have the potential to short circuit and create a hazard of electrocution and fire; however, it appeared these connections were likely done subsequent to the work performed by the contractor.

MNF-W issued a letter to the Deputy Governor, Office for Technical Affairs, Al Anbar province, referencing an existing operation and maintenance agreement requiring the Government of Iraq to provide preventive maintenance to facilities rehabilitated or constructed by the U.S. government. MNF-W requested the Deputy Governor's assistance to "correct the deficiencies in the [electrical] wiring and lavatories to protect the students and faculty from harm."

SIGIR appreciates the concurrence by MNF-W to the construction deficiencies identified in the draft report. SIGIR agrees the Government of Iraq needs to address the electrical wiring and lavatories in order for this facility to function safely and at optimal capacity.

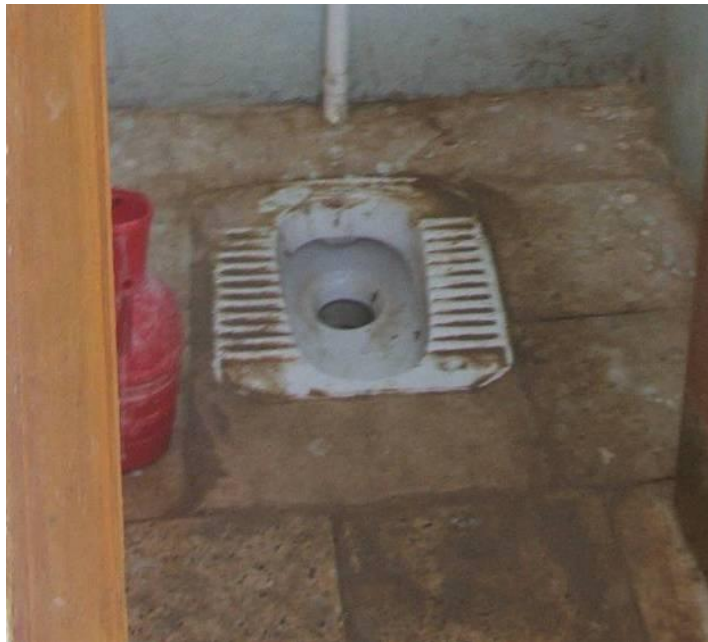
During the site visit, SIGIR inspected the newly constructed restroom facility and septic holding tank. The restrooms were supplied with eastern-style toilets, which appeared to function (Site Photo 12).

Site Photo 12. Eastern-style toilet

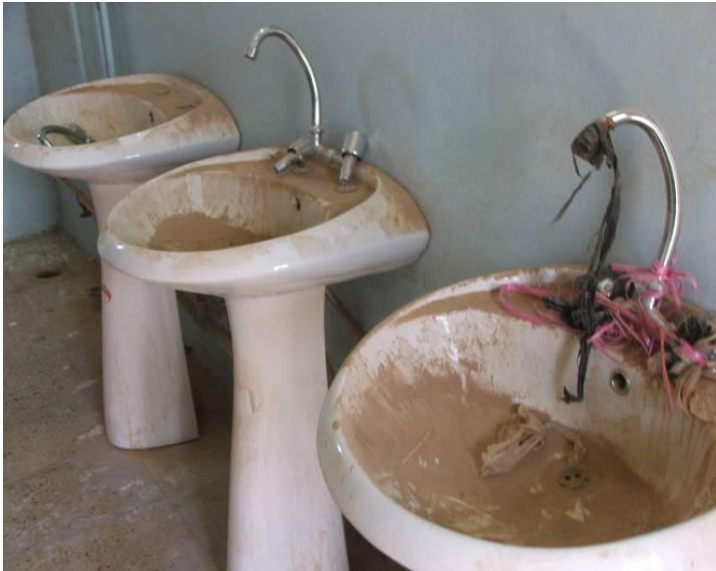
Individual lavatories were installed in the restrooms; however, there were signs of abuse and most did not function (Site Photo 13). While most lavatories appeared to be connected to the septic holding tanks, SIGIR did observe one lavatory discharging

directly into the ground. The required hot water heater had been installed (Site Photo 14).

Site Photo 13. Damaged lavatories

Individual lavatories had been installed in the restrooms; however, there were obvious signs of abuse and most did not function. Although most lavatories appeared to be connected to the septic holding tanks, SIGIR did observe one lavatory discharging directly into the ground.

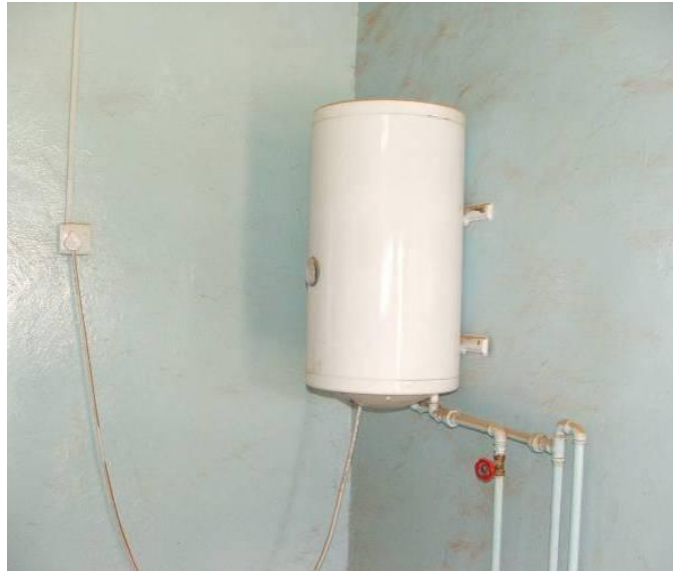
Site Photo 14. Hot water heater
