AL IQITADAR SCHOOL
UNDER THE COMMANDER'S EMERGENCY RESPONSE PROGRAM
ANBAR PROVINCE, IRAQ

SUSTAINMENT ASSESSMENT

SIGIR PA-08-141
JANUARY 26, 2009

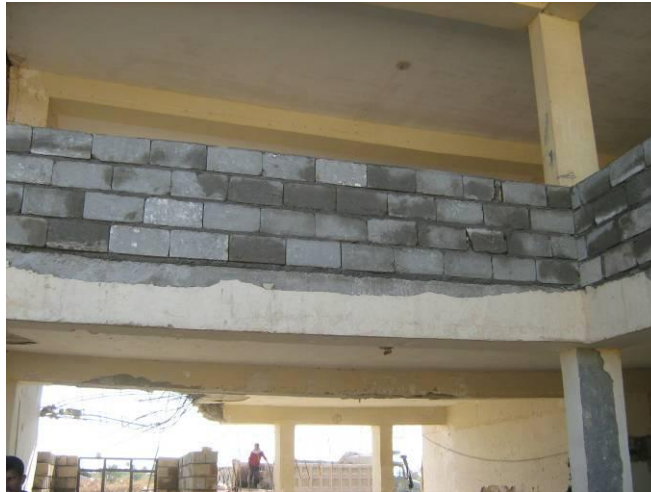
Site Photo 4 documents the building masonry work during rebuilding

Site Photo 4. Masonry work during rebuilding (Courtesy MNC-I)

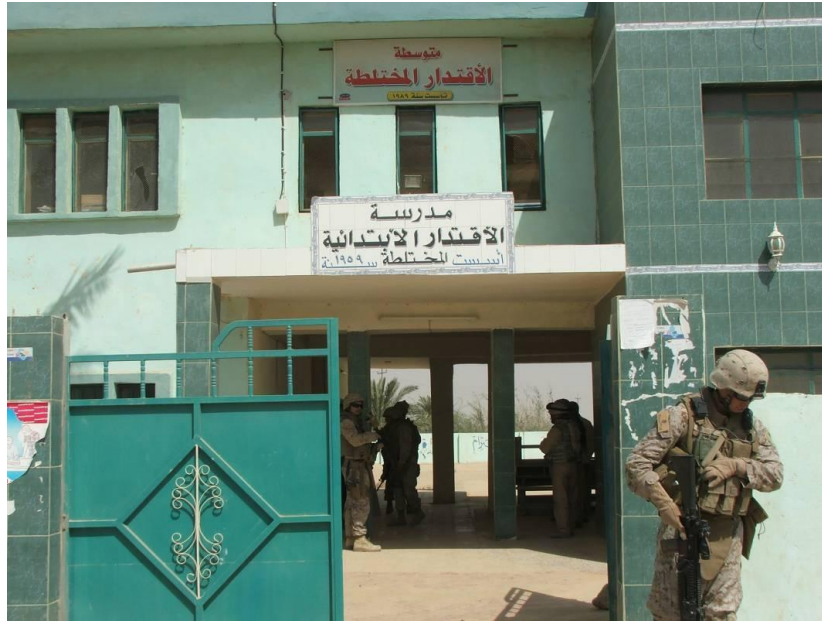
Site Photo 5. Al Iqtadar School on 21 September 2008

On 21 September 2008, the SIGIR assessment team performed an on-site assessment of the Al Iqitadar School project (Site Photo 5). SIGIR was escorted to the site by the local U.S. Marine unit and accompanied by the school's headmaster. At the time of the site visit, the school year had not started.

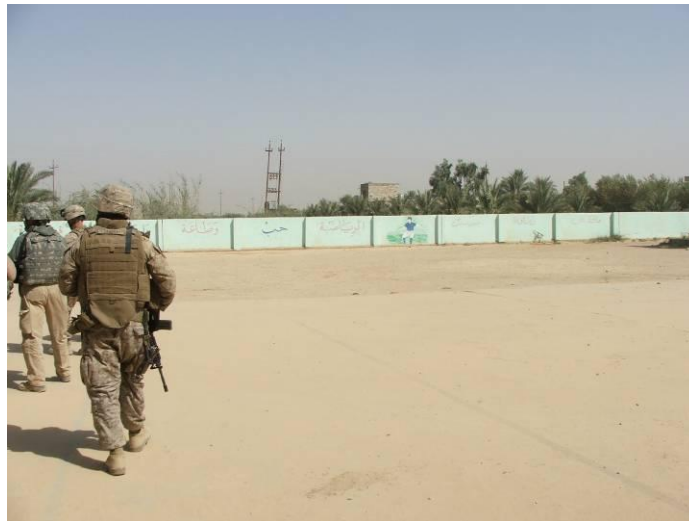
Site Photo 6. Perimeter wall

- removal of all debris on building premises
- repair of perimeter wall and gate (Site Photo 6)
- replacement of interior/exterior doors
- replacement of damaged windows

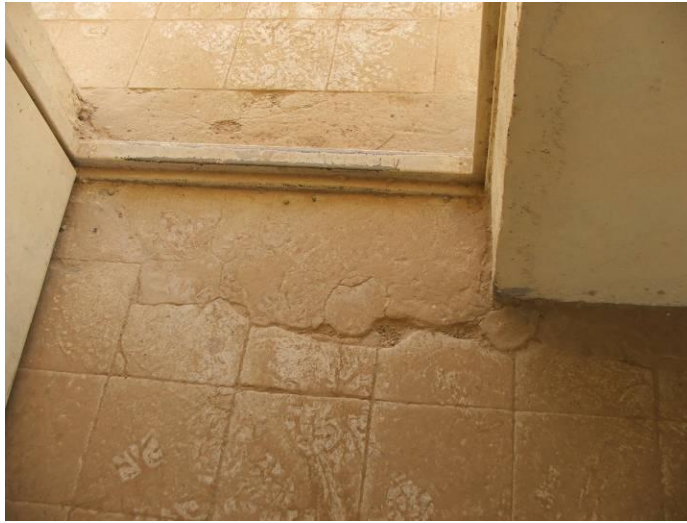
During the site visit, SIGIR observed the construction of the new classroom buildings. The roof tiles appeared to be in good condition throughout the expanse of the roof. There were drainage holes at the roof's edges, which will allow water to drain from the roof. The exterior and interior walls appeared to be adequately repaired/replaced. The majority of the interior tile and concrete floor work was good; however, there were areas of broken tiles and uneven floors (Site Photo 7).

Site Photo 7. Uneven floors

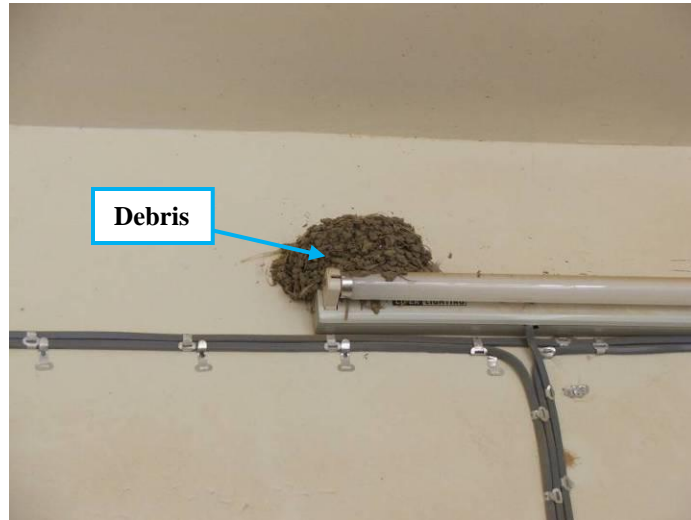
During the site visit, SIGIR did not detect any instances of potentially harmful electrical system tampering. However, some of the light fixtures housed debris from a lack of routine maintenance (Site Photo 9).

Site Photo 9. Debris on light fixture

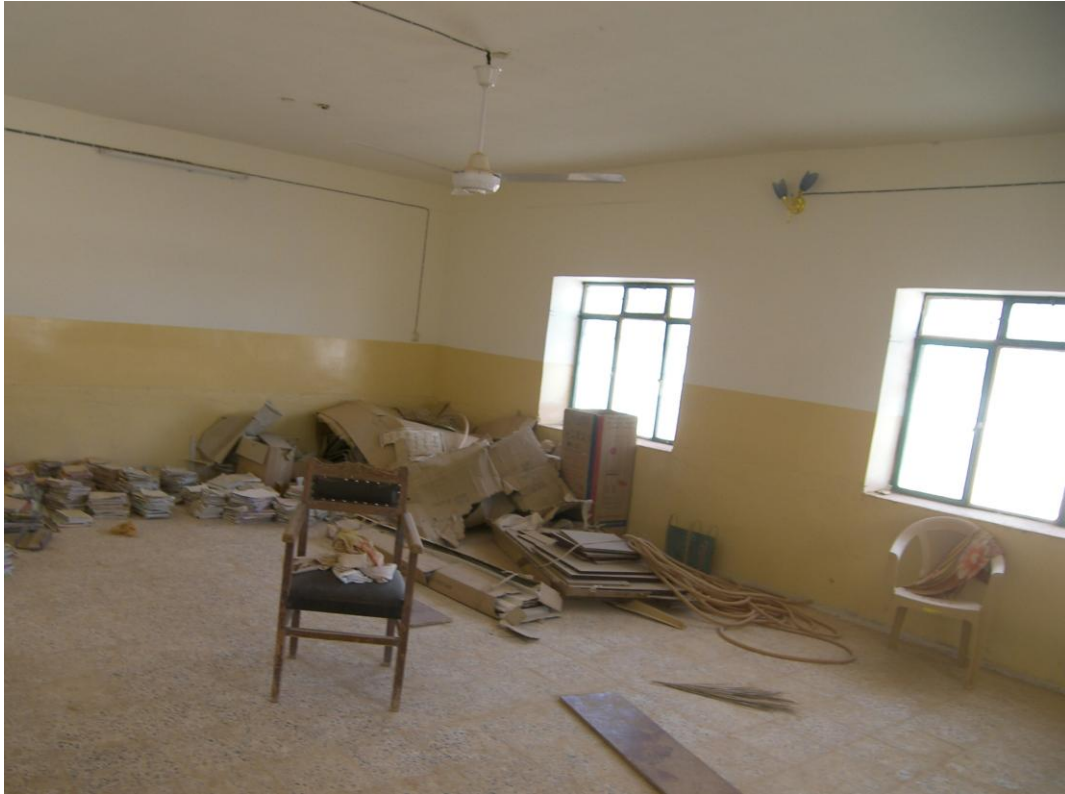
There were obvious signs, during the site visit, that the school was not being properly maintained. For example, debris in the schoolrooms (Site Photo 10) and a significant amount of dirt and dust was observed. According to the Headmaster, school was to begin at the conclusion of Ramadan. In order to be ready for the first day of school, a considerable amount of cleaning is required.

Site Photo 10. Schoolroom debris
