SHIQAQ HAI MUSALLA  
PRIMARY HEALTHCARE CENTER  
KIRKUK, IRAQ

SUSTAINMENT ASSESSMENT

**SIGIR PA-08-157**  
**APRIL 13, 2009**

## Shiqaq Hai Musalla Primary Healthcare Center

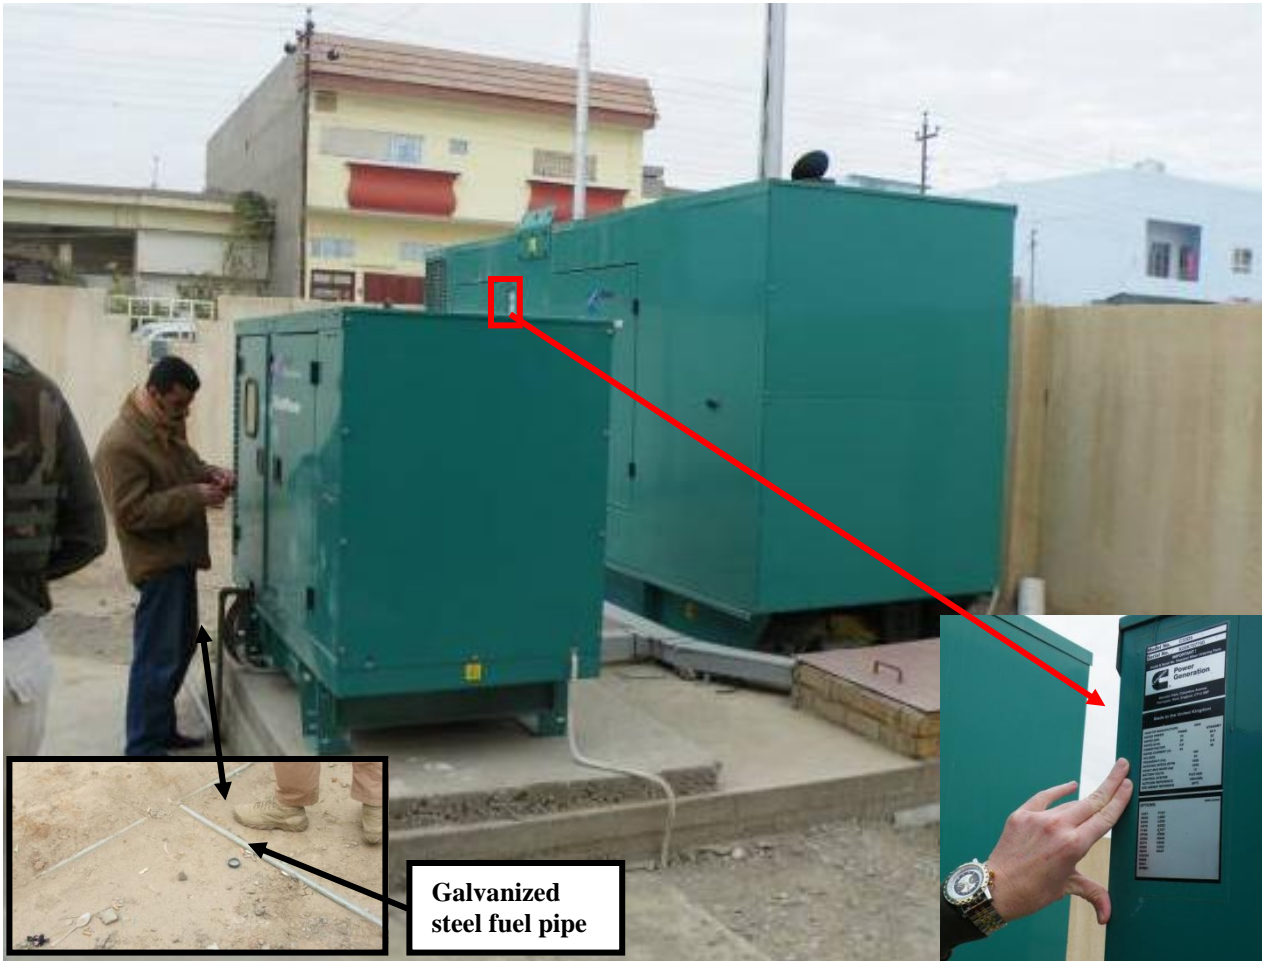
**Site Photo 4. Two generators providing primary and emergency backup power for the PHC**

The Shiqaq Hai Musalla PHC is connected to the national grid; however, the national grid is unreliable and provides approximately four hours of electricity per day. The primary source of electricity for the facility is provided from one of the two generators located on site (Site Photo 4). The larger generator, one-megawatt, is used for primary power; while the smaller generator, 500-kilovolt, is for emergency backup. During the site visit, the generators appeared to be relatively clean and in working order. SIGIR verified the generators' specifications via the faceplates.

Since the Shiqaq Hai Musalla PHC is connected to the national grid, an automatic transfer switch is critical to transfer to generator power once electricity from the national grid is lost. The PHC design incorporated the use of an automatic transfer switch. SIGIR verified the installation of the automatic transfer switch, which according to the administrator, was functioning correctly.

SIGIR noticed no visible evidence of fuel leaks in the fuel line or inside the generator housing. The fuel line appeared to be galvanized steel pipe that was placed on the surface of the ground (Site Photo 4). Galvanized steel is susceptible to corrosion and may over a long period of time create issues with fuel leaks. Without careful monitoring, small leaks may go undetected, potentially wasting fuel, increasing the risk of fire, harming the environment, and endangering the welfare of the occupants.

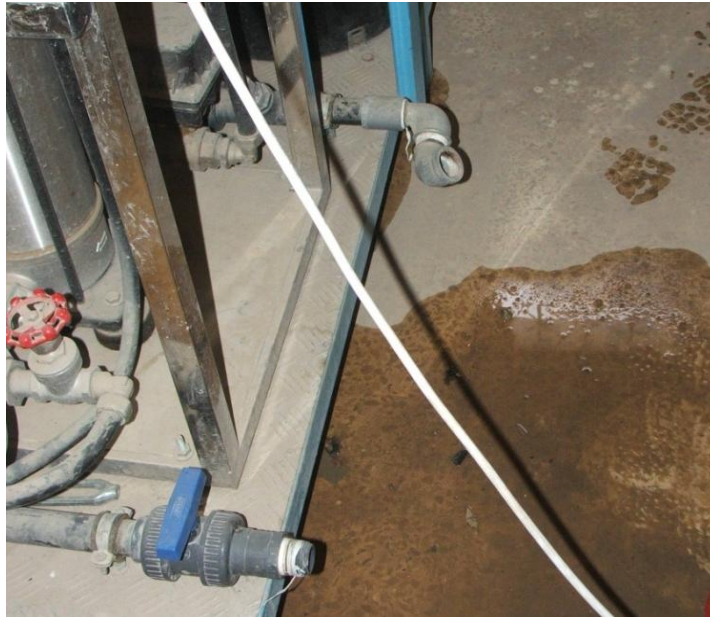
The RO unit appeared to be installed, but had been disconnected from the facility's water system (Site Photo 5). The PHC administrator did not respond to several requests by SIGIR as to who disconnected the RO and why.

**Site Photo 5. Disconnected RO unit**

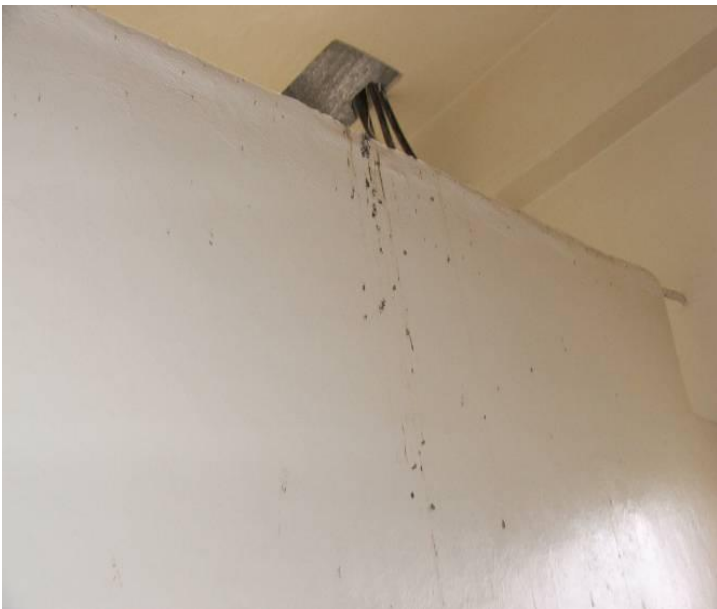
SIGIR observed evidence that birds were nesting in the general vicinity of the RO unit and potable water equalization tanks, with bird feces visible on the partition wall (Site Photo 6). In addition, one of the tank lids was open, permitting contamination of the potable water supply (Site Photo 7). Contamination of the water supply with bird feces increases the risk of exposure to patients and staff of avian born diseases such as histoplasmosis, cryptococcosis, or psittacosis.

**Site Photo 6. Possible water contamination source**

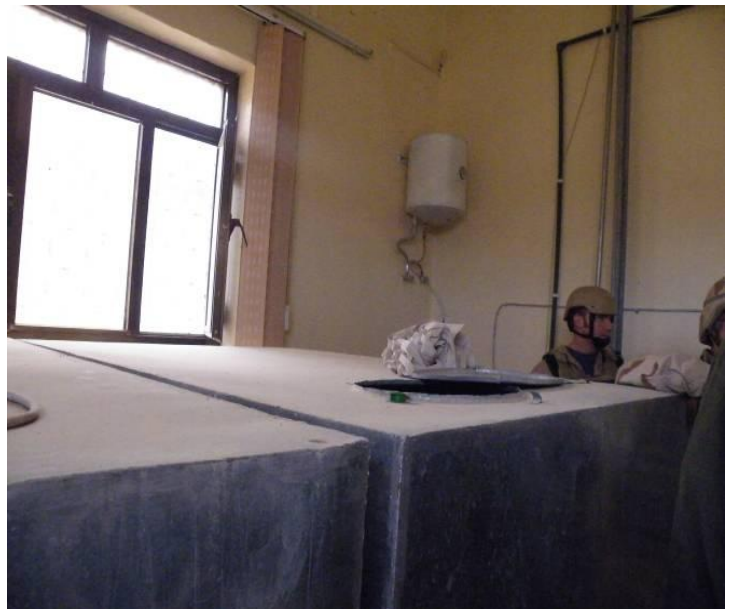
**Site Photo 7. Uncovered equalization tank**

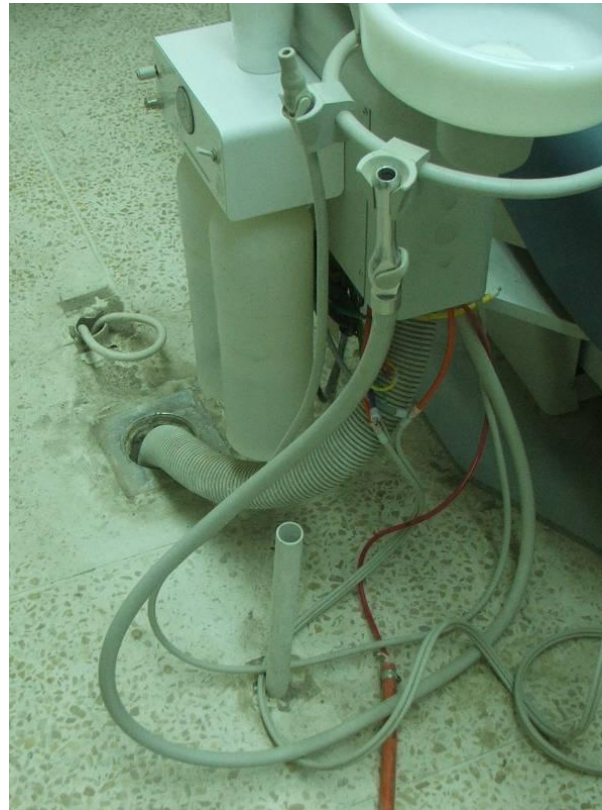
The contractor’s installation of the dental chairs, while functional, did not appear to conform to any known plumbing or electric code. The drain for the chairs was placed directly into the floor drain with a significant gap between the floor drainpipe and the chair discharge hose. The electrical connection for the chair was made using a modified extension cord (Site Photo 9).

**Site Photo 9. Dental chair connections**

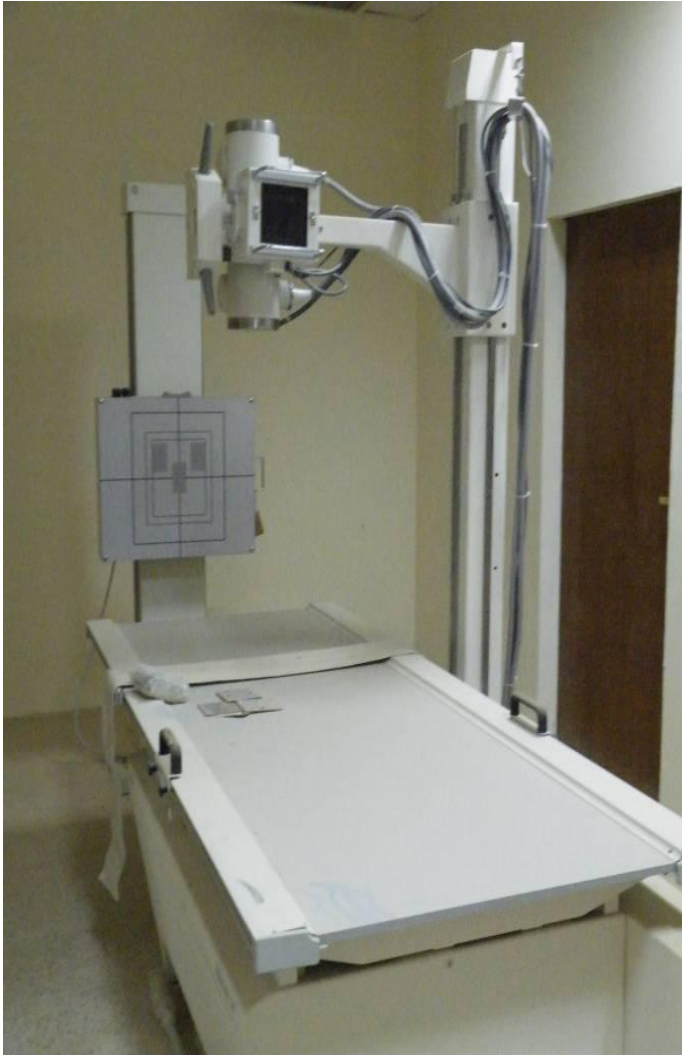
The original design of the facility included medical imaging capabilities, specifically an x-ray room and equipment. SIGIR observed that the x-ray equipment was installed (Site Photo 10); however, according to the administrator, the contractor did not verify the equipment was operational. In addition, the administrator stated that the facility’s staff did not have the capability to operate the x-ray equipment; consequently, the facility does not offer x-ray service to its patients.

**Site Photo 10. X-ray equipment**

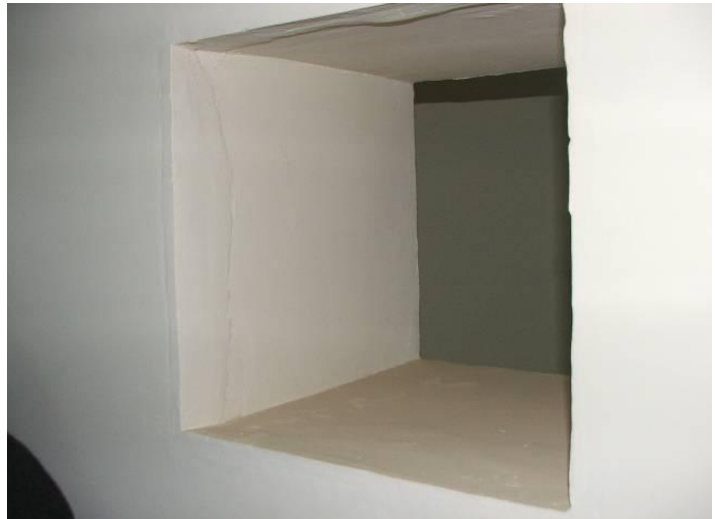
Due to the x-ray equipment emitting low levels of radiation, radiation shielding is required to protect the PHC’s personnel and patients. The initial design required mass concrete walls with lead lining, lead-lined doors, and a leaded-glass observation window to provide radiation shielding.

In the 19 July 2007 acceptance letter, one of the two noted deficiencies was “x-ray leaded glass,” which was to be “installed later.” SIGIR noted that the contractor had not installed the required leaded-glass observation window (Site Photo 11). In addition, SIGIR noticed that the x-ray room exterior door and darkroom doors installed by the contractor appeared to be standard wooden doors. The inspection team could not verify the presence of lead lining on the concrete walls.

**Site Photo 11. Missing observation window**

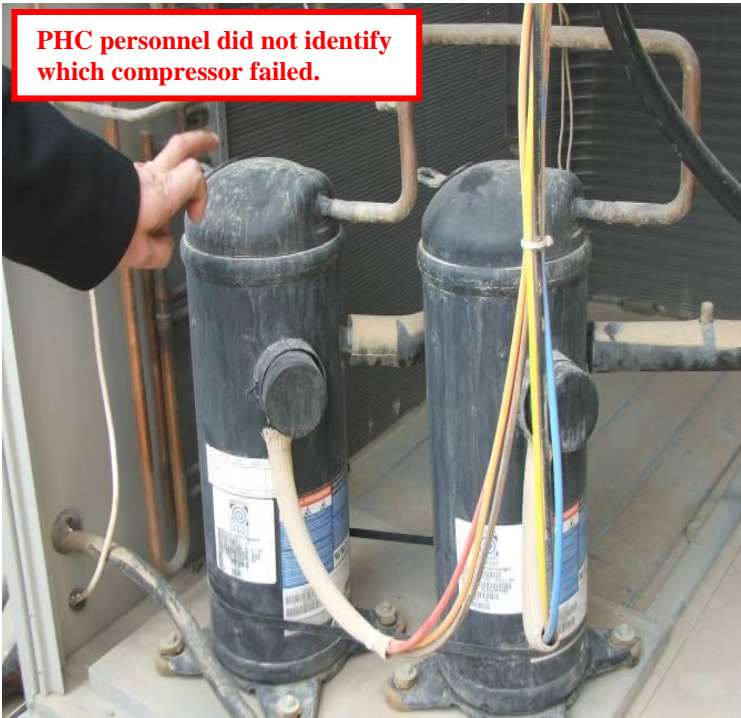
Due to security concerns, only one SIGIR team member was allowed to briefly access the roof to inspect the HVAC units. While on the roof, PHC personnel removed the side panel of one of the primary units for inspection (Site Photo 12). The administrator pointed out that one of the two compressors in the primary HVAC unit had failed, and currently, the facility was operating on reduced capacity.

**Site Photo 12. Failed HVAC compressor**

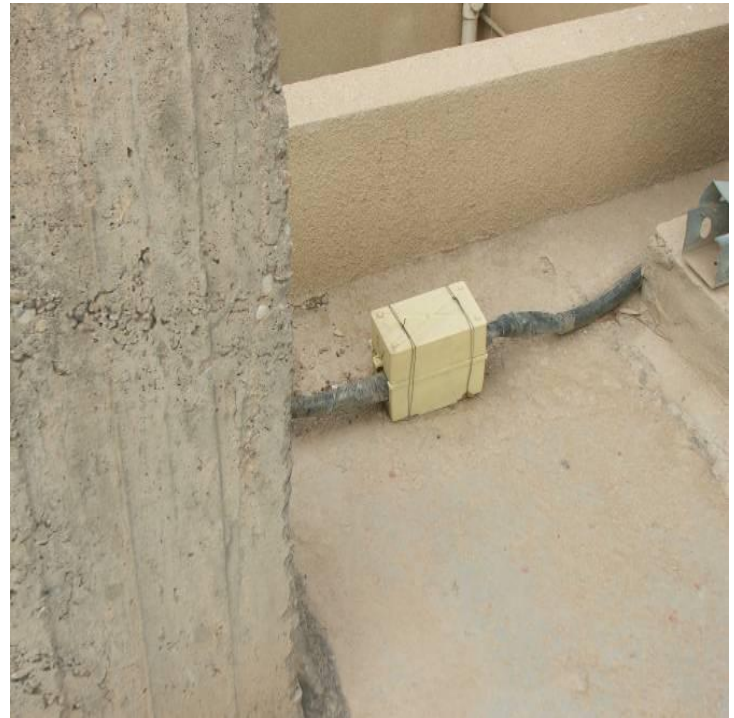
SIGIR noticed several splices of the electric cables for the units. The splices did not appear to conform to the International Electric Code, and in several locations it appeared that plastic index card boxes were modified to act as junction boxes for the electric power supply to the HVAC units (Site Photo 13). Due to the risk of severe shock, SIGIR did not dismantle the makeshift covering, and, as a result, was unable to determine if there was a splice. Since the makeshift junction was located on the roof, the connection was exposed to the harsh weather elements. Due to the significant electric current required to operate the HVAC, shorting of these lines would cause a serious risk of electrical shock and fire.

**Site Photo 13. Makeshift electrical junction**

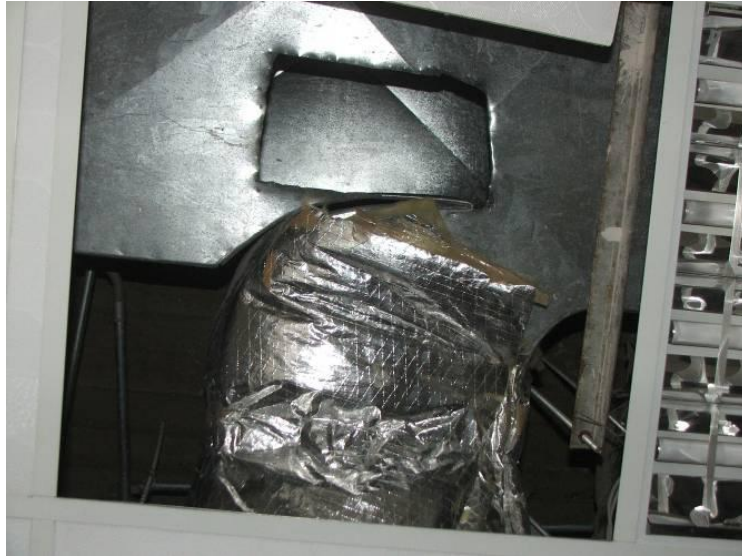
The administrator also stated that the heating units were not working. Based on SIGIR's observations on the roof, it appeared that the HVAC units were equipped with the ability to provide heat; however, the cause of the heating system failure could not be determined. SIGIR noticed that the staff was using small electric heaters to provide heat at individual workstations. The use of the small electric heaters taxes the emergency generator, while being inefficient and a significant fire hazard.

**Site Photo 14. Modified HVAC duct**

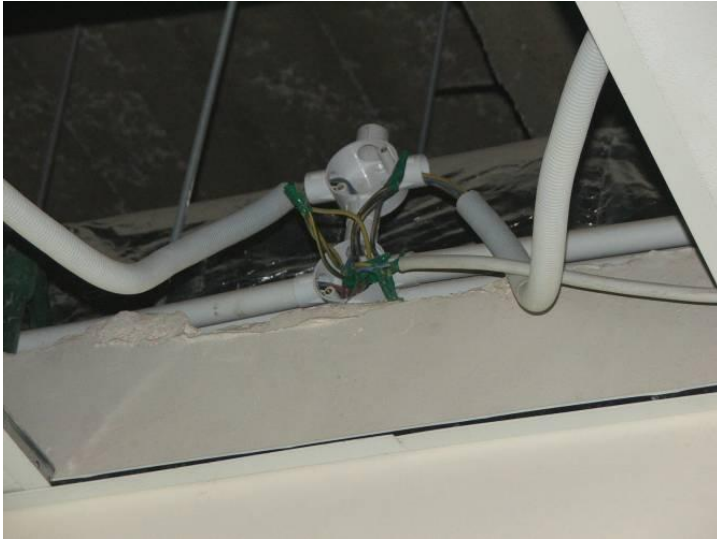
SIGIR observed several questionable electrical connections; none of which conform to the International Electric Code (Site Photo 15). Due to time limitations on site and the fact that the PHC staff had occupied the facility for over a year, SIGIR could not determine if the original contractor performed this work or if it had been "modified" by PHC personnel.

**Site Photo 15. Poor electrical connection**

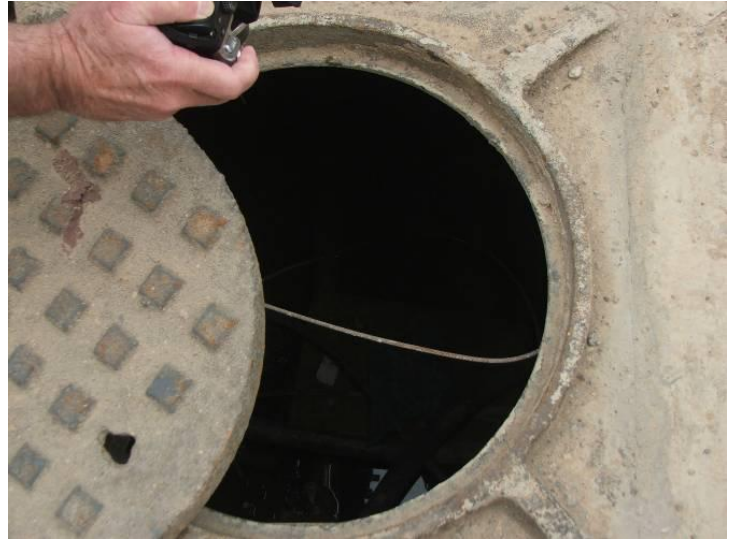
SIGIR noticed that several of the electric manholes had standing water in them (Site Photo 16). Also, there was debris in the manholes, but it was unclear if the debris was left from the original construction, or if it had been deposited recently.

**Site Photo 16. Debris and water in electric manhole**
