**HAI TISEEN PRIMARY HEALTHCARE CENTER  
TAMEEM PROVINCE, IRAQ**

**SUSTAINMENT ASSESSMENT**

**SIGIR PA-08-158  
APRIL 16, 2009**

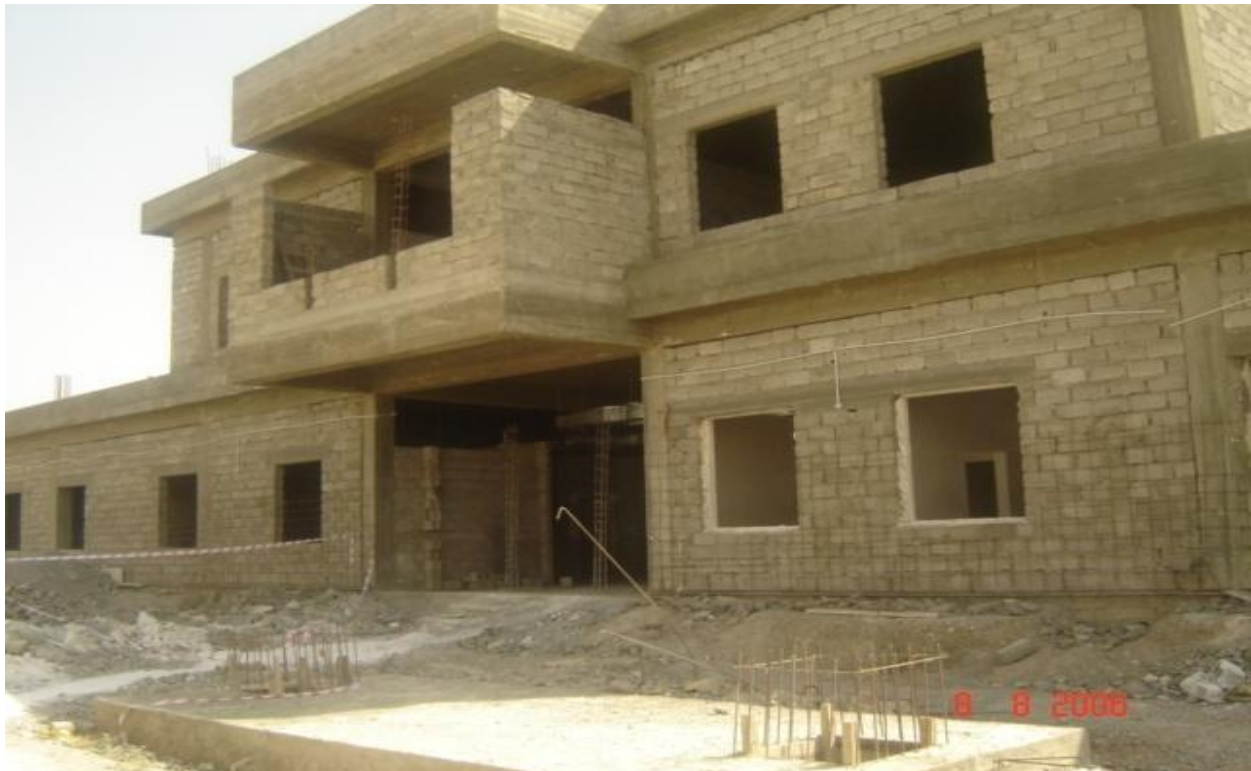
The GRN project file contained limited information regarding the extent of the construction or the condition of the facility when Parsons was terminated. Consequently, SIGIR relied on project file photographs from the approximate time of contract award to determine the condition of the partially completed facility (Site Photo 1). Based on these photographs, SIGIR determined that Parsons completed the following items:

- structural concrete columns and beams
- interior and exterior concrete block walls

**Site Photo 1. Condition of partially constructed PHC when the new contract was awarded  
(Courtesy of GRN)**

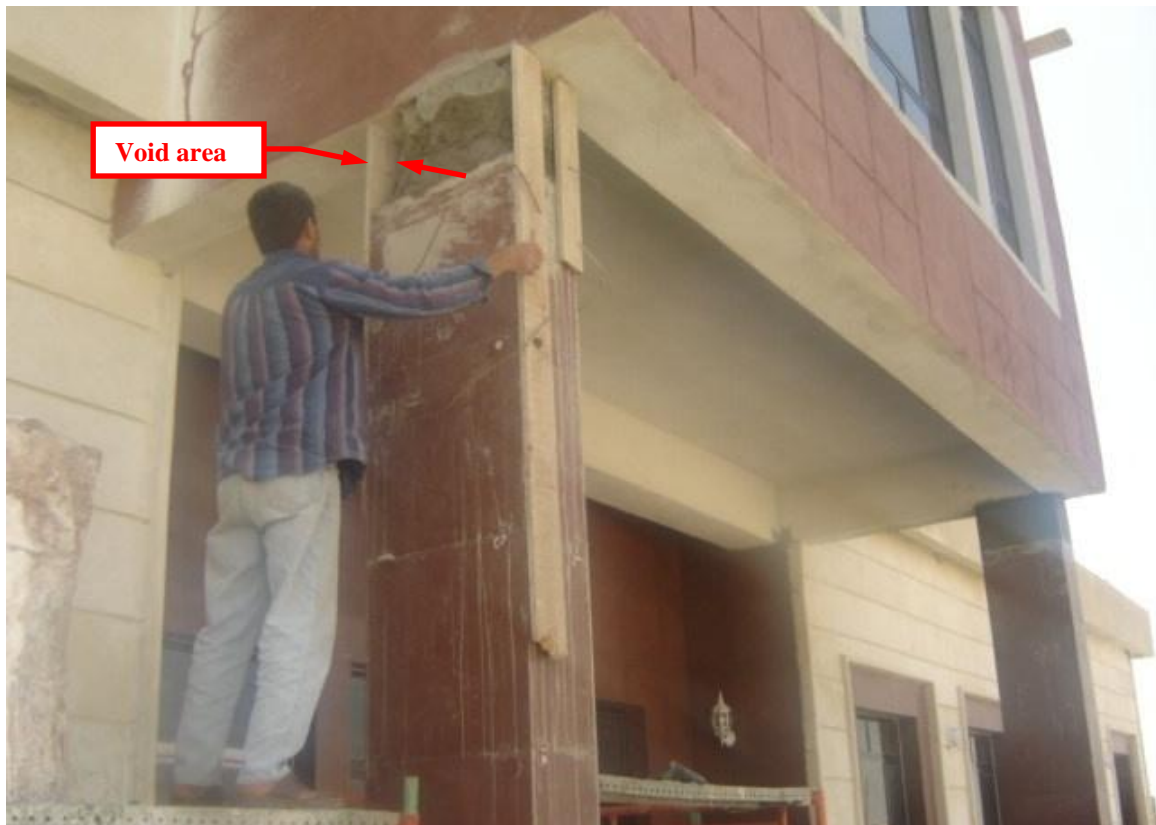
A review of the QA reports and photographs identified an issue with the quality of the connection between the newly constructed column and the original structure. Site Photo 2 shows the exposed connection prior to placement of the finish tile. The column contact area at the connection appears to be significantly less than the cross sectional area of the column. The void area at the connection is also asymmetric and may induce off-center loading of the column that was not anticipated in the design.

**Site Photo 2. Apparent poor quality of beam/column connection  
(Courtesy of GRN)**

The poor quality concrete and the reinforcing steel splice would result in a connection with very little shear capacity. This would severely limit the amount of lateral load transfer at the connection and could result in complete failure of the connection under a lateral load caused by wind or seismic activity.

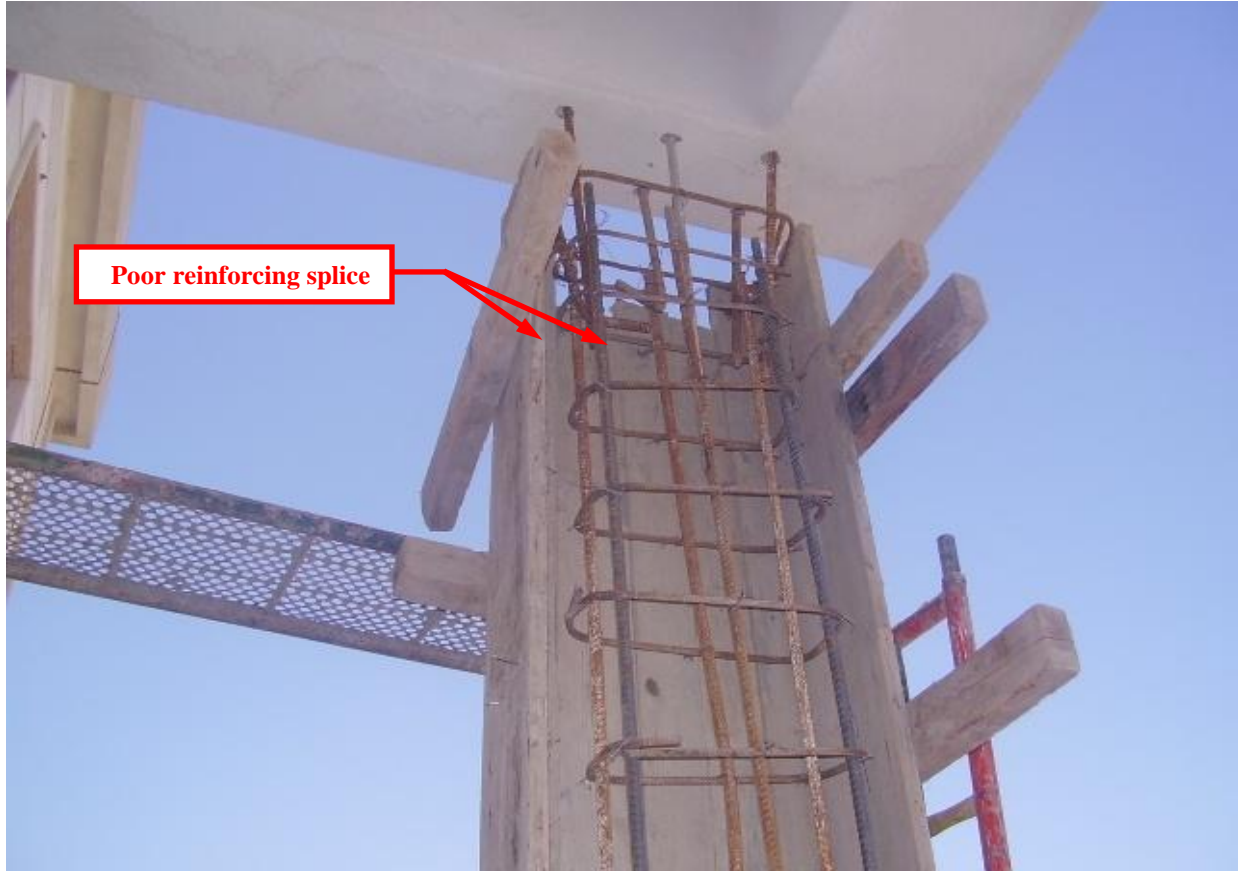
In addition to the poor quality concrete work, the QA representative identified an issue with the reinforcing steel splice. The QA report, dated 7 March 2007, identified Site Photo 3 as “*over lap is not good.*” After reviewing the photograph, SIGIR agreed with this assessment.

**Site Photo 3. Poor quality reinforcing splice (Courtesy of GRN)**

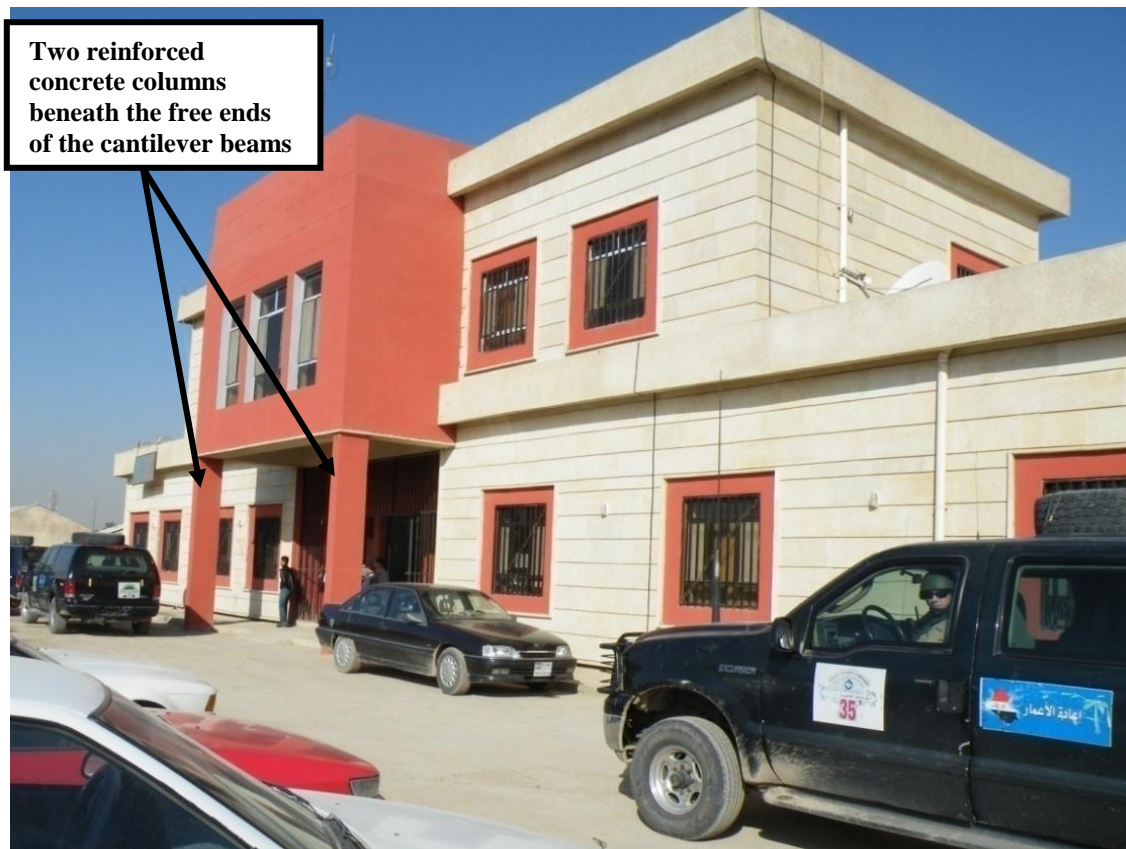
Site Photo 4. Hai Tiseen PHC

On 15 December 2008, SIGIR performed an on-site assessment of the Hai Tiseen PHC (Site Photo 4). A GRN Kirkuk Area Office engineer and the PHC’s administrator accompanied SIGIR during the site visit. Due to security concerns, the time allotted for the site visit was approximately 30 minutes and access to the roof was prohibited. Consequently, SIGIR performed an expedited assessment of the areas available; therefore a review of all work completed was not possible.

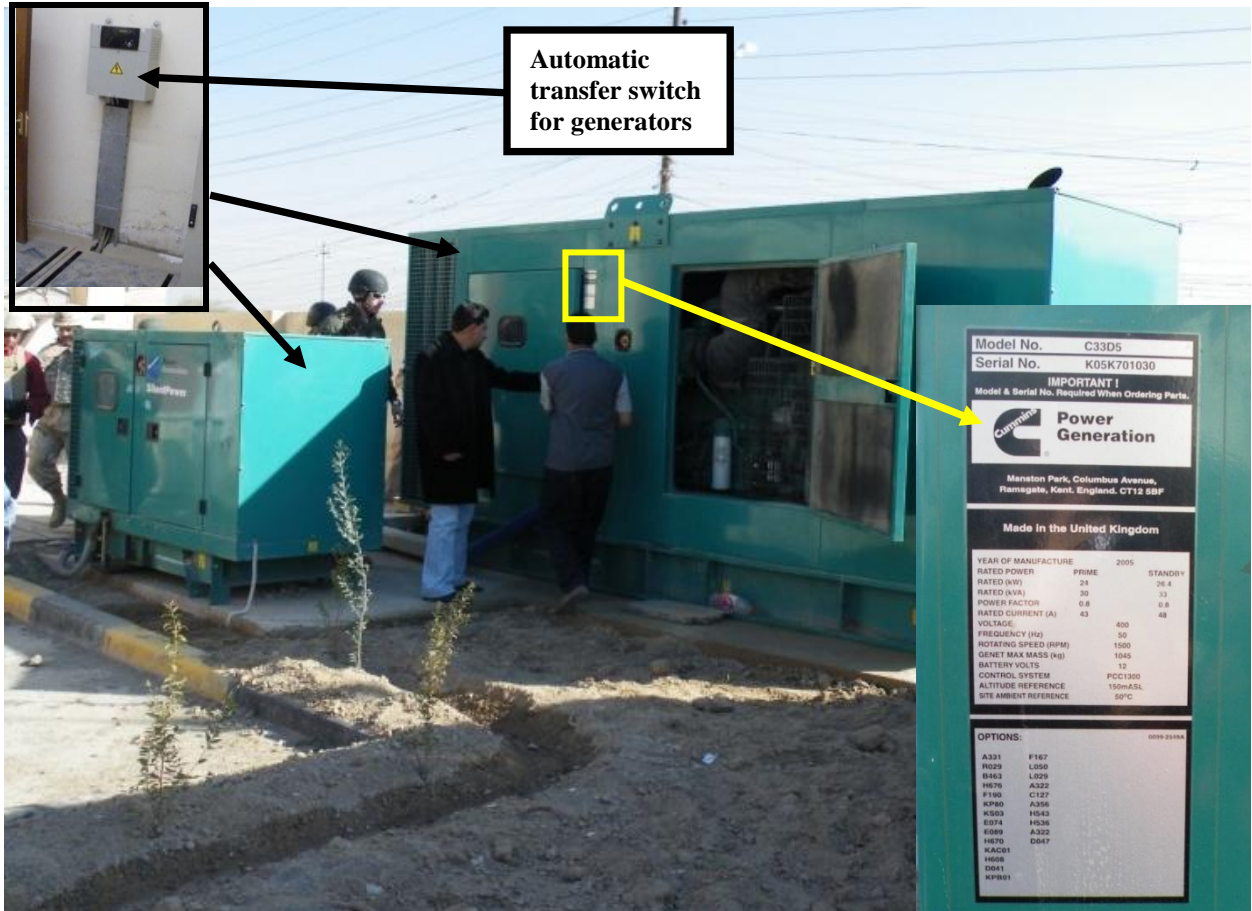
Site Photo 5. Two generators providing primary and emergency backup power for the PHC

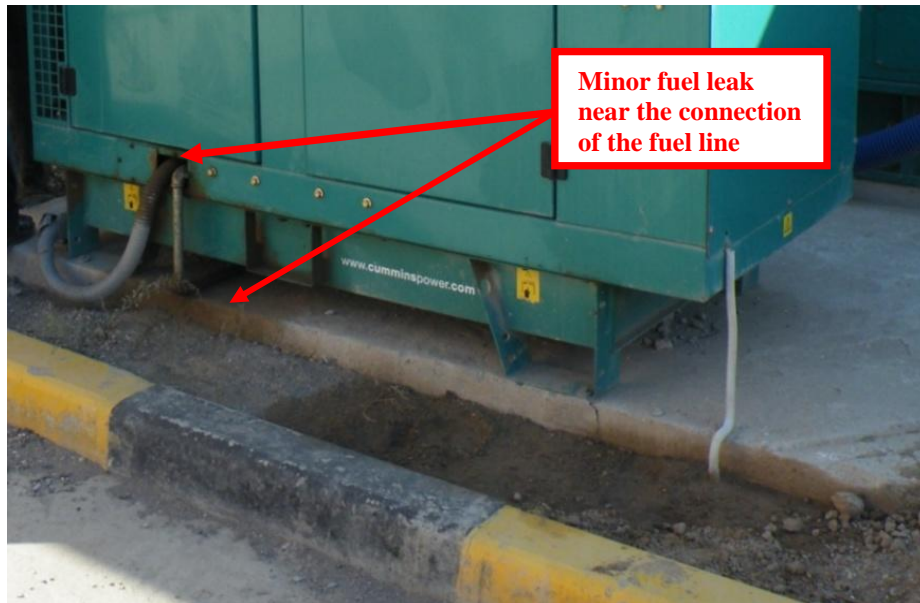
SIGIR noticed evidence of a minor fuel leak from the 500-kV emergency backup generator (Site Photo 6). The minor fuel leak was near the connection of the fuel line to the emergency generator and had spread into the soil in front of the generator. This leak presents a potential fire hazard and the PHC's maintenance staff needs to investigate the cause and repair the problem.

Site Photo 6. Minor fuel leak from 500-kV emergency backup generator

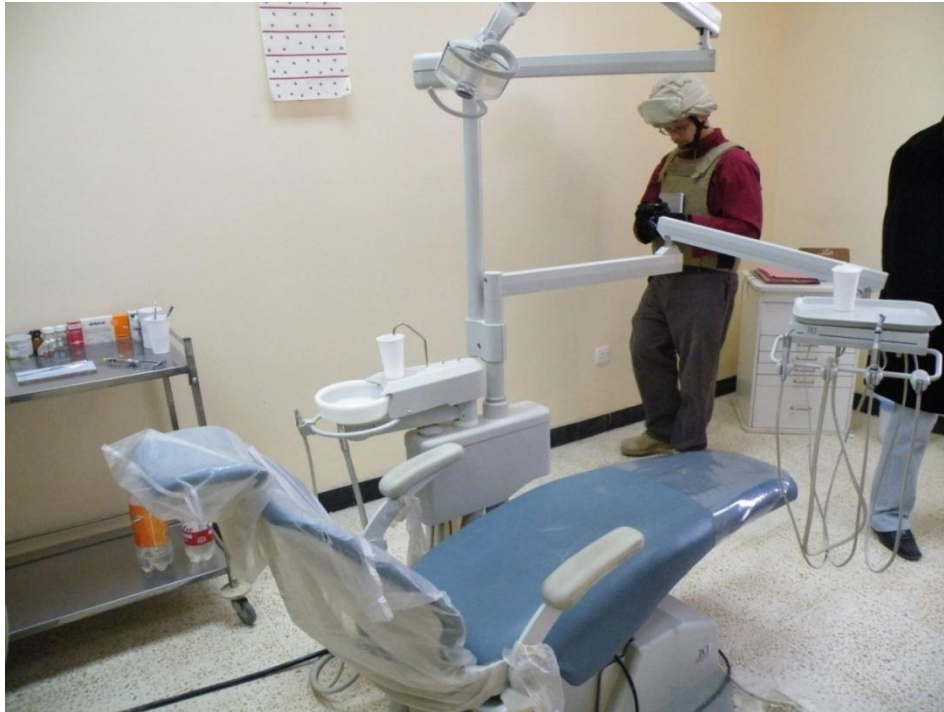
During the site visit, SIGIR observed that the dental chairs were installed. While one dental chair appeared to be in use (Site Photo 8), the second dental chair appeared to have a plugged drain with stagnant water in the rinse basin (Site Photo 9). During the inspection, SIGIR observed a dentist treating a patient while using the working dental chair.

The contractor's installation of the dental chairs, while functional, did not appear to conform to any known plumbing or electric code. The drain for each chair was placed directly into the floor drain with a significant gap between the floor drainpipe and the chair discharge hose. Also, the air lines were not connected for the dental chairs.

**Site Photo 8. Dental chair and tools**

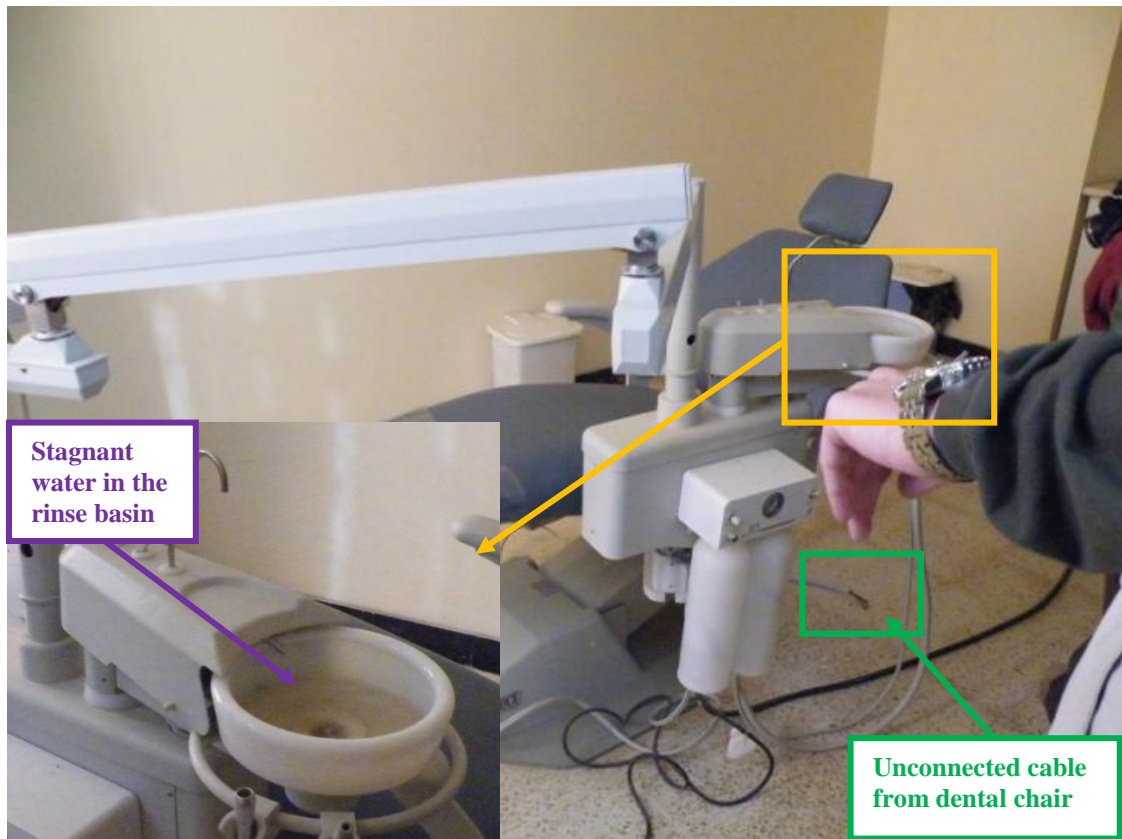
**Site Photo 9. Second dental chair with stagnant water**

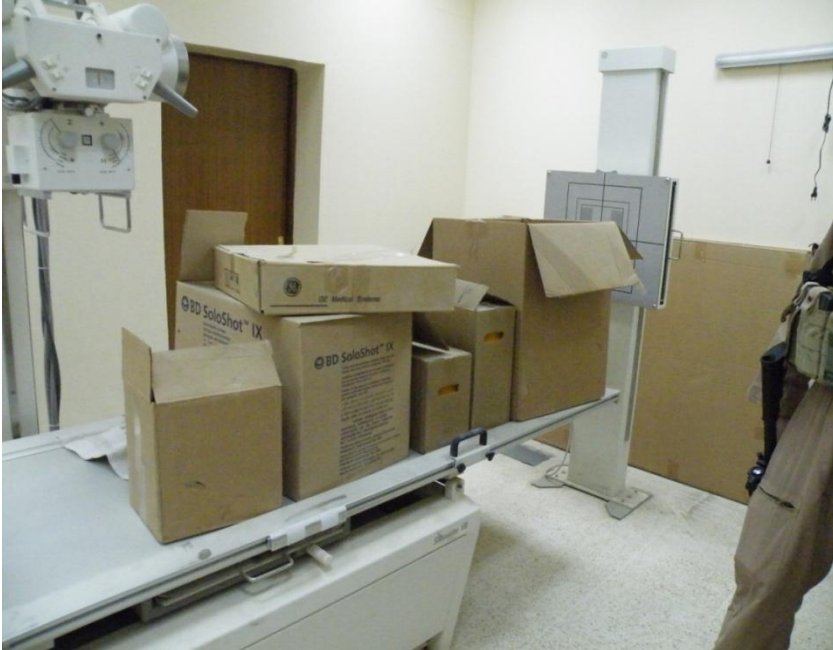
The PHC contract included medical imaging capabilities, specifically an x-ray room and equipment. SIGIR observed that the x-ray equipment was installed (Site Photo 10); however, according to the administrator, the contractor did not verify the equipment was operational. In addition, the administrator stated the facility's staff did not have the technical capability to operate the x-ray equipment; consequently, the facility cannot offer any x-ray services to its patients. Currently, the PHC uses the x-ray room as a medical supply storage room.

**Site Photo 10. X-ray room used as a medical supply storage room**

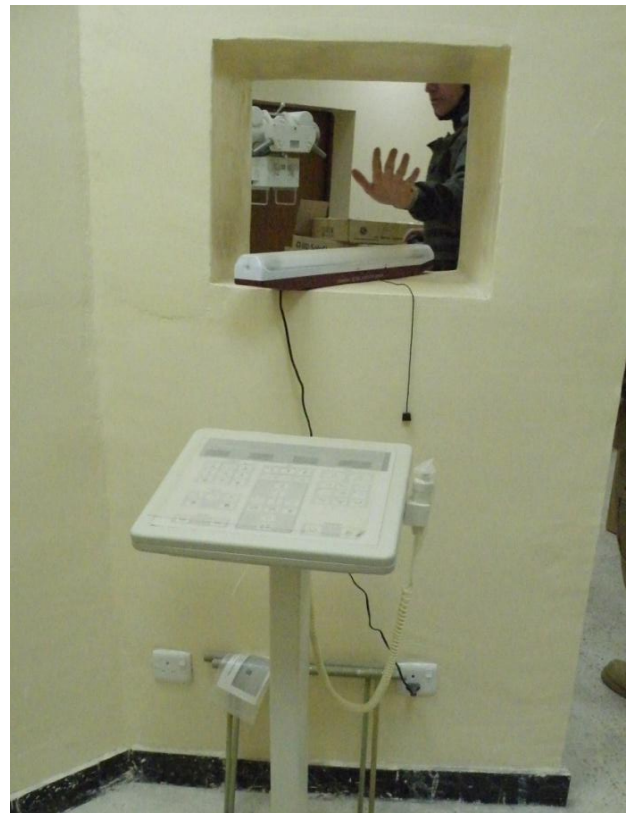
Due to the x-ray equipment emitting low levels of radiation, radiation shielding is required to protect the PHC's personnel and patients. The initial design required mass concrete walls with lead lining, lead lined doors, and a leaded glass observation window to provide radiation shielding.

In the 18 July 2007 acceptance letter, one of the noted deficiencies was "x-ray machine," which was to be "installed later." SIGIR noted that the contractor did install the x-ray machine; however, the contract-required installation of a leaded-glass observation window was not installed nor was it noted as a deficiency on the acceptance letter (Site Photo 11). In addition, SIGIR noticed that the contractor installed x-ray room exterior door and darkroom doors appeared to be standard wooden doors. The inspection team could not verify the presence of lead lining on the concrete walls.

**Site Photo 11. Missing leaded glass observation window**

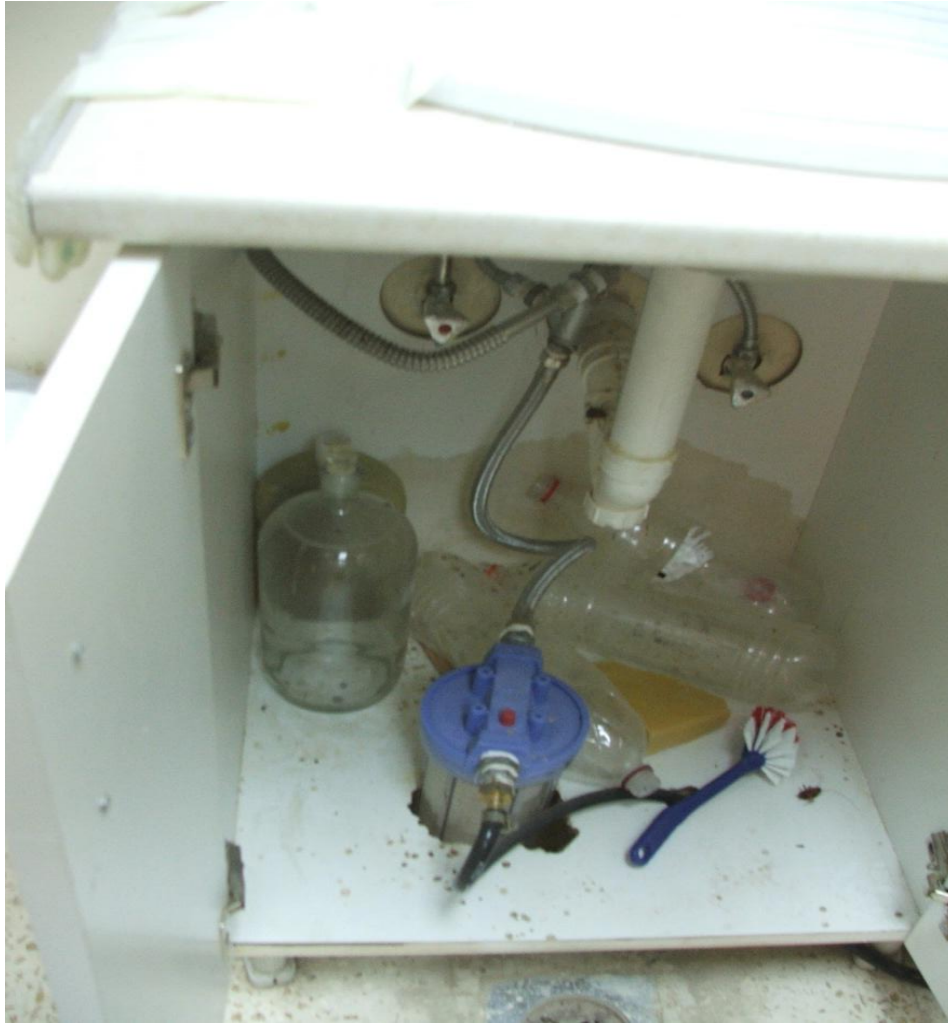
SIGIR did observe an issue with insects inside the PHC; specifically, SIGIR noticed several deceased insects beneath cabinets and on the floor in the dentist's room (Site Photo 12). The presence of vectors in a healthcare facility is unacceptable, since vectors introduce pathogens to patients through direct contact, or secondary contact with contaminated equipment and instruments.

**Site Photo 12. Dead insect and debris underneath the sink in the dentist's room**
