ROLL-ON/ROLL-OFF BERTH
PORT OF UMM QASR, IRAQ

SUSTAINMENT ASSESSMENT

SIGIR PA-08-162
JULY 8, 2009

SUBJECT: Report on Roll-On/Roll-Off Berth, Port of Umm Qasr, Iraq
(SIGIR Report Number PA-08-162)

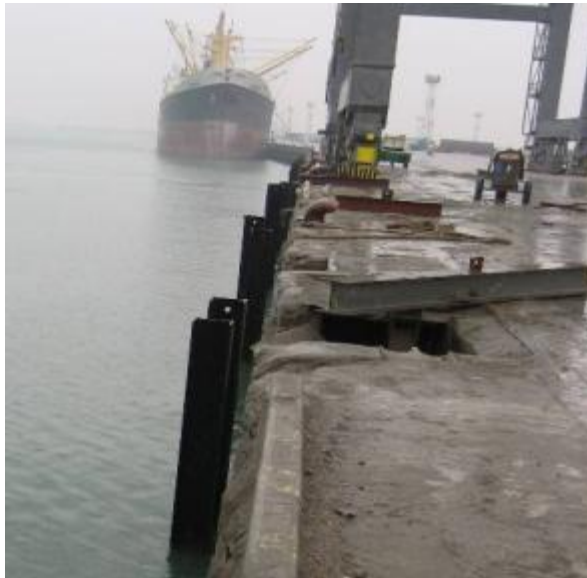
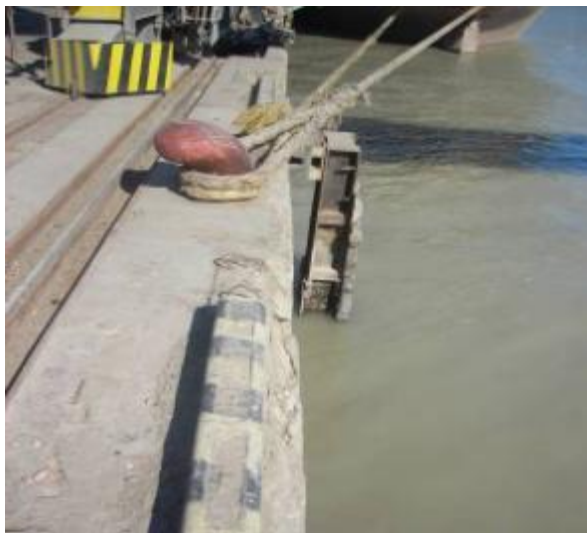
Site Photos 5 and 6. Berth 5 jetty fenders in disrepair (Courtesy of GRS)

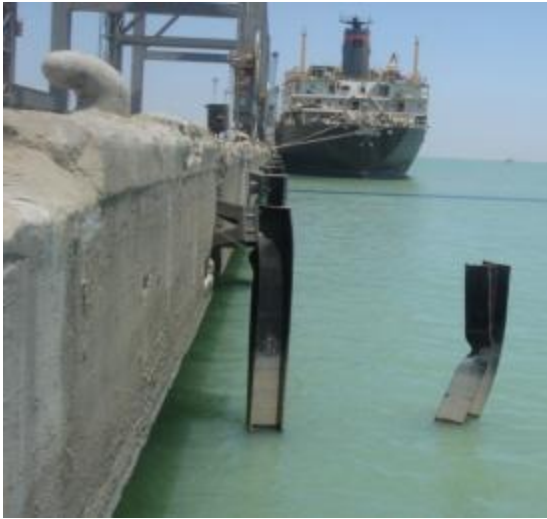
**Site Photo 7. Damaged jetty fenders
(Courtesy of GRS)**

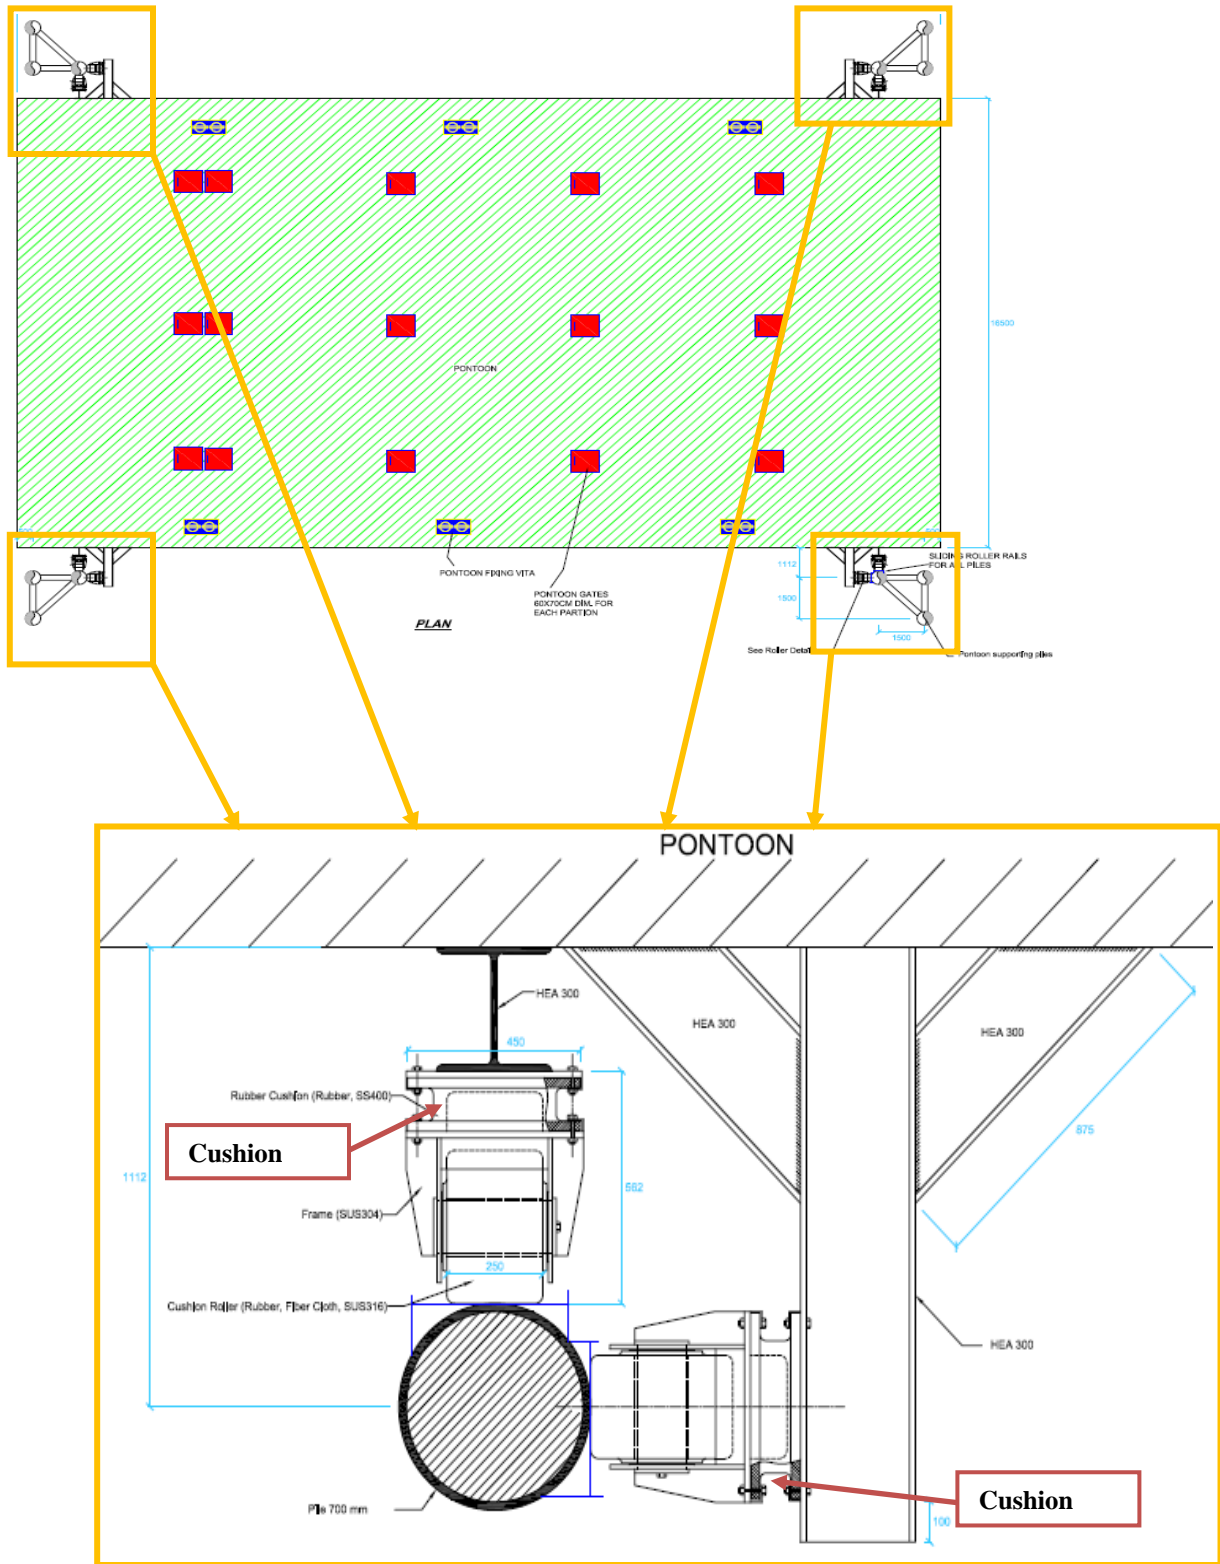
Originally, the contractor designed the cushion roller assemblies with flexible elastomeric mounts (cushions) (Figure 3). The mounts permit relative movement of the rollers and prevent binding on the vertical tracks caused by irregularities in the roller system geometry.

Figure 3. Rails/rollers - enlarged (Courtesy of the USACE)

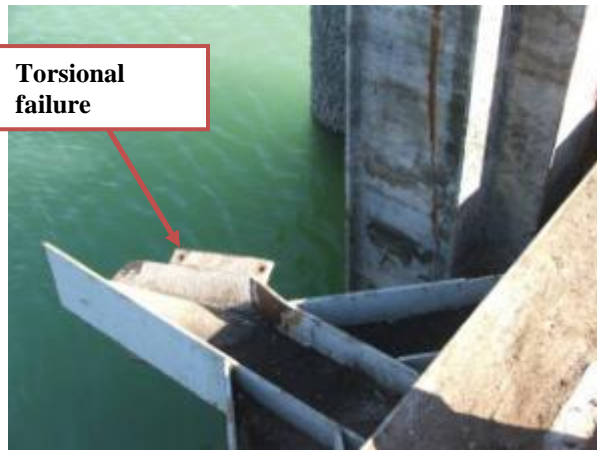
At the time of the site assessment, all four of the rail/roller assemblies had been severely damaged, including missing rollers and bent support beams. The specific cause of the damage could not be determined; however, GRS personnel stated that the damage was caused by careless/rough operations by port personnel. Based on information obtained from the site assessment and SIGIR’s review of the project information, the cause of the damage was inconclusive, but SIGIR noted several factors as likely contributors.

occurred: the damaged steel cantilevers exhibit textbook torsion failure of a steel wide flange section with transverse tearing of the flange (Site Photo 12).

Site Photo 12. Torsional failure of rail/roller

1. Pontoon guide rail and roller assemblies
2. Hinges that connect the steel structure decking and the pontoon decking
3. Two rubber fenders on the berthing dolphins

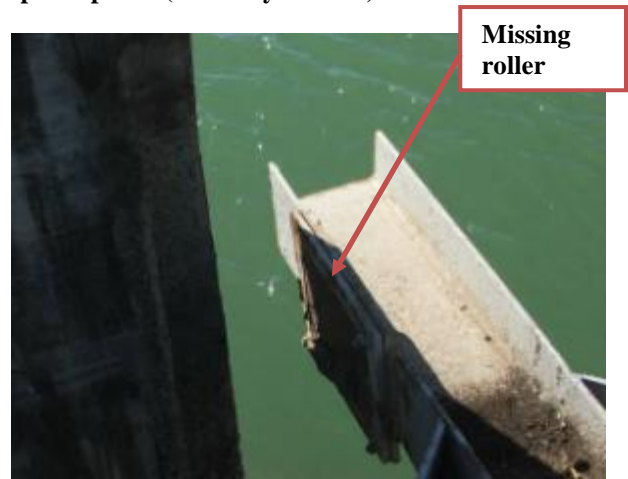
Once a cushion roller assembly is damaged, the change in load path for the remaining roller assemblies could result in overload and additional assembly failures. This appears to have occurred; the roller assemblies are damaged or missing at all four pontoon-supporting pile locations (Site Photo 13).

Factors such as ships approaching the pontoon too fast or poor mooring during storms would increase loading on the roller assemblies and exacerbate the issues with the assembly mounting and potential binding. If present, these factors would accelerate damage of the assemblies.

Another possible cause of the damage to the rail/roller assemblies would be exceeding the maximum ship size to use RORO Berth 22. According to the design calculations, RORO Berth 22 was designed for a 15,000 deadweight tonnage ship with a maximum displacement of 27,500 tons. GRS personnel could not provide information on the size of ships actually using the facility. The continued lack of maintenance or repair of the rail/roller assemblies will result in further damage to the pontoon structure.

Site Photo 13. Missing rail/roller

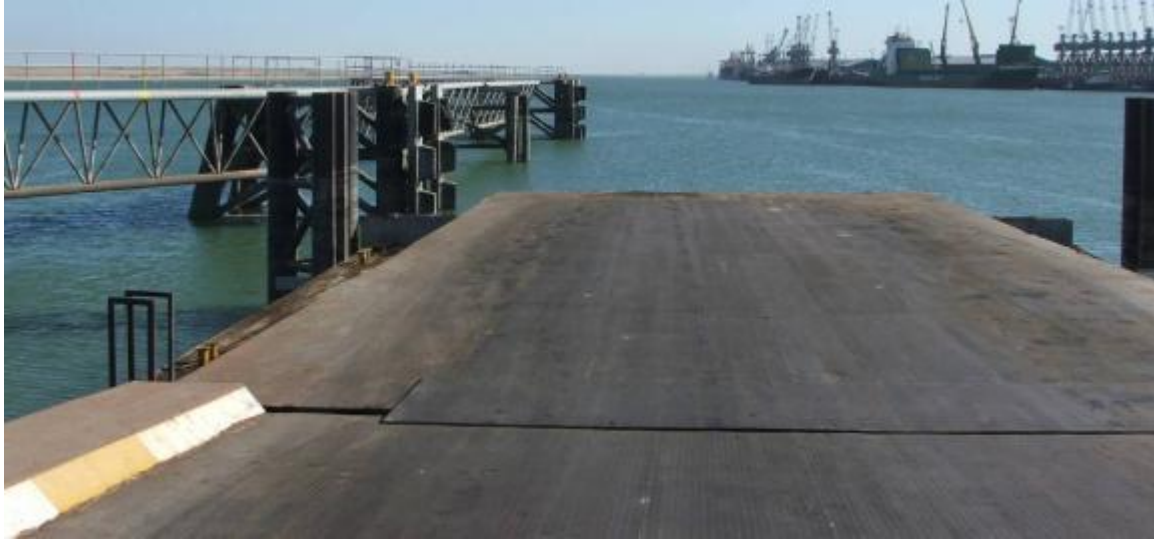
During the site assessment, no ships were docked at the RORO Berth, and no loading or unloading was taking place (Site Photo 14). Unfortunately, as SIGIR departed, a ship was entering the port to dock at RORO Berth 22. Reviewing the docking methods and unloading and/or loading process would have been the best indicator of how the project was functioning, if the current damage is limiting the use of the facility, and if rough docking procedures are damaging the facility.

Site Photo 14. Empty RORO Berth 22

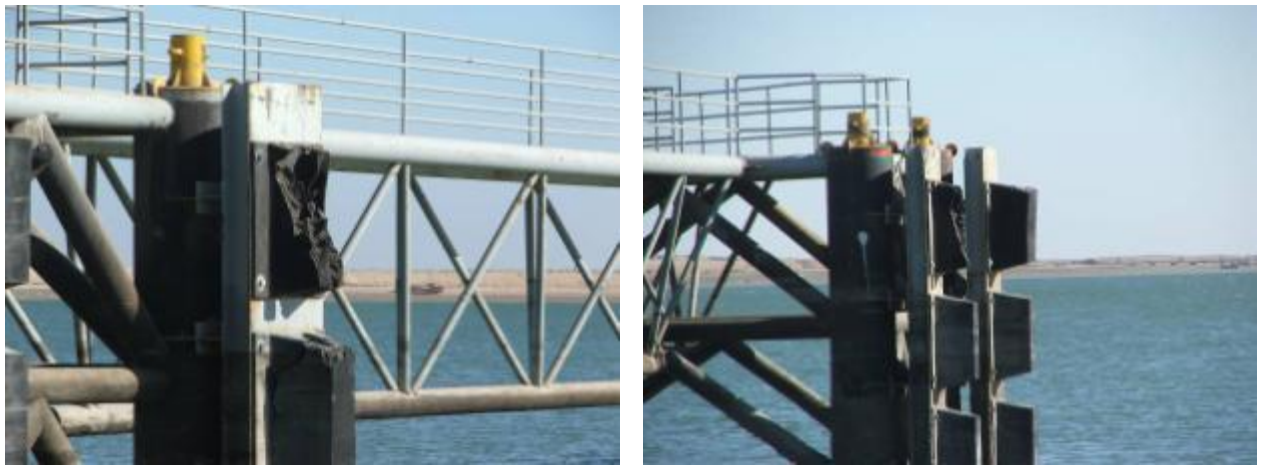
The design showed that RORO Berth 22 fenders were 600 mm high and 1150 mm long. At the time of the inspection, one of the rubber fenders on the first berthing dolphin had been severely damaged. The rubber fender appeared to be sheared off (Site Photos 15 and 16). The specific cause of the damage could not be determined; however, GRS personnel stated that the damage was caused by careless/rough operations by port personnel. In SIGIR's opinion, the damage was probably caused by ships approaching the dolphin too fast or poor mooring during storms. The damage will not have a significant impact on the operations of the facility; SIGIR considers this a minor maintenance issue.

Site Photos 15 and 16. RORO Berth 22 sheared rubber fenders

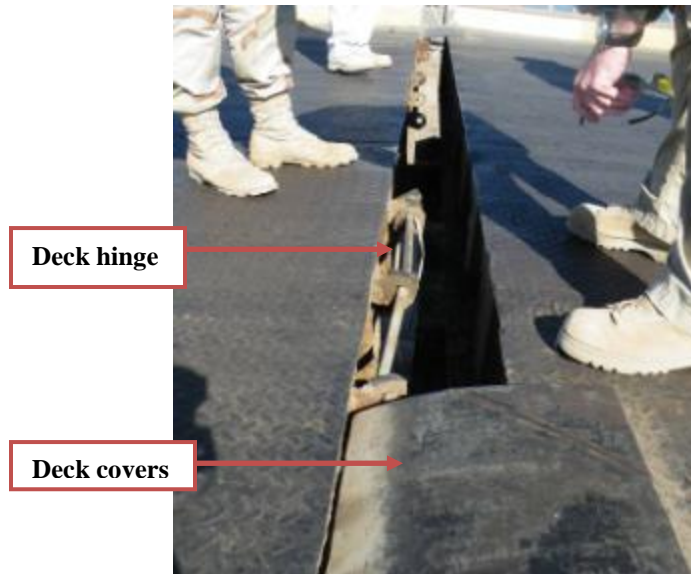
The contractor installed steel deck hinges to connect the fixed steel decking to the ramp decking. At the time of the site assessment, the steel deck hinges were damaged (Site Photo 17). The damage included missing hinges and steel deck covers. The specific cause of the damage could not be determined; however, the damage appears to be caused

by careless operation of vehicles and rolling stock¹¹ or traveling at excessive speeds over the hinge. In addition, SIGIR concludes that the damage of the cushion roller assemblies and resulting movement of the pontoon and attached ramp misaligned the ramp and exposed the plate to impact from vehicles and rolling stock.

Site Photo 17. RORO Berth 22 deck hinges
