**RABEAA POINT OF ENTRY  
SCREENING FACILITY  
RABEAA, IRAQ**

**SIGIR PA-09-173  
JANUARY 11, 2010**

## Rabeaa Point of Entry Screening Facility

### Summary of Report: PA-09-173

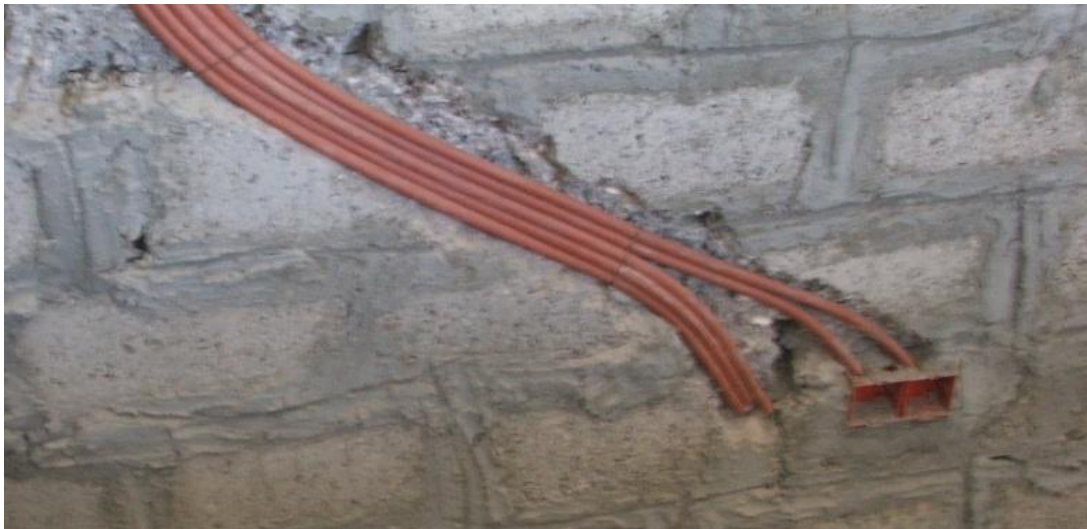
The conduit for future electrical wiring was embedded in the interior masonry walls (Site Photo 5). The SOW, Section 26.2.1 required that all building electrical lines were to be "surface mounted in conduit vice embedded." In addition, the conduit used did not match the COR approved product submittal.

**Site Photo 5. Electrical conduit embedded in interior wall**

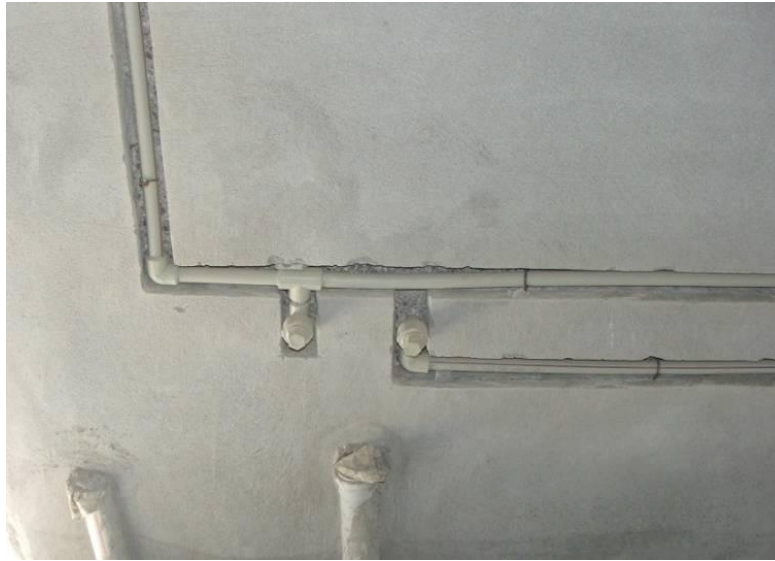
SOW, Section 22.5.3 required the contractor to use "schedule 40 galvanized steel pipes" and the water lines were to be surface mounted. The COR approved the use of a Turkish made product, pilsatherm (plastic) pipe, in a product data submittal. SIGIR noted that the COR approved a different water pipe product even though the pilsatherm pipe data submittal was unclear whether it met the International Plumbing Code standards as required by the SOW, Section 21.1.1. Also, the COR did not provide a contract price adjustment that should have been calculated when approving cheaper products and installation methods. At the time of the site visit, SIGIR noted that the potable water

lines were embedded in the masonry walls and were constructed using polypropylene (plastic) pipe (Site Photo 6).

**Site Photo 6. "Pilsatherm" water pipes embedded along exterior wall**

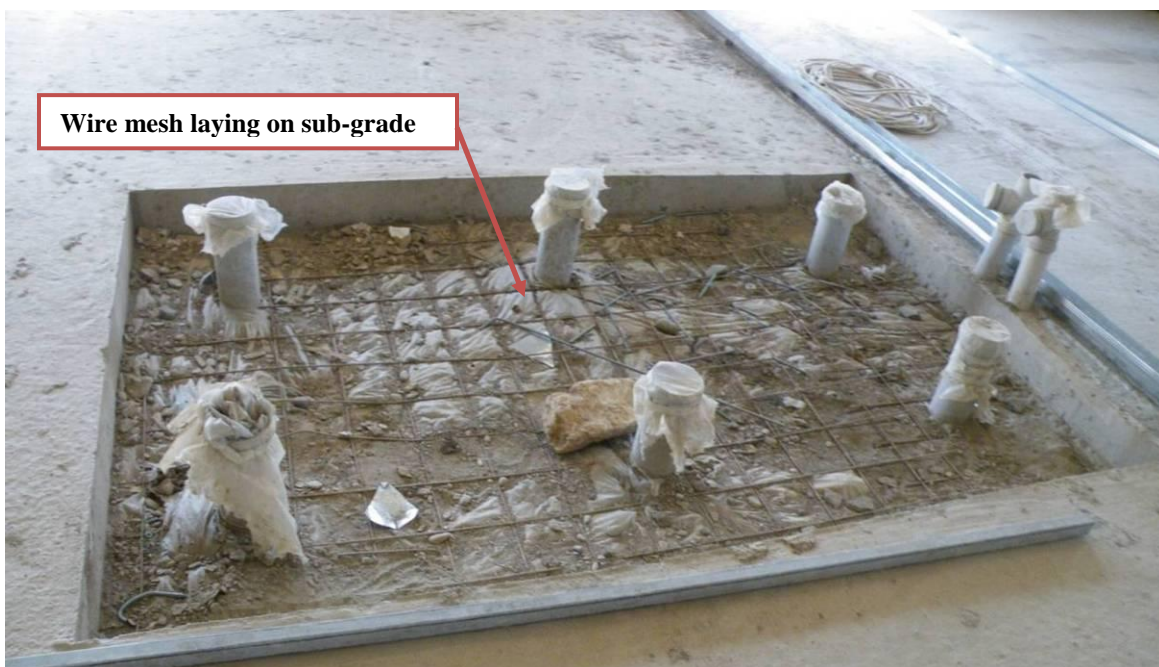
The SOW, Section 22.7.1 and 22.8.1 stated that the contractor was to provide sewer piping of "ductile steel with a minimum 100 millimeter (mm) diameter." In the product data submittal documents provided by GRN, the COR approved the use of the Turkish pilsa (type of plastic) 9001 series pipe. Although SIGIR would not recommend the use of ductile steel pipe, the COR did not provide a contract price adjustment when approving the pilsa 9001 series pipe for the contractor to use. Also, the pilsa pipe data submittal provided by GRN was unclear as to whether the pilsa 9001 series pipe met the International Plumbing Code. At the time of the site assessment, the contractor installed the sanitary sewer piping under the concrete floor slab with polyvinyl chloride (plastic) pipe (Site Photo 7).

**Site Photo 7. "Pilsa 9001" sewer pipes under floor slab**

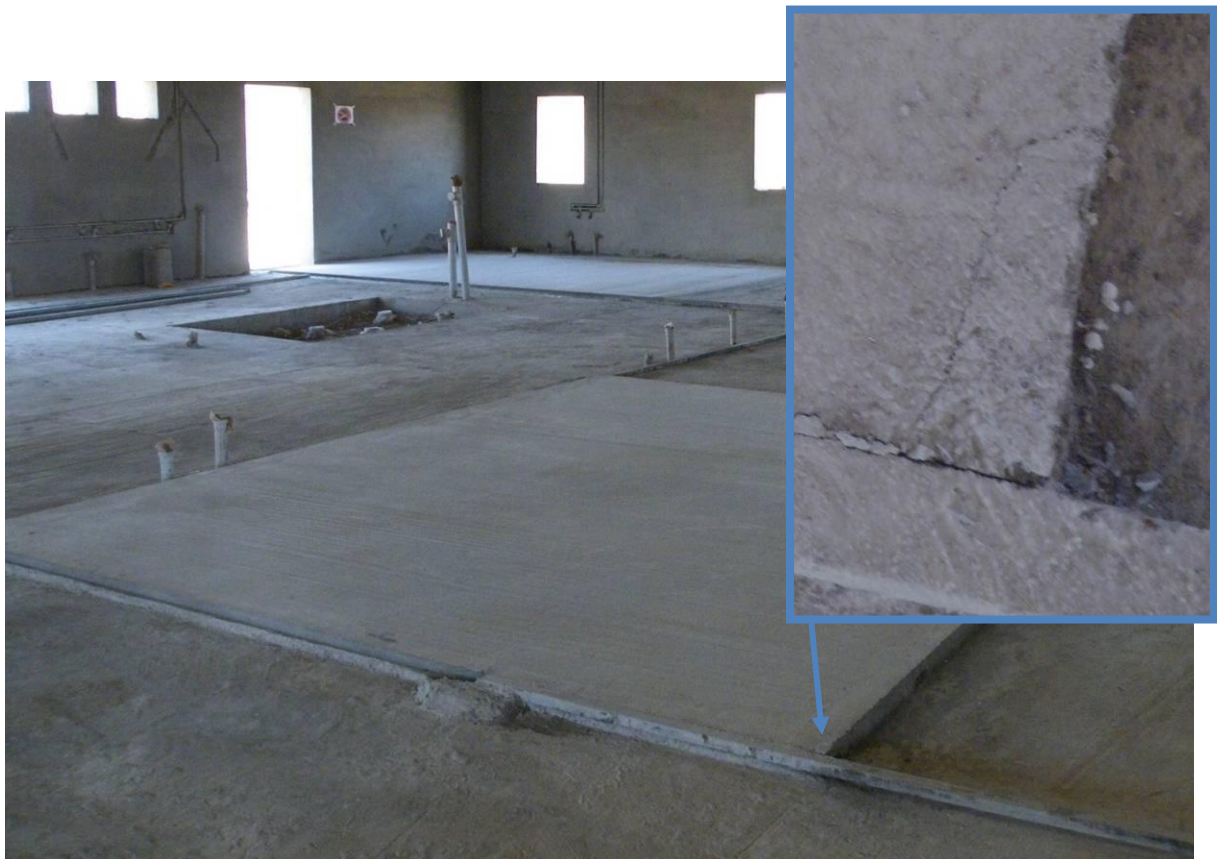
The concrete floor slab was constructed in two separate lifts (Site Photo 8). A thicker rough finish slab, estimated at 150mm thick, was poured throughout the building, except for areas where pipe penetrations were necessary. At the time of the site assessment, the contractor was starting to pour the second thinner mortar overlay, estimated to be 45mm thick, where the contractor was to lay the ceramic tile on top. SIGIR noticed that the construction of the floor slab showed improper jointing, unlevel construction, and cracking of the thin mortar overlay. In addition, SIGIR noticed from the missing sections of the floor slab that the wire mesh was laying on the sub-grade and was not lifted up properly (Site Photo 7).

**Site Photo 8. Construction of mortar overlay on floor slab.**

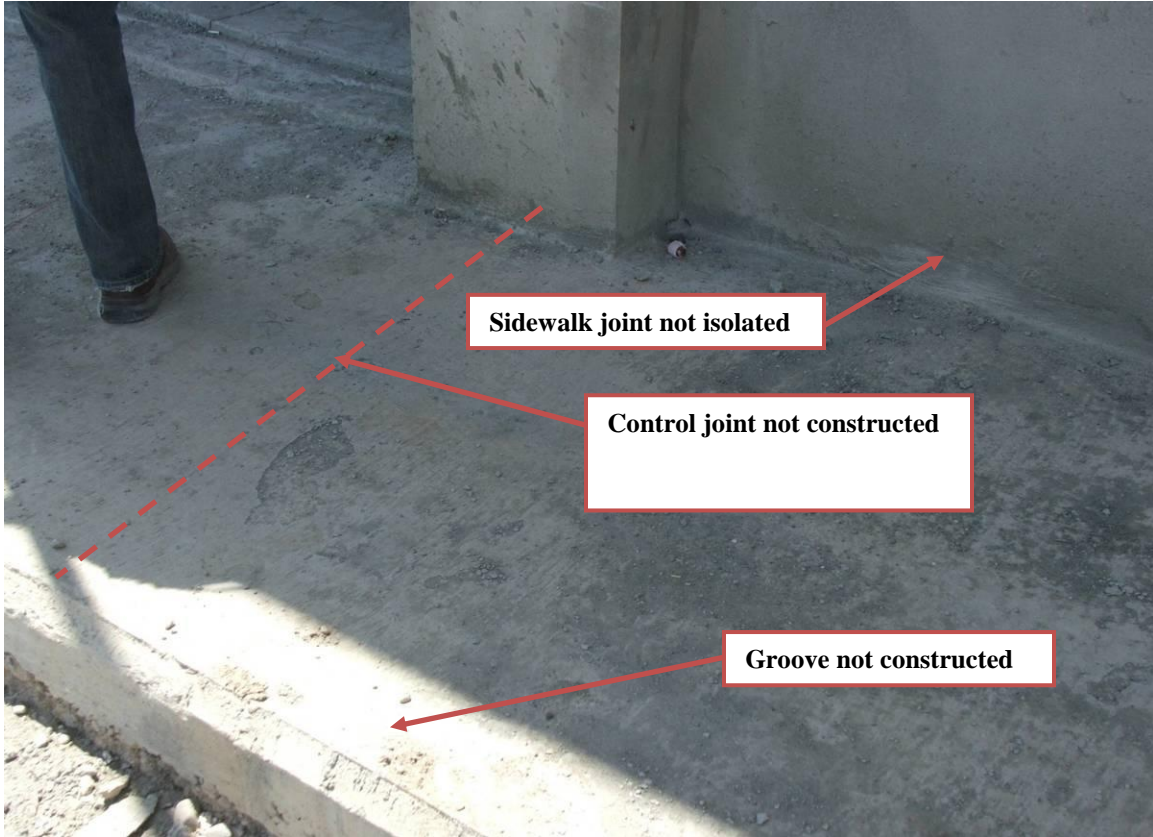
At the time of the site assessment, the exterior sidewalk was partially constructed; the construction was determined to be lacking an isolation joint next to the building, control joints, and a 200mm groove (Site Photo 9). Both the isolation joint and the groove were included in the 100% drawings submitted for approval (Figure 5). The control joints (contraction joints) were required every 1.2 meters (m) per a special note on the plans.

**Site Photo 9. Construction of exterior sidewalk**

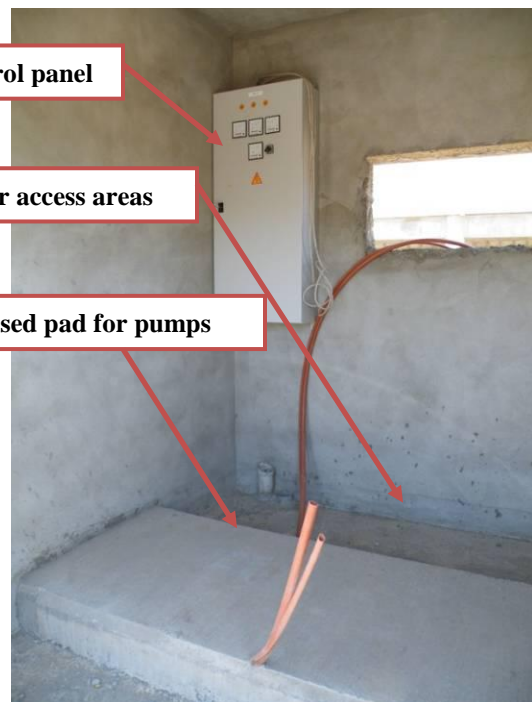
Although the construction of the water pump house was partially completed, SIGIR noted that the construction of the raised concrete pump pad was not constructed in accordance with the drawings (Figure 6 and Site Photo 10). Specifically, the raised floor as submitted on the plans was a 1.8m square raised concrete pad. The actual construction of the raised concrete pad was not configured in a square and did not allow for access against one exterior wall. Once the booster pumps are placed on the concrete pad, the access to the electrical control panel could be impeded. The original design allowed for unimpeded access all around the raised pump pad.

Site Photo 10. 100% Water pump room - actual construction

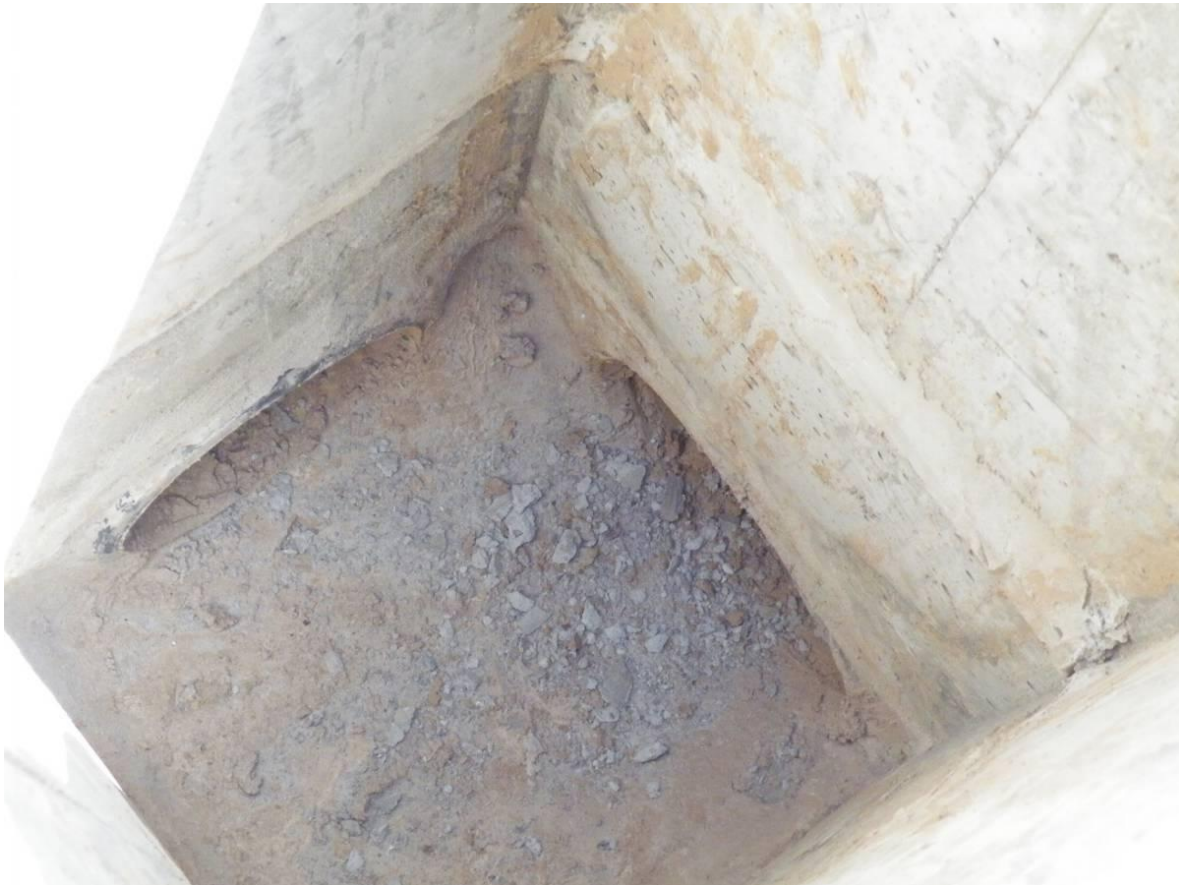
The sanitary sewer manhole contained debris in the bottom of the manhole and the sewer line. Also, the manhole lacked any access steps (Site Photo 11).

**Site Photo 11. Sanitary sewer manhole with debris and no access steps**

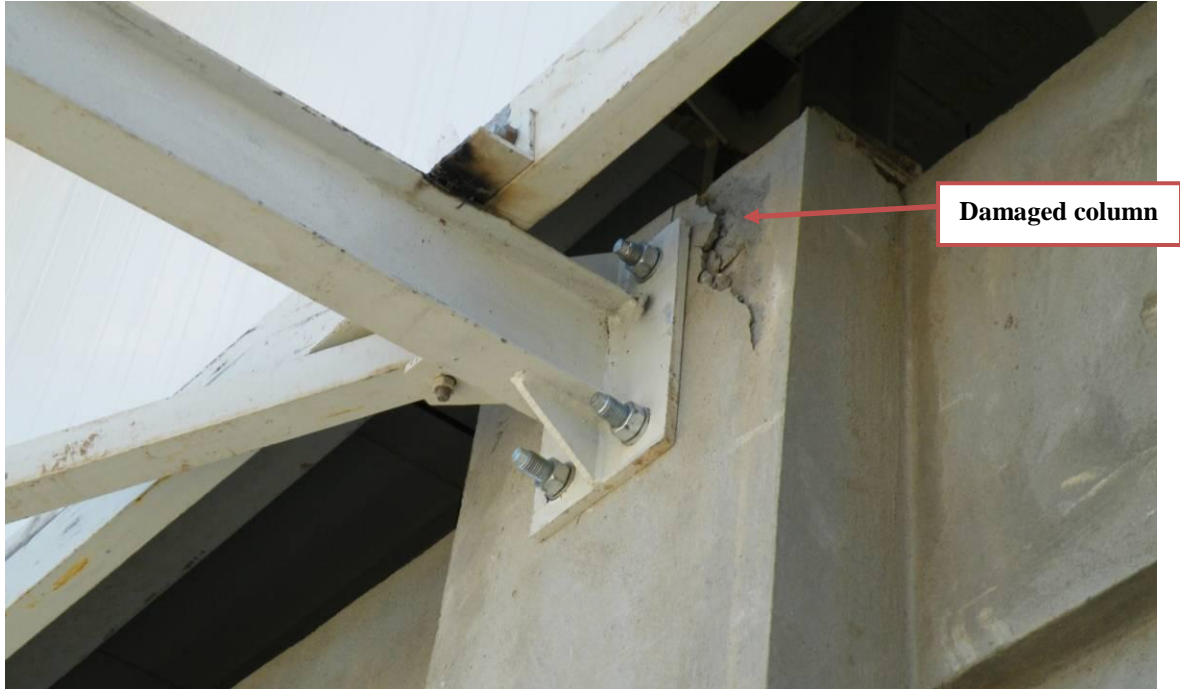
SIGIR determined that the construction of the perimeter awning was defective and required repair. The anchor bolts that attached the steel structural shade to the building columns were not embedded in the columns correctly and caused damage to the column (Site Photo 12). Also, SIGIR noted that the contractor hit steel reinforcement while drilling holes for the anchor bolts, which caused damage to the columns (Site Photo 13). If the anchor bolts were embedded in the columns before pouring the columns, the need for drilling holes would have been unnecessary. SIGIR found no evidence that epoxy or expanding fasteners were used to ensure that the anchor bolts were securely fixed into the columns. The anchor bolts should be load tested prior to the structural members being erected.

**Site Photo 12. Column damage from unsecured anchor bolts**

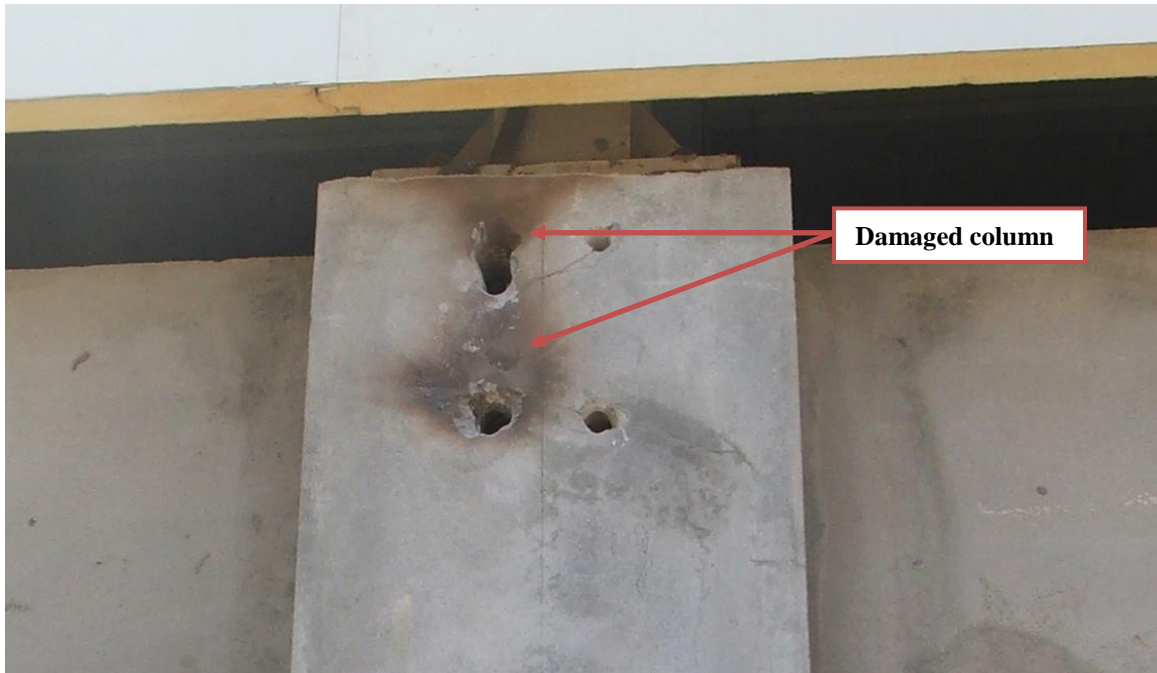
**Site Photo 13. Column damage from drilling holes for anchor bolts**

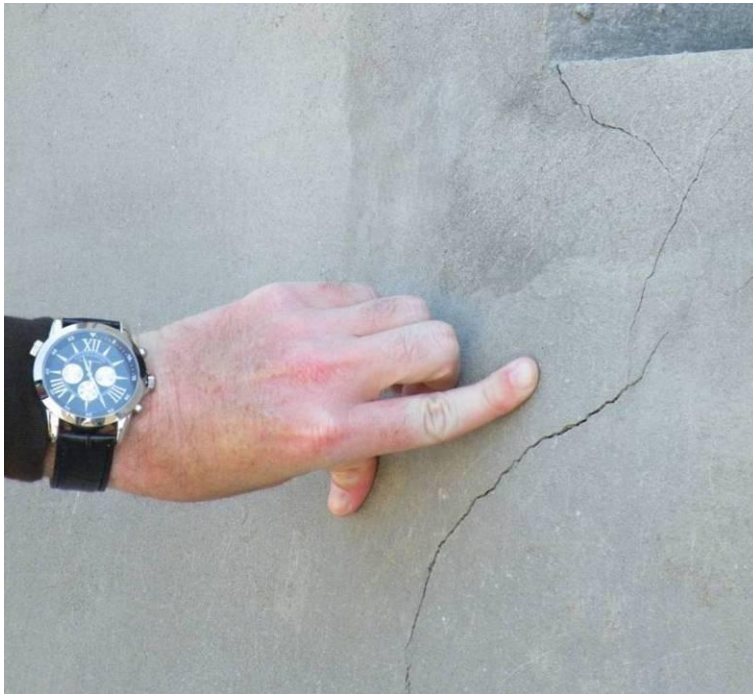
SIGIR observed that the west end of the building contained significant cracking of the mortar surface coating of masonry block and concrete columns (Site Photo 14). The damage appeared limited to the west end of the building. However, SIGIR was unable to determine why the damage occurred, and informed the GRN Mosul Area Office representative that the cracking could be due to shrinkage.

**Site Photo 14. Cracking of the surface coating on the block walls and columns**

14, page 17 of the report. Had the crack been a structural default the crack would have been more vertical or horizontal.

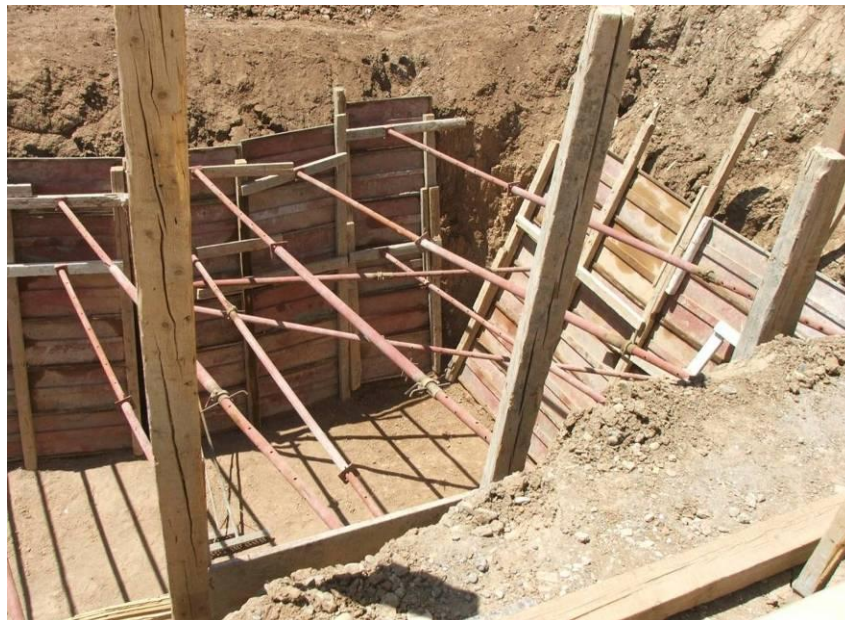
Further, SIGIR noted that the construction site continues to have on-going safety issues. According to GRN Mosul Area Office representatives, a “Stop Work Order” was issued on 17 March 2009, when an employee fell to his death while not following proper safety procedures. The “Stop Work Order” was on-going at the time of the site assessment and a review of the safety plans and on-site safety procedures was being conducted. SIGIR observed that the project site was unsafe due to the open excavations for the sanitary sewer lines and septic tank. The trench excavations either lacked shoring completely or were improperly braced (Site Photo 15).

**Site Photo 15. Improperly braced shoring for septic tank construction.**

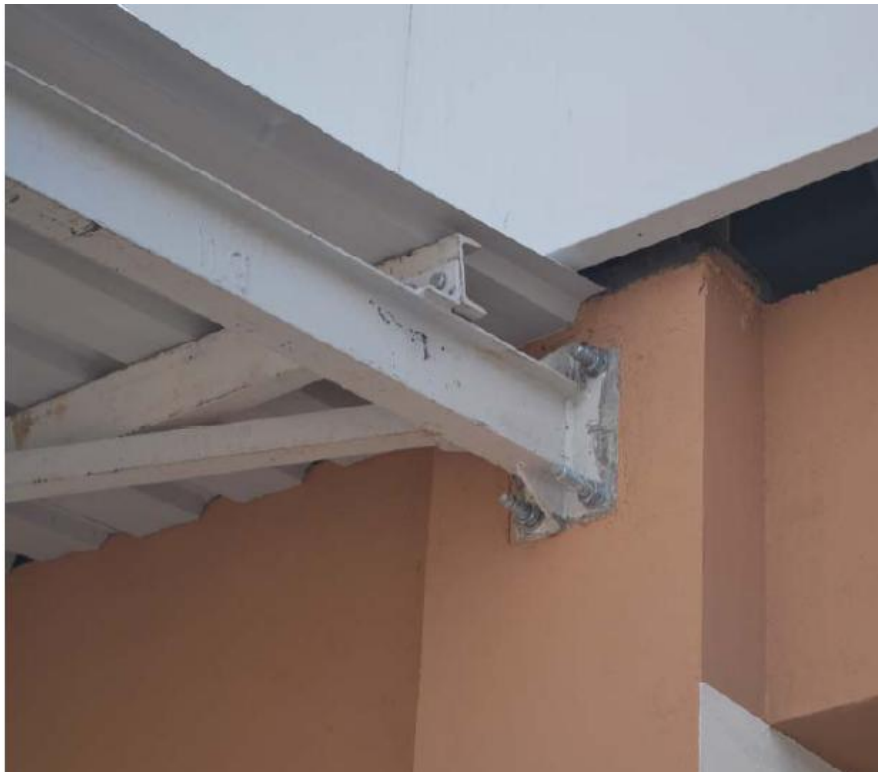
Site Photo 16. Corrective fix to the perimeter awning (Courtesy of USACE)

Subsequent to the SIGIR site visit, the Mosul Area Office representative provided information and photographic confirmation of action taken by the contractor on the perimeter awning issue. The photograph shows the repaired awning connection with the epoxy adhered anchor bolts embedded in the columns (Site Photo 16).
