HAMMAM AL ALIL DIVISION TRAINING
CENTER
MOSUL, IRAQ

SIGIR PA-09-174
JANUARY 7, 2010

Summary of Report: PA-09-174

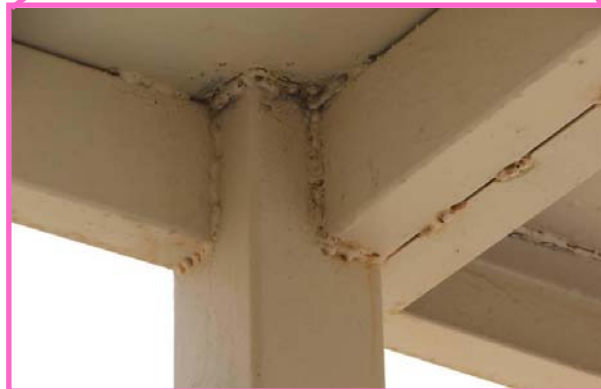
The contractor furnished metal containers for target storage and administrative materials that were located inside the chain link fence. Range towers were constructed directly behind the firing positions and had a roof, staircase, and spotlight. The range towers were constructed with steel framing and metal plate decking which were joined together with what SIGIR observed to be poor quality welding (Site Photo 3). However, the connections used the entire perimeter of the joining members as faying⁵ surfaces, and relatively light loads were expected in the tower, so the connections appeared adequate (Site Photo 4).

Site Photo 4. Poor weld quality at connections

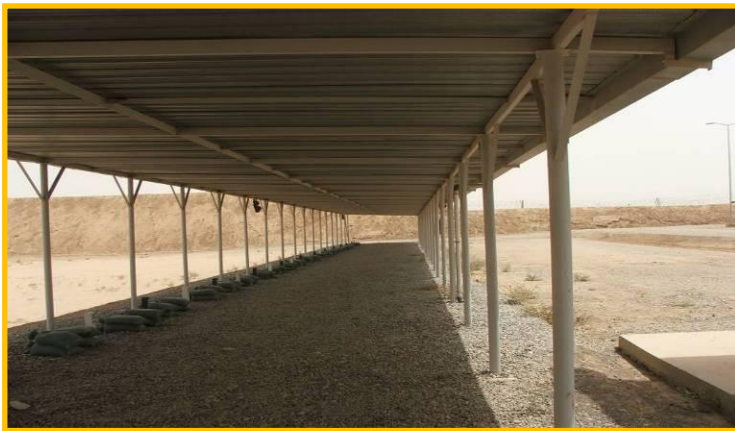
At the up-range end of the small arms range were the outdoor training facility bleachers, and firing positions (Figure 4). The firing positions were constructed with coarse aggregate pads and an overhead sunshade (Site Photo 5). The contractor constructed the sunshades over the firing positions with corrugated metal roofing supported on steel framing.

Site Photo 5. Firing positions

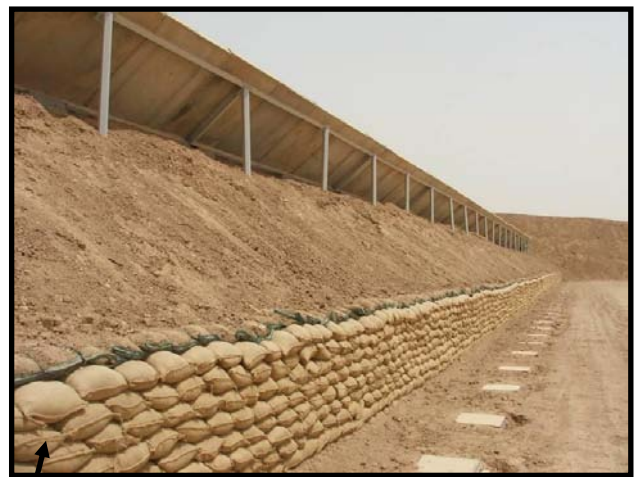
The GRN Mosul Area Office representative stated that the original construction for the ricochet catcher included light gage steel angles supporting the concrete panels. After initial construction, the angles failed under the weight of the panels, and the contractor was required to replace the angles with steel I-beam sections.

Site Photo 6. Ricochet catcher

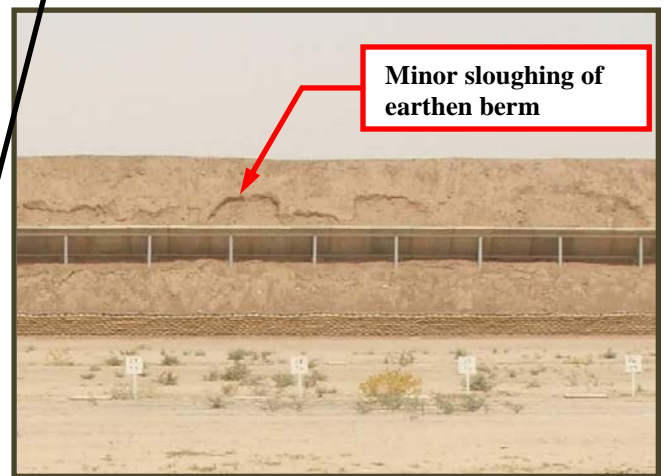
Site Photo 7. Earthen berm

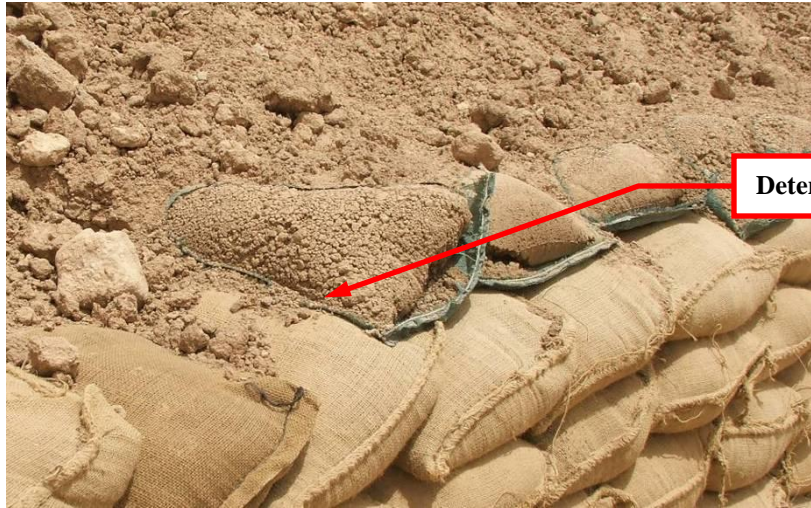
The contractor was required to provide 1,500 sandbags, filled with sand, for the project. During the site assessment, SIGIR observed that the contractor used two different types of sandbags. The contractor used one type of sandbag that was natural fiber and a second type of sandbag that was constructed from polypropylene (type of plastic). Polypropylene sandbags are known to degrade in sunlight; therefore, polypropylene sandbags require covering to prevent deterioration. Several of the polypropylene sandbags had already deteriorated (Site Photo 8). In addition, the contractor used the polypropylene sandbags to construct a headwall for the drainage pipe through the earthen embankment (Site Photo 9). At the time of the site assessment, a majority of the sandbags used in the construction of the headwall were disintegrating. The failure of the headwall coupled with the instability of the slope material will likely lead to a localized collapse of the berm, which will result in blocking the drainage pipe.

Site Photo 8. Deteriorating sandbags

2. Require the contractor to replace all of the deteriorating sandbags located at the division training center project while the warranty is valid.

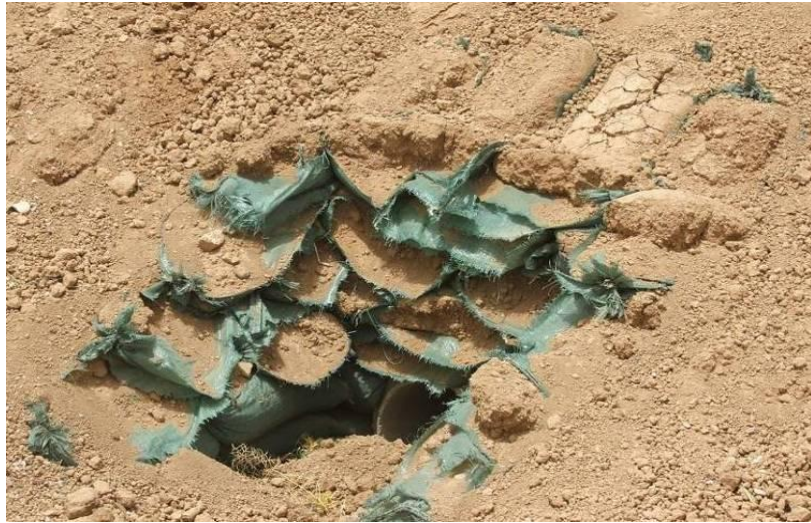
Site Photo 9. Deteriorating headwall

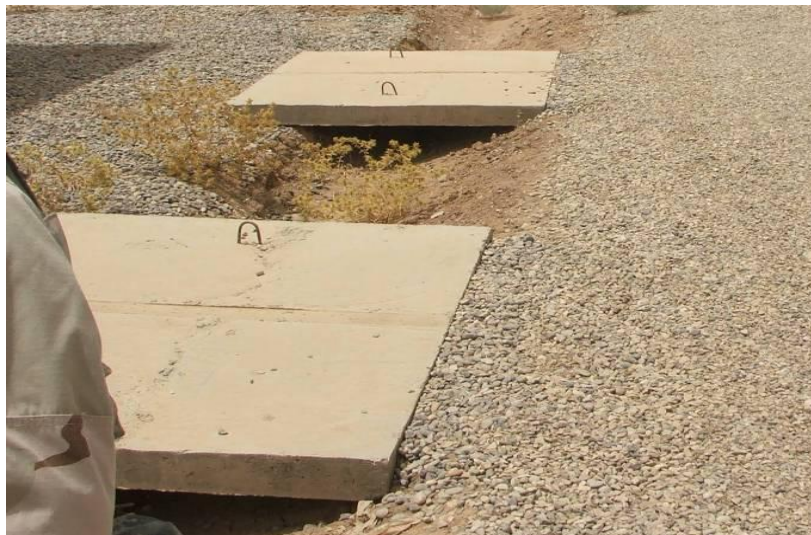
In addition to piping, roadside swales⁹ were constructed to convey runoff away from the range site. The contractor used precast concrete planks in several areas as footbridges over the swale (Site Photo 10). SIGIR observed a safety hazard where the contractor had not removed the rebar lifting lugs from the panels

Site Photo 10. Precast concrete panel footbridge

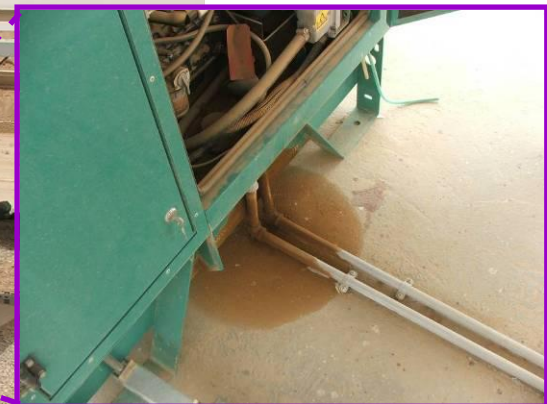
The generator was connected to the fuel tank with galvanized steel piping. SIGIR noted that there was evidence of a fuel leak at one of the joints in the fuel line (Site Photo 12). The GRN Mosul Area Office representative stated that the leak was previously discovered and repaired and that the fuel noted during the site assessment was from an earlier leak. As the Gulf Region District of USACE stated in response to a draft of this report: “Given the frequent sand and dust storms in Iraq, dirt would have re-accumulated had the pipes and foundation been pressure washed or replaced when the leak was repaired.”

Site Photo 12. Fuel leak at joint

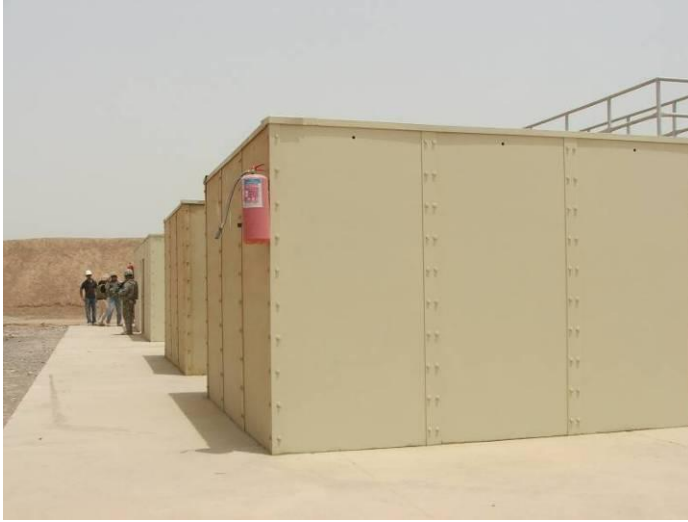
No significant cracking or displacement of the slab was observed, although minor shrinkage and cracking were present, which indicates poor curing practice. However, the minor shrinkage and cracking should not affect the structural integrity of the slab. The training structures utilized modular, panelized construction with bolted connections between the panels. The training structures were constructed without a roof. The panels were arranged to provide rooms and corridors with some panels containing entry doors (Site Photo 14).

Site Photo 13. MOUT facility exterior

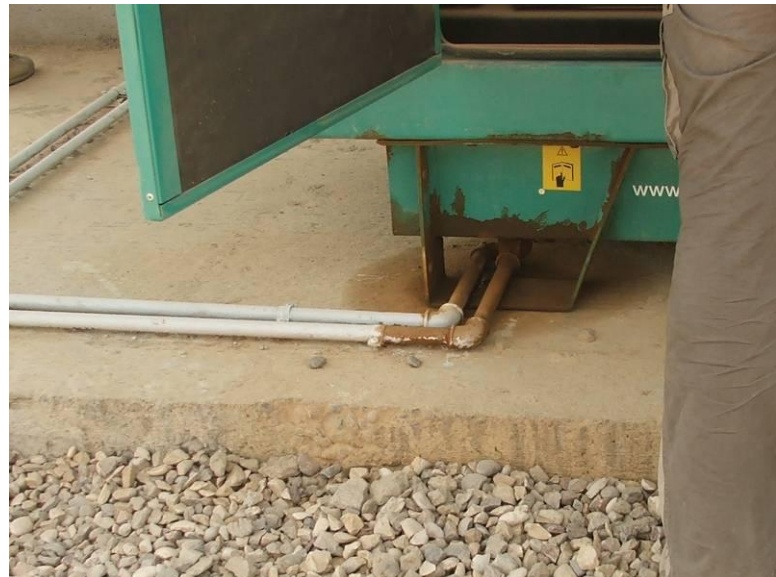
The generator was connected to the fuel tank with galvanized steel piping. SIGIR noted that there was evidence of a fuel leak at one of the joints in the fuel line (Site Photo 17). The GRN Mosul Area Office representative stated that the leak was previously discovered and repaired and that the fuel seepage noted during the site assessment was from an earlier leak. During the site assessment, the GRN Mosul Area Office representative attempted to start the generator. The generator started, but did not continuously function. Due to the limited time available, SIGIR was unable to determine the cause of the generator fault. However, the generator not functioning could be due to a lack of system load and not a defect in the power generation system.

Site Photo 17. Fuel leak at joint

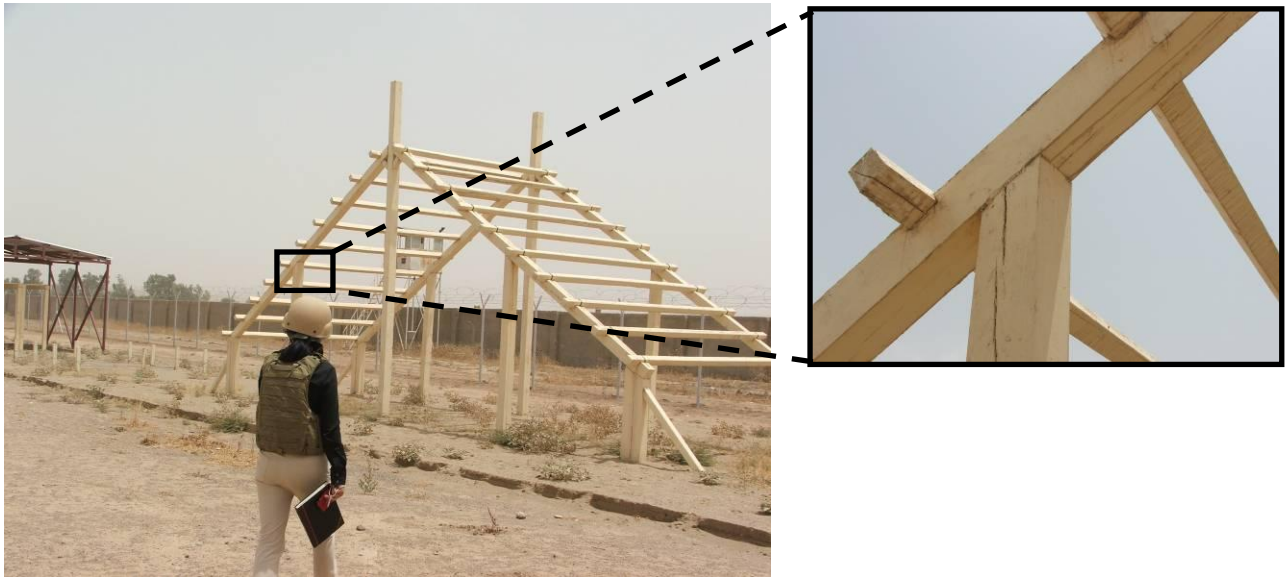
The SOW required that areas surrounding and underneath the obstacles should consist of a deep bed made of sand, sawdust or crushed/ground rubber. SIGIR observed that the obstacles were constructed over native material similar to the ground cover on other areas of the project. It does not appear that provisions were made to place the required ground cover beneath the obstacles.

Site Photo 20. Obstacles for combat assault course

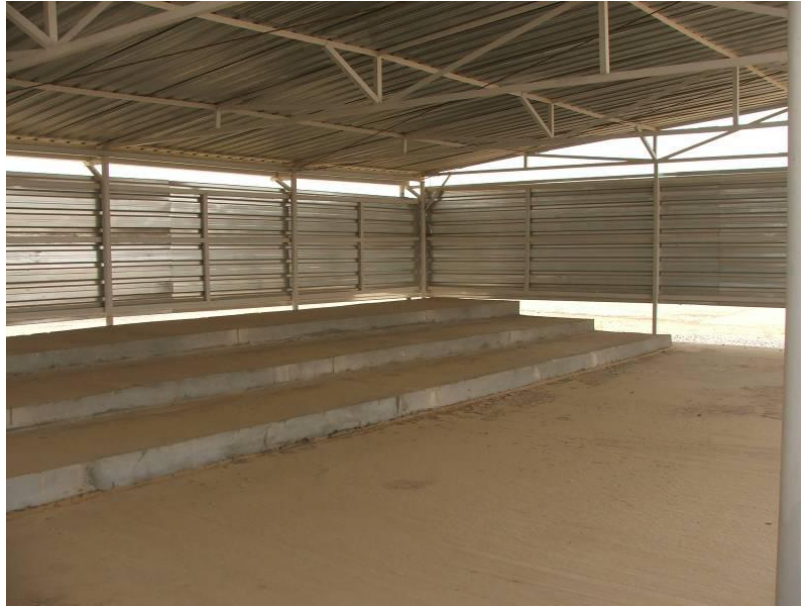
The SOW required translucent material for the cladding and provided specific details for windows inserted in the walls. SIGIR observed that the exterior cladding of the buildings was not consistent with the SOW, and the outdoor training facilities did not contain windows or translucent material for cladding.

Site Photo 22. Outdoor training facility (interior)
