**ABATTOIR (SLAUGHTERHOUSE) IN  
QALADZE  
SULAYMANIYAH, IRAQ**

**SIGIR PA-09-179  
OCTOBER 16, 2009**

### Summary of Report: PA-09-179

SUBJECT: Report on the Abattoir (Slaughterhouse) in Qaladze, Sulaymaniyah  
Province, Iraq (SIGIR Report Number PA-09-179)

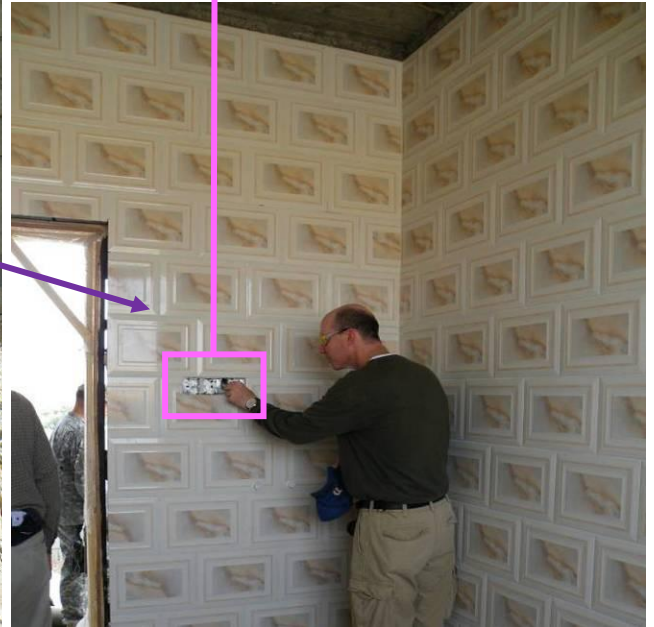
Site Photo 9. Glazed ceramic tiles on the interior walls

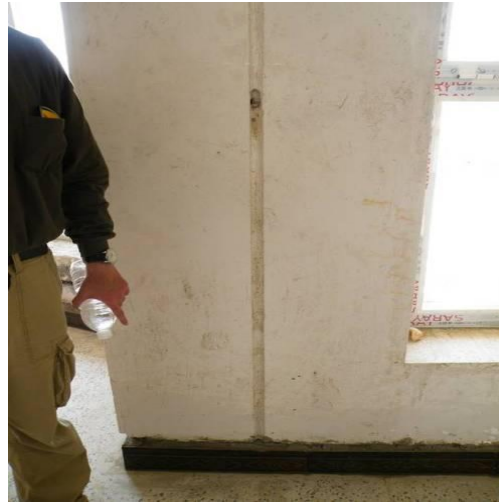
First, the facility's expansion joint system, which is to protect the structure from thermal variations, was incomplete. The expansion joint was correctly designed/placed for the ceiling beams, columns, walls, and roof slab; however, the joint was incorrectly finished and/or not finished at all for the floor and parapet (Site Photos 16-19). An expansion joint was designed and constructed for the wall columns; however, instead of placing the proper expansion joint material inside the joint, the contractor plastered inside it instead. The absence of an expansion joint for the parapet has resulted in a vertical crack. SIGIR found no expansion joint system for the facility's exterior walls. Considering that these walls are exposed to excessive heat in the summer and snow in the winter, a well-designed expansion joint system was warranted. Additionally, sealed joints prevent moisture, dust/dirt particles, and crawling insects from entering the living spaces. Consequently, an expansion joint system promotes structural safety for the building and also provides a better living environment for the occupants.

Site Photo 17. Wall expansion joint incorrectly filled with plaster

During the site visit, SIGIR identified these deficiencies to the KRO representatives. They readily agreed to the need for internal and external expansion joints and discussed the issue directly with the contractor's on-site representative. The contractor's representative agreed to provide a corrective action plan for the expansion joints to the KRO representatives.

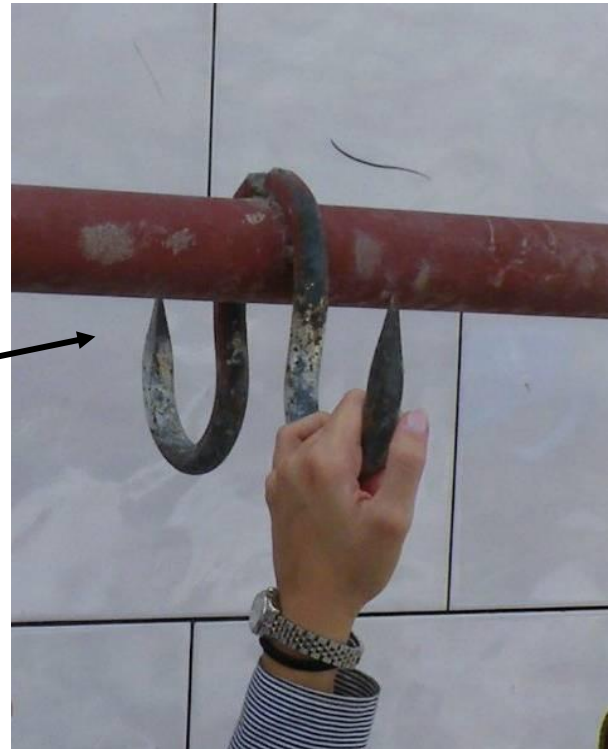
Finally, SIGIR noticed exposed meat-product support hooks throughout the entire abattoir—in the slaughterhouse, winter hall, and administration and meat processing facility (Site Photo 21). The very sharp tip of the exposed meat hook is approximately 5'7" above the ground (Site Photo 22). A typical construction area contains many tripping hazards, such as bags of materials, loose parts, and uneven flooring. It is a distinct possibility that a worker or visitor to the site may trip and fall into the meat hook. The meat hooks are essential to the production process for the facility; however, they also pose an extreme hazard for the workers.

Site Photo 22. Close-up of exposed meat hook

SIGIR pointed out this potential safety hazard to the KRO representatives, who agreed with the assessment and stated they would look into corrective action, such as covering the pointed ends with a suitable length of ½-inch diameter polyvinyl chloride pipe.

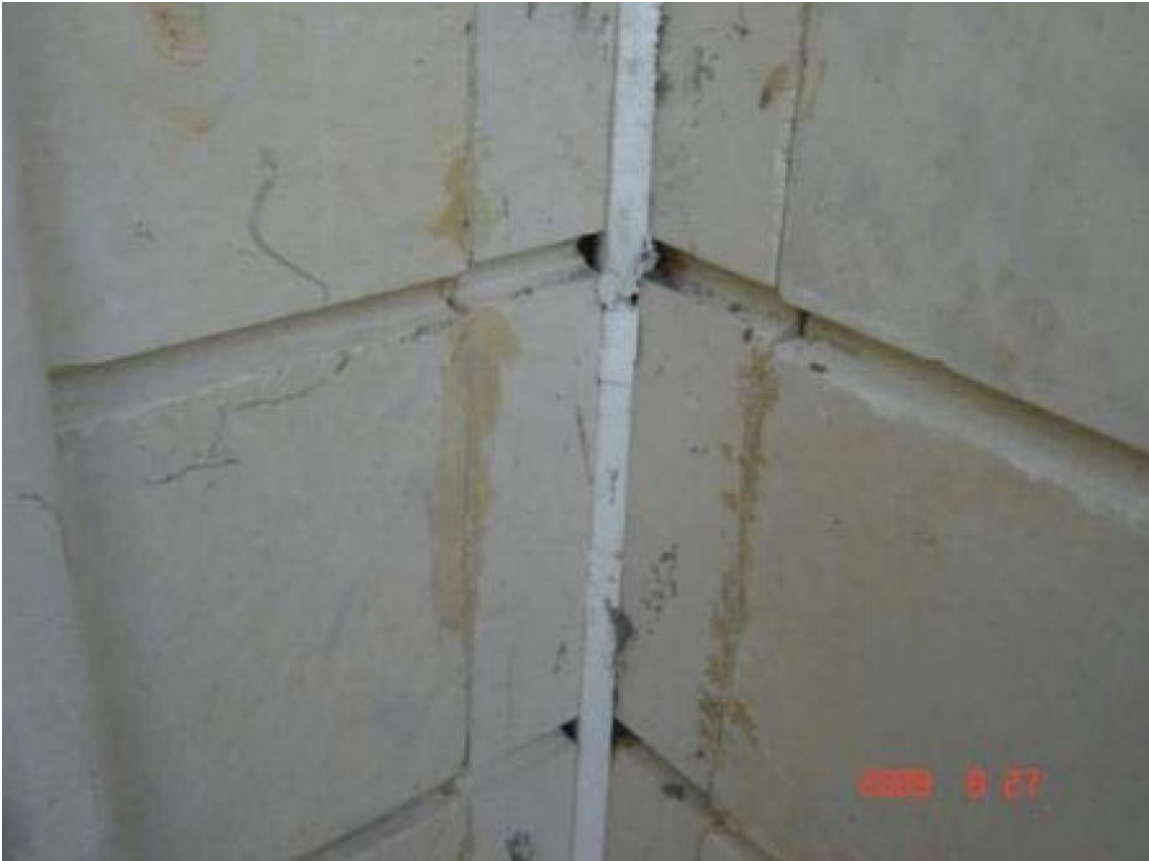
**Site Photo 23. Contractor's initial attempts to add expansion joints to exterior of the facility  
(Courtesy of the USACE KRO)**

The KRO representatives immediately followed up with the contractor to take corrective actions relating to the deficiencies that SIGIR identified during the site visit. By September 2009, the contractor had already corrected the stair issue and was working on the expansion joints. The contractor provided photographic documentation to support his claim of corrective actions taken. The photographs show measurements of stair heights and also the initial construction of an exterior expansion joint (Site Photo 23).
