Summary of Report: PA-09-182

Al Kasik Location Command

SUBJECT: Report on the Al Kasik Location Command, Al Kasik, Iraq (SIGIR Report Number PA-09-182)

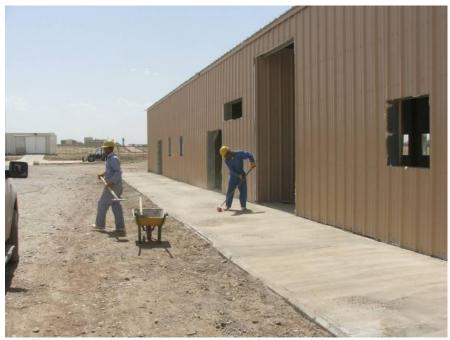
SIGIR observed the contractor performing site grading for the warehouse administration building. The site was relatively flat with little variation in topography, and there were no apparent low areas near the administration building or exterior latrine. The grading directed runoff away from the administration building and exterior latrine (Site Photo 1).

Site Photo 1. Site grading at the front of the administration building

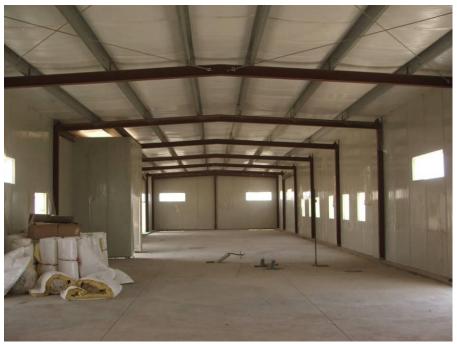
The administrative building structure was a pre-engineered metal building. The configuration of the structure was a clear-span steel frame with no interior supports (Site Photo 2). The frame was supported on a continuous 50 centimeter (cm) x 50 cm strip footing. The structural steel was erected and secondary members—such as purlins (roof supports), girts (wall supports), and cross-bracing (diagonal supports)—were installed.

Site Photo 2. Warehousing platoon administration building interior

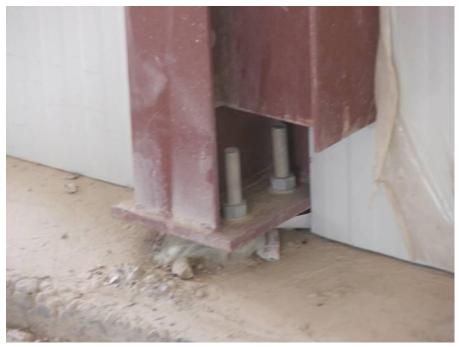
Also, the non-shrink grout beneath the column base plates for the frames was not yet placed (Site Photo 3).

Site Photo 3. Column base plate prior to placement of non-shrink grout

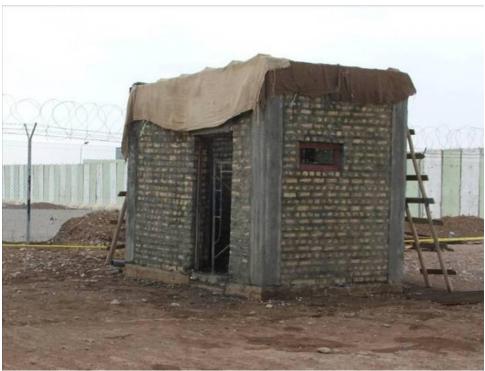
At the time of the site visit, the latrine was partially constructed. The structure was constructed using typical local construction methods that utilized reinforced-concrete frame with brick infill, and the contractor was curing the reinforced-concrete roof slab (Site Photo 4). The brick infill was mortared on all sides, as required by the SOW.

Site Photo 4. Latrine exterior

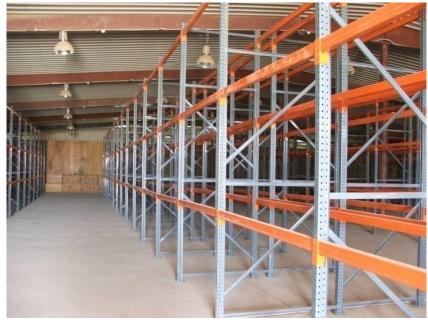
The SOW required the installation of pallet racks in the existing warehouse building. At the time of the site assessment, the contractor was nearly finished installing the pallet racks (Site Photo 5). However, some of the bracing for the racks was not installed. Bracing for the rack system is critical for structural integrity and to prevent toppling.

The contractor stated that the existing warehouse floor was not level and sloped toward the front entry door. The contractor stated that prior to anchoring the racks to the existing concrete slab; steel shims would be installed to level the racks. Also, the contractor stated that shelves were being fabricated for the racks to provide storage for non-palletized items.

Site Photo 5. Pallet racks in existing warehouse

- The contractor should perform a final check of the rack system after construction completion and to verify that all bracing is installed and all legs are securely fastened to the floor slab.
- The water and sewer piping create a conflict with the installation of the sanitary manhole and could potentially contaminate the water supply.
- The raft foundation contained no provisions to continue the reinforcing steel through the construction joint or provide fuel proofing to prevent leaks.

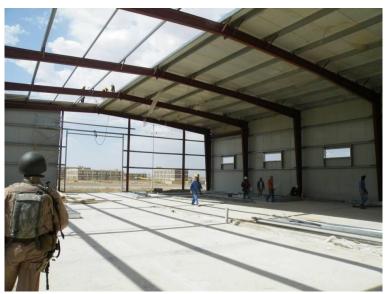
The maintenance garage was a pre-engineered metal building, configured as a clear-span steel frame with no interior supports (Site Photo 6). The frame was supported on a continuous 60cm x 50cm strip footing. At the time of the site assessment the structural steel was erected and secondary members—such as purlins, girts, and cross bracing—were installed. The contractor was installing the exterior sandwich panels. The contractor installed the non-shrink grout under the column base plates for the garage.

Prior to installing the concrete floor slab, the contractor installed the utility lines beneath the floor. Several penetrations through the slab were noted, and an area for a trench drain was formed near the middle of the slab. SIGIR did not note any open utility excavations near the maintenance garage.

Site Photo 6. Maintenance garage prior to completion of exterior panel installation

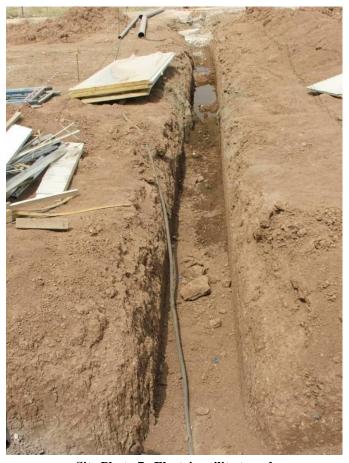
was no evidence that the utilities were connected from the existing main utility lines to the exterior of the building.

Site Photo 7. Electric utility trench

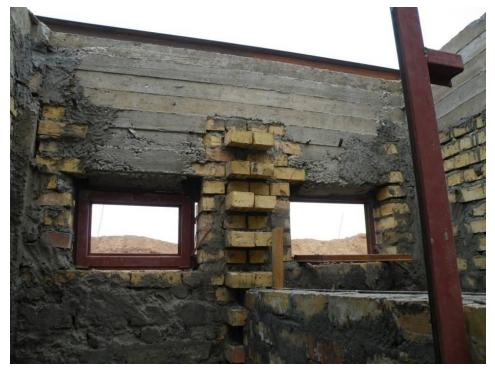
does not appear to greatly affect the integrity of the building, it is indicative of poor workmanship and less overall quality of construction in this area.

Site Photo 8. Bond beam increased depth in lieu of lintel

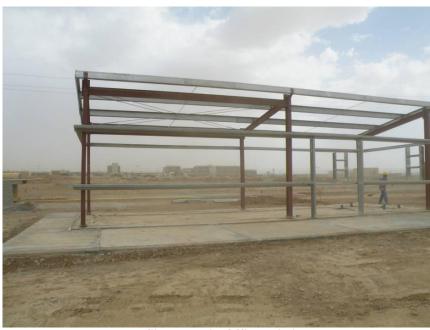
At the time of the site assessment, the foundation for the office building was constructed, and some of the structural steel was erected (Site Photo 9). Unlike other buildings constructed under this contract, the contractor included a restroom on the interior of the office building. The contractor constructed the plumbing beneath the concrete floor slab and extended the water and sewer piping through the foundation to the exterior of the building. SIGIR noted that the water and sewer lines were placed in the same trench, similar to other buildings at the Al Kasik Location Command project.

Site Photo 9. Office building

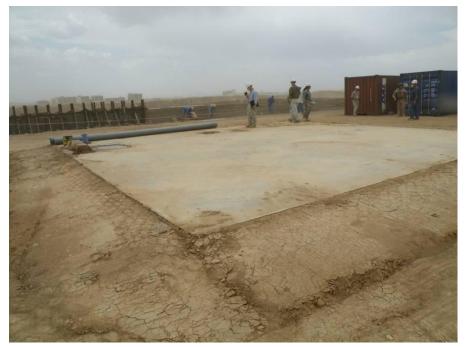
The contractor was required to provide 1,500,000 liters of bulk storage for diesel fuel and 500,000 liters of bulk storage for benzene for the project. The contractor's design provided the required storage with three 500,000-liter circular tanks and two 250,000-liter circular tanks. The tanks are above-ground, inside an earthen dike containment structure. At the time of the site assessment, the contractor had completed the bulk fuel storage foundation for the circular tanks (Site Photo 10). The design required the foundation for the tanks to be circular; however, SIGIR observed that the foundation was square.

Site Photo 10. Completed tank foundation

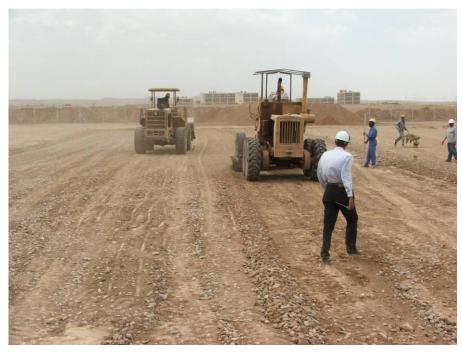
SIGIR observed the contractor performing site grading, compaction, and foundation construction for the distribution point (Site Photo 11).

Site Photo 11. Site grading for diesel storage at the distribution point

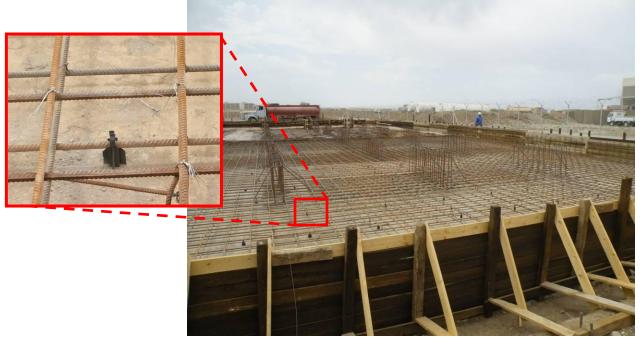
The contractor was constructing the raft foundation for the benzene storage for the distribution point, half of the foundation slab was poured, and the concrete was being cured. The remaining section of the foundation slab was formed and appeared to be ready for pouring (Site Photo 12).

SIGIR noted that the contractor had exercised good construction technique and was using spacers and chairs to elevate and hold the reinforcing mats for the slab (Site Photo 12 inset). In addition, the contractor installed temporary bracing to reinforce the piers to prevent displacement during pouring operations.

During the inspection of the raft foundation, SIGIR discovered one issue. It appeared that the contractor placed a construction joint near the middle of the foundation slab. It did not appear that provisions were made to continue the reinforcing steel through the construction joint or provide fuel proofing. There was also no evidence of a shear transfer mechanism at the joint—such as dowels or a shear key—and no fuel stop was noted.

Site Photo 12. Raft foundation for benzene storage

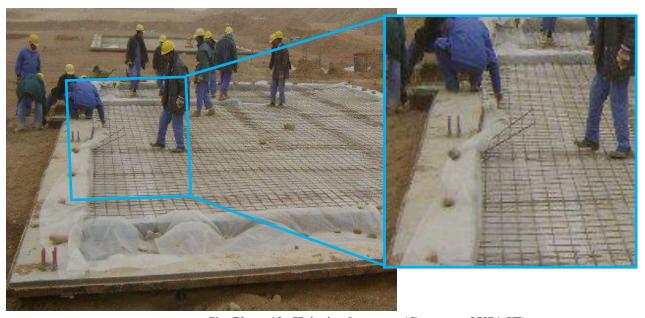
The QC representatives monitored field activities and completed daily QC reports, which presented a brief background on the number of workers on site, the work activities and testing performed, and the documented deficiencies identified. The project manager signed off on the reports. In addition, the QC representatives supplemented the daily QC reports with photographs reinforcing the information provided in the daily reports. The 20 February 2009 QC report documents hairpin installation to resist lateral loads. These were required by the design before compacting the sub base and installing the concrete floor slab for the administration building in the reclamation platoon section of the project (Site Photo 13).

Site Photo 13. Hairpin placement (Courtesy of USACE)
