# National Transportation Safety Board

## Safety Recommendation

**In reply refer to:** A-03-07 through -10

On May 25, 2002, China Airlines flight CI-611, a Boeing 747-200 (B18255), crashed in the Taiwan Straits near the northern end of the Penghu Islands, Taiwan. Radar data indicate that the airplane experienced an in-flight structural breakup at about 35,000 feet. The airplane was on a scheduled passenger flight from Chiang Kai Shek International Airport, Taipei, Taiwan, to Chek Lap Kok Airport (Hong Kong International Airport), Hong Kong, China. All 225 occupants were killed.

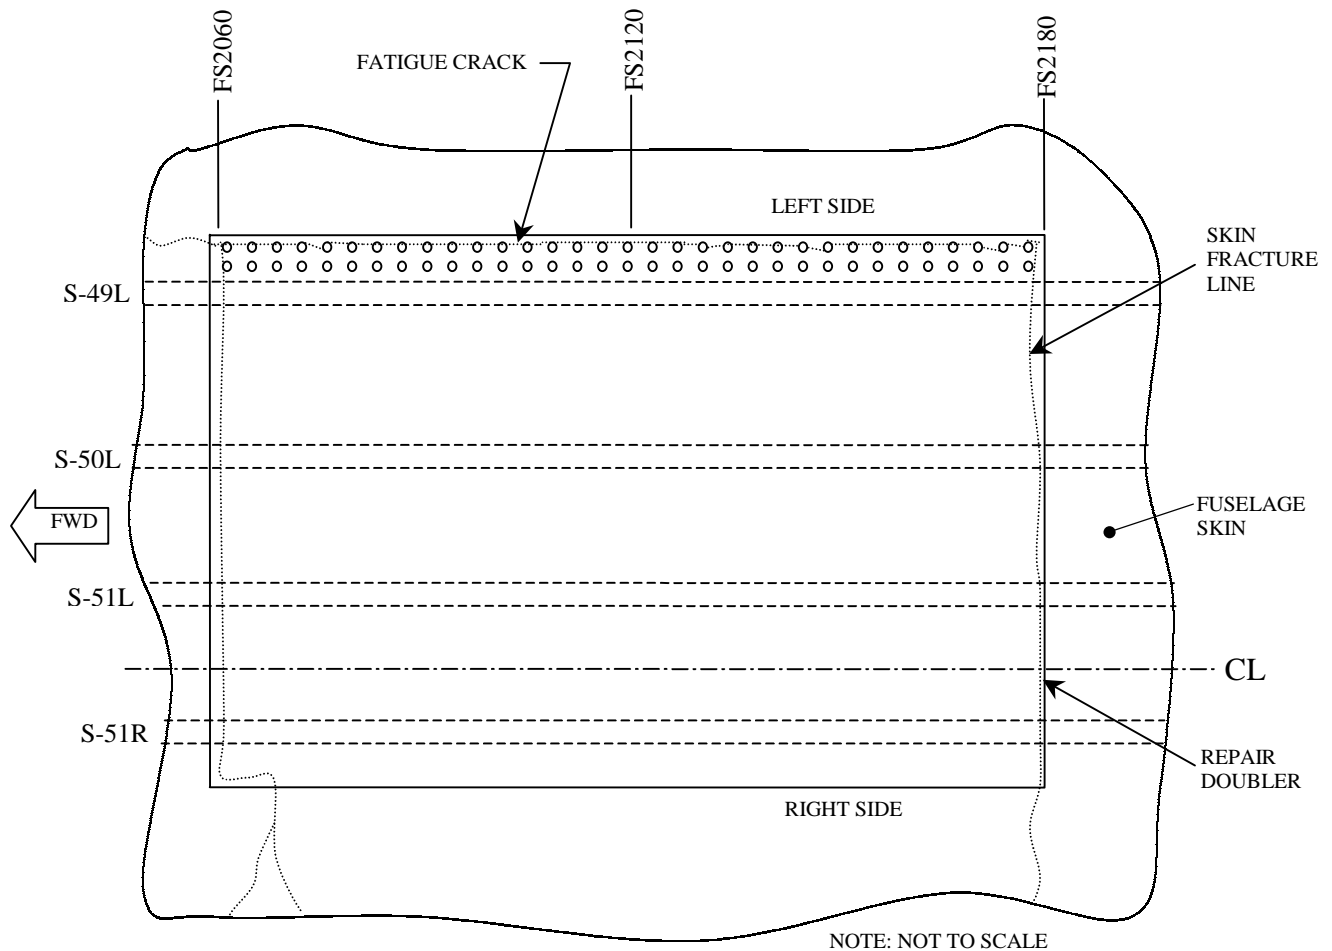
The recovered wreckage from the accident airplane included the repair doubler installed between FS 2060 and 2180. The doubler, which was about 120 inches long, 22 inches wide, and 0.100 inch thick, was installed over the original fuselage belly skin between stringers S-49L and S-51R. Although, as noted above, maintenance records indicate that the repair was conducted in accordance with the Boeing SRM, several discrepancies were noted. Specifically, the Boeing SRM required that the damaged skin be removed before installation of the doubler. However, the damaged skin was not removed; the fuselage skin underneath the doubler exhibited severe longitudinal scratching. Some of the scratching was located just outside the left perimeter of the repair rivets but was still hidden under the outer edge of the doubler. Further, most of the rivets attaching the doubler to the fuselage skin were overdriven, and some of the parts used in the repair did not meet the applicable material specifications.

Metallurgical examination of the recovered wreckage revealed a region of fatigue cracking with multiple-site fatigue damage (MSD)<sup>2</sup> extending for about 93 inches under the left edge of the doubler; the fatigue cracks in this region originated at the unremoved scratching just outside of the rivet line and propagated completely through the thickness of the skin in many areas within the fatigue region (see figure 1).<sup>3</sup> The fatigue region also contained individual fatigue cracks that were linked by quasi-stable crack growth, resulting in a single 93-inch-long crack. Almost all<sup>4</sup> of the fatigue cracking was located underneath the doubler and would not have been visible from the exterior of the airplane.

<sup>3</sup> The fuselage skin was also fractured underneath the forward and aft edges of the doubler, but these fractures did not show evidence of fatigue cracking. Rather, the fractures were consistent with overload failure.

<sup>4</sup> Only 5 inches of the crack extended outside the forward edge of the doubler.

**Figure 1.** Detail of the China Airlines 747-200 repair doubler  
(View looking up at bottom of aft fuselage)
