# National Transportation Safety Board

## Safety Recommendation

**In reply refer to:** A-03-13 and -14

On January 24, 2003, a Beech 95 (Travelair), N2733Y, lost control shortly after takeoff from Cable Airport, Upland, California, after a 2 1/2-foot section of a blade separated from a Hartzell model HC-92ZK-2 propeller installed on the No. 2 (right) engine of the airplane. Witnesses reported observing the airplane's right engine suspended below the right wing,<sup>1</sup> and the airplane entering a steep right bank turn, rolling inverted, and descending until impacting a private residence in Rancho Cucamonga, California. The house was severely damaged, the airplane was destroyed, and the pilot, its sole occupant, was killed. The flight was being conducted under 14 *Code of Federal Regulations* Part 91 and was the first flight following overhauls of both propellers.<sup>2</sup>

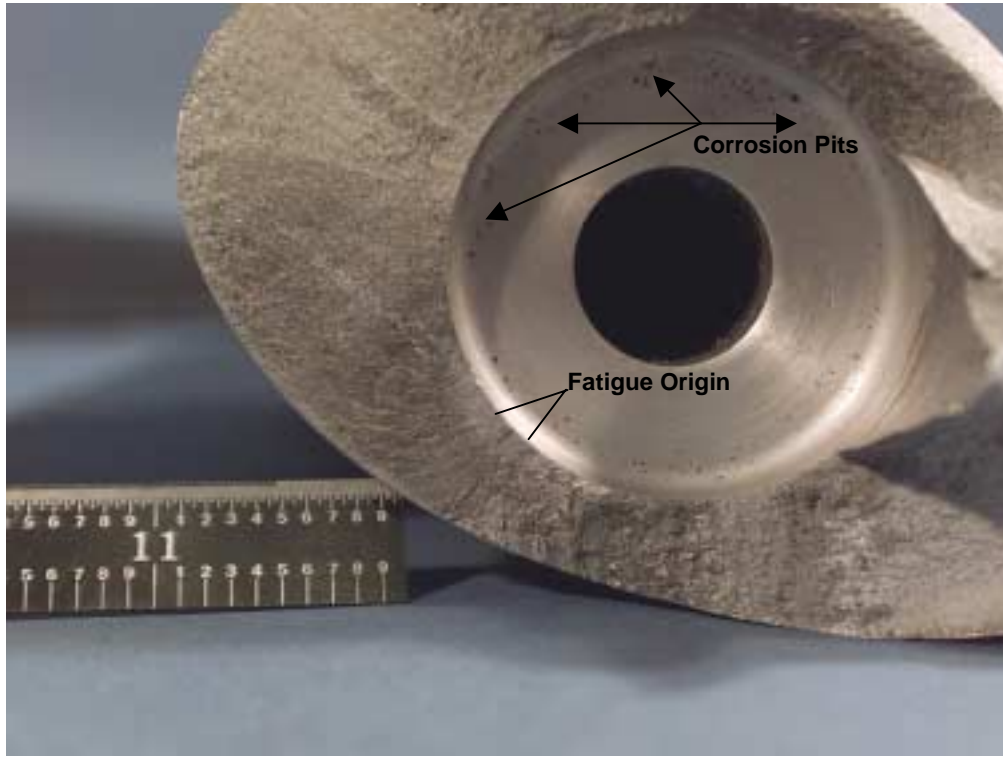
The separated section of the Hartzell 8447-12A (Z-shank)<sup>3</sup> blade was recovered about 1 mile from the accident site. Examination of the fracture surfaces at the National Transportation Safety Board's Materials Laboratory revealed that the blade had failed due to fatigue cracking that initiated at corrosion pits on the internal surface of the blade's pilot tube hole (see figure 1). The cracking had progressed through about 60 percent of the blade cross section and around more than half of the pilot tube bore before final overstress separation. According to maintenance records, T&W Propellers, LLC, Chino, California,<sup>4</sup> performed the overhauls for both propeller assemblies. The overhaul entries, dated January 11, 2000, indicated that the overhauls were completed in accordance with Hartzell Manuals 105A (Propeller Model HC-92ZK-2 Overhaul Manual), 133C (Aluminum Propeller Blade Overhaul Manual), and 202A (Hartzell Standard Practices Manual), and all applicable service bulletins, service letters, and

**Figure 1.** Magnified View of a Portion of the Outboard Fracture Face

Discoloration in the fatigue region of the fracture indicated that corrosion or a staining agent was introduced into the crack when the crack size was about 2 inches long. Safety Board investigators noted that a crack of this size would have been easily detectable by a properly performed dye penetrant inspection, as described in Hartzell overhaul data (Hartzell specifies a dye penetrant inspection of the bore area as part of the overhaul procedures).

Postaccident examination of both propeller blades from the right engine revealed other indications of an improperly performed overhaul. According to the overhaul instructions contained in Hartzell Manual 133C, a smooth, high-quality finish is required in the area where the fatigue cracking initiated. However, both propeller blades showed corrosion pits in this area and on the end face of the pilot tube hole. Hartzell overhaul data also specify that paint be applied to this and adjacent areas of the pilot tube hole. No paint was present on any of these surfaces. Finally, there was no evidence that the pilot tube hole had been chemically conversion coated although this is also required at overhaul. Disassembly and inspections of the blades from the left propeller uncovered similar maintenance discrepancies, with one blade having larger and deeper corrosion pits than the fractured blade.

Require the immediate inspection of all propeller parts and propeller assemblies overhauled or inspected by T&W Propellers, Chino, California, to determine if they are airworthy. (A-03-13)

Require that all Hartzell Z-shank propellers be overhauled every 2,000 hours or 5 years, whichever comes first, as recommended by the manufacturer. (A-03-14)
