National Transportation Safety Board

Safety Recommendation

Date: October 14, 2003

In reply refer to: A-03-45 and -46

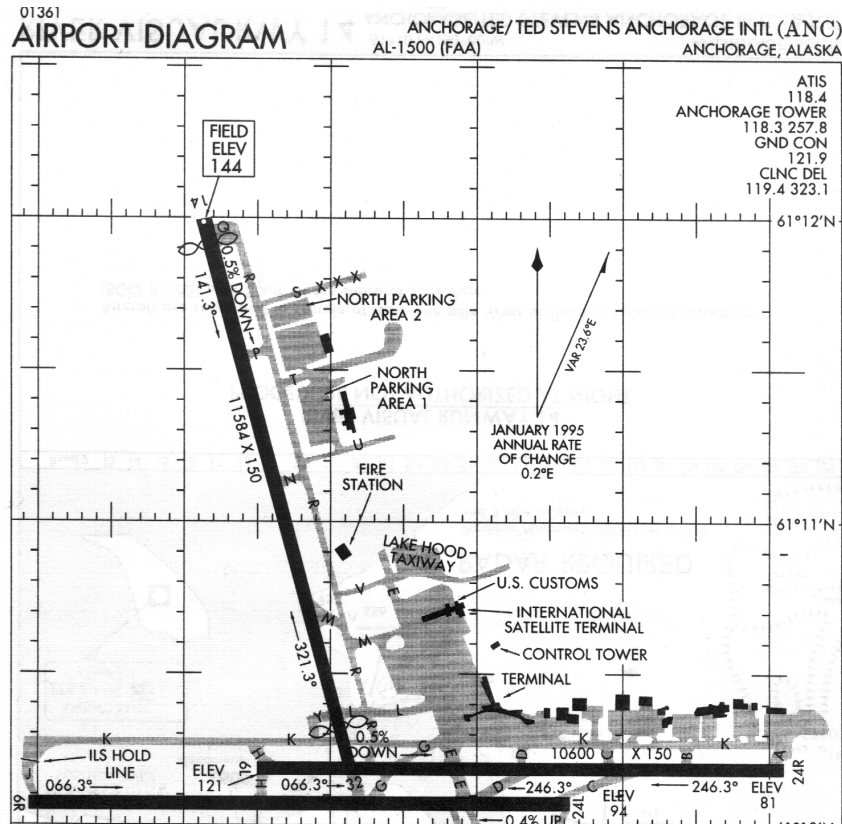
Figure 1. ANC Airport Diagram

As shown in figure 1, ANC has three runways: 32/14, 6L/24R, and 6R/24L. The end of runway 32 intersects with runway 6L. Flight crews of aircraft departing runway 32 normally depart from the displaced threshold of runway 32 and do not occupy the intersection of runways 32/6L; however, they may use the full runway (known as the runway 32 extension²) by informing ANC tower controllers on initial contact that they wish to do so. These aircraft then line up with runway 32 and hold in the intersection of runway 32/6L, where they may be required to wait for some time depending on other traffic in the area. Other aircraft may be conducting approaches to runway 6L while runway 32 departures are holding at the intersection.

ANC tower staff stated that FAA Order 7110.65 “Air Traffic Control,” paragraph 3-9-8, “Intersecting Runway Separation”³ is the basic separation rule applied between runway 32 departures and runway 6L arrivals. In addition to the separation requirements of paragraph 3-9-8, ANC tower controllers also follow separation directives defined in the facility’s standard operating procedures manual. Paragraph 4-5-6(c) in the manual directs controllers to ensure that large jets and turboprop airplanes departing from runway 32 are past taxiway M or, depending on the size of the aircraft, at a point between taxiways L and M (see figure 1) before any aircraft using runway 6L crosses the threshold or begins takeoff roll.

Because ANC's procedures do not impose nighttime or visibility restrictions when departing aircraft are holding at the runway 32/6L intersection, the Safety Board believes that the FAA should modify the ATC procedures used at ANC when departing aircraft are authorized to use the full length of runway 32 and arrivals are in progress to runway 6L (and the ATC procedures at any other airport where aircraft are permitted to hold in runway intersections) by amending FAA Order 7110.65, "Air Traffic Control," to explicitly prohibit holding aircraft in runway intersections at night or during low visibility when arrivals are in progress to any runway making up the intersection.

Modify the air traffic control (ATC) procedures used at Ted Stevens Anchorage International Airport when departing aircraft are authorized to use the full length of runway 32 and arrivals are in progress to runway 6L (and the ATC procedures at any other airport where aircraft are permitted to hold in runway intersections) by amending FAA Order 7110.65, "Air Traffic Control," to explicitly prohibit holding aircraft in runway intersections at night or during low visibility when arrivals are in progress to any runway making up the intersection. (A-03-45)

Assist Ted Stevens Anchorage International Airport management in evaluating the airport's runway and taxiway layout to identify and, if necessary, construct holding areas for runway 32 departures that are clear of runways 6L and 6R. (A-03-46)
