National Transportation Safety Board

Safety Recommendation

Date: May 17, 2001

In reply refer to: A-01-23 through -26

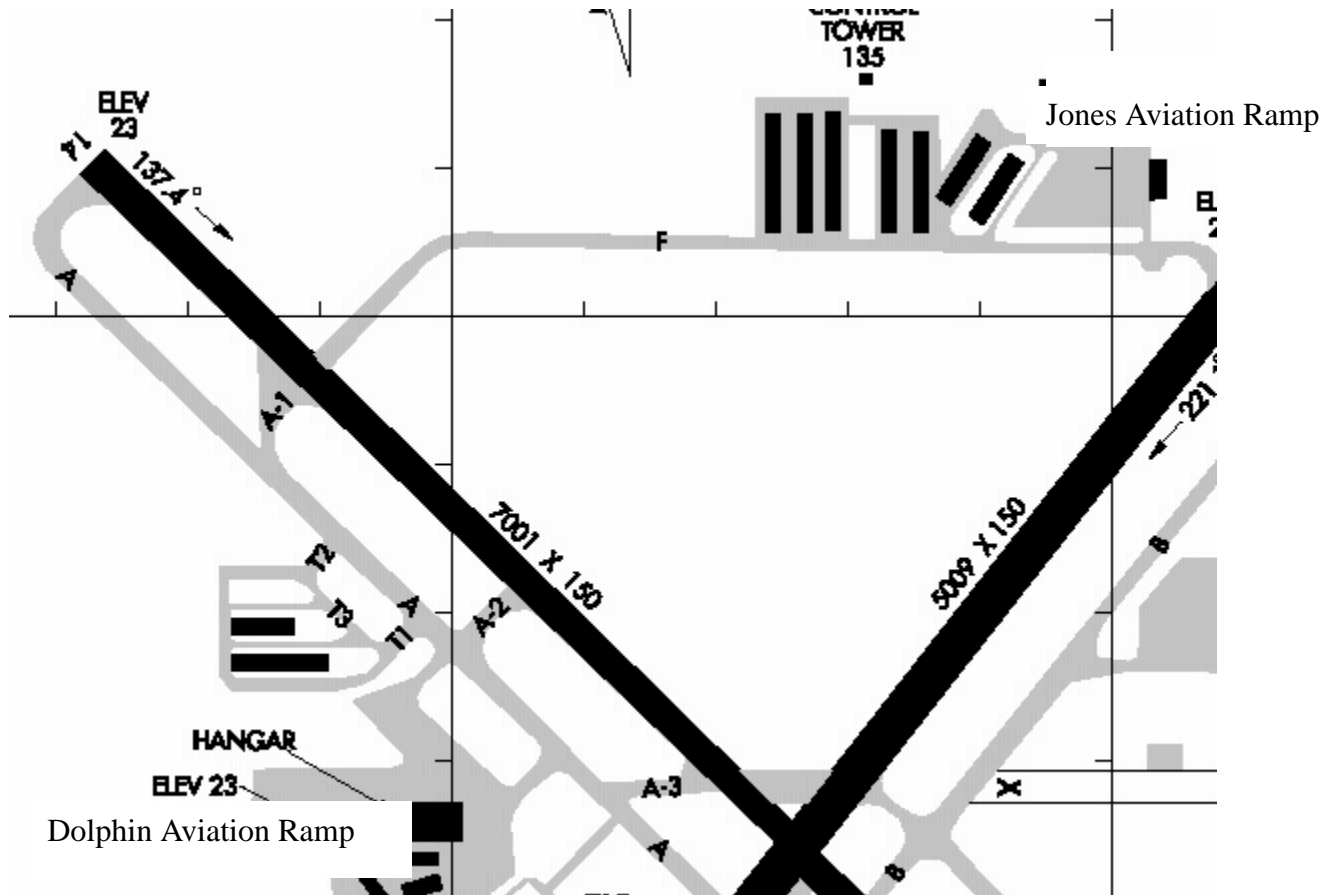
Figure 1. Diagram of SRQ.

At 1024:46, the pilot of N89827 called the SRQ ground control/clearance delivery controller (GC) requesting a visual flight rules departure. N89827 originated at the Dolphin Aviation ramp, located on the south side of SRQ. At 1025:24, the SRQ GC instructed N89827 to “taxi to runway [14].” Taxiway A, which is adjacent to the Dolphin Aviation ramp, runs parallel to runway 14 and joins it at the end. N89827 proceeded to runway 14 via taxiway A. As the GC issued the taxi instructions to N89827, he was relieved by the supervisor/ground controller (SGC). The GC provided a relief briefing to the SGC and left the tower cab. At 1028:03, the pilot of N79960 transmitted to ground control that he was “at [J]ones and ready to taxi.” The Jones Aviation ramp is on the north side of SRQ; aircraft originating at the Jones Aviation ramp intending to use runway 14 are normally assigned intersection departures from taxiway F. At 1028:45, the SGC cleared N79960 to “taxi to runway [14].” The pilot of N79960 was required by 14 CFR 91.129(i)⁷ to hold at the intersection of runway 14 and taxiway F, and he did so.

According to a postaccident interview with the LC, on the basis of the information in the flight progress strip, he believed that N79960 was positioned for takeoff at the approach end of runway 14. It would have been difficult for the LC to visually distinguish between the second airplane waiting at taxiway A (N52553) and the second airplane waiting at taxiway F (N79960) because they were both motionless Cessna 172s. Therefore, when N89827 began its takeoff roll from the approach end of runway 14, the LC erroneously believed that it was safe to instruct N79960 to taxi onto the runway for departure. Witnesses stated that when N89827 obtained takeoff speed near the 6,000-foot remaining marker (about 200 feet from the collision point), N79960 entered the runway from a taxiway on the left side of the runway. When N79960 entered the runway at intersection F, the two airplanes collided.
