NATIONAL TRANSPORTATION SAFETY BOARD  
WASHINGTON, D.C.

SAFETY RECOMMENDATION(S)

P-83-8 and -9

On October 29, 1982, Washington Gas Light Company dispatched a three-person crew, consisting of a crew leader, a crew mechanic, and a helper mechanic, to make three service line extensions in a new housing development at Burke, Virginia. The extensions were to be made without shutting off the flow of gas in the main.

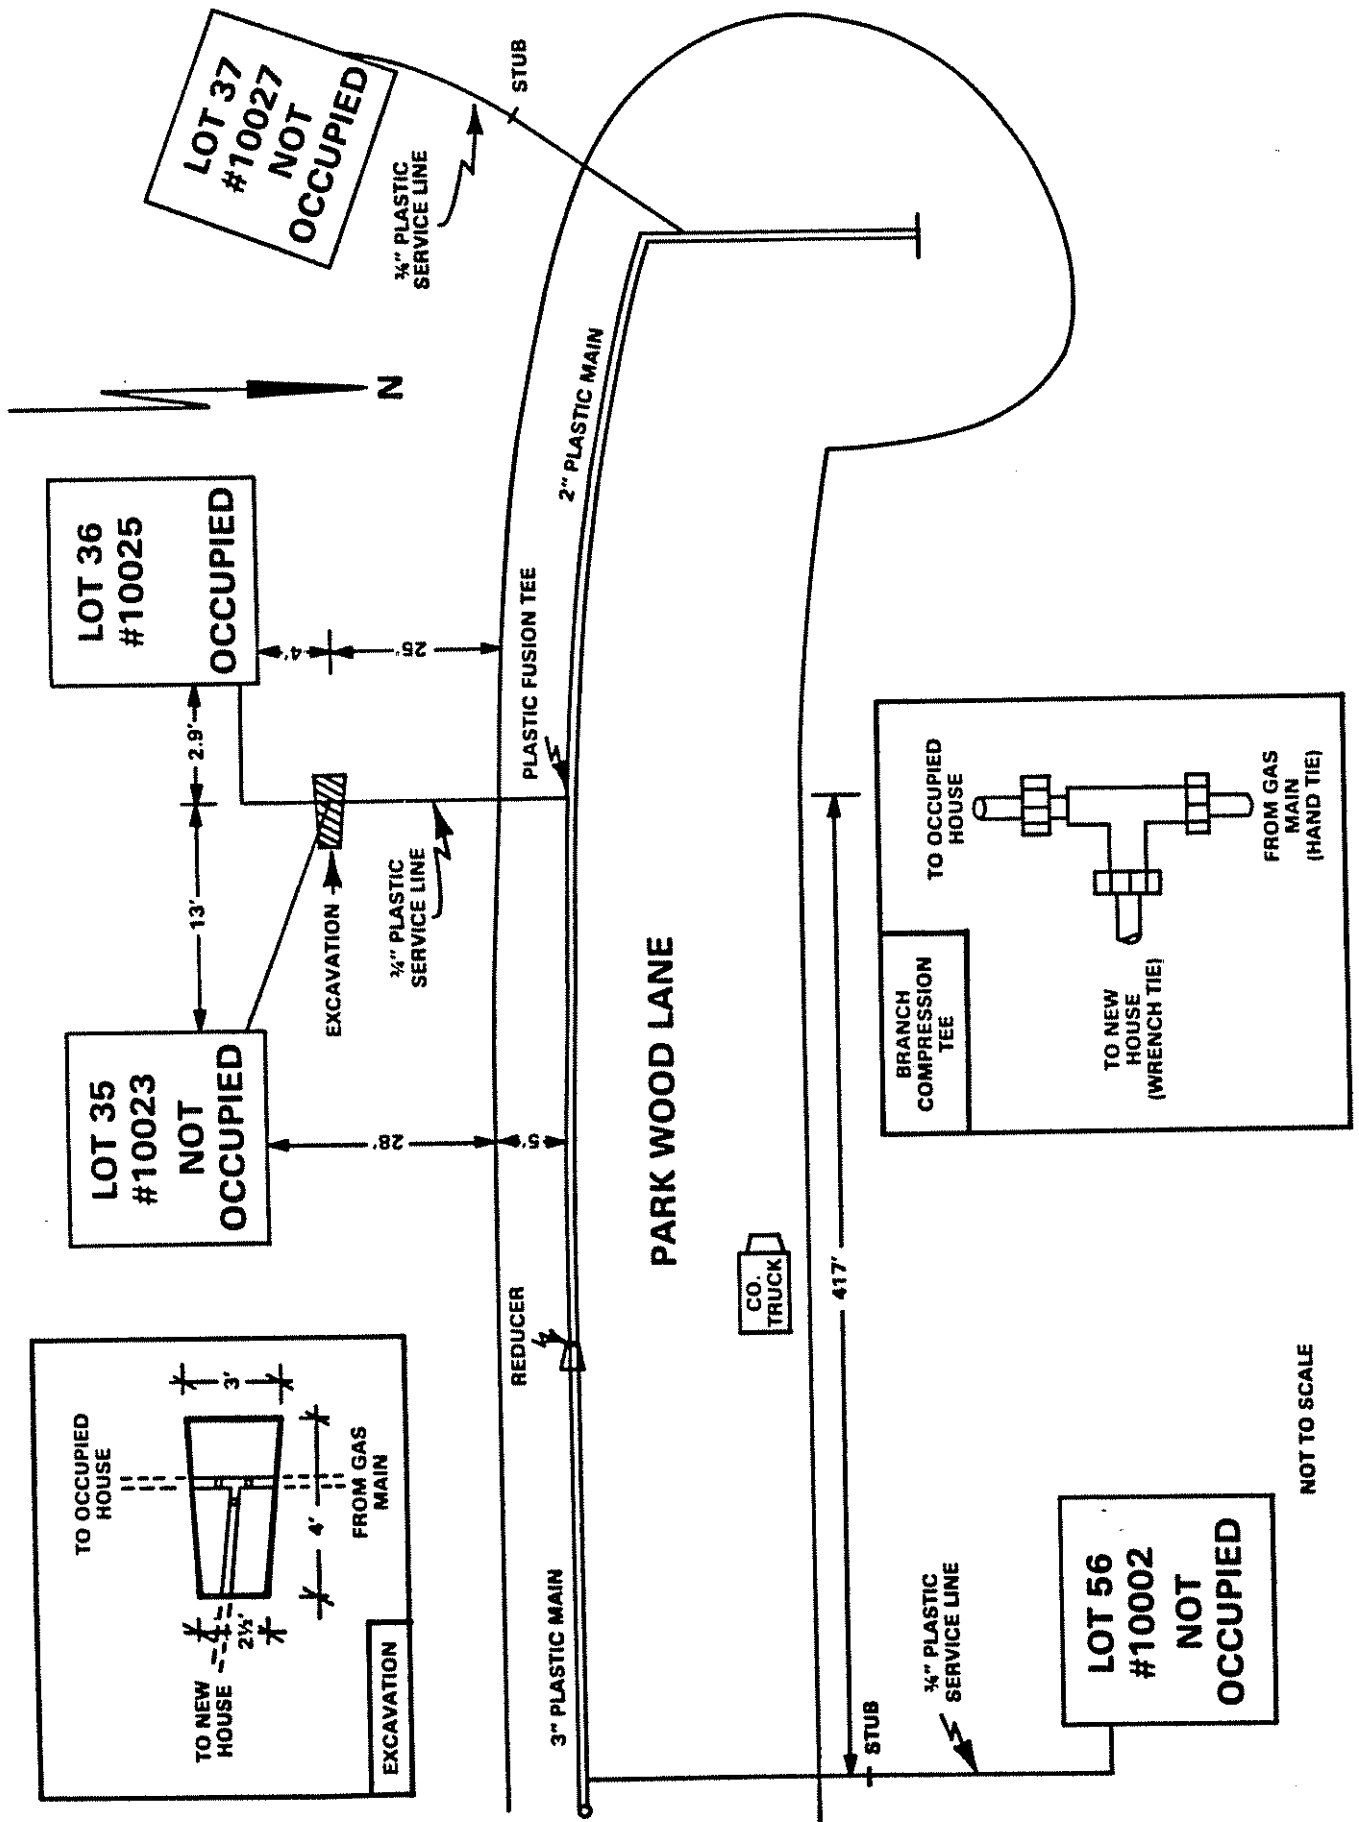
FIGURE 1. PLAN VIEW OF ACCIDENT SITE

About 10:30 a.m., the crew arrived at the work site and connected the service line for residence No. 10027 (see figure 1) to an existing service line stub. After making this connection, the crew was to install a branch service line to residence No. 10023 from the service line connected to the house next door, No. 10025. Using hand tools, a hole 30 inches deep was excavated to expose the plastic service line. The service line was cut, and the end of the service line segment which contained gas under pressure was sealed with a cap. The installation required that a branch tee connection be installed in the service line to No. 10025 to allow No. 10023 to be served from the same service line. A check of the service truck disclosed that the appropriate compression tee was not available at the job site; by radio, the crew leader called the foreman and advised him that a branch tee was needed. While waiting for the requested fitting, the crew began work at residence No. 10002.

After removing the crew mechanic from the excavation, the crew leader and helper mechanic noticed that the compression tee was partially installed. One downstream connection was completed; the other downstream connection had been made, but the retaining nut was only hand-tight. The upstream connection had not been made, and the cap had been removed from the portion of the service line under pressure. Company
