# National Transportation Safety Board

Washington, D.C. 20594  
Safety Recommendation

In reply refer to: A-96-107 through -120

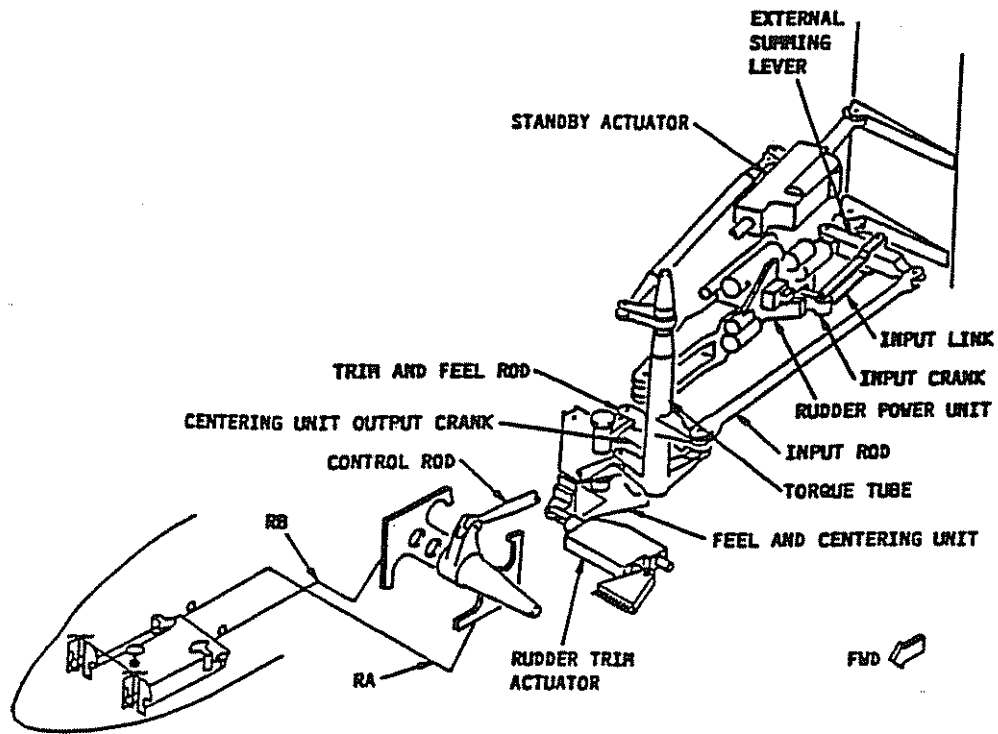
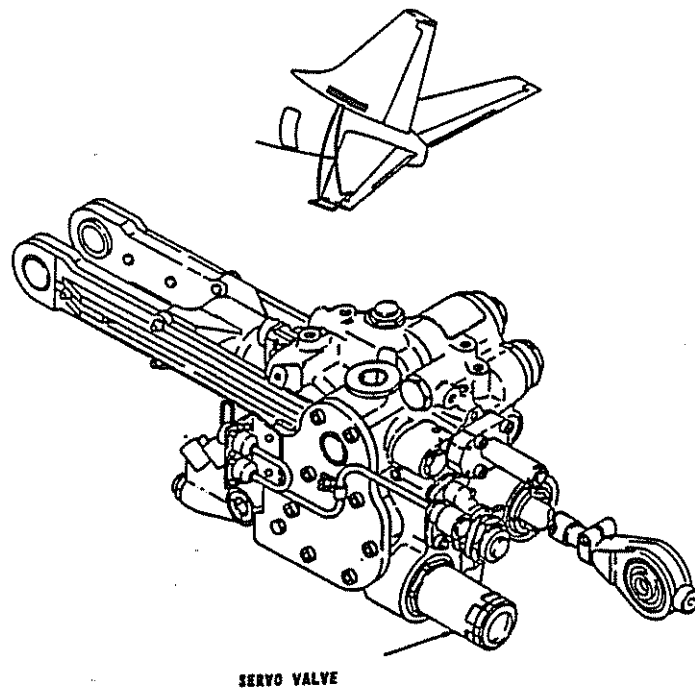
Figure 1. B-737 Rudder System and Main Rudder Power Control Unit

While there are insufficient data regarding the Colorado Springs accident to resolve whether a deflection of the rudder was a factor in the accident, the data for USAir flight 427 accident strongly suggest that the airplane yawed and rolled in response to a deflection of the airplane's rudder coincident with the encounter of a wake vortex, and the data for the Eastwind accident support rudder involvement. However, the Safety Board has not found evidence in any accident or incident of a failure of the B-737 directional control system that could have caused an uncommanded rudder deflection. Figure 1 provides a depiction of the B-737 rudder system and the main rudder power control unit (PCU).
