Safety Recommendation

In reply refer to: A-96-35 through -37

On September 2, 1995, about 0838 mountain standard time, a Cessna 421C airplane, N6234G, crashed in hilly desert terrain near Beaver Dam, Arizona. All eight occupants were killed, and the airplane was destroyed. The airplane was being operated as a corporate/executive flight under the provisions of Title 14 Code of Federal Regulations (CFR) Part 91, from North Las Vegas, Nevada, to West Yellowstone, Montana. Visual meteorological conditions prevailed.

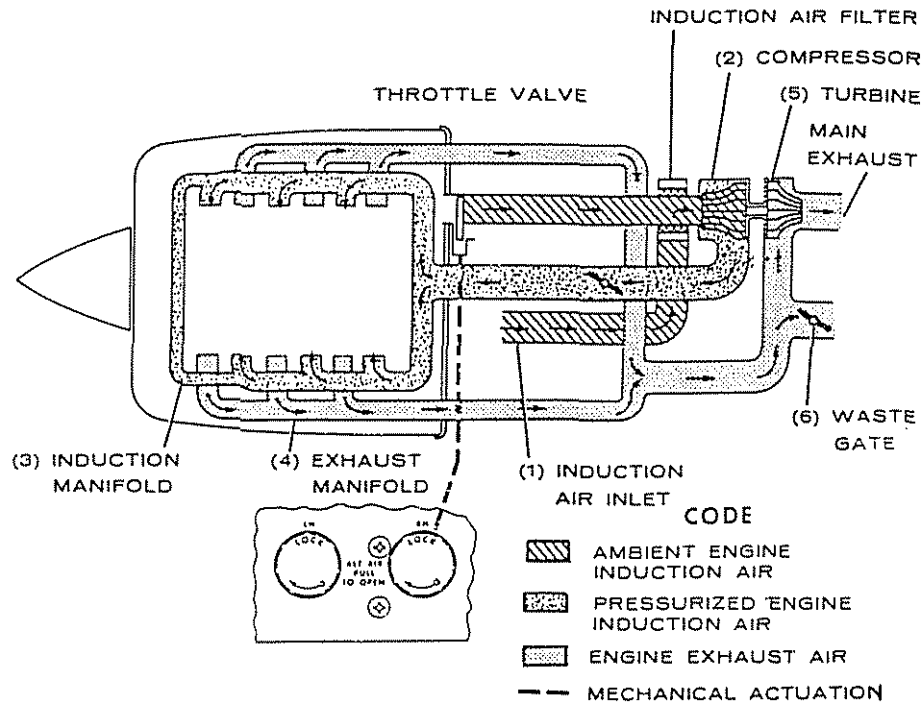
TURBO-SYSTEM SCHEMATIC

The examination of the wreckage showed that the left engine exhaust system Wye duct collector (which was made from Inconel 601),² part of the engine turbocharger system (see schematic shown below), had a warped flange at the outlet to the waste gate, with evidence of exhaust gas leakage in the warped area of the flange. The airplane structure next to the Wye duct collector also showed impingement from exhaust gases leaking from the warped flange.

In the Cessna 421C Pilot's Operating Handbook, the manufacturer states, in part, that changes in the flow of exhaust gases into the turbine will increase or decrease the speed of the turbocharger. A leak in the exhaust system, such as the one noted at the left engine waste gate outlet flange of the accident airplane, would cause a decrease in the turbine speed, and consequently, a loss of engine power.

Amend Airworthiness Directive (AD) 75-23-08 R5 to require the recurring visual inspection set forth in the AD of all-Inconel exhaust system components in Cessna twin-engine, turbocharged airplanes. In addition, the Inconel exhaust system parts should be permanently marked to demonstrate that they are made with Inconel material. Any worn, damaged, or otherwise defective exhaust system components or assemblies should be replaced before any further flight. (Class II, Priority Action) (A-96-35)
