# National Transportation Safety Board

## Safety Recommendation

In reply refer to: A-93-133 through -135

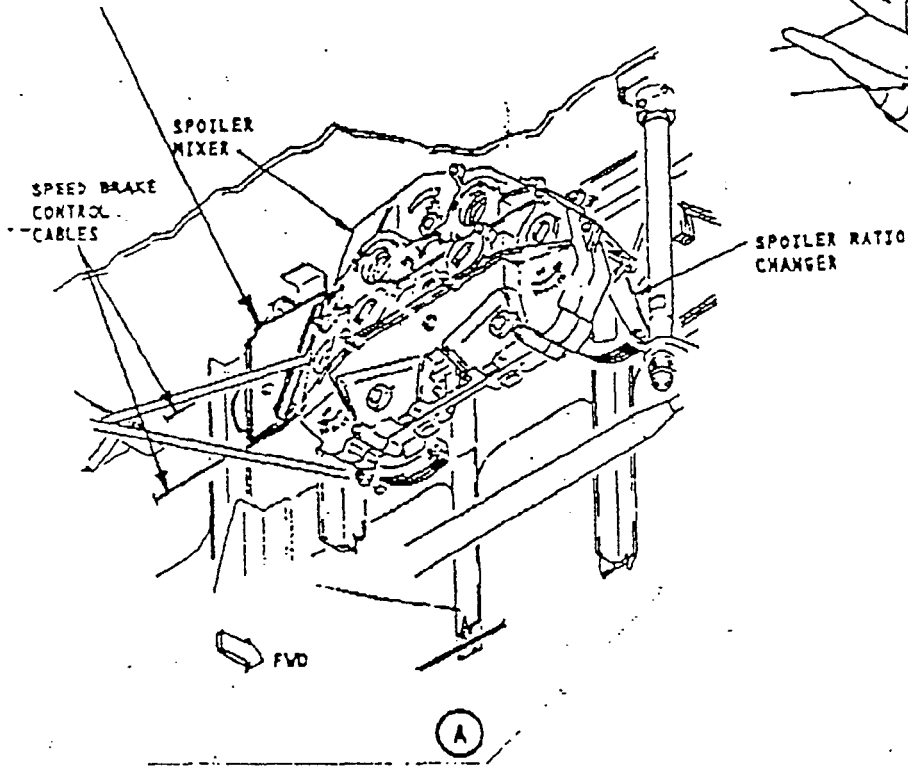
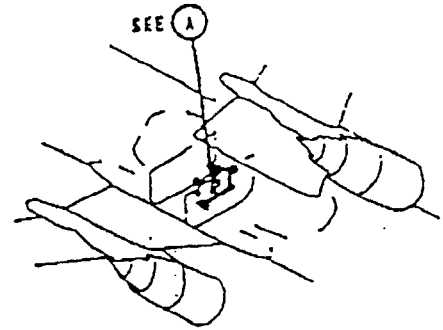
AFFECTED PULLEY LOCATION  
(SEE NEXT PAGE)

Examination revealed that the speed brake down control cable had failed at a point where it rides over a pulley in the right main landing gear well. This cable runs from the speed brake control lever in the cockpit to the spoiler ratio changer in the right main landing gear well. The spoiler panels can be extended by the speed brake control lever when the airplane is airborne or after landing to increase aerodynamic drag. If the speed brake down control cable fails, the spoiler panels are prevented from subsequently retracting when the speed brake control lever is moved back into the down position.

USAir determined that the speed brake down control cable failed because it had been misrouted. Instead of being routed on the pulley adjacent to the spoiler ratio changer, the cable was riding atop two spacers that attach cable guards to the pulley. Wear from riding on these spacers caused the cable to fail 14 inches from the spoiler ratio changer.

Issue an Airworthiness Directive for a one-time inspection of all Boeing 737 series airplanes to determine if the speed brake down control cable is properly routed. Any cable found improperly routed should be removed and replaced before the airplane returns to service. (Class I, Urgent Action) (A-93-133)
