# National Transportation Safety Board

## Safety Recommendation

**In reply refer to:** A-99-12 through -15

On March 30, 1998, Royal Airlines flight 311, a Boeing 727-212 airplane, registered in Canada as C-FRYS, experienced an uncontained failure<sup>1</sup> of the low pressure turbine (LPT) in the No. 2 engine, a Pratt & Whitney (P&W) JT8D-17A, during the takeoff roll at the Fort Lauderdale-Hollywood International Airport, Fort Lauderdale, Florida. The flightcrew reported that at approximately 100 knots, they felt a thud, and the engine fail light in the cockpit illuminated. The takeoff was rejected, and the No. 2 engine fire warning light illuminated. The flightcrew discharged both fire extinguishing bottles into the No. 2 engine nacelle, stopped the airplane on an adjacent taxiway, and initiated an evacuation of the airplane. Of the 186 revenue passengers, 2 infants, and 8 flight crewmembers on board, 10 passengers sustained injuries during the evacuation. The airplane was operating on an instrument flight rules flight plan under the provisions of 14 Code of Federal Regulations Part 129 as an international charter passenger flight from Fort Lauderdale to Toronto, Canada.

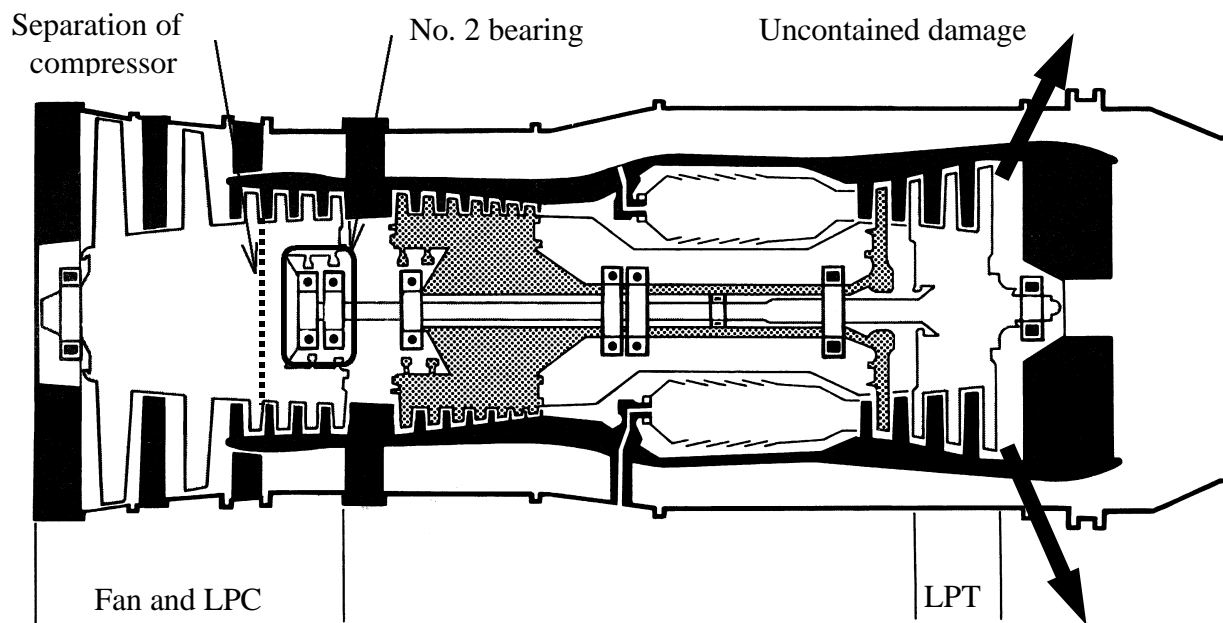
Figure 1. JT8D engine

The JT8D engine's low pressure rotor system is made up of a two-stage fan, which consists of the 1<sup>st</sup> and 2<sup>nd</sup> stage fan rotors,<sup>3</sup> and a four-stage low pressure compressor (LPC), which consists of the 3<sup>rd</sup>, 4<sup>th</sup>, 5<sup>th</sup>, and 6<sup>th</sup> stage compressor rotors. The two-stage fan and four-stage compressor are joined to the three-stage LPT, which consists of the 2<sup>nd</sup>, 3<sup>rd</sup>, and 4<sup>th</sup> stage turbine rotors, by a drive shaft, all of which rotate as one unit under normal conditions (see figure 1). The examination of the incident engine revealed that the 1<sup>st</sup> and 2<sup>nd</sup> stage fan rotors and the 3<sup>rd</sup> stage compressor rotor rotated together but independently from the remainder of the low pressure rotor system from the 4<sup>th</sup> stage compressor rotor rearward. The examination also showed that the 2<sup>nd</sup>, 3<sup>rd</sup>, and 4<sup>th</sup> stage LPT disks were intact but that all of the LPT blades were fractured adjacent to the blade root platforms, and most of the LPT vanes were missing. Although the engine was outfitted with an LPT containment shield, as required by Airworthiness Directive (AD) 94-20-09, the containment shield was broken into three pieces, and the engine was cut in two just aft of the LPT by liberated LPT blades.<sup>4</sup>

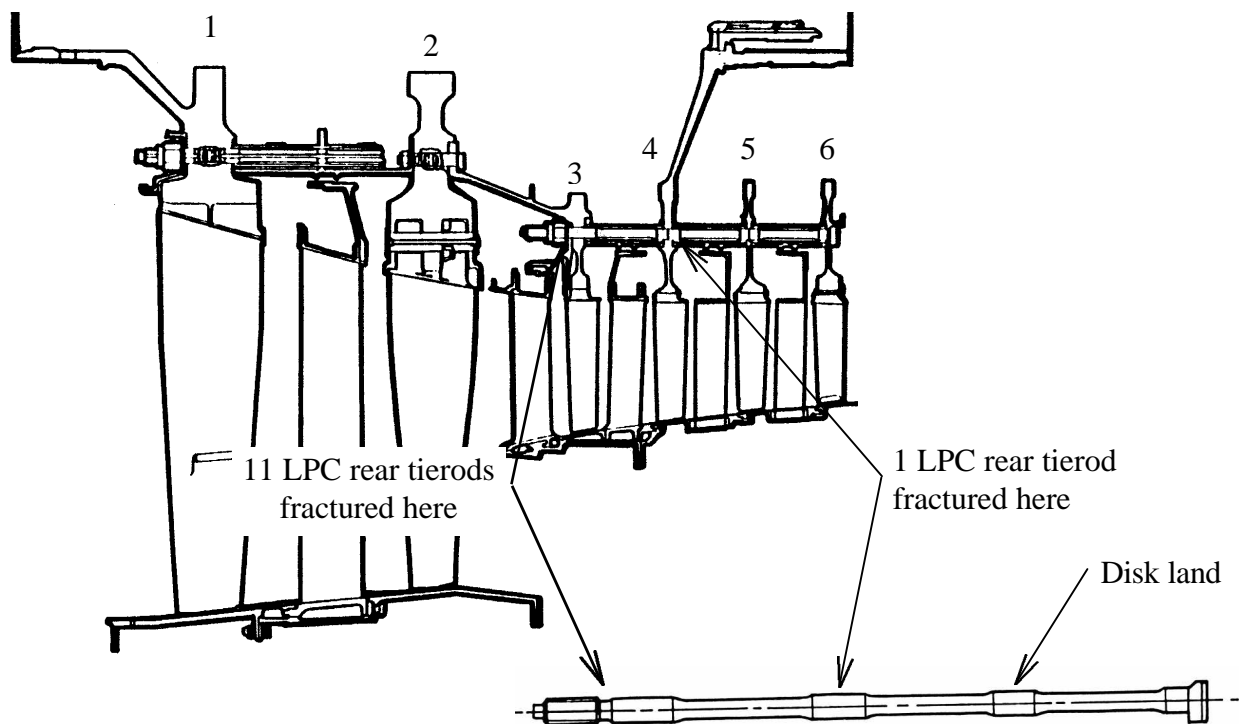
Figure 2. Cross-section of the JT8D fan and LPC and view of an LPC rear tierod

The 4 stages of the JT8D engine's LPC are held together by 12 long bolts, called LPC rear tierods, that pass through alternating disks and spacers (see figure 2). The disassembly of the Royal Airlines LPC revealed that one LPC rear tierod, part number (PN) 789550, was fractured transversely across the tierod's 4<sup>th</sup> stage compressor disk land.<sup>5</sup> The entire fracture face on the

tierod had surface corrosion, suggesting that the tierod had been broken for some time. Because of overstress, the 11 remaining LPC rear tierods were fractured at their forward ends between the 3<sup>rd</sup> stage compressor disk lands and the tierod nut threads. All six of the recovered tierod nuts and ends had numerous pockmarks on one side, and the tierod ends were bent away from the pockmarks. The pockmarks and bending damage suggest that after the initial tierod fractured and was liberated from the compressor, it tumbled around in the cavity at the front of the LPC and impacted the other tierod nuts and ends until they eventually fractured, causing the compressor to separate between the 3<sup>rd</sup> and 4<sup>th</sup> stage rotors and the engine to fail. Eleven equally spaced fan exit vanes had the imprints of the tierod nuts on the leading edge, indicating that the 11 remaining tierods fractured simultaneously when the engine failed.

The Safety Board's examination of the LPC rear tierod with the corroded fracture face revealed that a fatigue fracture originated from a small area of galling<sup>6</sup> on the 4<sup>th</sup> stage compressor disk land. On July 7, 1982, as a result of 33 LPC rear tierod fractures at the 3<sup>rd</sup> and 4<sup>th</sup> stage disk land locations that caused damage in JT8D engines, P&W issued Service Bulletin (SB) 5407.<sup>7</sup>

Require that all Pratt & Whitney JT8D-1 through -17AR engines be disassembled at the next shop visit and that the low pressure compressor rear tierods be removed, cleaned, stripped of any antigallant and nickel cadmium (nicad), non-destructively inspected, replated with nicad, coated with the antigallant, and reinstalled or that new tierods coated with the antigallant be installed. (A-99-12)

Require Pratt & Whitney to revise its JT8D engine manual to require that the low pressure compressor rear tierods be inspected with an appropriate non-destructive inspection method. (A-99-13)

Require a repetitive borescope inspection of Pratt & Whitney JT8D-1 through -17AR engines to check for fractured low pressure compressor (LPC) rear tierods and, if found, require the removal of those engines from service for repair. Periodic reinspections should continue until a non-destructive inspection of the LPC rear tierods is performed or the tierods are replaced. (A-99-14)
