National Transportation Safety Board
Washington, D.C. 20594

Safety Recommendation

In reply refer to: A-99-32 through -34

On July 9, 1998, an Airbus Industrie A300B4-605R airplane, N80057, powered by two General Electric Aircraft Engines (GEAE) CF6-80C2A5 engines and operated as American Airlines (AA) flight 574, experienced a fire in the No. 1 (left) engine shortly after takeoff from San Juan, Puerto Rico. The flight crew declared an emergency, initiated the in-flight engine fire procedures, and returned to San Juan, where an emergency evacuation was performed and the fire was extinguished with the assistance of airport fire department personnel. Of the 252 passengers and crew members on board, 28 passengers received minor injuries during the evacuation. Flight 574 was conducted as a regularly scheduled passenger flight from San Juan to Miami, Florida, under the provisions of 14 Code of Federal Regulations Part 121.

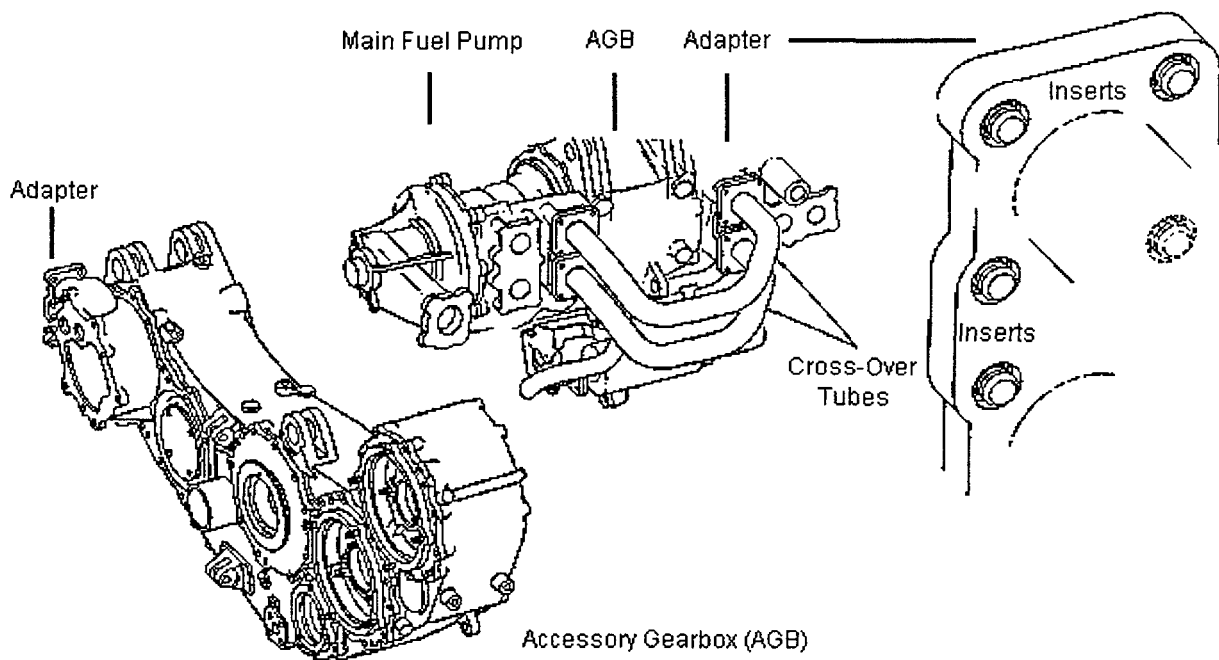
Figure 1. Accessory Gearbox Adapter Configuration and Insert Locations

Examination of the engine revealed that all the accessory gearbox (AGB) adapter attachment bolt inserts had backed out, allowing fuel lines (cross-over tubes) to unseat from the adapter (See figure 1). This allowed pressurized fuel to spray onto hot engine parts and ignite, resulting in the nacelle fire. Examination of the adapter revealed that it had been reworked per GEAE Service Bulletin (SB) 72-743, which called for the installation of new adapter inserts to permit a higher and more consistent bolt torque that would improve the clamping interface and eliminate fuel leaks from the adapter cross-over tube interface.

GEAE issued SB 72-743 on August 25, 1994, and AA approved the SB for incorporation in March 1995; however, AA discovered in September 1995 that the replacement insert specified in SB 72-743 was much smaller than the hole, allowing it to slide completely through. AA notified GEAE of the error and an alternate insert was authorized, but GEAE did not revise the SB. AA issued Supplement 1 to its SB 72-743 instructions to specify the new insert in October 1995. Meanwhile, the incident adapter had already been reworked to the original SB. Motoren- und Turbinen-Union (MTU) in Hannover, Germany, reworked the incident adapter on September 26, 1995, but installed inserts different than those specified in the SB. However, as with the inserts specified in the SB, the inserts from the incident adapter were also too small for the

adapter holes and were not the correct thread pitch. Consequently, the insert threads did not have the proper engagement with the housing and allowed fuel leakage. MTU did not notify GEAE or AA of any difficulties in complying with the SB or of its installation of alternate inserts not specified in the SB.

Although the Safety Board's investigation continues, it supports the corrective actions taken by GEAE and the Federal Aviation Administration (FAA) after the incident to address the cause of the engine fire. Specifically, GEAE has issued two all operators wires (AOWs) to inform all CF6-80C operators of the San Juan incident, the investigation's findings, and GEAE's and FAA's planned follow-on actions. These actions include suspension of SB 72-743; advance notification of Alert Service Bulletin (ASB) 73-A283³ and SB 73-284; and advance notification of the FAA's plan to issue an airworthiness directive (AD). On January 6, 1999, the FAA issued AD 99-01-01 to require compliance with GEAE SB 73-284.

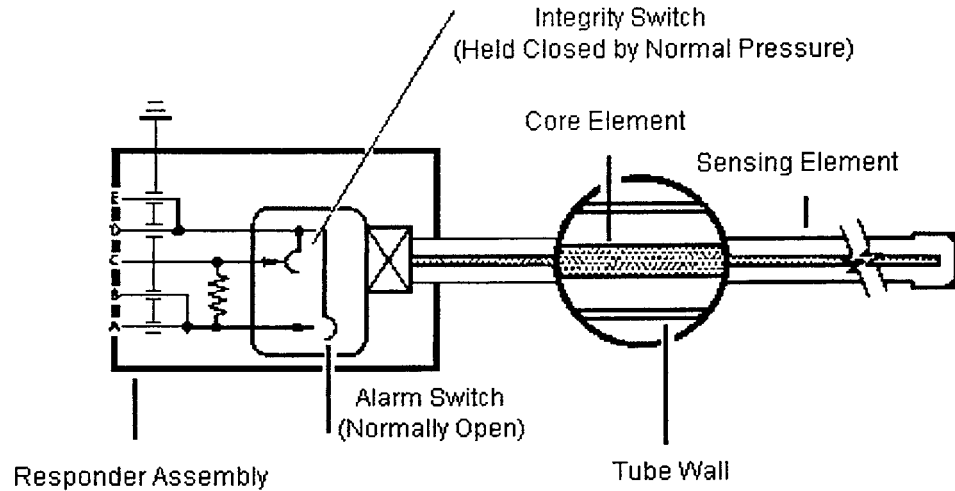
Figure 2. Internal Components of the Engine Fire Detection Loop Assembly

Application of heat to the fire loop causes an increase in internal gas pressure, which acts on a pressure diaphragm inside the responder assembly. If the gas pressure within the loop increases sufficiently, the alarm switch is closed (See figure 2), and a fire signal is sent to the FDC unit. A pressure drop inside the loop because of a gas leak causes the integrity switch to open, sending a fault signal to the FDC unit. A loss of electrical continuity from the responder will also send a fault signal.

Examination of the fire detection system from the incident airplane revealed extensive fire damage to the No. 1 engine's core wiring harness (loop B),⁶ which would have caused the loss of responder signal to the FDC unit. Because both loops were selected ON in the cockpit, the FDC unit would have interpreted the signal loss as a loop fault and consequently disengaged the fire warning and activated the loop fault warning in the cockpit.

Issue an airworthiness directive to require that all operators of Airbus A300-600 and A310 airplanes modify the engine and auxiliary power unit (APU) fire detection systems to automatically arm the remaining loop for fire detection in the event of a single loop fault in the engines or APU. (A-99-32)
