National Transportation Safety Board

Safety Recommendation

In reply refer to: A-99-51 through -54

On October 15, 1998, Delta Air Lines flight 915, a McDonnell Douglas MD-88, N902DE, experienced an uncontained failure¹ in the No. 2 (right) engine, a Pratt & Whitney (P&W) JT8D-219, immediately after takeoff from Logan International Airport, Boston, Massachusetts. The pilots reported that, just after takeoff, they felt a light thump, the airplane yawed to the right, and the cockpit instrumentation indicated that the No. 2 engine had lost power. The pilots then declared an emergency and returned to Boston. None of the 128 passengers, 4 flight attendants, and 2 pilots on board were injured. The airplane was operating on an instrument flight rules flight plan under the provisions of 14 Code of Federal Regulations Part 121 as a regularly scheduled passenger flight from Boston to Atlanta, Georgia.

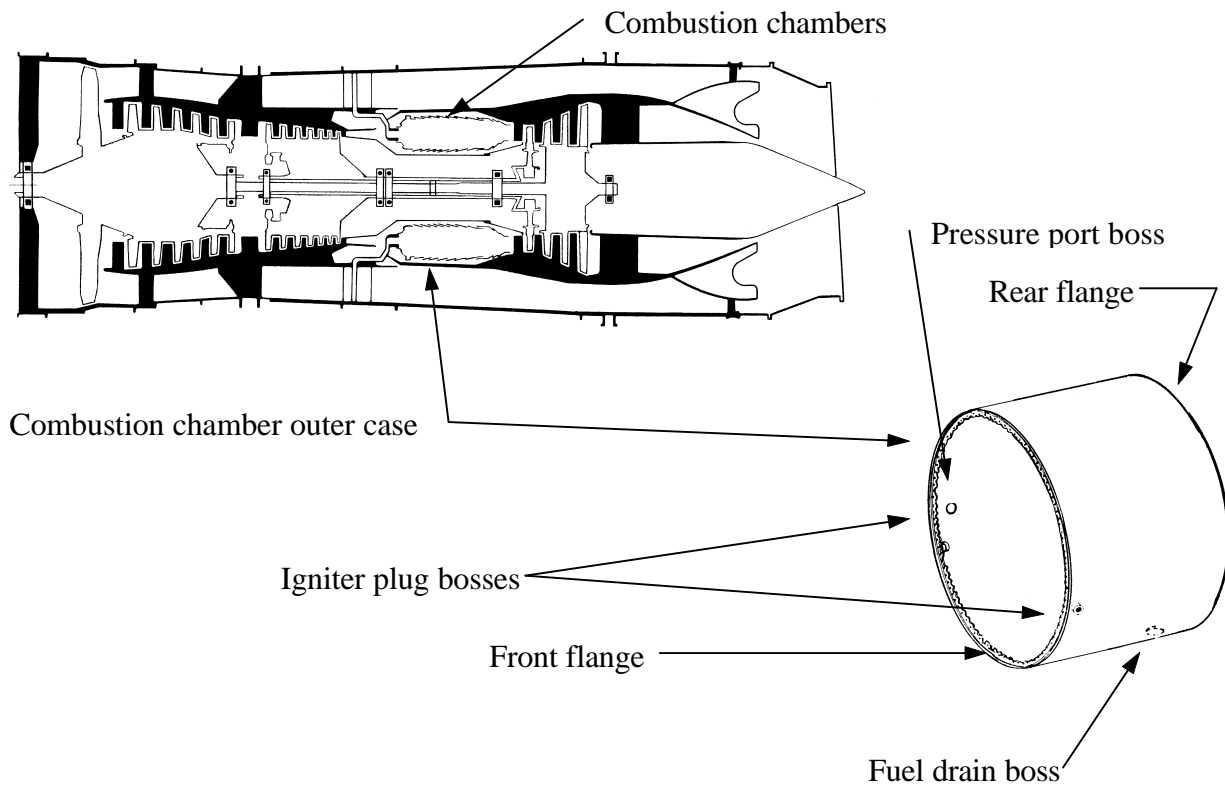
The examination of the No. 2 engine revealed that the rear sections of the upper and lower forward cowl doors were deflected away from the engine and that the rear cowl doors were missing. The airplane's vertical stabilizer and fuselage adjacent to the No. 2 engine sustained minor damage from impact by the upper cowling. Subsequent disassembly of the engine revealed the combustion chamber outer case (CCOC) had ruptured axially from the fuel drain boss² at the bottom of the case.

Figure 1. JT8D-200 engine cross section showing the location of the CCOC, and an enlarged view of the CCOC showing the location of the bosses and the case's front and rear flanges.

The ruptured CCOC was examined at the National Transportation Safety Board's materials laboratory. This examination revealed a fatigue fracture that had multiple origins along the weld on the exterior side of the fuel drain boss. The fracture had propagated about 150° around the boss and then axially, about 1½ inches forward and ½ inch rearward. The fatigue striations indicated that the crack had existed for approximately 1,340 cycles before the CCOC ruptured. The fracture originated from a mechanically thinned area of the boss' flange that had grinding marks consistent with previous work. The measured thickness of the boss flange adjacent to the fatigue fracture was 0.080 inch; however, the fuel drain boss' engineering drawing required a thickness of 0.099 to 0.109 inch.

Because the maintenance records indicated that Delta did not accomplish any weld repairs to the ruptured CCOC, the Safety Board concludes that the grinding adjacent to the weld that thinned the fuel drain boss flange was done by P&W during its rework of the CCOC.⁸ The Safety Board is concerned that other JT8D-1 through -17AR and JT8D-200 CCOCs that were reworked during manufacture may have been accepted with a below-minimum thickness case wall or boss flange from which a crack could initiate and propagate to rupture. Therefore, the Safety Board believes that the FAA should require, as an interim action, P&W to identify all JT8D-1 through -17AR and JT8D-200 engine CCOCs that had boss welds reworked during manufacture; require repetitive on-wing inspections of those CCOCs for boss weld cracks at intervals appropriately less than 1,340 cycles in service; and, if cracks are found, require the removal of those engines from

Require that all Pratt & Whitney JT8D-1 through -17AR and JT8D-200 engines have a one-piece, integral boss combustion chamber outer case (CCOC) installed at the next shop visit that the engine's CCOC becomes accessible. (A-99-51)

Require, as an interim action, Pratt & Whitney to identify all JT8D-1 through -17AR and JT8D-200 engine combustion chamber outer cases (CCOC) that had boss welds reworked during manufacture; require repetitive on-wing inspections of those CCOCs for boss weld cracks at intervals appropriately less than 1,340 cycles in service; and, if cracks are found, require the removal of those engines from service for replacement of the CCOC. Periodic inspections should continue until a one-piece, integral boss CCOC is installed. (A-99-52)

Require, as an interim action for those Pratt & Whitney JT8D-200 engine combustion chamber outer cases (CCOC) that did not have the boss welds reworked during manufacture, repetitive on-wing inspections of the bosses at appropriate intervals for cracks in the welds and, if cracks are found, require the removal of those engines from service for replacement of the CCOC. Periodic inspections should continue until a one-piece, integral boss CCOC is installed. (A-99-53)

Require a one-time inspection to identify any Pratt & Whitney JT8D-1 through -17AR and JT8D-200 combustion chamber outer cases (CCOC) with nonmagnetic bosses. If such bosses are found, require the removal of those engines from service for replacement of the CCOC with a one-piece, integral boss CCOC. (A-99-54)
