National Transportation Safety Board

Safety Recommendation

In reply refer to: A-99-5 through -7

Brief of Accident

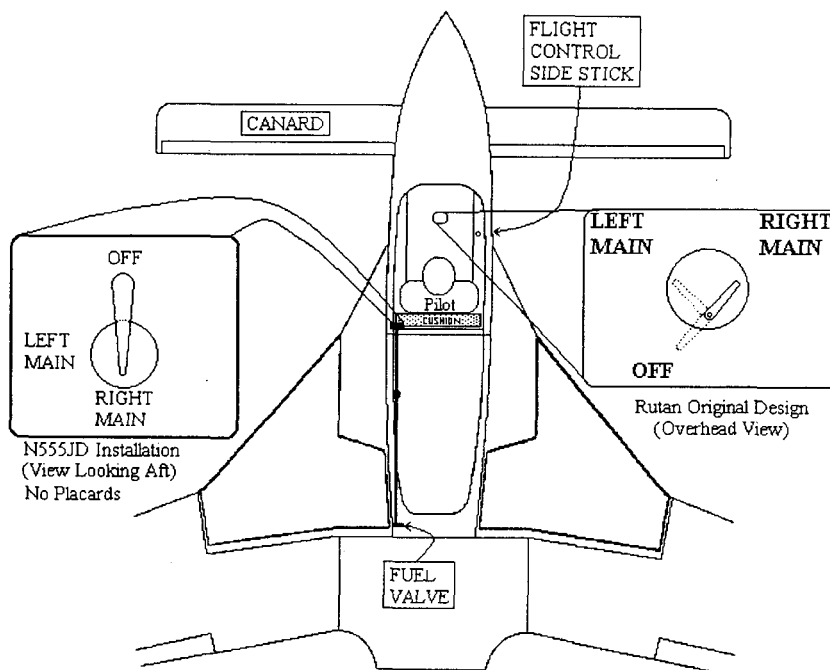
Figure 1—Comparison of fuel selector handle locations in Long-EZ

The amateur builder of N555JD modified the fuel system design by locating the fuel selector handle on the left side of the bulkhead that forms the front cockpit seat back. It was positioned approximately behind the front-seat pilot's left shoulder (see figure 1). The builder also changed the orientation of the handle so that upward selected "Off," right selected the left tank, and downward selected the right tank. The corresponding 3-position fuel selector valve was installed inside the rear cockpit on the front of the engine firewall just behind the rear seat and was connected to the selector handle via two torque tubes and a universal joint. The selector handle was about 4 feet forward of the fuel selector valve. No placard or marking existed (nor was it required) on the fuel selector handle base that would have indicated to the pilot its operating position. Further, as has been stated, the sight gauges were not marked to quantify the amount of fuel in the tanks.

N555JD vs. Original design

The flight control side sticks in both cockpits were installed in armrests on the right side of the cockpits, measured about 6 inches high, and were similar in function to a conventional control stick. During the postaccident investigation, simulation by Safety Board staff showed that the front-seat pilot in the accident airplane would have had to loosen his shoulder harness, completely release the flight control stick, turn in his seat, and stretch to his left when reaching over the left shoulder with his right hand to change the position of the fuel selector handle on the accident Long-EZ airplane. The Safety Board investigator, in every simulation, inadvertently applied right rudder when turning his body and reaching for the fuel selector handle. This finding concerned the Safety Board because the design change that moved the fuel selector handle introduced a safety hazard in N555JD. On the basis of the accident circumstances and witness accounts, the Board concluded that the accident pilot probably inadvertently applied right rudder while manipulating the fuel selector, precipitating the loss of control that preceded the accident.

Amend FAA Order 8130.2C to specify that, before the issuance of special airworthiness certificates, experimental, amateur-built airplanes should be inspected for needed placards and markings on cockpit instruments and for the appropriate placement and operation of essential system controls to ensure that they provide clear marking, easy access, and ease of operation. (A-99-5)
