# National Transportation Safety Board

## Safety Recommendation

**In reply refer to:** A-99-79

On August 28, 1998, a Eurocopter BK 117 (BK 117) helicopter, operated by St. Louis Helicopters, dba Topeka Lifestar, touched down and then rolled over during an emergency landing after the No. 1 engine cowling and its access door separated during a landing approach at the Topeka-Forbes Airport, Topeka, Kansas. None of the three occupants were injured. The helicopter sustained substantial damage.

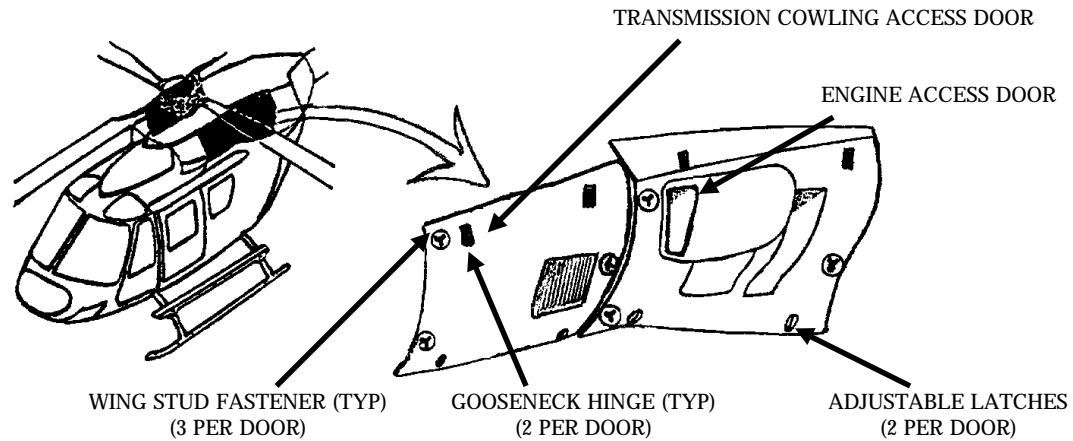
**Figure 1. BK 117 Cowling Access Door Latch Assembly**

The BK 117 engine and transmission cowling access doors are configured with two upper gooseneck hinge assemblies that secure the access doors to the cowling and allow them to open in the upward direction (see figure 1). Two lower adjustable latches secure the doors to the bracket attached to the airframe. These lower latches have an adjustable tension hook that, when properly adjusted, engages under the lip of the airframe bracket and secures the door for flight. The access doors are also secured to the airframe with three wing head stud fasteners (two forward and one aft).

Inspection of the separated engine cowling access door from the accident helicopter revealed that the forward adjustable latch was deformed and bent and that the aft latch was not damaged. All three wing head stud fasteners were missing, and the two forward wing head stud fastener holes were distorted. The investigation concluded that the aft adjustable latch of the engine cowling access door was not properly secured, which allowed the door to open fully upward and contact the main rotor blades. An examination revealed that it is possible for maintenance personnel and/or flight crews to believe that the latches are secure when, in fact, they are not, because the face of the latch covers the hook even when the hook is not engaged. The wing head stud fasteners are not designed to withstand in-flight airloads; therefore, if the cowling access door is not properly latched, in-flight separation of the door may occur.

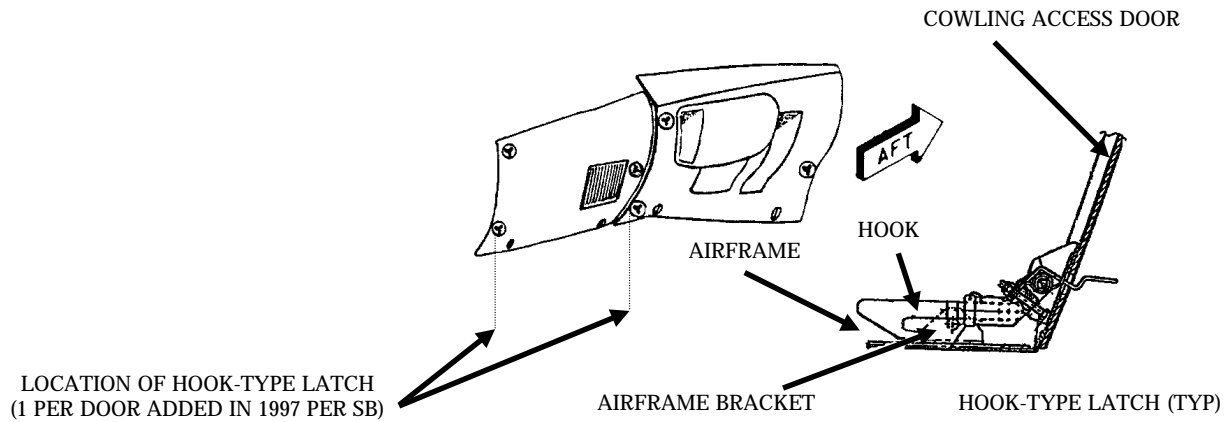
**Figure 2. Suggested BK 117 Access Door Latch Assembly**

On June 16, 1997, Eurocopter issued Service Bulletin (SB) MBB-BK 117-20-109, which recommended that a hook-type latch be retrofitted to the cowling access doors (see figure 2). The hook-type latch was designed to prevent the cowling access door from opening fully if the adjustable latches failed or were not secured properly.

The Safety Board is concerned that despite the issuance of AD 95-08-12, cowling access doors continue to open in flight, jeopardizing safety. Installation of a hook-type latch in accordance with SB MBB-BK 117-20-109 would enhance safety and prevent the cowling access doors from opening fully and coming in contact with the rotor blades in flight. Therefore, the Safety Board believes that the FAA should issue an AD to require compliance with SB MBB-BK 117-20-109 to reduce the potential for in-flight engine and transmission cowling access door separations.

Issue an airworthiness directive to require compliance with Eurocopter Service Bulletin MBB-BK 117-20-109 to reduce the potential for in-flight engine and transmission cowling access door separations. (A-99-79)
