National Transportation Safety Board
Washington, D.C. 20594

Safety Recommendation

In reply refer to: A-99-8

LAX98FA008
FILE NO. 1406 10/12/97 PACIFIC GROVE, CA AIRCRAFT REG NO. N555JD TIME (LOCAL) - 17:28 PDT

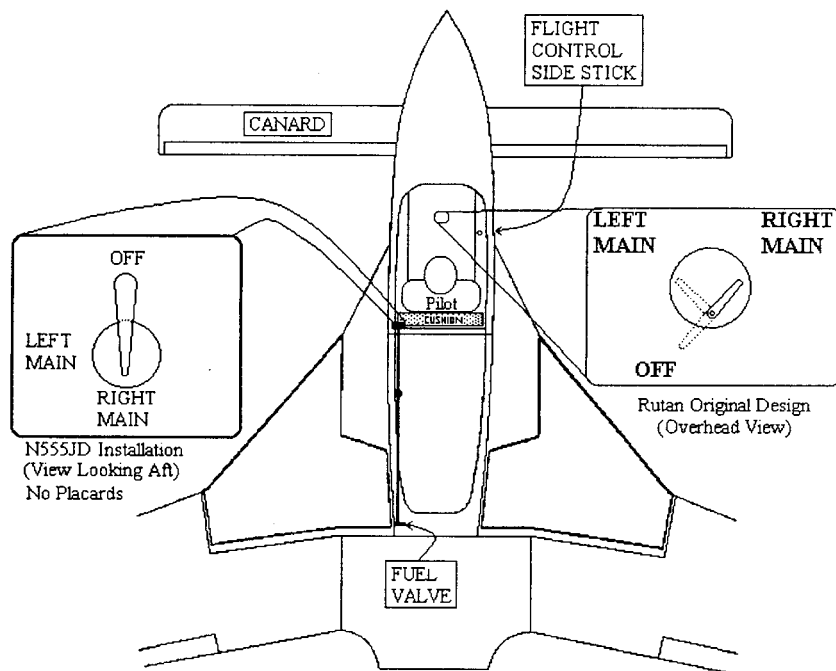
The amateur builder of N555JD modified the fuel system design by locating the fuel selector handle on the left side of the bulkhead that forms the front cockpit seat back. It was positioned approximately behind the front-seat pilot's left shoulder (see figure 1). The builder also changed the orientation of the handle so that upward selected "Off," right selected the left tank, and downward selected the right tank. The corresponding 3-position fuel selector valve was installed inside the rear cockpit on the front of the engine firewall just behind the rear seat and was connected to the selector handle via two torque tubes and a universal joint. The selector handle was about 4 feet forward of the fuel selector valve. No placard or marking existed (nor was it required) on the fuel selector handle base that would have indicated to the pilot its operating position. Further, as has been stated, the sight gauges were not marked to quantify the amount of fuel in the tanks.

Figure 1—Comparison of fuel selector handle locations in Long-EZ

N555JD vs. Original design

The fuel selector valve assembly from the accident airplane was found in an intermediate position; the selector valve port from the right tank fuel supply line was about 33 percent open to the engine feed line and the left was about 2 to 4 percent open to the engine feed line. An engine test run in a test cell showed that full power could be attained (with fuel in both tanks) with the selector valve in the “as found” position. However, with fuel in only one tank and the other fuel

line open to the atmosphere to simulate an empty tank, the engine lost power with the fuel selector valve in the "as found" position. The position of the fuel selector handle from the accident airplane could not be determined because of damage to the torque tubes between the valve and the selector handle.
