National Transportation Safety Board
Washington, D.C. 20594

Safety Recommendation

In reply refer to: A-99-9

On October 12, 1997, about 1728 Pacific daylight time, an experimental category, amateur-built Adrian Davis¹ Long-EZ airplane, N555JD, crashed into the Pacific Ocean near Pacific Grove, California. Air traffic control communications indicated that the airplane had departed from the Monterey Peninsula Airport's runway 28L about 1712, and the pilot performed three touch-and-go landings and departed to the west moments before the accident. Witnesses reported that they heard engine popping and a reduction in engine noise before the accident. The pilot made no distress calls. The pilot was killed, and the airplane was destroyed.

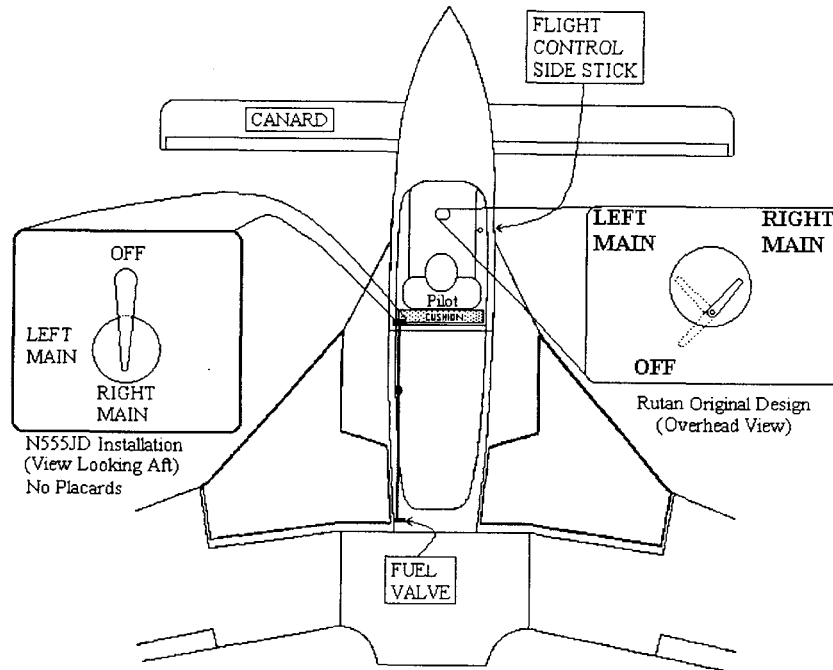
Figure 1—Comparison of fuel selector handle locations in Long-EZ

The amateur builder of N555JD modified the fuel system design by locating the fuel selector handle on the left side of the bulkhead that forms the front cockpit seat back. It was positioned approximately behind the front-seat pilot's left shoulder (see figure 1). The builder also changed the orientation of the handle so that upward selected "Off," right selected the left tank, and downward selected the right tank. The corresponding 3-position fuel selector valve was installed inside the rear cockpit on the front of the engine firewall just behind the rear seat and was connected to the selector handle via two torque tubes and a universal joint. The selector handle was about 4 feet forward of the fuel selector valve. No placard or marking existed (nor was it required) on the fuel selector handle base that would have indicated to the pilot its operating position. Further, as has been stated, the sight gauges were not marked to quantify the amount of fuel in the tanks.

N555JD vs. Original design

The flight control side sticks in both cockpits were installed in armrests on the right side of the cockpits, measured about 6 inches high, and were similar in function to a conventional control stick. During the postaccident investigation, simulation by Safety Board staff showed that the front-seat pilot in the accident airplane would have had to loosen his shoulder harness, completely release the flight control stick, turn in his seat, and stretch to his left when reaching over the left shoulder with his right hand to change the position of the fuel selector handle on the accident Long-EZ airplane. The Safety Board investigator, in every simulation, inadvertently applied right rudder when turning his body and reaching for the fuel selector handle. This finding concerned the Safety Board because the design change that moved the fuel selector handle introduced a safety hazard in N555JD. On the basis of the accident circumstances and witness accounts, the Board concluded that the accident pilot probably inadvertently applied right rudder while manipulating the fuel selector, precipitating the loss of control that preceded the accident.
