National Transportation Safety Board
Washington, D.C. 20594

Safety Recommendation

In reply refer to: A-98-113 through -118

On June 18, 1998, a Swearingen SA226-TC Metroliner II airplane,¹ Canadian registry C-GQAL, operated by PropAir, Inc., crashed after the left wing separated during an attempted emergency landing at Mirabel Airport, Montreal, Quebec, Canada. The flight was operating as a charter from Montreal to Peterborough, Ontario, Canada. The airplane had departed from Montreal's Dorval Airport and was climbing through 12,500 feet when the flightcrew reported a loss of hydraulic pressure and a fire on the left side of the airplane. The pilot then shut down the left engine and declared an emergency. The flightcrew lost control of the airplane at low altitude during the final approach for landing. The airplane was destroyed, and the two flightcrew members and all nine passengers were killed.

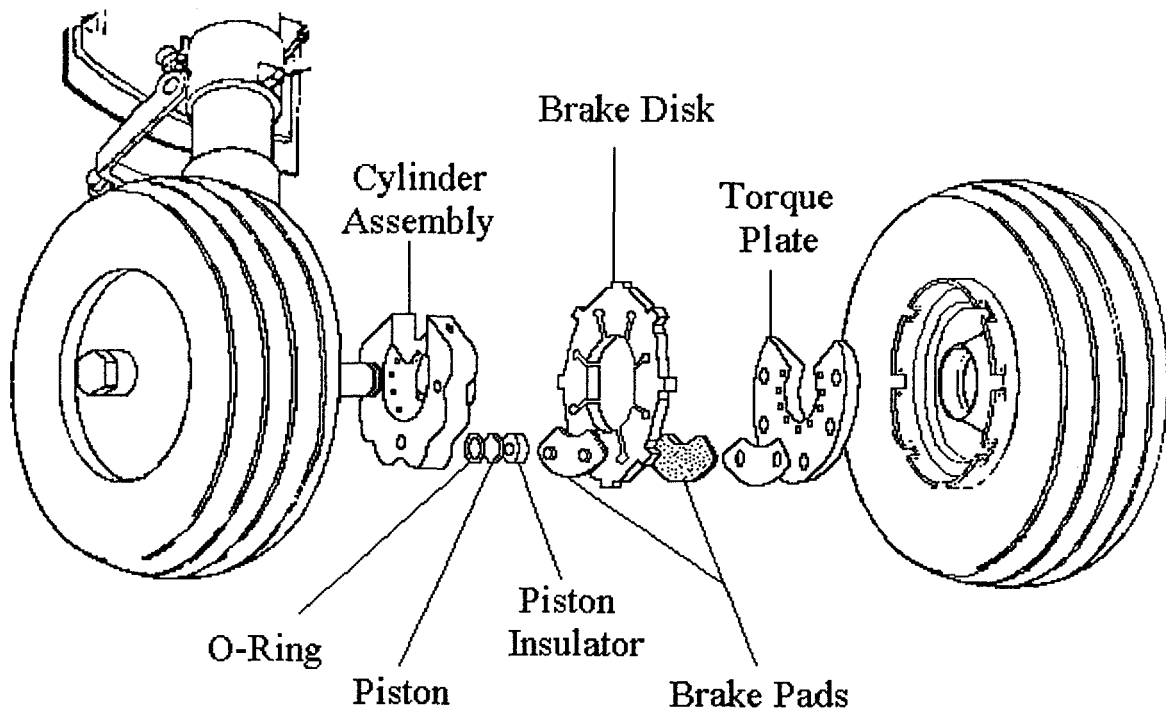
Figure 1. B.F. Goodrich 2-1203 Disk Brake Assembly

The airplane involved in the Montreal accident was equipped with B.F. Goodrich part number (P/N) 2-1203 wheel brake assemblies (see figure 1).² The left wheel well included the

² The B.F. Goodrich P/N 2-1203 series brake assembly is a floating-type, single-disk assembly. The steel disk has smooth sides, expansion slots, and tangs around the outer diameter. The tangs are keyed into the wheel so that both rotate together. The disk floats in and out of the wheel to prevent binding during brake application. The cast-aluminum alloy housing, which is bolted to the landing gear strut, has six cylinders, aluminum alloy pistons, and O-rings to prevent leakage. Each piston is protected from the brake pad by an asbestos piston insulator to minimize heat transfer from the disk to the piston. During brake application, hydraulic fluid is forced into the cylinder, and the piston pushes against the insulator, movable brake pad, disk, and opposing brake pad and torque plate to clamp the rotating disk. The airplane involved in the Montreal accident had the original design P/N 2-1203 wheel brake assembly. Subsequent P/N 2-1203 brake assemblies have suffixes of -1 through -4.
