National Transportation Safety Board

Safety Recommendation

In reply refer to: A-98-122 through -124

On June 2, 1998, a Boeing 757-232 (B-757), N629DL, owned and operated by Delta Airlines, Inc., was damaged when its left off-wing emergency evacuation slide separated from the airplane during a scheduled flight operated under Title 14 Code of Federal Regulations Part 121 en route from LaGuardia Airport (LGA) to Cincinnati/Northern Kentucky International Airport (CVG). The pilot reported that during climbout from LGA he noticed the engine indication and crew alerting system (EICAS) light illuminate, indicating that the left off-wing slide door was open. The flight continued to CVG and landed without further incident. None of the occupants were injured.

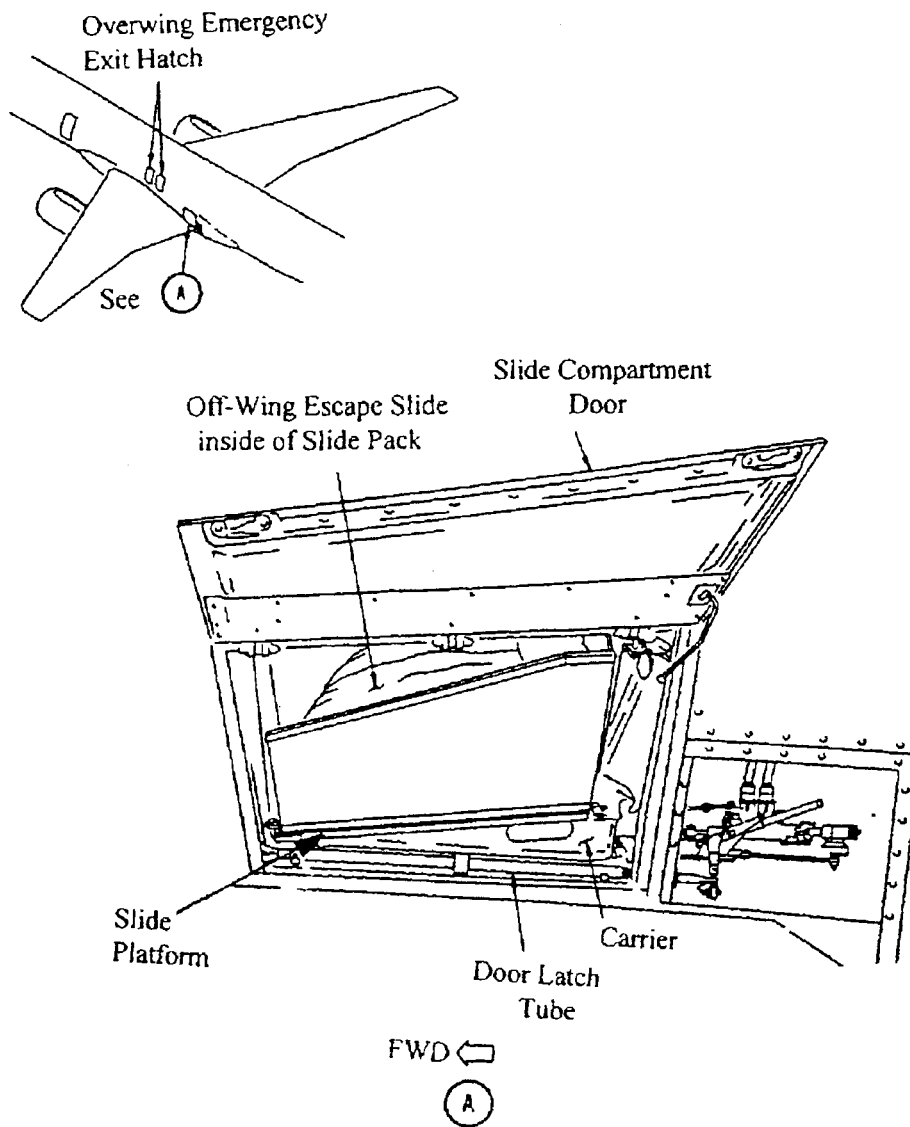
Figure 1.—B-757 Off-Wing Escape Slide Assembly

The B-757 off-wing emergency escape slide system is located just above the trailing edge of each wing in the aft wing/body fairing and consists of a ramp/slide folded into a "slide pack" attached to a packboard and installed on a carrier assembly. To service the slide, a mechanic must first open the slide maintenance access door and release the trigger on a round yellow handle. The yellow handle actuates a pneumatic actuator, which unlatches the slide compartment door. The slide compartment door is locked in the closed position by lowering the yellow handle to its lowest position; this secures the door latch tube that is located along the lower edge of the slide compartment (see figure 2). A door sensor (micro switch) located on the aft edge of the door sill activates the "EMER DOORS" light on the cockpit overhead annunciator panel and displays the "L WING SLIDE" or "R WING SLIDE" EICAS message if either off-wing slide door opens more than 0.24 inch at its sensor switch.

Replacement of the slide requires that a mechanic remove the main landing gear wheel well access cover located directly beneath the slide carrier compartment to remove the bolts that secure the slide pack to the carrier. Also, the carrier has a locking pin that can only be viewed by a mechanic from the lower wheel well. When the slide's carrier is fully locked in place and the yellow crank handle is moved to the down and locked position, the locking pin should be fully engaged in the carrier's locking lug. The maintenance manual provides step-by-step guidance for the removal and installation of the B-757 off-wing emergency escape slide, and section 25-65-09

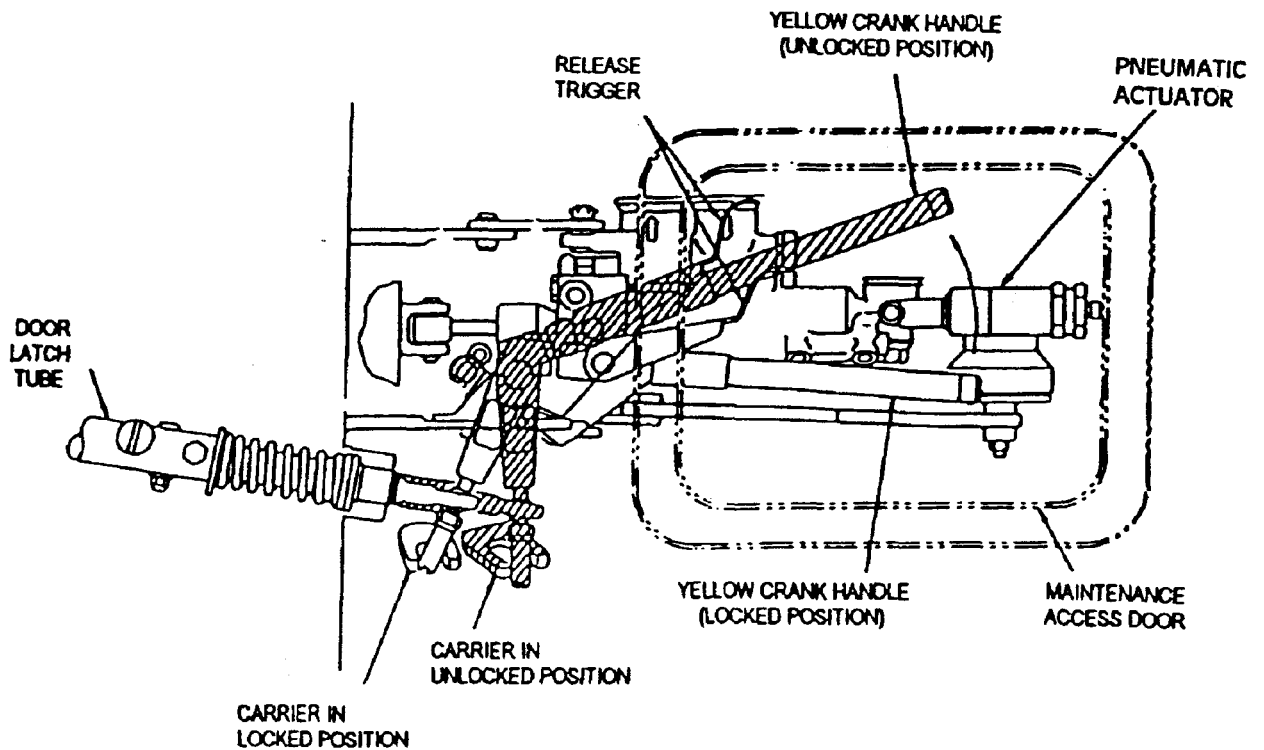
Figure 2.—B-757 Off-Wing Escape Slide Actuator Assembly

During its investigation of the B-757 off-wing escape slide, the National Transportation Safety Board found that Delta Airlines had performed a replacement of the left off-wing emergency escape slide 2 days before the incident. The two mechanics who replaced the slide stated that it was the first time they had replaced a B-757 off-wing slide. The mechanics stated that they referred to the B-757 maintenance manual, sections 25-65-00 and 25-65-01, and the placard on the inside of the maintenance access door while they replaced the slide.¹ One mechanic maneuvered the round yellow actuator handle that secures the off-wing emergency slide door within the slide compartment (see figure 2), and the other mechanic held the slide door closed (by sitting on the wing and pressing on the door with both his feet.) The mechanic who manipulated the round yellow actuator handle said it was difficult to ensure that the handle was in the full-

down position, stating that “it took several attempts to move the actuator handle to the latched position.” The mechanics stated that after the door was latched one mechanic ran his finger around the door to ensure it was closed, and then both mechanics checked the EICAS in the cockpit to ensure that the door was closed. One of the two mechanics said that he had received instructions on how to replace the slide about 4 or 5 years ago during a 2-week B-757 initial maintenance training class that provided instructions on all B-757 systems. The other mechanic had not yet received training on the B-757 off-wing escape slide replacement during his 3 months of employment at Delta.

- difficulty in visually inspecting the forward edge of the slide compartment door to ensure that it is correctly latched,
- the aft location of the door's electrical sensor may not clearly indicate whether the forward edge of the slide compartment door is latched, and
- the incorrect installation of the lockbase retainer on the door latch tube, which can prevent locking the door latch tube in the latched position.

To remedy these problems, the SB provided instructions to replace the lockbase retainer and the bearing for the door's latch tube and to relocate the door's sensor forward on the slide compartment door.

- 1.) installation of a bumper on the slide pack carrier to ensure it is pushed in far enough to be locked in place and to prevent movement of the carrier before actuation of the yellow crank handle,
- 2.) the addition of a witness mark on the lip of the maintenance access door frame that aligns with the yellow crank handle to ensure the handle is in the locked position, and
- 3.) the rewriting of the instructions on the placard on the inside of the maintenance access door to provide clear, concise direction to ensure the door is faired and latched prior to flight.
