National Transportation Safety Board

Safety Recommendation

In reply refer to: A-98-25 and -26

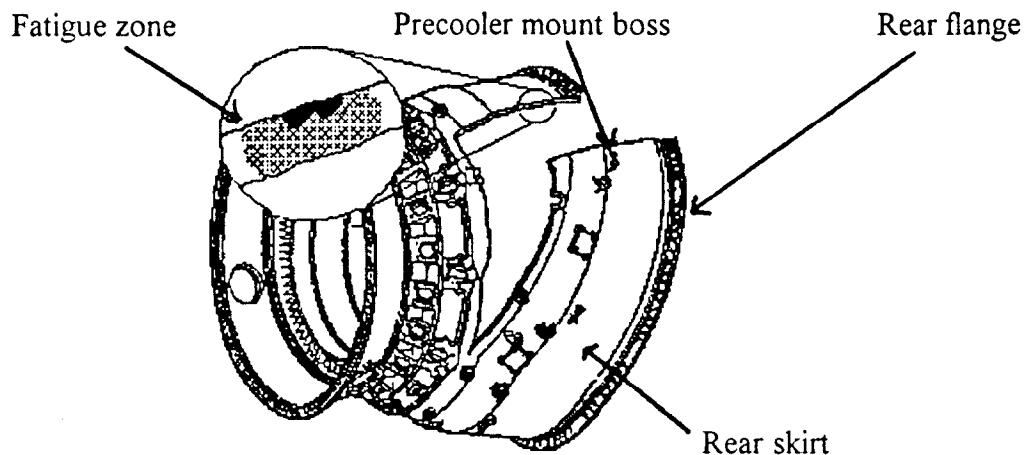
The National Transportation Safety Board's (NTSB) examination of the engine discovered an L-shaped crack in the outer pressure wall in the rear skirt area of the diffuser case that was deflected outward exposing the bulged combustion chamber inside the engine. The crack extended fore and aft approximately 18 inches from the diffuser case's rear flange at the 11 o'clock¹ position. The crack turned 90° and extended circumferentially around approximately 120° of the case's circumference, in the counterclockwise direction. The crack passed adjacent to a 3-inch long, dog bone-shaped embossment (boss), located about 10 inches forward of the rear flange at the 11 o'clock position. The boss was the attachment point for the upper most mount bracket of the engine's 116-pound precooler.²

A section of the diffuser case rear skirt (see figure 1) was examined at the Safety Board's materials laboratory in Washington, D.C. Examination of the fracture surface, approximately 10 ½ inches from the rear flange, adjacent to the upper precooler mount boss, revealed a 5-inch long discolored high cycle fatigue³ (HCF) zone with about 90,000 striations. The fatigue initiated at a crack that looked like two thumbnail-shaped, gray-colored areas, which were approximately 0.040-inch wide by 0.010-inch deep. High levels of delta phase precipitate⁴ were discovered in the thumbnail-shaped origin areas. Individual 0.0005 to 0.0008-inch deep toolmarks or scratches were found on the outer case wall extending the length of the origin area. Numerous additional toolmarks were found on the exterior surface of the rear skirt. The toolmarks were formed when the exterior surface of the case was machined (blended) during manufacture. The diffuser case had accumulated 9,342 total flight cycles⁵ since new.

Figure 1: Ruptured diffuser case

A metallurgical analysis of the fracture surface indicated that the thumbnail-shaped cracks had initiated at the base of the toolmarks because of a combination of high residual stresses and low-cycle fatigue⁶ (LCF). The crack then propagated in HCF, as evidenced by the very small striation spacing found in the majority of the 5-inch long fatigue zone, after which the crack progressed to failure in tensile overload.

The proximity of the crack origin to the precooler mount boss and the HCF crack propagation suggests that high precooler vibration imparted higher than normal loading into the precooler mount boss and the diffuser case. Additionally, the postincident fatigue tests of the case material indicates that high levels of vibration alone are insufficient to initiate a crack. The

evidence also suggests that a tool mark or other defect in the case, combined with LCF, is required to initiate a crack and that high levels of vibration can propagate the crack.

Require a one-time visual inspection of the diffuser case rear skirt on Pratt & Whitney JT9D-7Q engines to locate scratches and tool marks when the diffuser case is next at the piece-part level, and blend repair as required to prevent tool marks and scratches from becoming crack initiation sites. (A-98-25)

Require modification of the engine bracket that attaches to the diffuser case's precooler upper mount boss on the Pratt & Whitney JT9D-7Q installation to increase clearance between the bracket and support link to reduce vibration and to reduce wear. (A-98-26)
