National Transportation Safety Board

Washington, D.C. 20594
Safety Recommendation

Date: March 6, 1998

In reply refer to: A-98-27 through -33

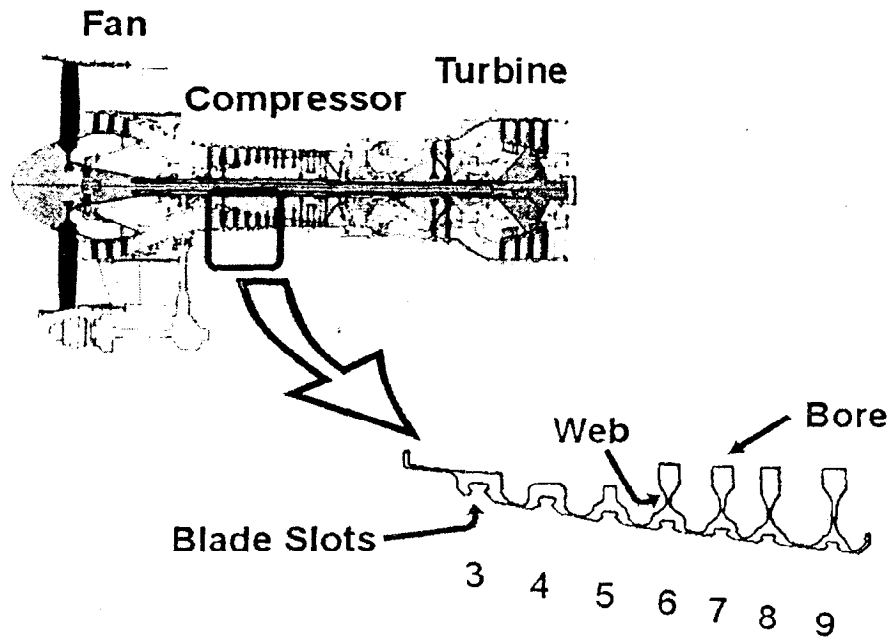
On September 7, 1997, Canadian Airlines International flight CP30, a Boeing 767-300ER airplane, equipped with General Electric Aircraft Engines (GEAE) CF6-80C2B6F engines, experienced an uncontained failure¹ of the high-pressure compressor (HPC) stage 3-9 spool (figure 1) in the No. 1 (left) engine during takeoff at Beijing, China. The airplane was on a regularly scheduled passenger flight from Beijing to Vancouver, Canada. The flightcrew reported that during the initial part of the takeoff as the throttles were advanced, the No. 1 engine surged. This was followed by a fire warning in the cockpit and significant vibration in the airplane. The crew rejected the takeoff at a speed of about 20 knots and discharged both fire bottles for the No. 1 engine. The engines were shut down, and the airplane was towed to the terminal without further incident. The 199 passengers and 10 crewmembers on board sustained no injuries.

The examination of the engine revealed substantial damage in the area of the HPC. The HPC case was ruptured aft of the stage 2 variable stator vanes. The stage 3 disk portion of the HPC stage 3-9 spool had separated from the remainder of the spool, exited the engine, and broken into three pieces, all of which were recovered. The No. 1 engine's right-hand thrust reverser cowl had a 2-inch by 1-inch cut in the skin. The reported fire was caused by fuel that had leaked from a line that supplies pressure to the active clearance control² valve, which was severed by one of the liberated pieces of the 3rd-stage disk.

Figure 1.—Typical 3-9 spool in cross section.

Metallurgical examination of the 3rd-stage disk of flight CP30's HPC spool was conducted at the TSB's engineering and the Safety Board's materials laboratories. The examination revealed a fatigue fracture that was about 1 3/4-inches long and about 1/2-inch deep, emanating from an area (not a clear, specific origin) at or near the bottom of a dovetail blade slot. Metallographic examination of numerous sections from the area of the fracture revealed a band of abnormal microstructure that contained predominantly alpha phase (the Ti-6242 alloy outside of the area of abnormal microstructure contained a mixture of approximately equal amounts of alpha and beta phases⁵) and elevated oxygen levels. This band of abnormal microstructure extended from the front to the rear face of the 3rd-stage disk and intersected the bottom of the dovetail slot.

Require General Electric Aircraft Engines to develop and implement improved inspection techniques that will provide 100 percent inspection coverage of high-stress areas of the CF6-50 and -80 series high-pressure compressor stage 3-9 spool and that will provide the maximum coverage possible of other areas. (A-98-27)
