National Transportation Safety Board

Washington, D.C. 20594
Safety Recommendation

Date: March 17, 1998
In reply refer to: A-98-40

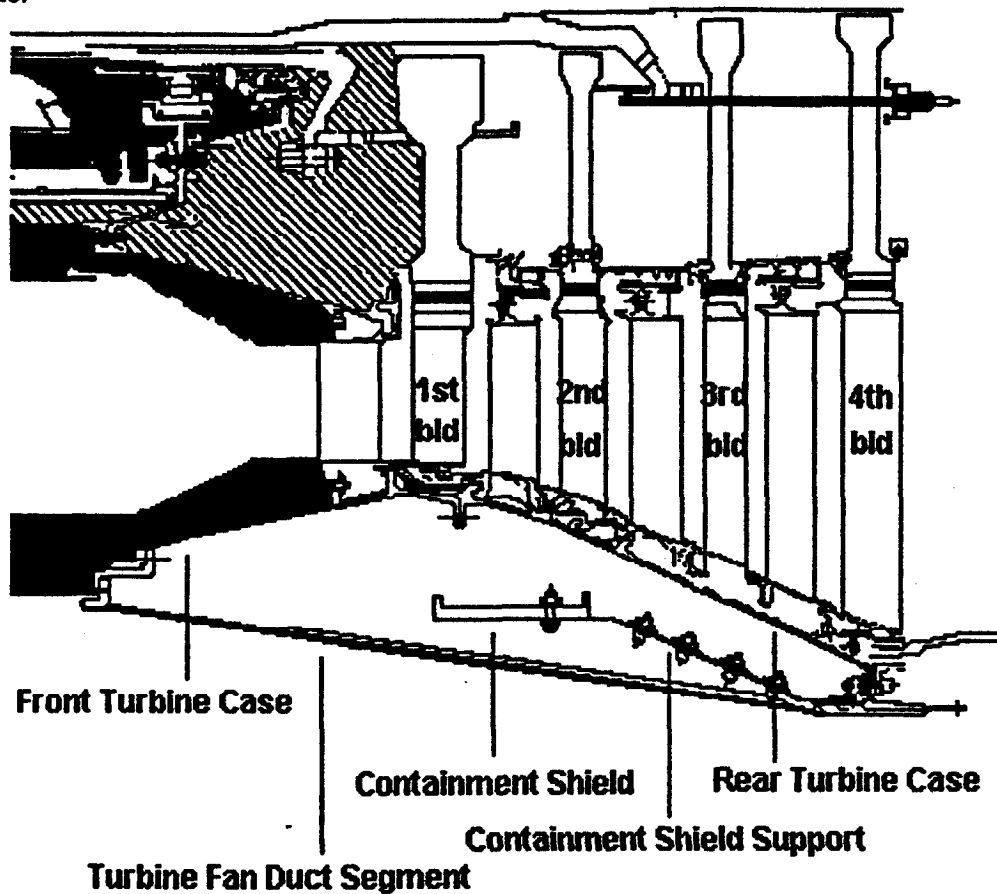
The engine was equipped with an HPT containment shield (see figure 1) as required by Airworthiness Directive (AD) 93-23-10.¹ The AD was issued on January 18, 1994, and is

applicable to all JT8D-209, -217, -217A, -217C, and -219 turbofan engines. The containment shield is a clam shell design consisting of two half-shields joined by clevis plates and supported by a cantilevered shield support attached to the HPT rear flange. Considerable impact damage (engine debris) was observed on the inner diameter (ID) of the containment shield; however, the shield remained intact. The impact of turbine material on the lower shield shifted it outward and aft from its normal installed position, buckling its support. First-stage turbine blades and 2nd-stage turbine vanes had exited the engine through the openings between the HPT and LPT case flanges and deflected off the containment shield ID while exiting the engine and before striking the airframe.

Figure 1 Containment Shield Configuration

The Reno Air and Centennial Airlines incidents have shown that the JT8D-200 series engine HPT containment shield design is inadequate to prevent all turbine parts from being liberated because the support is insufficient to sustain the shield in the proper location when impacted by some exiting turbine material. In addition, the incidents have shown that the containment shield is not wide enough nor the sidewalls deep enough to ensure that exiting material will be contained under a variety of exit paths. The Safety Board is concerned that the current containment shield cannot prevent HPT part liberation and therefore believes that the FAA should evaluate the current P&W JT8D-200 series engine HPT containment shield required by AD 93-23-10 and, if shown by evaluation, require that it be replaced with an HPT containment shield that would provide a larger coverage area and more impact resistance and durability.

Evaluate the current Pratt & Whitney JT8D-200 series engine high-pressure turbine (HPT) containment shield required by Airworthiness Directive 93-23-10 and, if shown by evaluation, require that it be replaced with an HPT containment shield that would provide a larger coverage area and more impact resistance and durability. (A-98-40)
